REPORT ON THE  
FOUNDATION CONDITIONS  
PROPOSED BRIDGE REPLACEMENT  
LEMIEUX, ONTARIO

REPORT ON THE  
FOUNDATION CONDITIONS  
AT  
PROPOSED BRIDGE  
CROSSING OF SOUTH NATION RIVER & BOUNDARY ROAD  
NEAR THE VILLAGE OF LEMIEUX, ONTARIO.  
FOR  
UNITED COUNTIES OF PRESCOTT & RUSSELL  
BY  
F O N D E X    L I M I T E D

File No. 3305-S

June 10th, 1974.

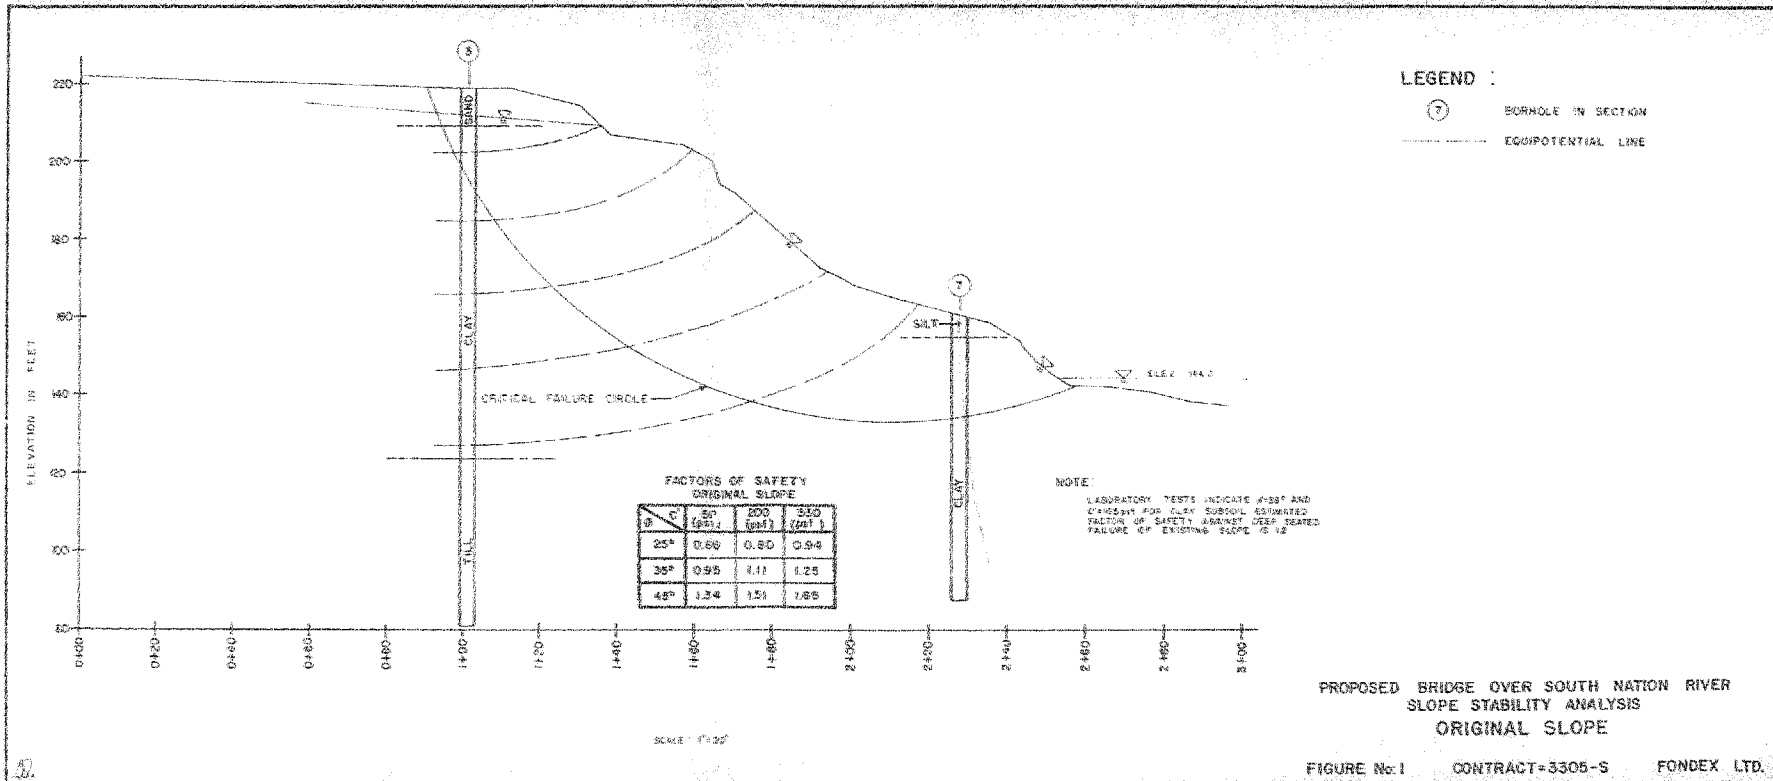
The present original north slope at the bridge centerline has been analyzed for stability using a wide range of shear strength parameters for the clay soil and the highest groundwater pressure conditions measured in the spring of 1974. For analysis, the river level was taken at its low level of elevation 144, on the basis that a rapid drop in river level could result, leaving the high ground water conditions that existed in the soil when the river was high.

The high groundwater table in the soil would not be dissipating as fast as the river fell. The factors of safety found for these conditions are shown in a table on Figure 1. The equipotential lines of groundwater head found from the piezometer readings are also shown on the section.

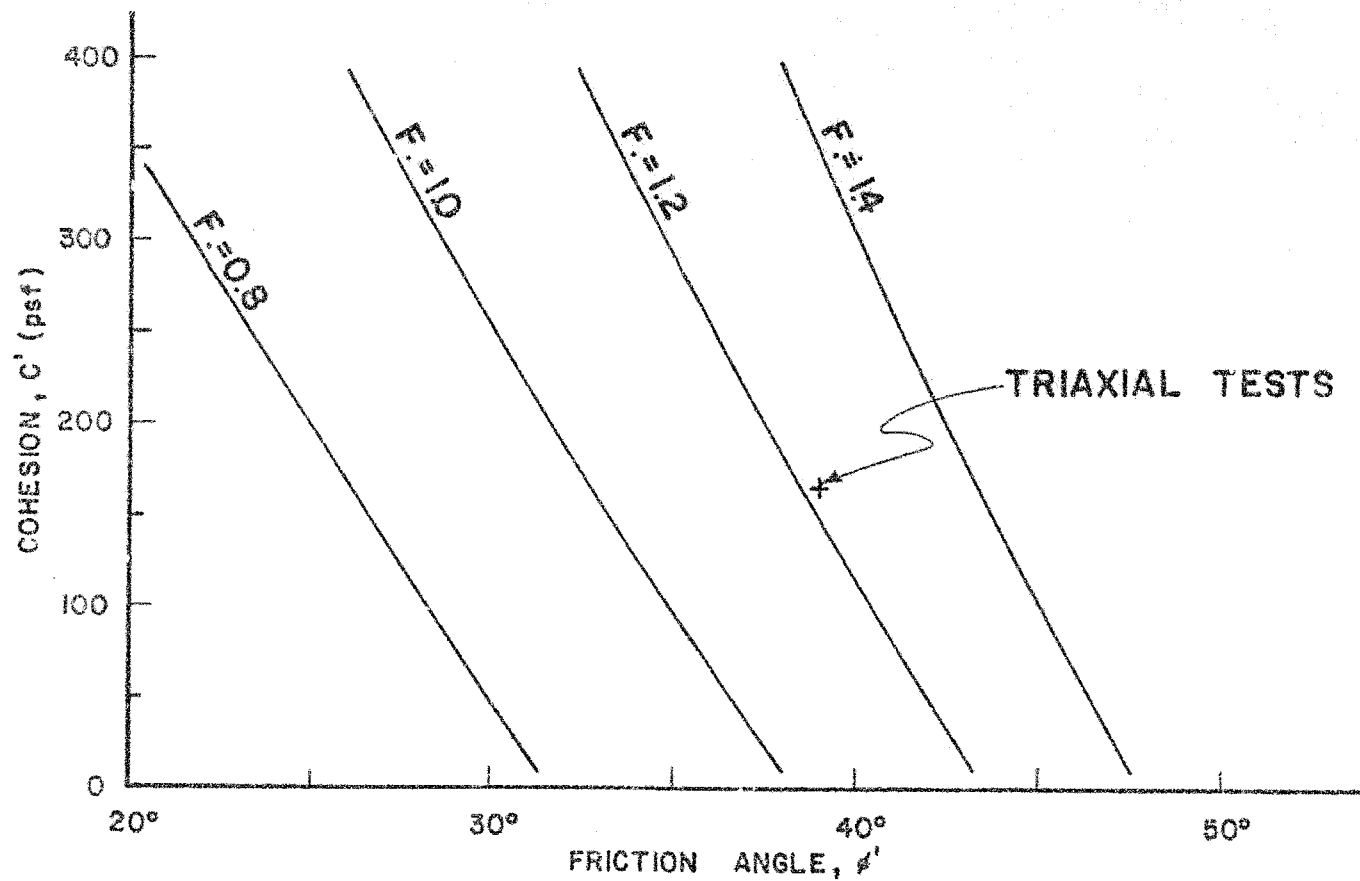
FIGURE No: 2

This shear strength is also plotted on Figure 2 and indicates that the slope has a factor of safety of approximately 1.2. If higher groundwater conditions can exist than occurred in the spring of 1974, the factor of safety would be less. As the toe of the slope does not have a downward flow gradient and in the region of borehole 7 has a slight upward flow gradient, failure is likely to be initiated there. This condition requires that the toe be stabilized by flattening if necessary and by protection against erosion.

SLOPE STABILITY ANALYSIS  
ORIGINAL SLOPE

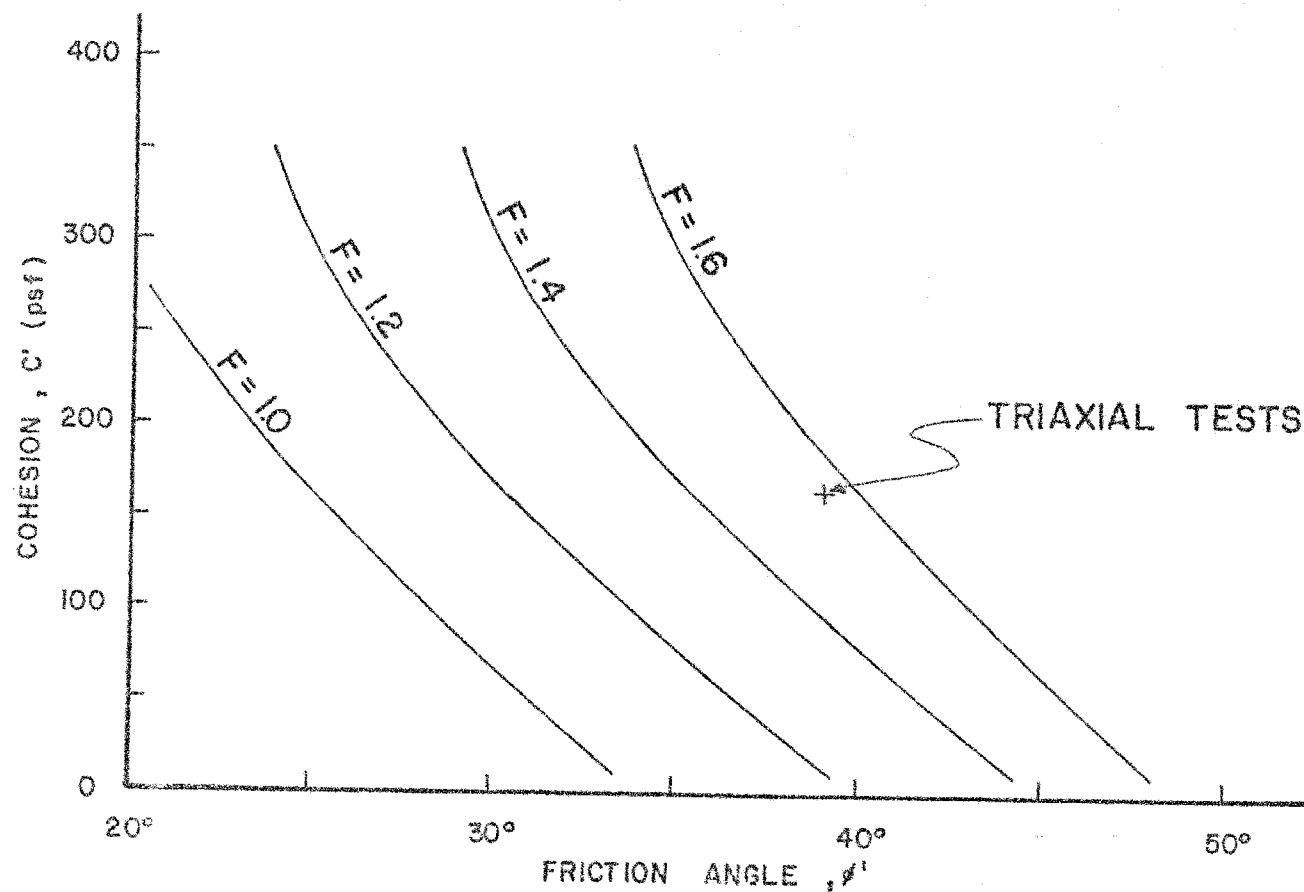
FIGURE No:II

A slope of 3 horizontal to 1 vertical at the bridge centerline has also been analyzed for stability. The groundwater flow conditions assumed for this case are shown in Figure 10. The factors of safety found for a wide range of shear strength parameters is also shown in a table on Figure 10. These factors of safety are summarized in Figure 11. The triaxial test results are plotted on Figure 11 and indicate that a 3:1 slope would have a factor of safety of approximately 1.5. This would appear to be an adequate factor of safety even though seismic forces have not been taken into account in the design.

SLOPE STABILITY ANALYSIS  
3 : 1 SLOPE

8. While the south valley slope needs no treatment for stability, it is recommended that the north valley slope be flattened to 3 horizontal to 1 vertical. The width of the flattened area need only be sufficient to accommodate the roadway, shoulders and ditches. The side slopes of the cut section should be no steeper than 2 horizontal to 1 vertical.
9. The toe of the north slope must be protected against erosion by rock rip-rap, extending from the bottom of the slope to approximate elevation 165. The rip-rap will be required over a distance of about 1400 feet between the two deep gullies on each side of the bridge site.
10. The upper fine sand deposit and the thick sand bands in the clay should be protected from erosion by the flow of groundwater by employing sand and gravel filters, and good surface drainage must be maintained.

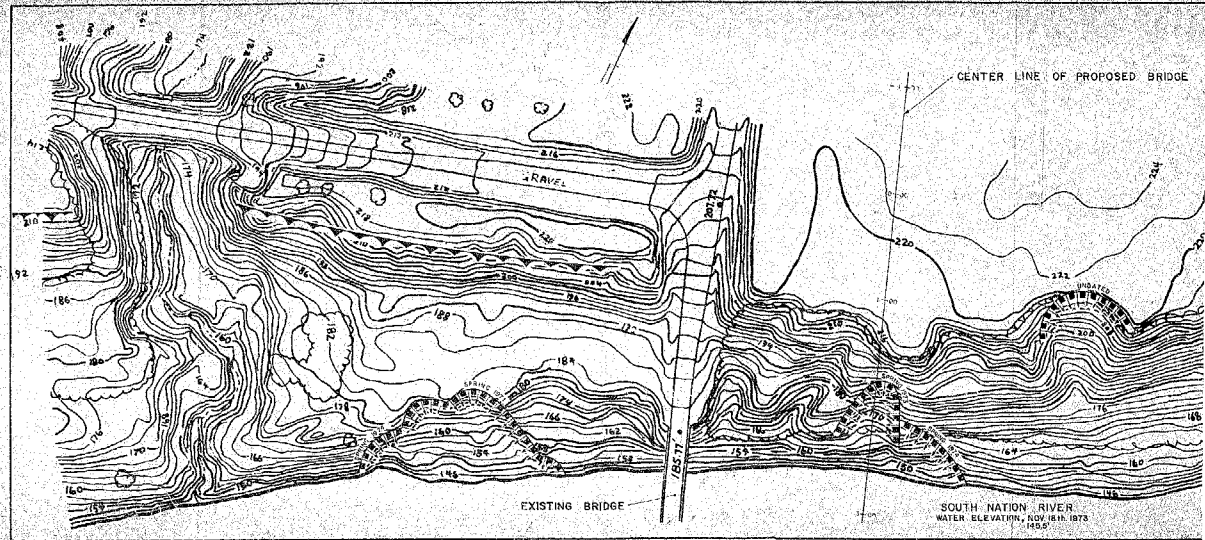
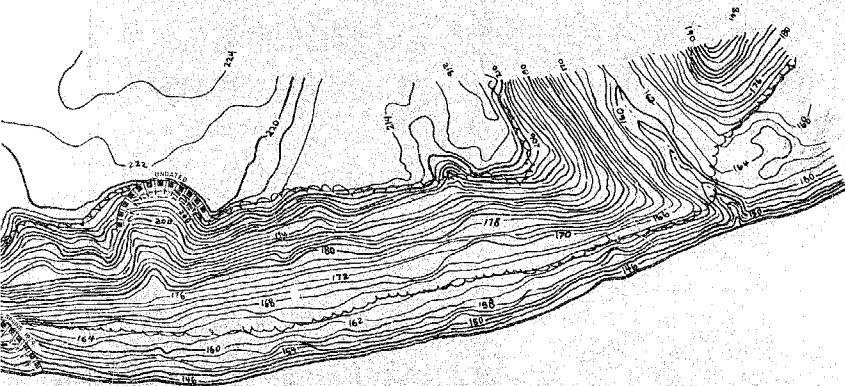
### MINOR FAILURES

river and several small slides have occurred recently, close to the bridge site. Excluding any surficial sliding due to the undercutting by the river, the computer stability analysis of the existing slope gave a factor of safety of 1.2 against a deep seated landslide. This factor of safety is not considered to be adequately high in view of the conditions which exist at this site. To be specific, if groundwater conditions higher than those experienced in the spring of 1974 were to occur, the factor of safety would be reduced. In addition, no allowance has been provided in the stability analysis for possible seismic forces. A flatter slope of 3 horizontal to 1 vertical produces a factor of safety of about 1.5, which is considered to be adequate even though seismic forces have not been accounted for in the analysis.
