LOCATION Slope Instability
South Bank of Ottawa River

DATE: November 22, 1973.

FOUNDATION INVESTIGATION REPORT
For
Slope Instability, South Bank of
Ottawa River
(Hwy. 17 Between Station 262 and Station 380)
Township of Cumberland
Regional Municipality of Ottawa-Carleton
W.O. 73-11053(X) - W.P. 159-73-01

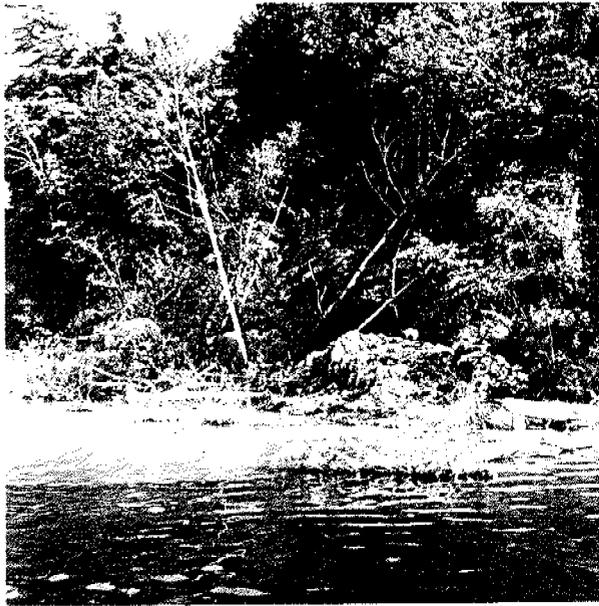
- i) This stretch of Hwy. 17 is located on the top of the Ottawa River bank. It was approximately 45 feet above the river water level during the time of the field observations. The overall slope of the river bank in this area ranges from 3:1 to 4:1. Heavy growth of trees and bushes exist at the lower half of the slope surface.
- ii) Active toe erosion was evident, resulted with localized near-vertical slopes of up to 10 feet high.
- iii) Two old failures (Station 263 and Station 265) were visible at mid-height of the river bank slope.
- iv) A distinctive toe failure was observed at Station 271 immediately west of the Cumberland Park. The size of this failure is approximately 50' wide by 20' deep. Grey marine Leda Clay was exposed (Refer to Plate Nos. 1, 2 and 11).

PLATE No.1
TOE FAILURE AT STATION 271

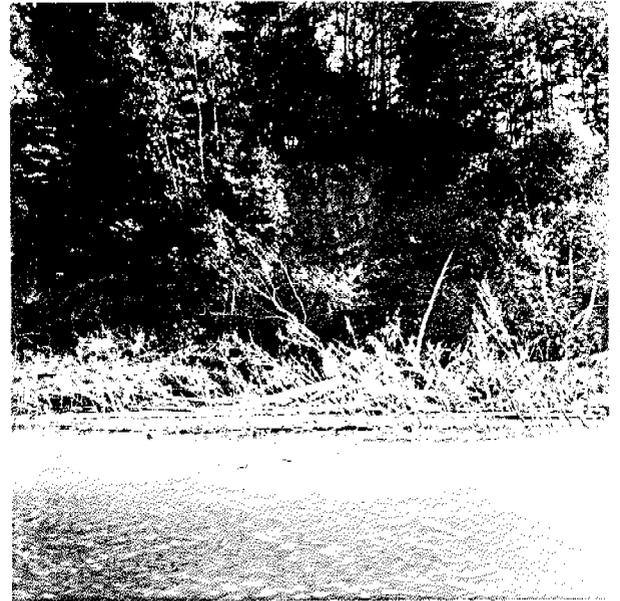
PLATE No.2
TOE FAILURE AT STATION 271

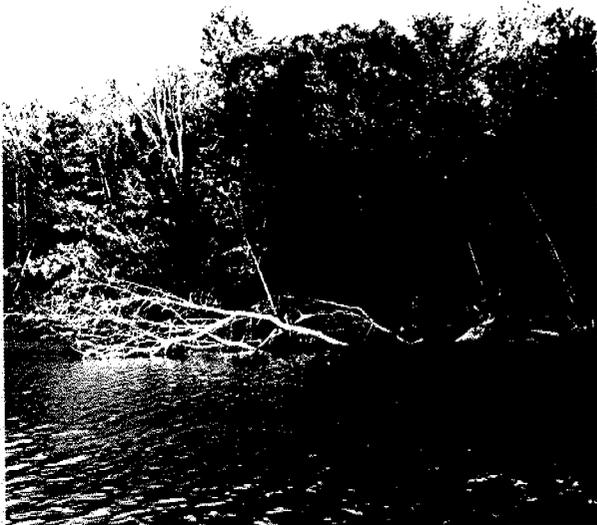
PLATE No. 7
TILTING OF TREES
STATION 373 TO STATION 380

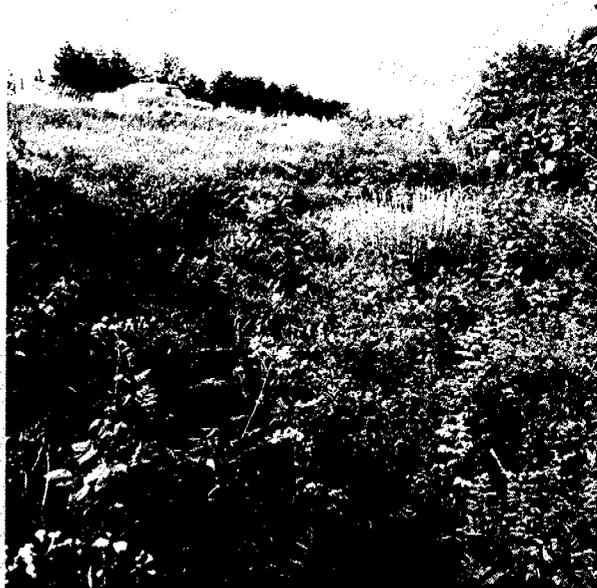
PLATE No. 8
SCAR OF OLD FAILURE

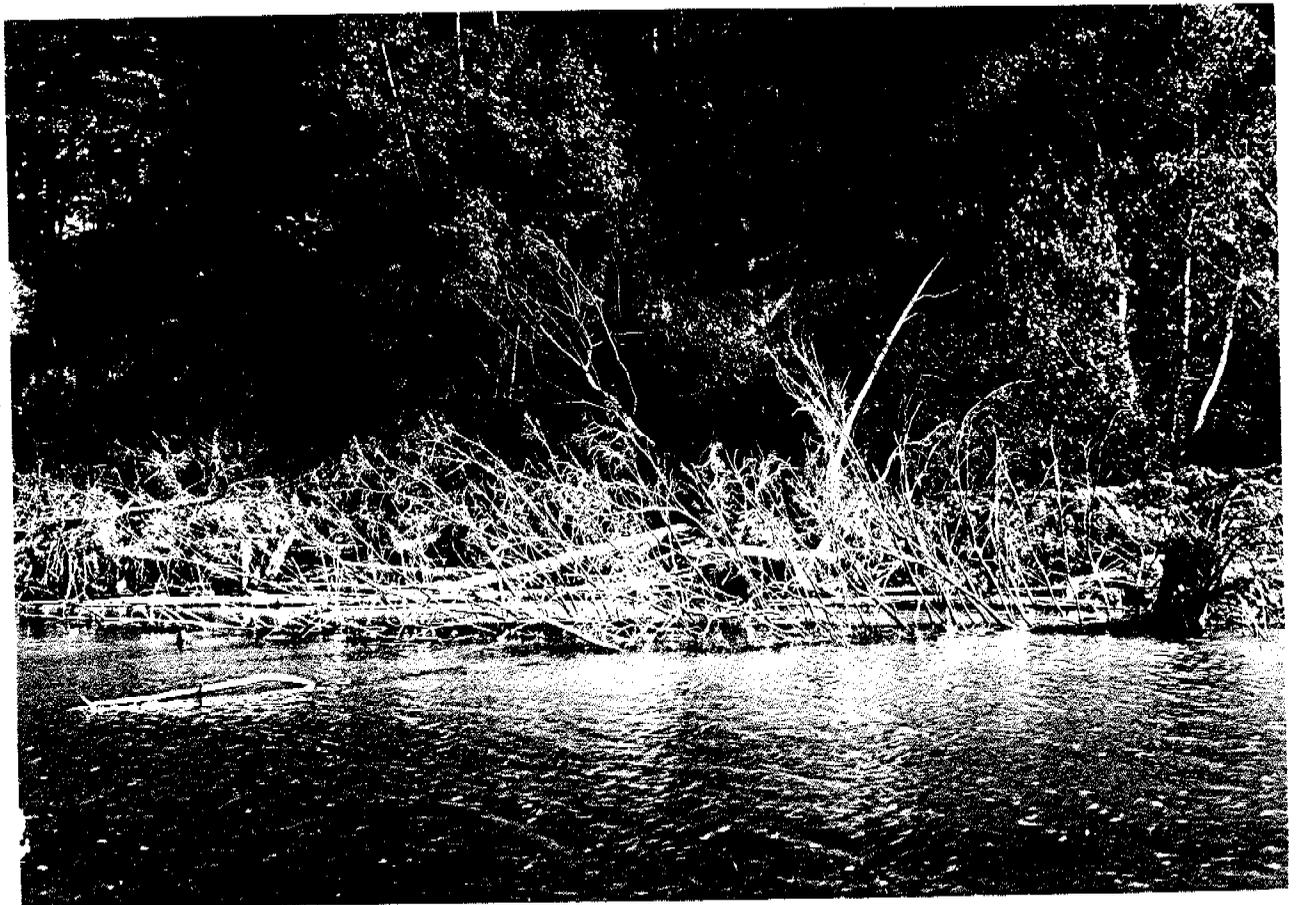
PLATE No. 11 TOE FAILURE AT STATION 271

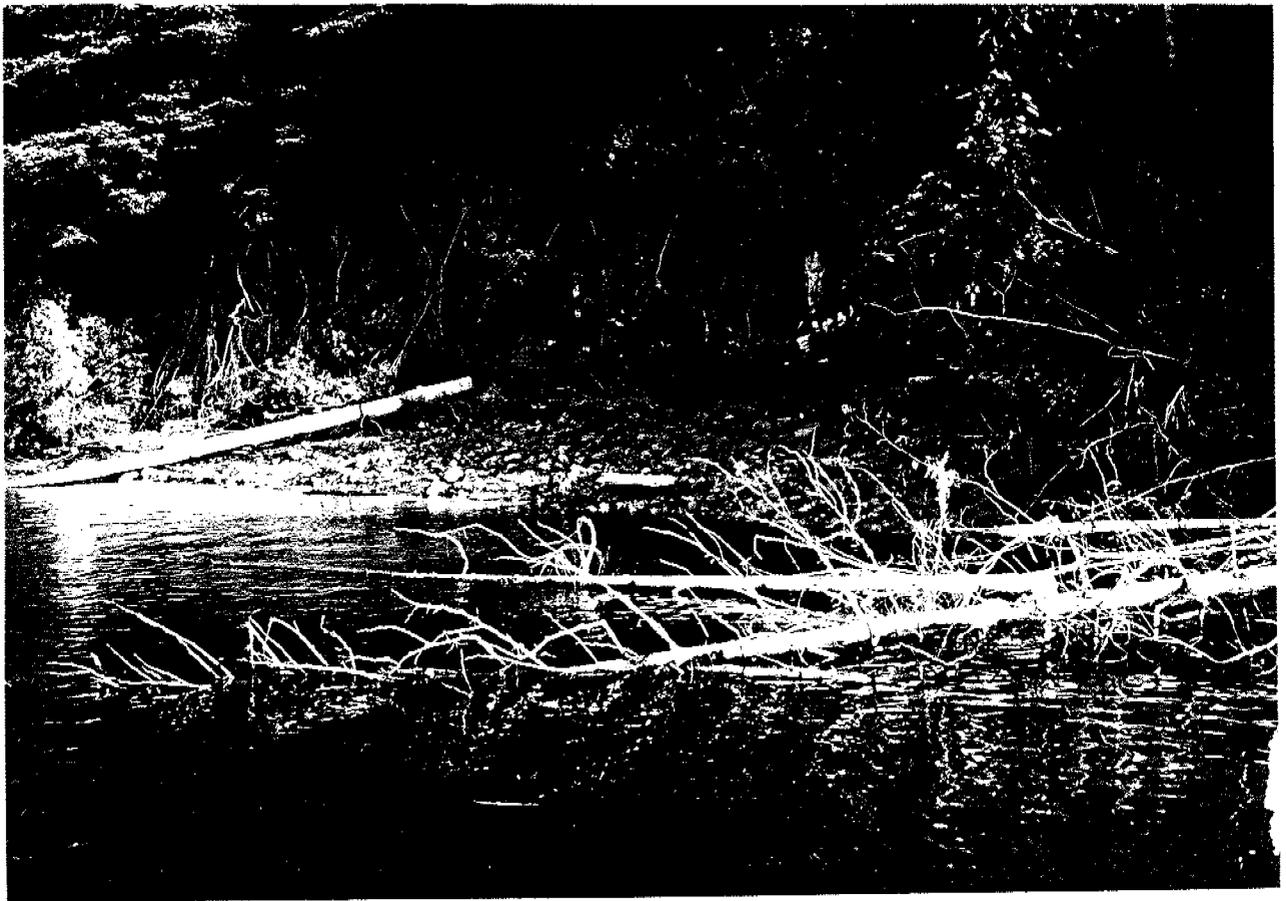
PLATE No. 12 TOE EROSION STATION 301 TO 307

In order to prevent any further toe erosion, rock fill toe berms extending to elevation 152 (approximately 2 feet higher than H.W.L.) will be necessary. It is further suggested that the existing condition of the slope above the berm elevation be conserved as the grass, bushes and trees would probably cut down the surficial erosion and lower the groundwater table, hence increase the stability of the river bank slopes.

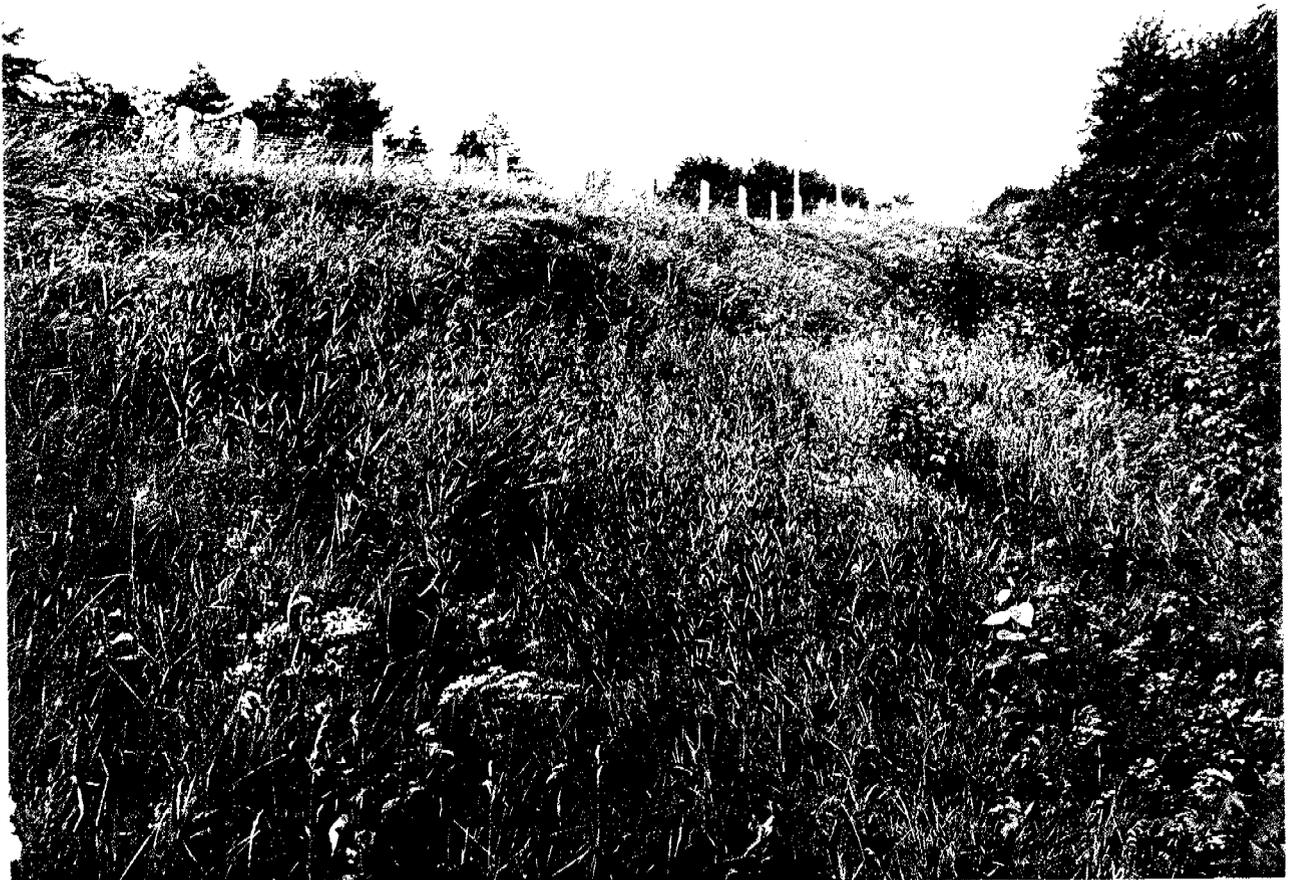
PLATE No.15 SCAR OF OLD FAILURE

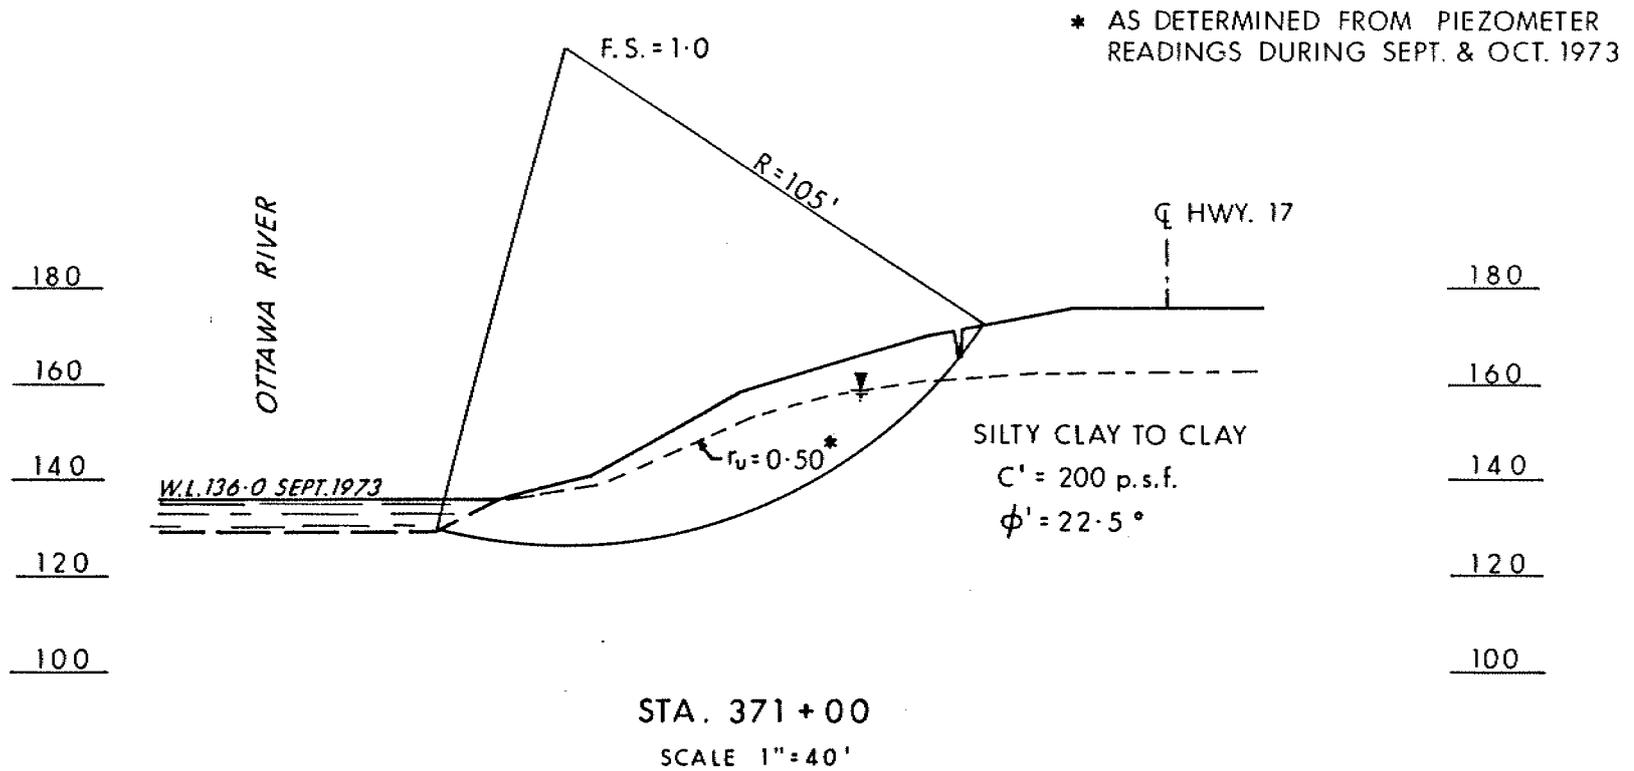
FIG. 16

In addition, W. J. Eden* proved that ϕ' contributes a relatively small portion of the shear strength mobilized along the potential slip surface and consequently small variation in the value of ϕ' does not significantly affect the computed factor of safety. The chosen slope was then analyzed using Bishop's slices method on the actual ground contours, with various combination of C' and the pore-pressure ratio r_u ($r_u = \frac{u}{\gamma h}$ where u is the excess pore-pressure at any point along the potential failure surface, h , the depth of the point in the soil mass below the soil surface and γ the bulk density of the soil). For $r_u = 0.62$ (groundwater table at surface and horizontal flow only), which is the most critical condition, a value of C' of 250 p.s.f. will yield a factor of safety of 1.0 (Refer to Figure No. 16). For $r_u = 0.5$, which represents the groundwater conditions prevailed in September, 1973, a value of C' of 200 p.s.f. gave a factor of safety of unity (Refer to Figure No. 17).

This portion of the Ottawa River Bank adjacent to Hwy. 17 failed during spring of 1973 after heavy rainfalls. Detailed stability analysis (Figure No. 16 and No. 17) were carried out by this office immediately after the failure and the necessary remedial measures (Figure No. 22 to No. 27) were provided to the Ottawa District. The suggested remedial measures were immediately incorporated. According to our recent field observations, this portion of the river banks appeared to be in a stable condition without any signs of distress.

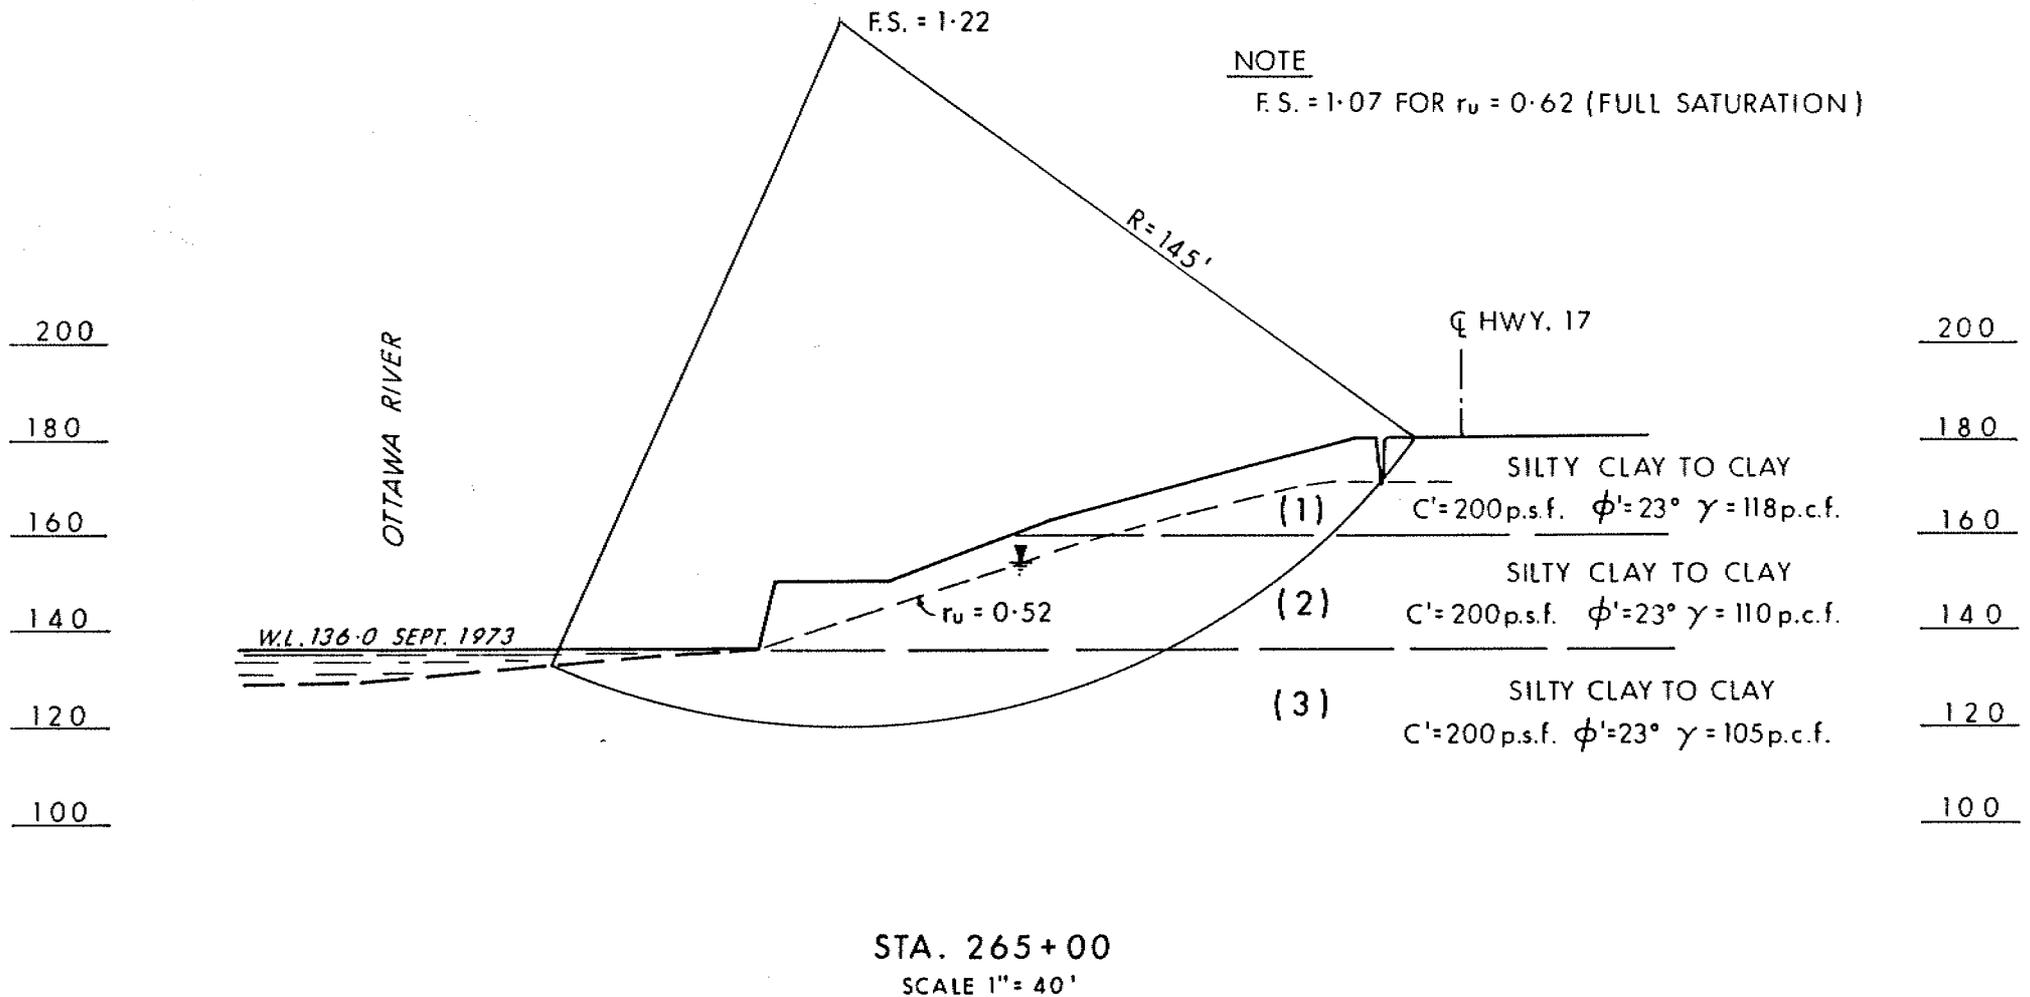
FIG. 17

Field observation was made by Dr. N. R. Gadd of Terrain Sciences Division of Federal Department of Energy, Mines and Resources, immediately after the failure took place. In his report, Dr. Gadd expressed that the drainage ditch on the south side of the highway showed evidence of long term saturation by the abundant growth of cat-tails in the ditch. Water was held in depressions in the vicinity of the distressed zone. In view of this, r_u should be very close to 0.62 at the time the failure took place.

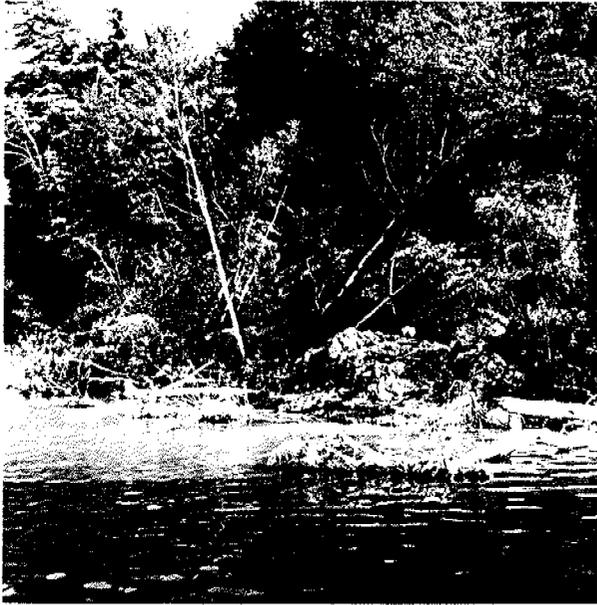
PLATE No.1

TOE FAILURE AT STATION 271

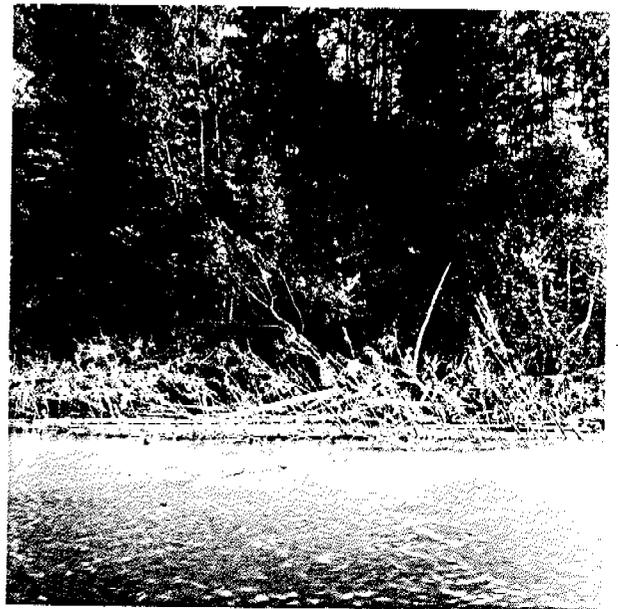
PLATE No.2

TOE FAILURE AT STATION 271

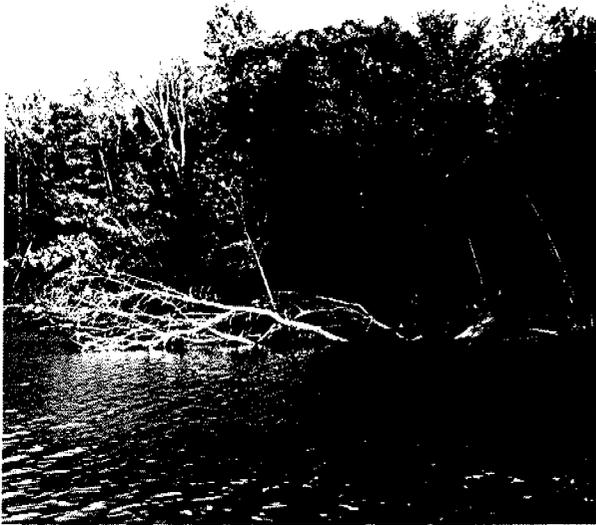
PLATE No 7
TILTING OF TREES
STATION 373 TO STATION 380

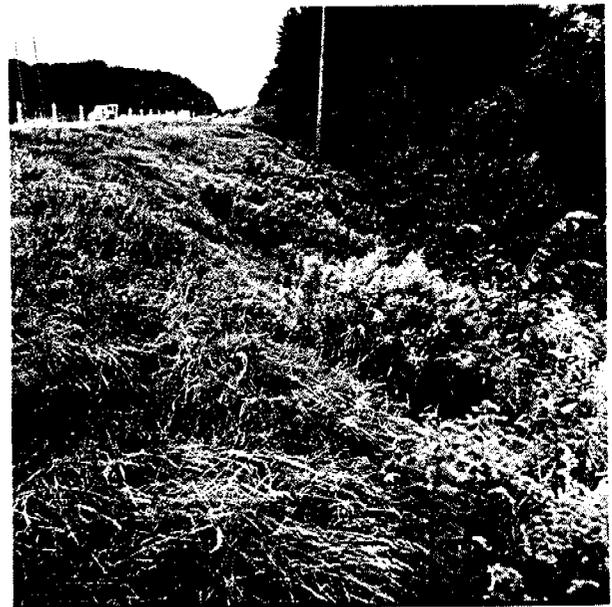
PLATE No 8
SCAR OF OLD FAILURE
