**foundation
investigation and
design report**

Embankment Instabilities
Orleans to Rockland

FOUNDATION INVESTIGATION REPORT

For
Embankment Instabilities
W.O. 86-11007; Site N/A
Hwy. 17, District 9, Ottawa

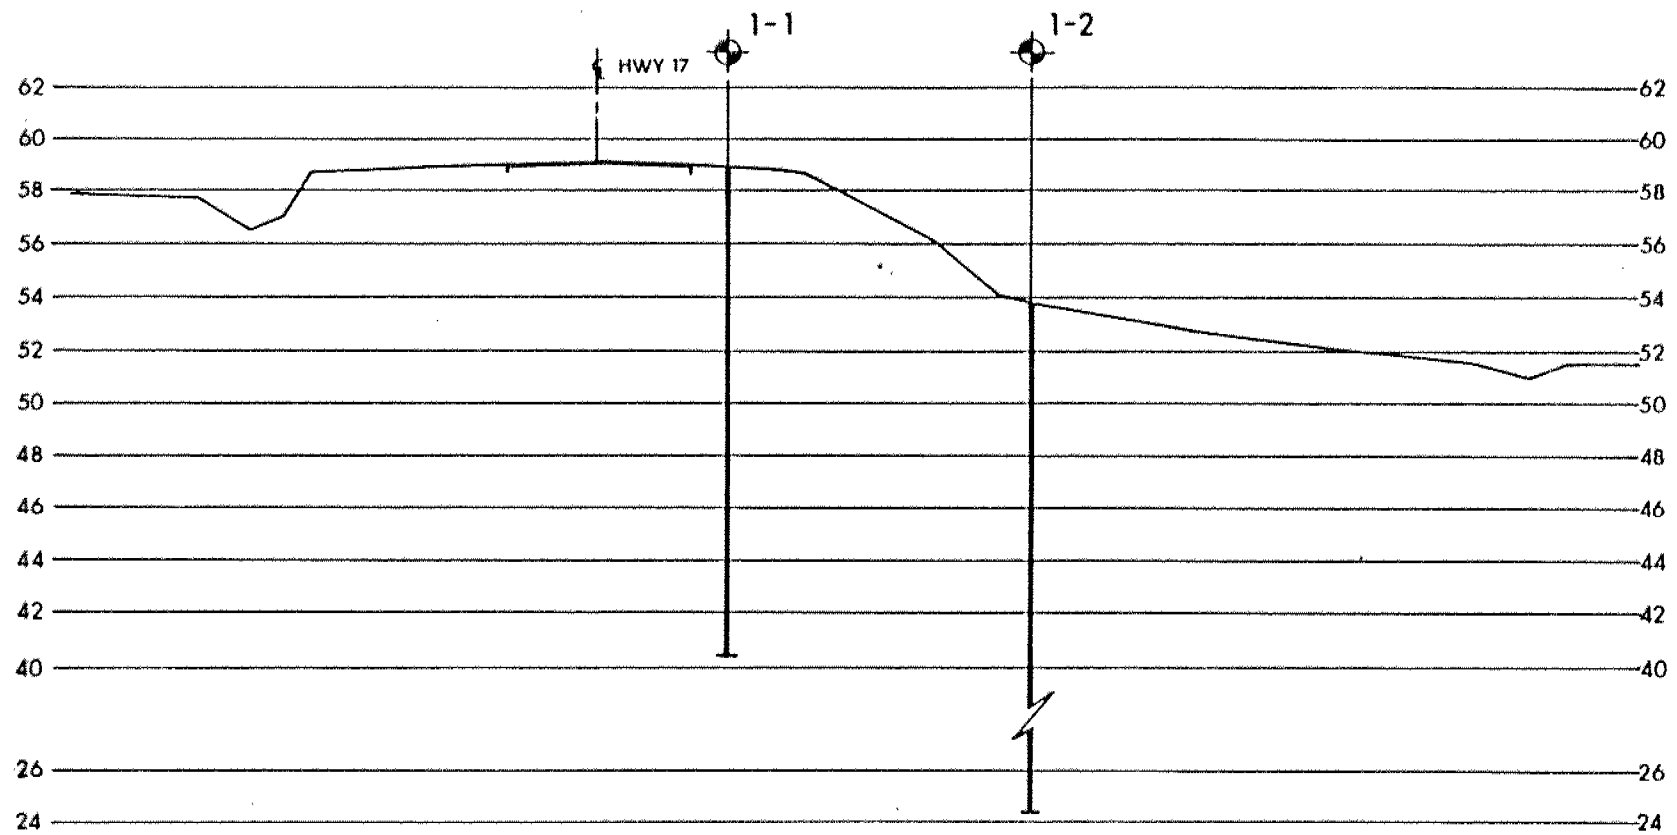
SECTION AT STA. 11+811.0
(SITE 1)

LEFT (NORTH)	RIGHT (SOUTH)
HORIZONTAL EXTENT	NA	Sta. 11+765 to Sta. 11+835
EXISTING EMBANKMENT GEOMETRY (APPROXIMATE)		5.2 m high @ 1.5H:1V
PROBLEM DESCRIPTION		- surficial failures
REMEDIAL RECOMMENDATIONS		- flatten slope to 2H:1V - apply blanket
PRIORITY		Low

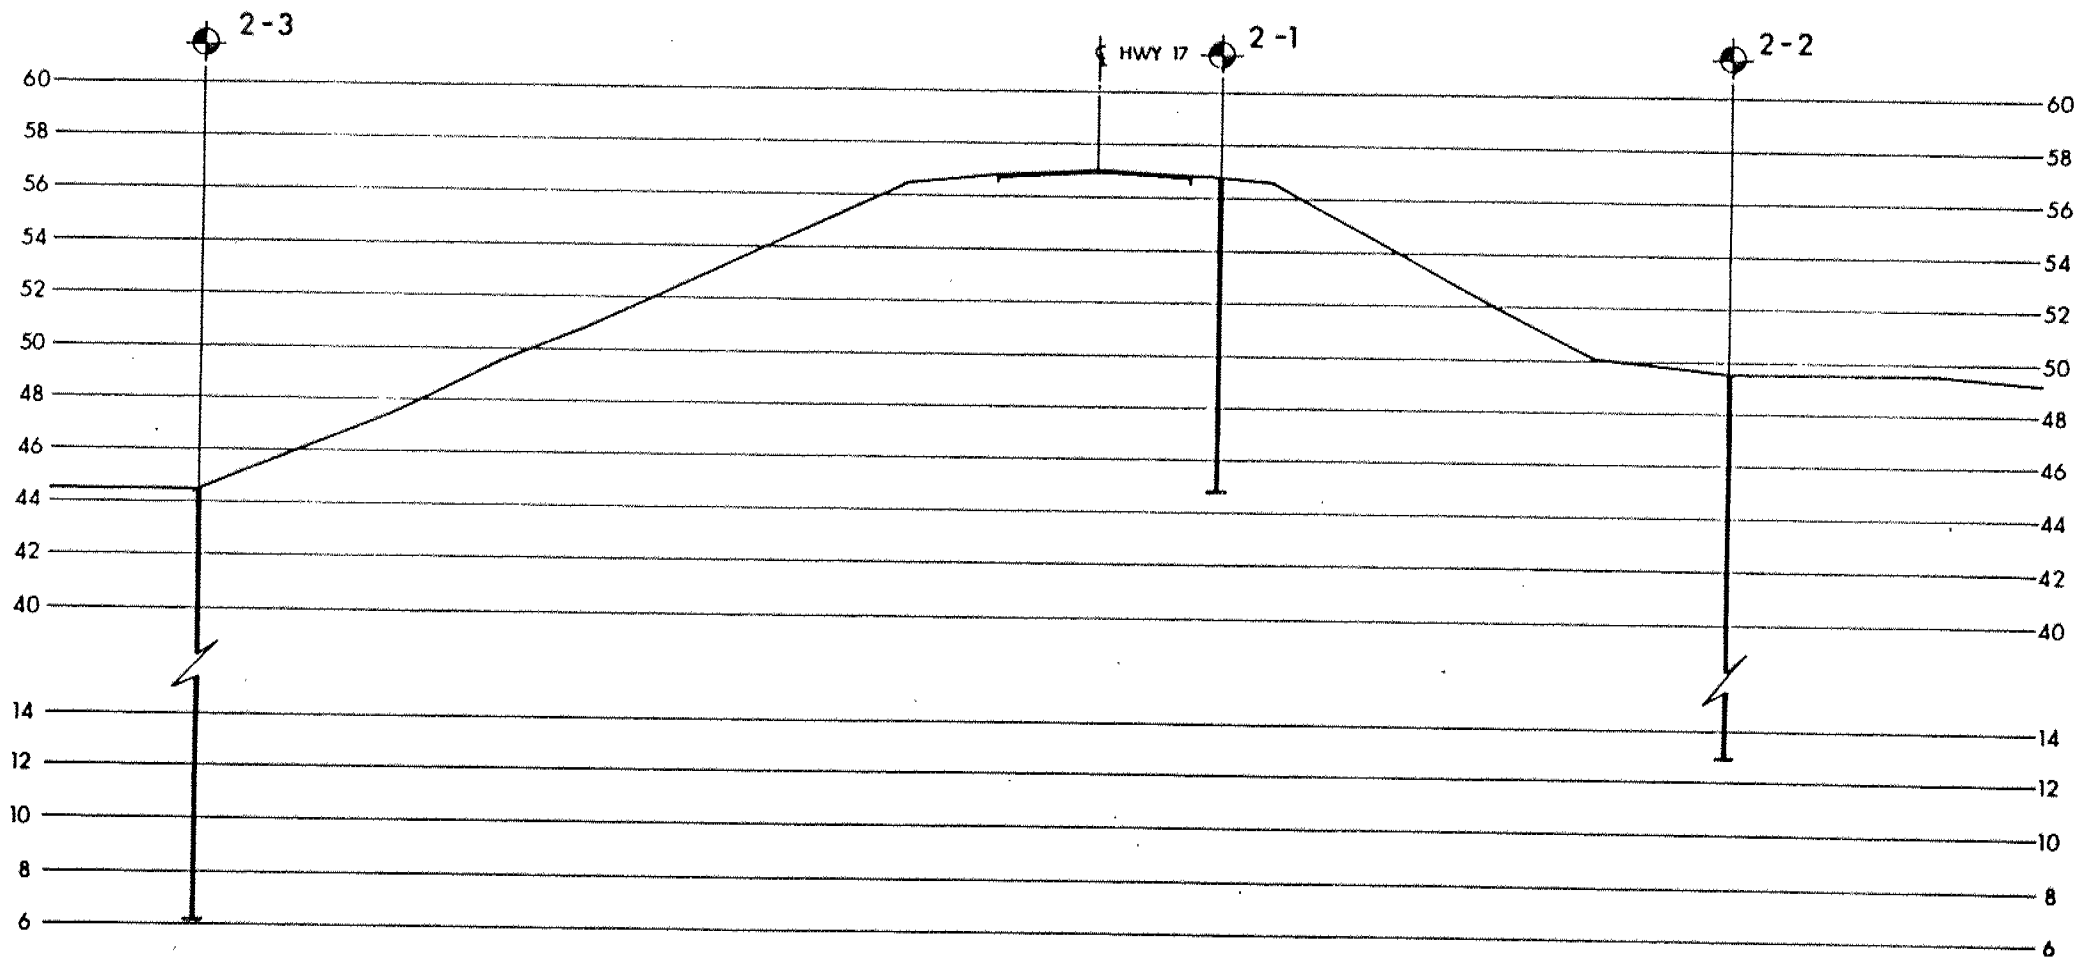
SECTION AT STA. 12+588.4
(SITE 2)

LEFT (NORTH)	RIGHT (SOUTH)
HORIZONTAL EXTENT	Sta. 12+560 to Sta. 12+675	Sta. 12+480 to Sta. 12+655
EXISTING EMBANKMENT GEOMETRY (APPROXIMATE)	12.2 m high @ 2H:1V	6.4 m high @ 1.9H:1V
PROBLEM DESCRIPTION	<ul style="list-style-type: none"> - surficial failures - unacceptably low safety factor against deep-seated failure 	<ul style="list-style-type: none"> - surficial failures
REMEDIAL RECOMMENDATIONS	<ul style="list-style-type: none"> *REFER TO SITE #2 DETAILS - maintain maximum slope of 2H:1V - apply blanket - construct berm 	<ul style="list-style-type: none"> - flatten slope to 2H:1V - apply blanket
PRIORITY	High	Medium

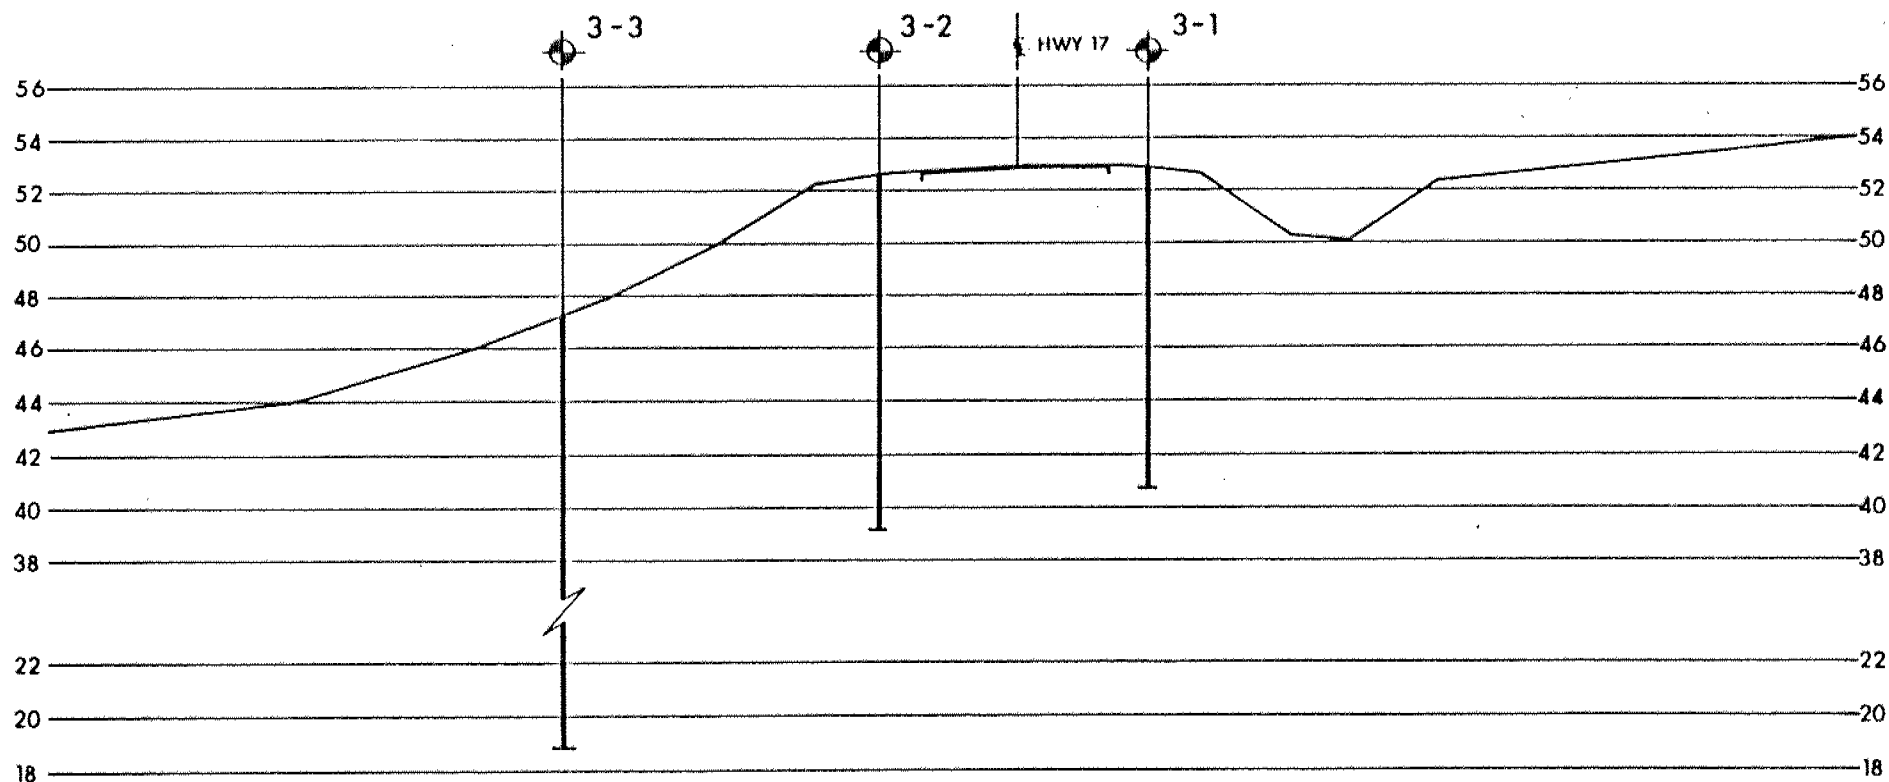
SECTION AT STA. 23+153.0
(SITE 3)

LEFT (NORTH)	RIGHT (SOUTH)
HORIZONTAL EXTENT	Sta. 23+050 to Sta. 23+200	approx. same as left chainage
EXISTING EMBANKMENT GEOMETRY (APPROXIMATE)	8.5 m high @ 2.3H:1V	2.4 m high @ 1.4H:1V
PROBLEM DESCRIPTION	<ul style="list-style-type: none"> - surficial failures - undermining and erosion at culvert outlet - unstable existing gabion structure 	<ul style="list-style-type: none"> - surficial failures - space restrictions
REMEDIAL RECOMMENDATIONS	<p>*REFER TO SITE #3 DETAILS</p> <ul style="list-style-type: none"> - maintain maximum slope of 2H:1V - apply blanket - construct berm - realign outlet creek parallel to culvert - backfill existing meandering outlet creek <p>Option 1: extend culvert Option 2: build gabion outlet structure Option 3: construct culvert outlet with rockfill</p>	<p>Option 1 - maintain drainage with culvert pipe parallel to highway</p> <ul style="list-style-type: none"> - flatten slope by backfilling - apply blanket <p>Option 2 - continued inspection and repair as required by end dumping rockfill to flatten slope</p>

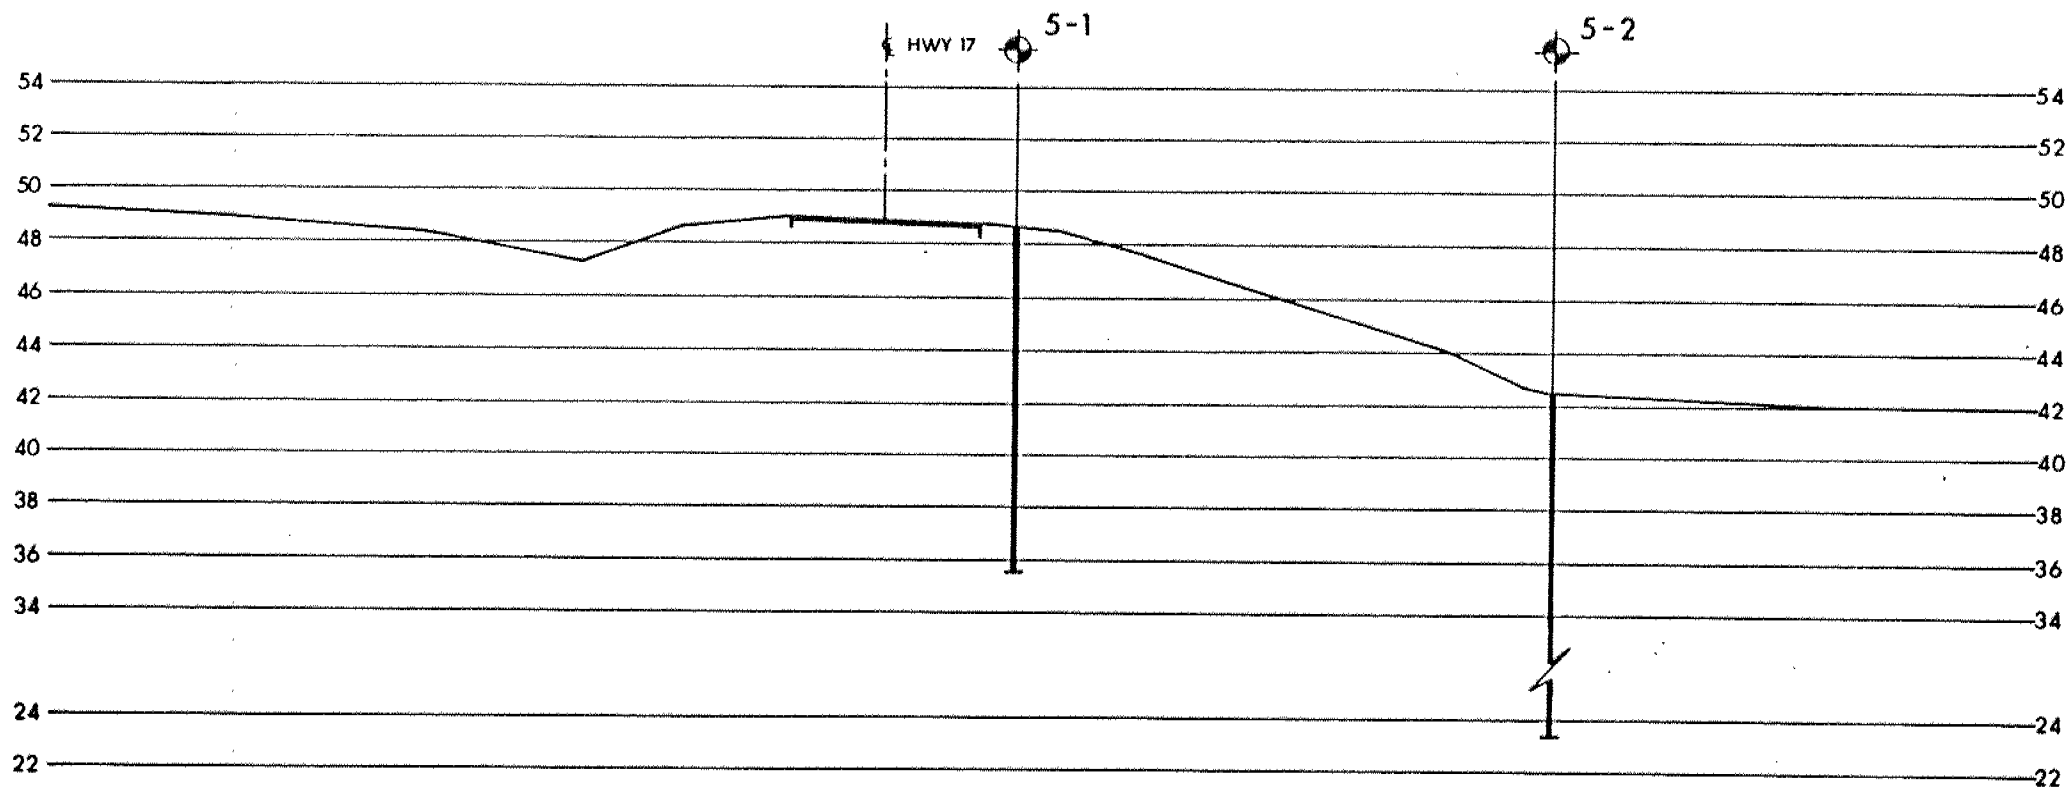
SECTION AT STA. 15+399.0
(SITE 5)

LEFT (NORTH)	RIGHT (SOUTH)
HORIZONTAL EXTENT	NA	Sta. 15+330 to Sta. 15+380
EXISTING EMBANKMENT GEOMETRY (APPROXIMATE)		6 m high @ 2H:1V
PROBLEM DESCRIPTION		- surficial failures
REMEDIAL RECOMMENDATIONS		- establish slopes @ 2H:1V or flatter - construct blanket
PRIORITY		Low - except for Sta. 15+350 to Sta. 15+360 which is medium priority

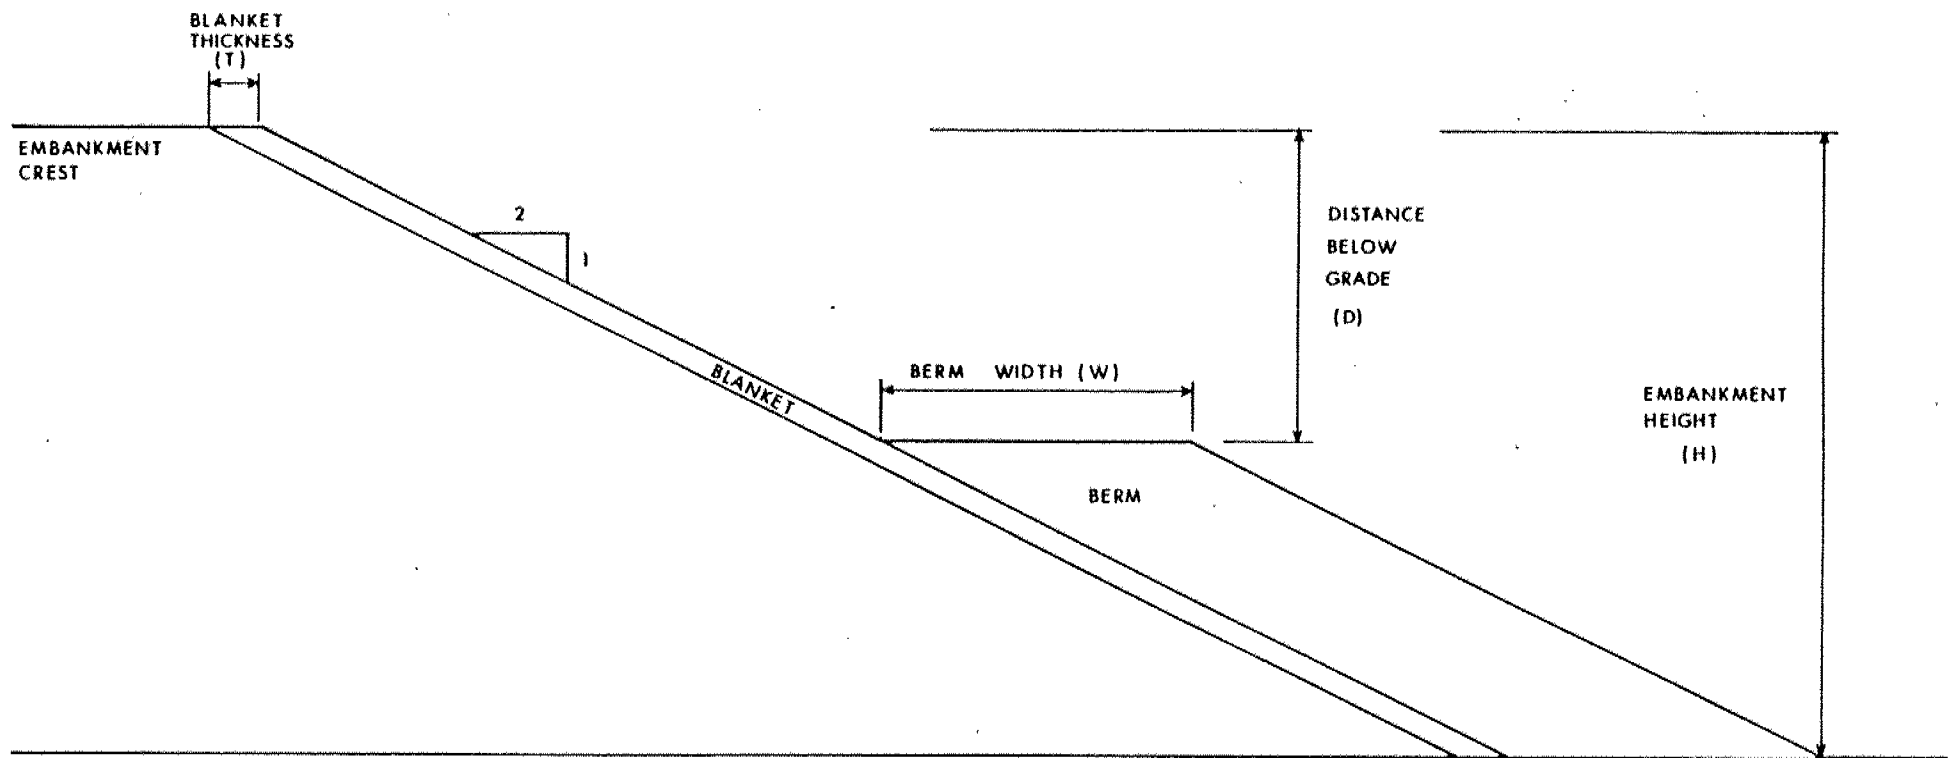
Figure -9

The instabilities at these sites are generally surficial failures characterized by slips and erosion. They are caused by the properties of the embankment material (clay) and the embankment geometry (relatively high embankments with relatively steep slopes).

The remedial recommendations for a typical instability are illustrated in Figure 9. Basically the slopes should be flattened to 2H:1V and covered with a 1 m thick blanket of rock fill or free-draining granular material.

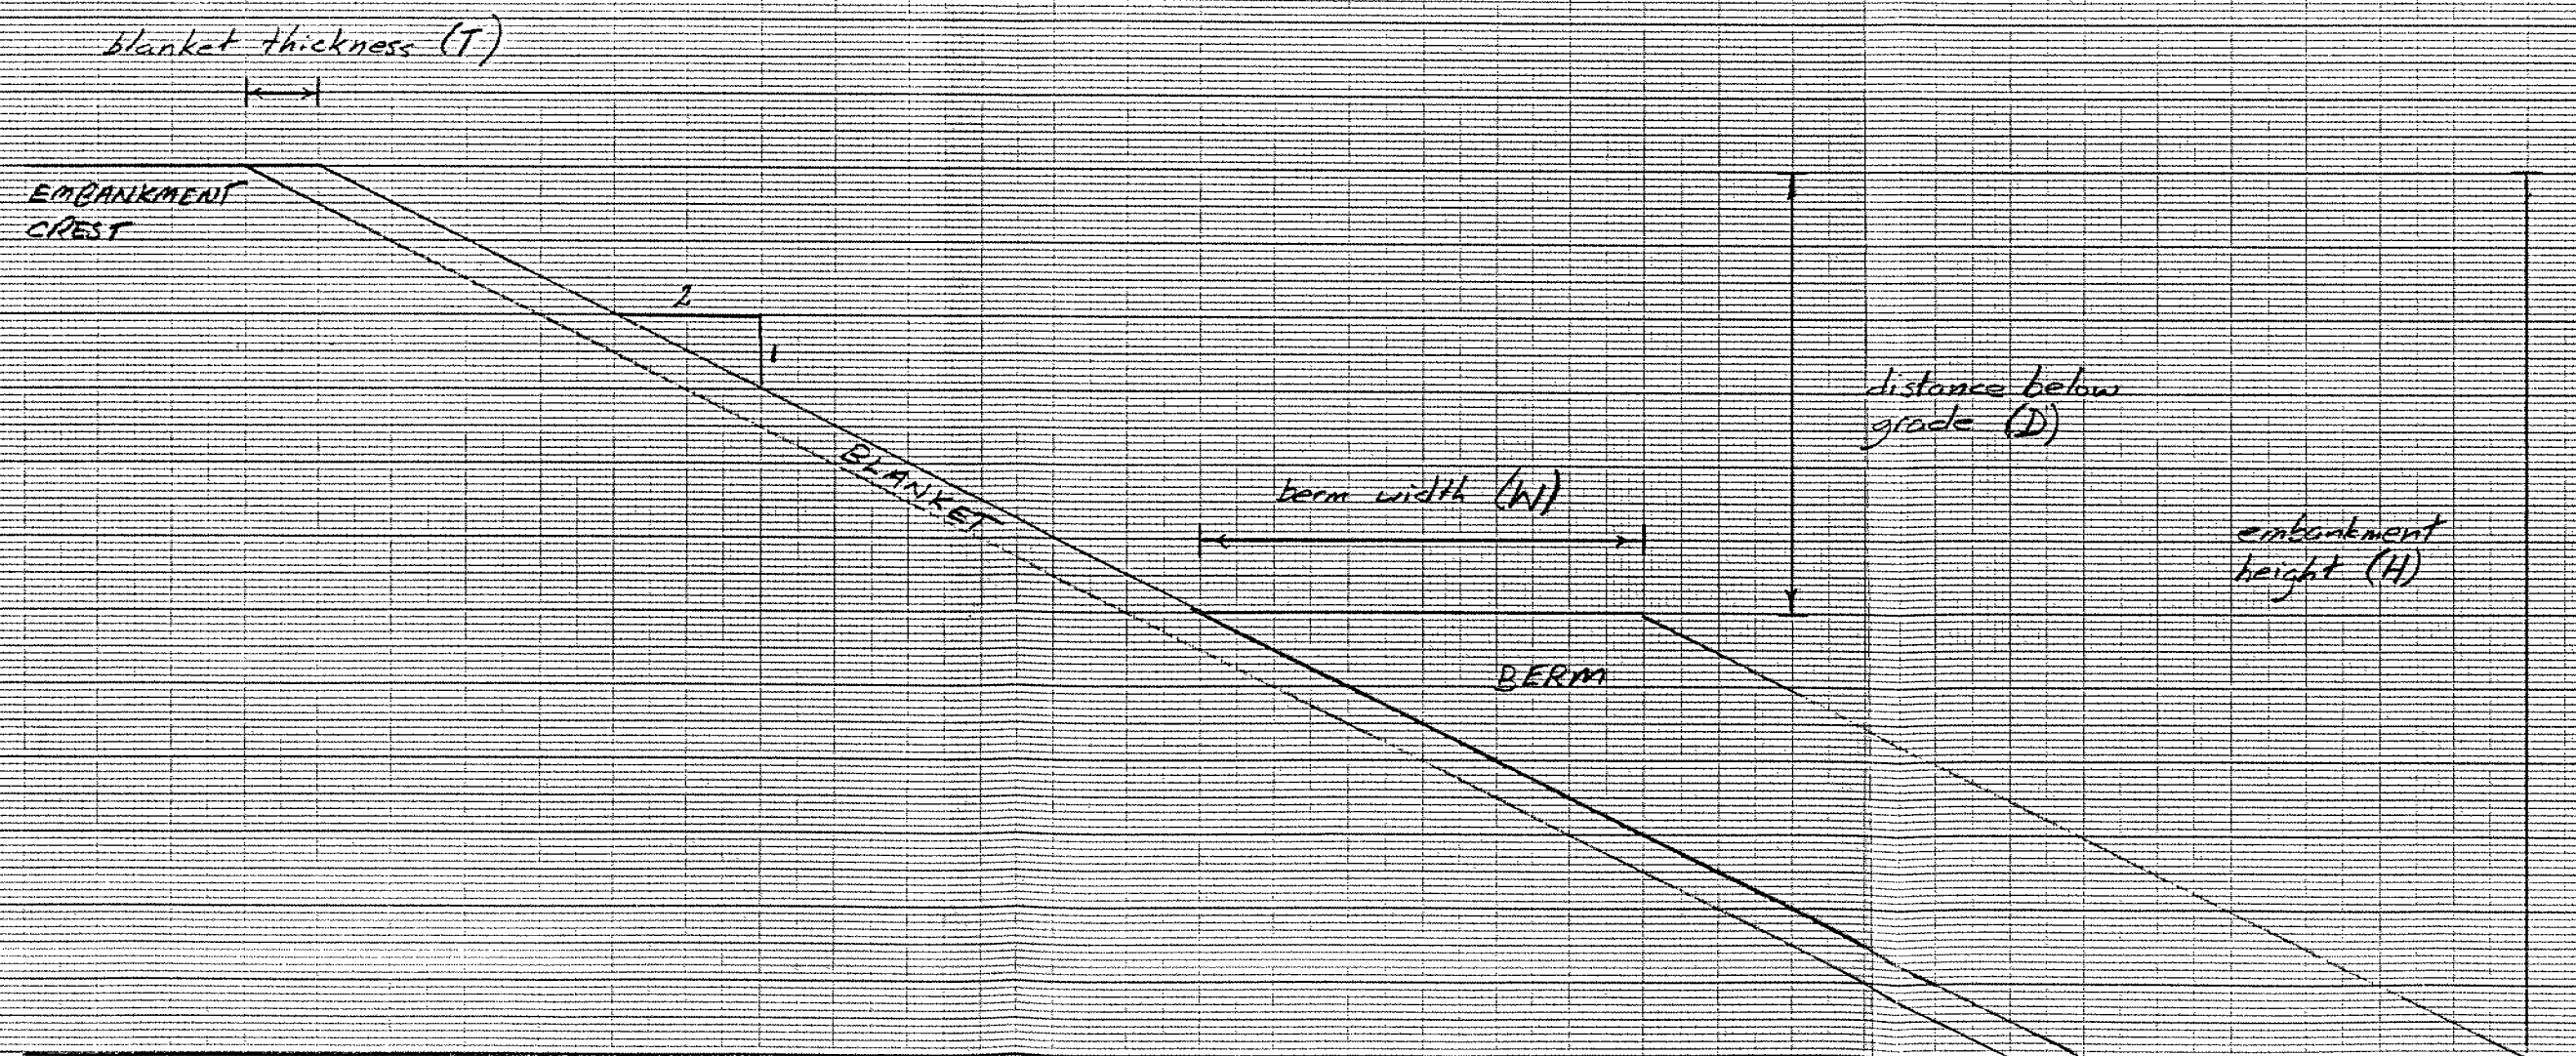
RECOMMENDED EMBANKMENT GEOMETRY

The instabilities at these sites are generally surficial failures characterized by slips and erosion. They are caused by the properties of the embankment material (clay) and the embankment geometry (relatively high embankments with relatively steep slopes). However, at Site 2 there are concerns that the present embankment geometry is near the deep-seated failure threshold.

The remedial recommendations for this typical instability are illustrated in Figure 1. Basically the slopes should be flattened to 2H:1V and covered with a 1 m thick blanket of rock fill or free-draining granular material.
