HWY. No. 17LOCATION Hwy 17 - Slope & Shoulder
 Failures ; Top of CumberlandNo of PAGES - 1

MEMORANDUM

Re: Slope Instability - Hwy 17 (approximately
0.5 km west of Regional Rd. 35)
Twp of Cumberland
W.P. 502-93-00
District 9, Ottawa

RE: Shoulder & Slope Failures at Sta 19+475, Twp of Cumberland.
WP 502-93-00, Hwy. 17 From Reg Rd # 37 to Rockland, Dist 9, Ottawa

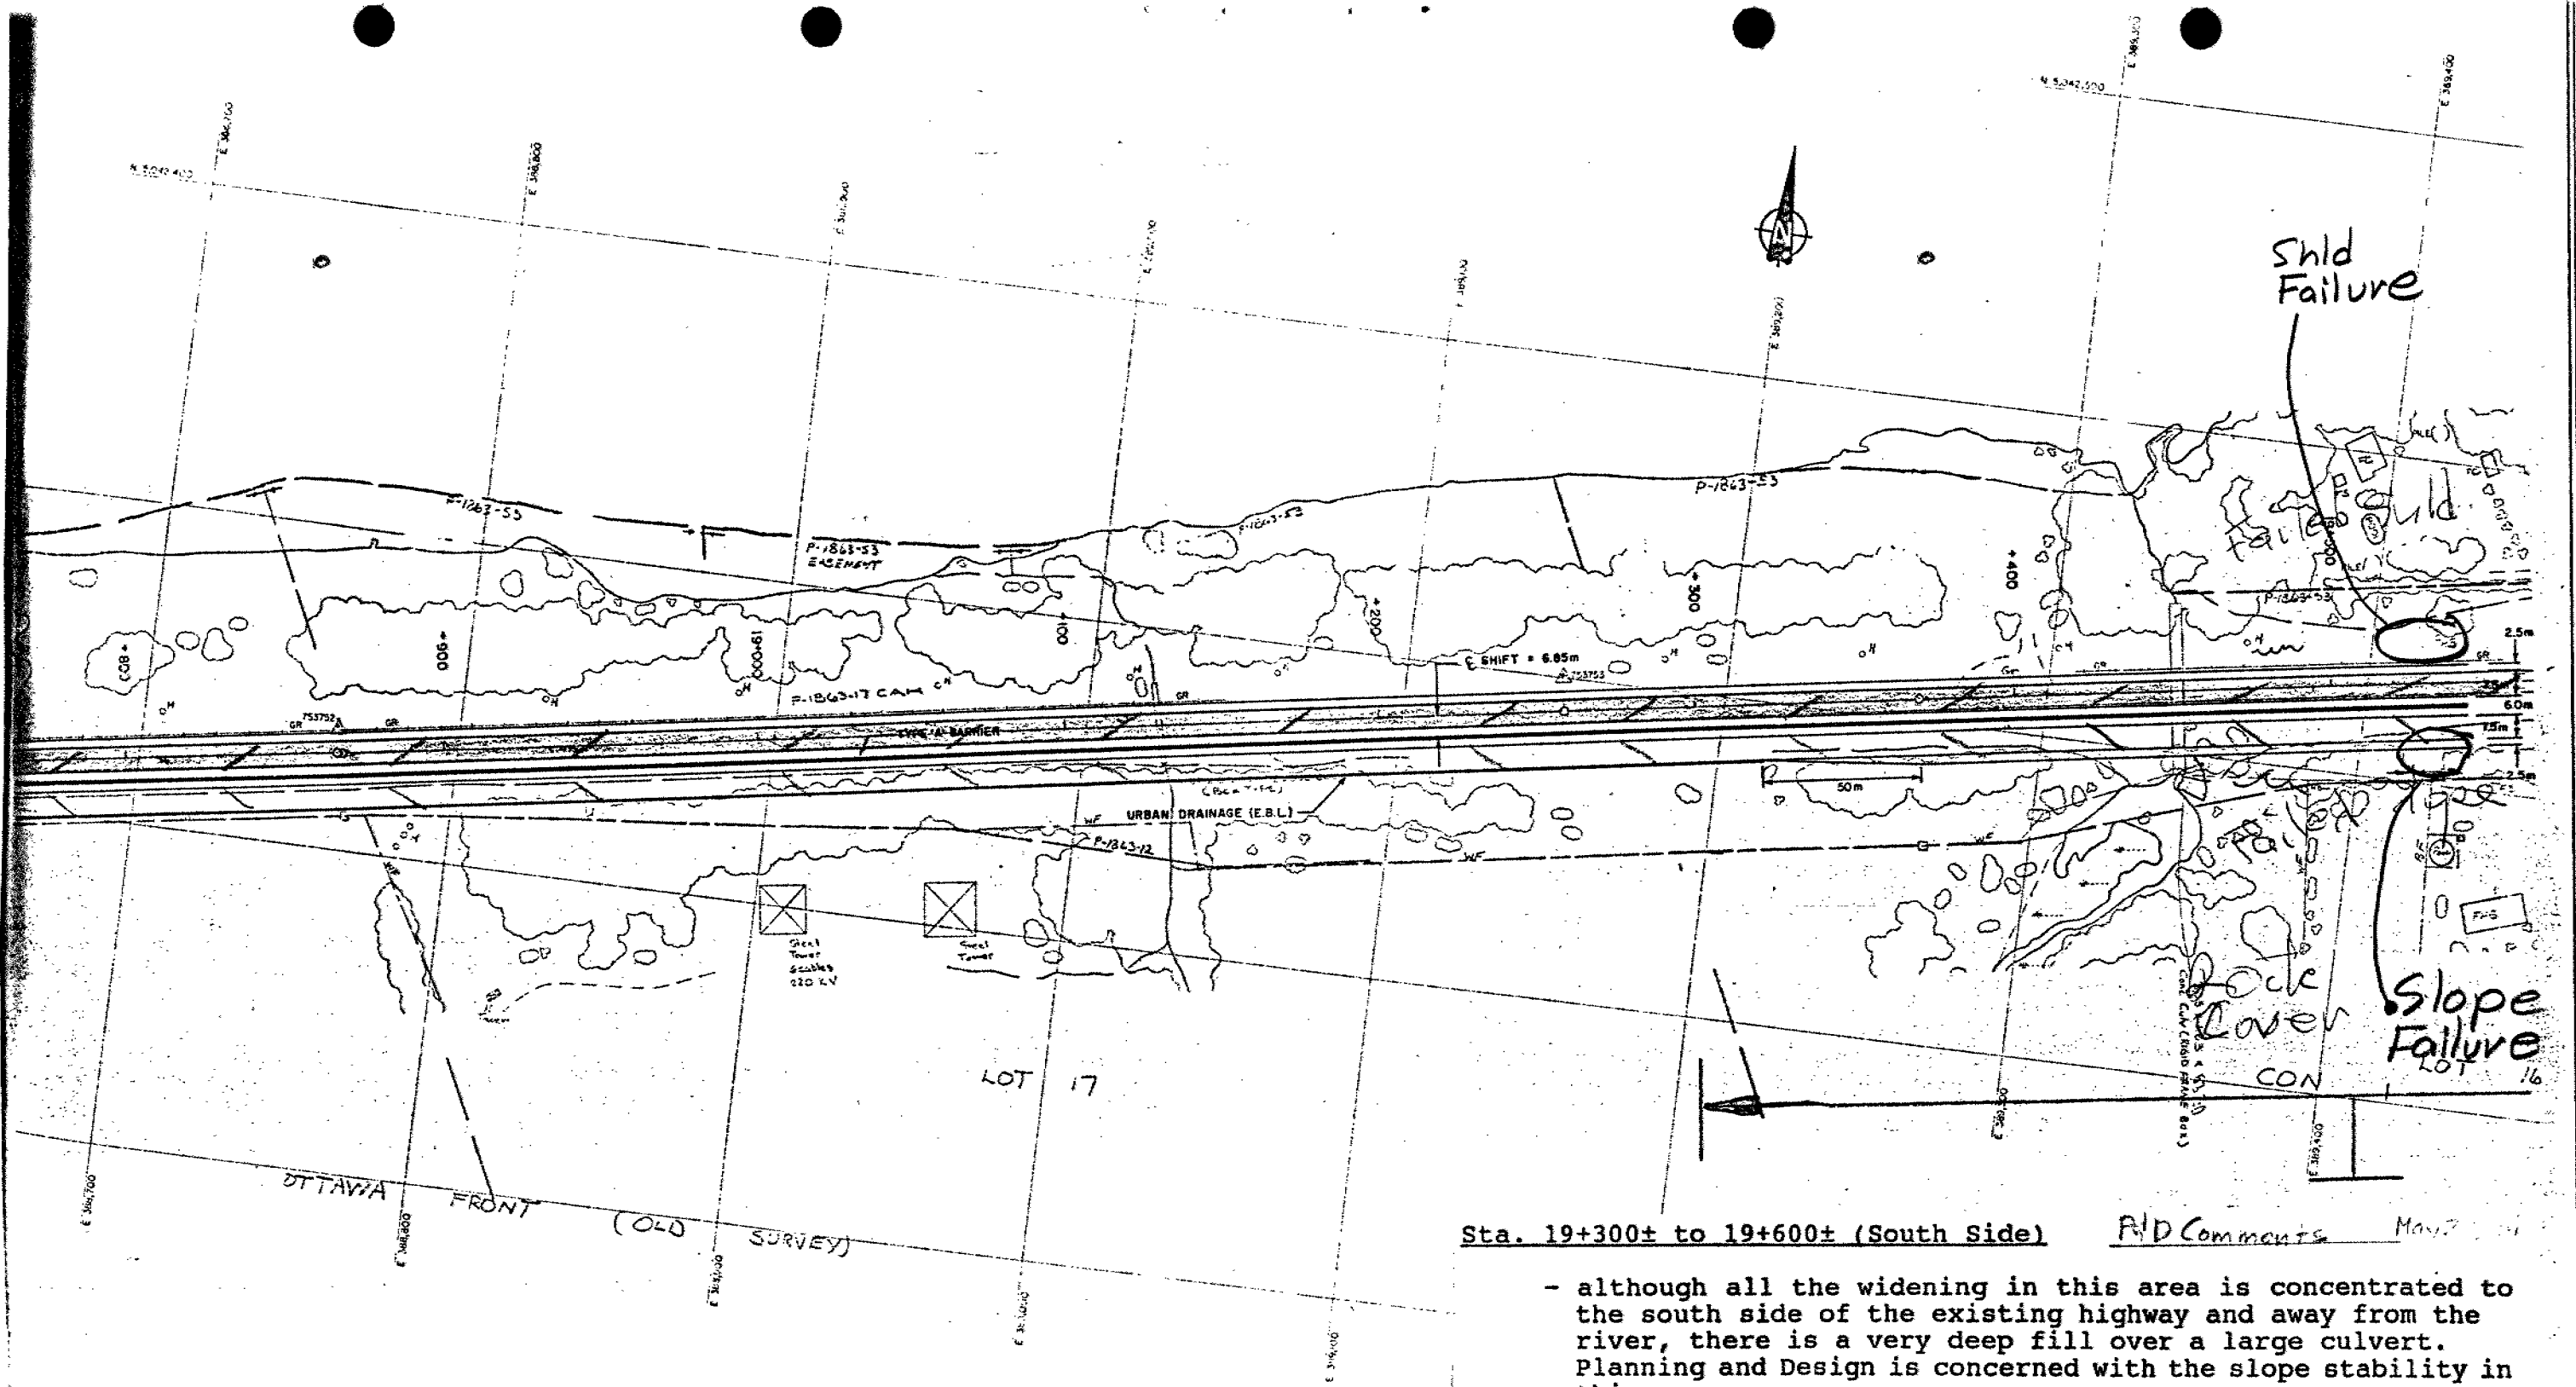
Figure 8

Sta. 19+300± to 19+600± (South Side) *AND Comments May 7*

- although all the widening in this area is concentrated to the south side of the existing highway and away from the river, there is a very deep fill over a large culvert. Planning and Design is concerned with the slope stability in this area.

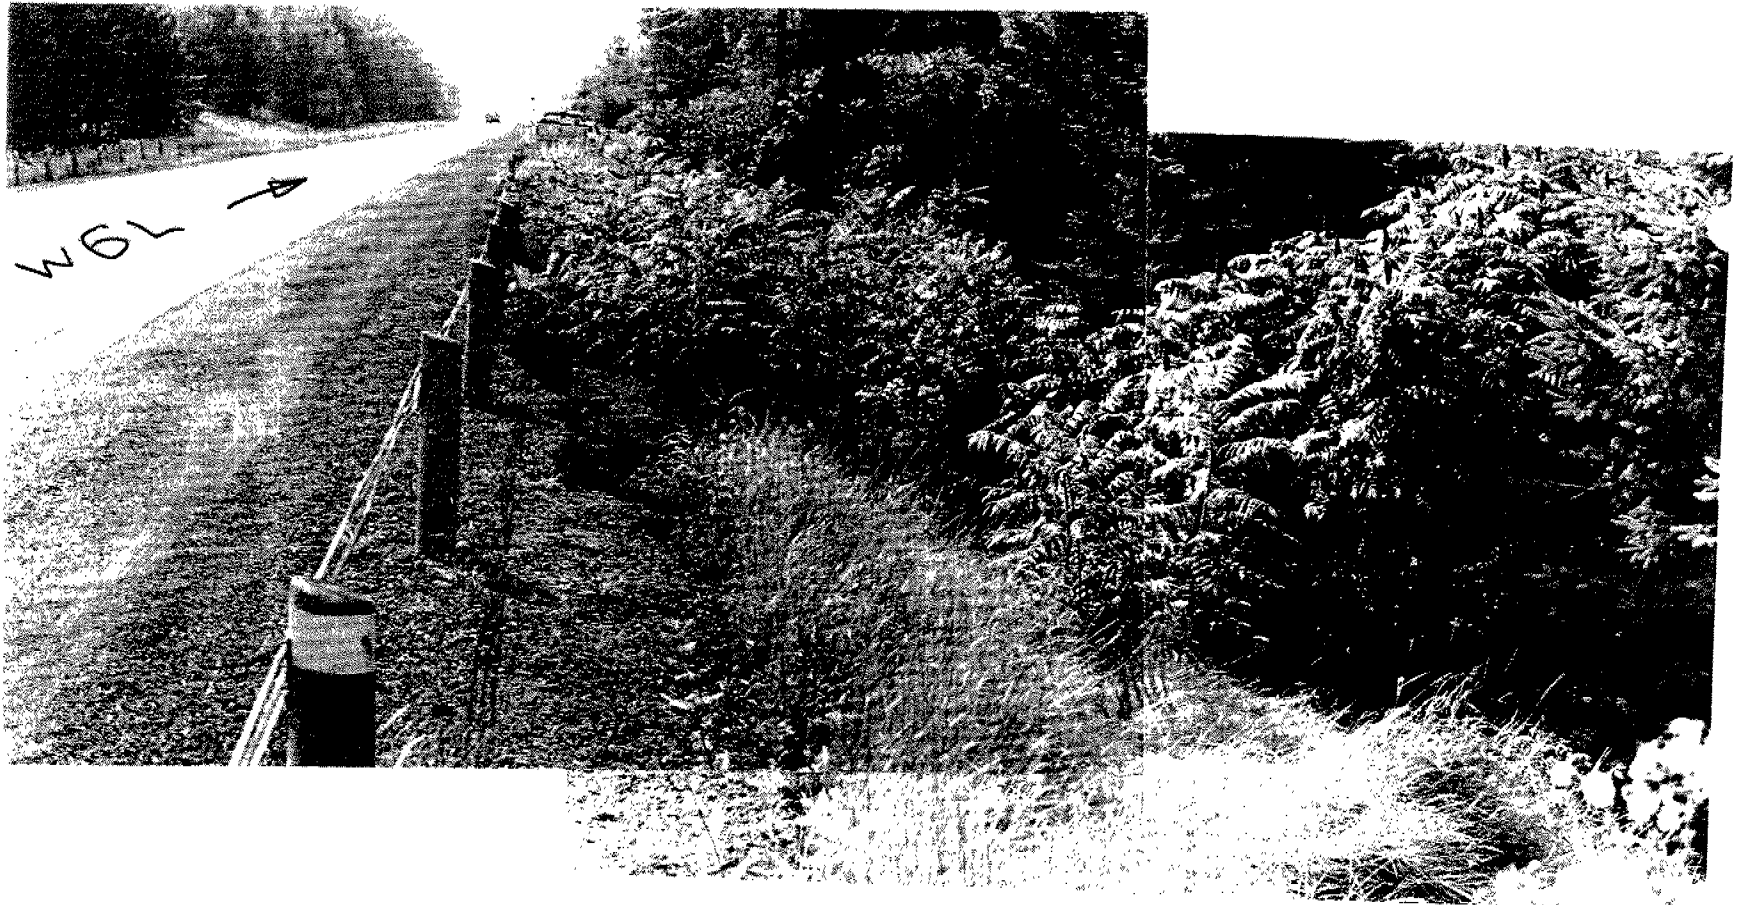
In mid August 94 a failure occurred in the shoulder at the top of a 8m fill over a box culvert on the Ottawa River side of Hwy 17 (Sta 19+475 It). Further investigation revealed a small slope failure on the other side of the fill in an area which appeared to have been previously stabilised with rock over-fill. (See attached photos). The District is monitoring the area and no treatment has taken place.

- i) The shoulder failure involves a surficial slippage of wet clays over the moist underlying clays in the 6m - 8m fill. (see photos taken August 17/94)
- ii) Photos taken Sept7/94 indicate that the shoulder slippage has progressed slightly since the initial investigation on August 17/94.
- iii) The lower portion of the slope below the shoulder slippage is treed, with a small water course at the 30m ROW limit. The private property here appears to be well maintained (Mown & Treed).
- iv) Stabilisation treatment will be complicated by the treed slope, the height and steepness of the slope, the watercourse at the base, and the slippage underway.

Failure at North Shoulder Hwy 17
Sta 19+475
Twp Gloucester

- (1) Remove surficial sliding mass. The thickness of the sliding mass is estimated as 0.3 to 0.5 m. The existing tree cover and roots present within the lower stable portion of the slope shall not be disturbed.
- (2) Replace the excavated material with 600 mm rockfill placed at 1.25H:1V or flatter. The rockfill shall be rip rap or gabion stone as specified in OPSS 1004.5.06.01.

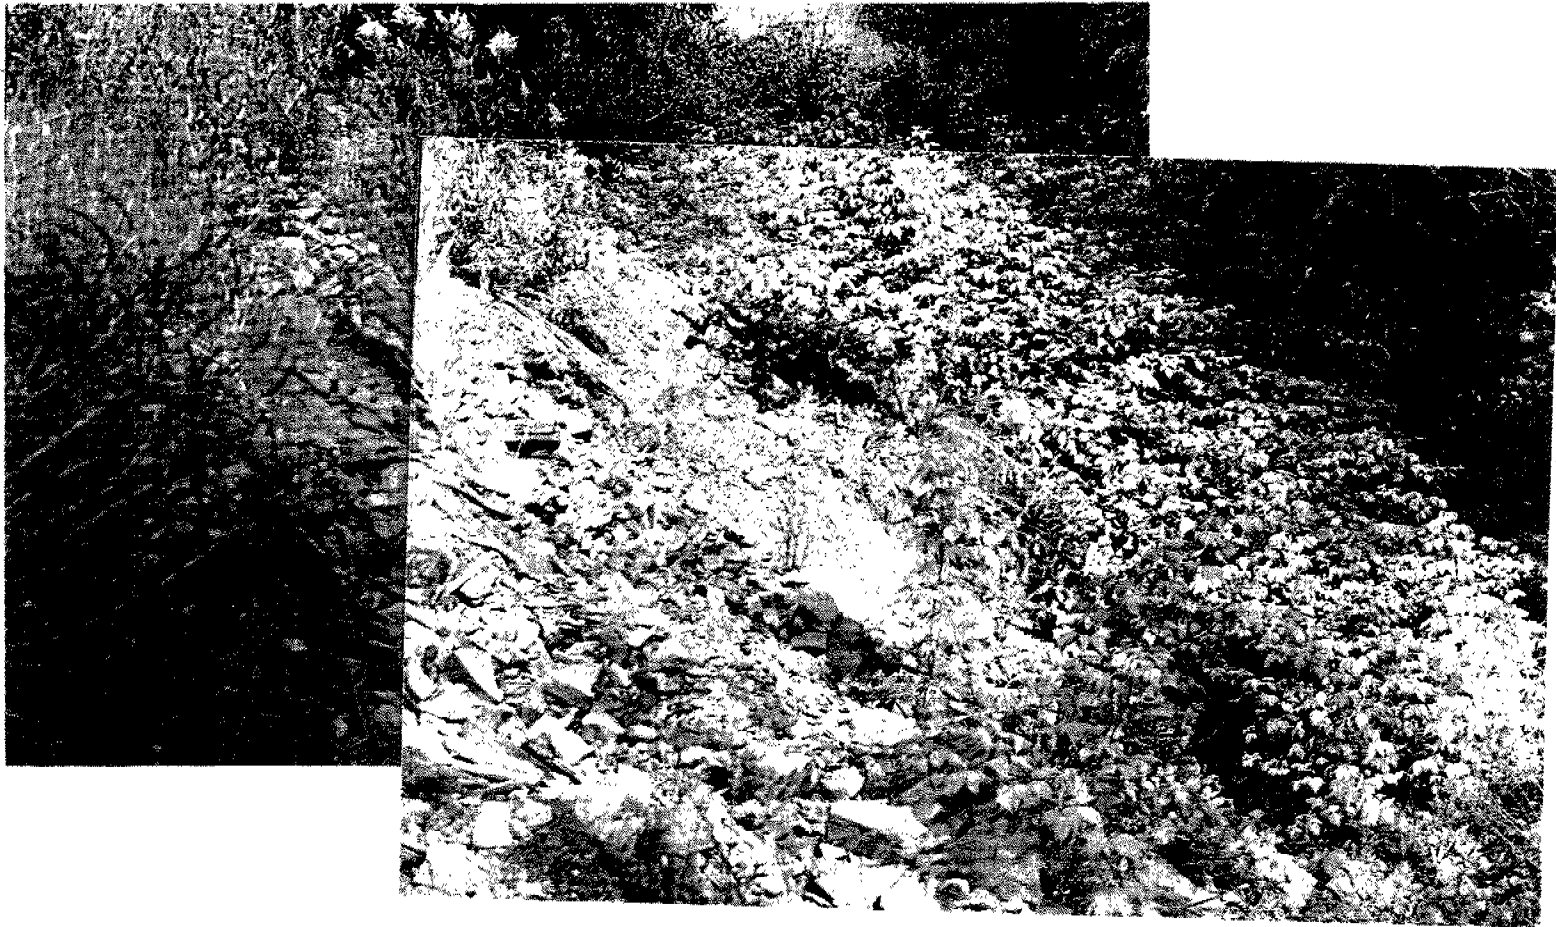
Sta 19+475

It appears that some rockfill has been placed at this location to remedy a possible previous surficial instability. The rock fill chosen does not appear to be of good quality and the rock has degraded and slaked as a result of weathering. In addition, the rockfill does not extend to the toe of the slope and hence earth is exposed at the toe. The slopes on the south side of Hwy 17 appear steeper than on the north side and are estimated as 1.5H:1V.

- i) This slope failure involved a surficial slippage of a rock overlay and the underlying clays. (see photos). The presence of the rock overlay (slope stabilisation) indicates a possible history of failures in this area.
- ii) The poor performance of the existing slope stabilisation was probably caused by the shallow depth of rock placed (+300mm).

Failure on South Slope Hwy 17

It is recommended that additional rockfill as specified above be positioned at the toe of the exposed slope as underpinning for the existing rockfill, and to prevent potential toe erosion.
