ONTARIO
DEPARTMENT OF HIGHWAYS

Memo to.....Mr. F. C. Browaridge..... Date.....September 1, 1955.....
.....Materials and Research Engineer..... Subject Re: Foundation of the Culvert.....
From.....G. N. Farantatos..... at Station 339+70 on Highway #16.....

A Report on the Subsurface Conditions
for the Culvert at

Project 55-F-20

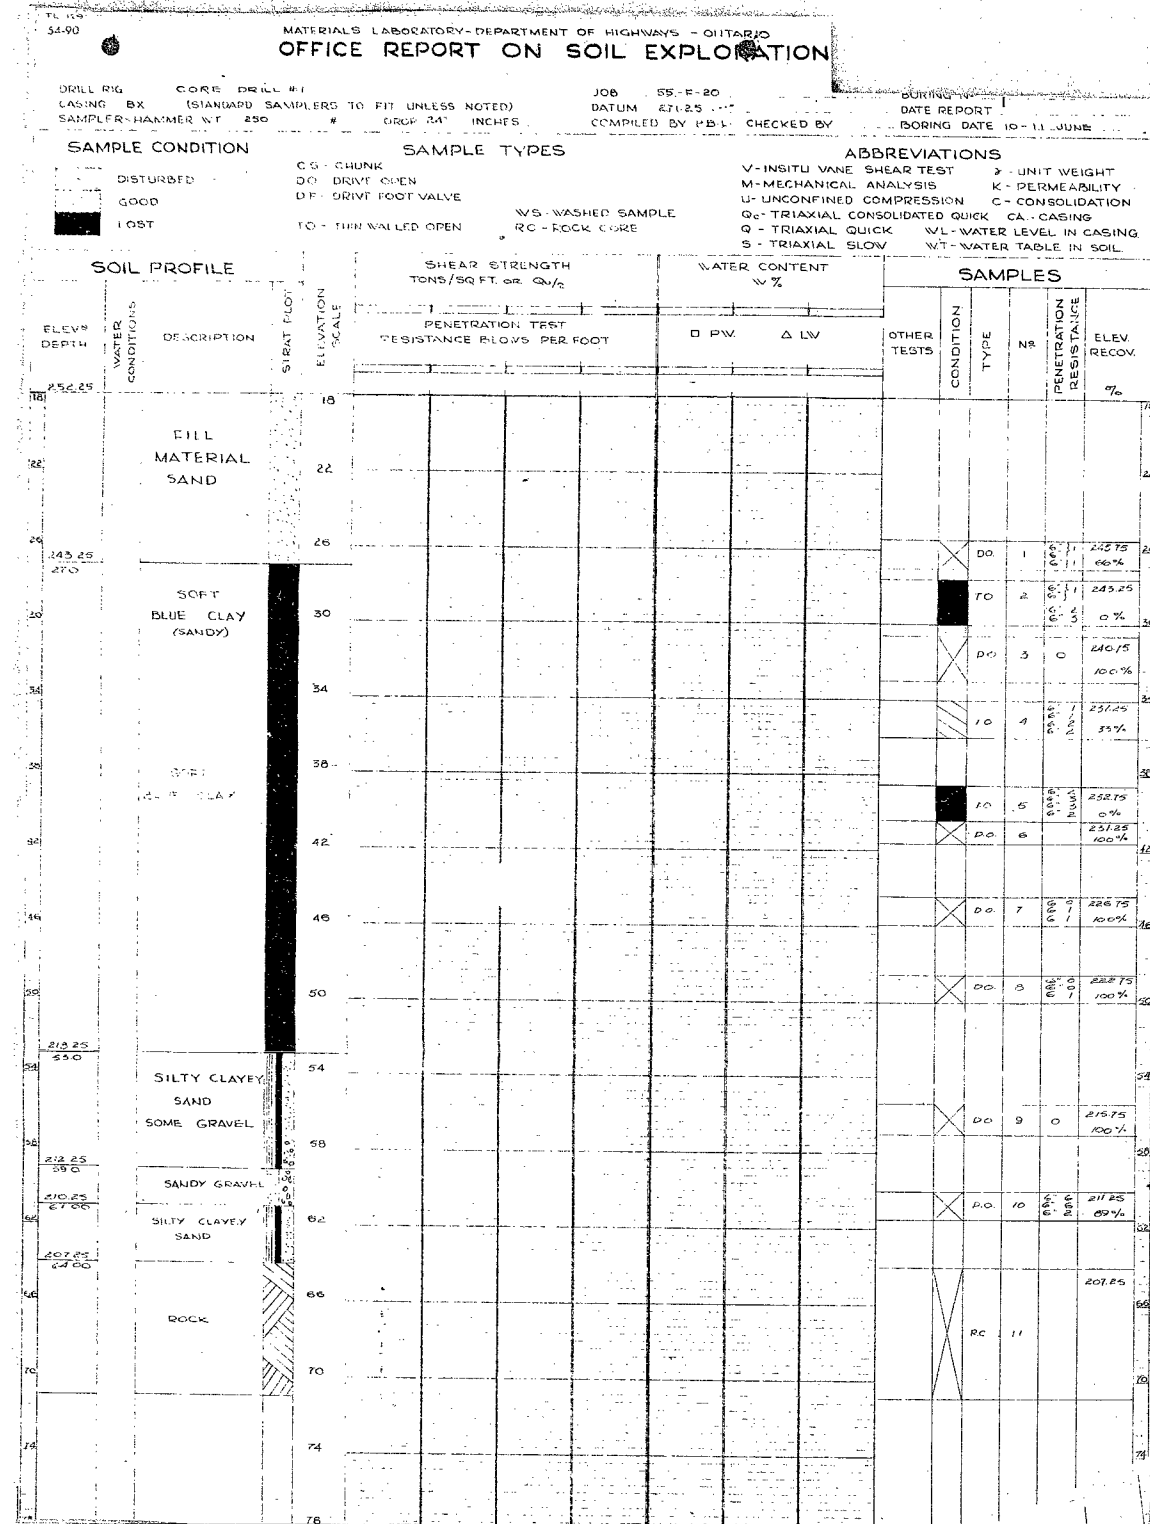
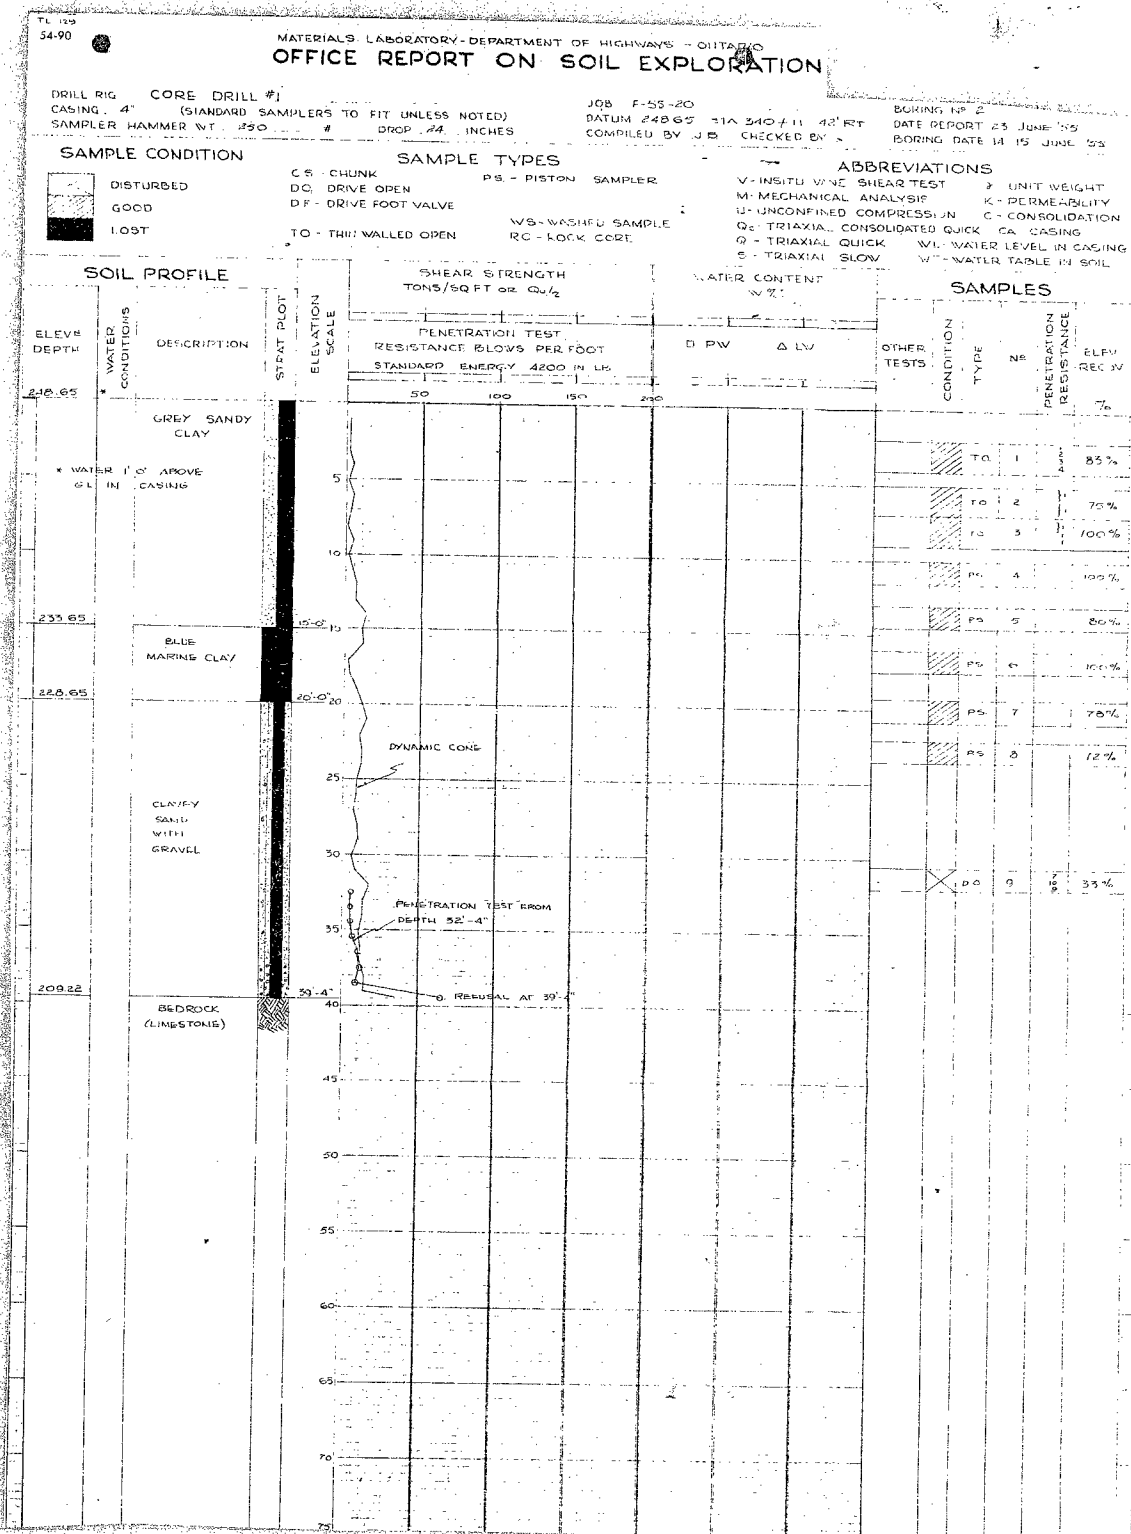
APPENDIX I

Excluding fill, a stratum of soft clay gray to light brown, not more than fifteen feet thick overlies soft blue marine clay. The existing culvert was found to lie on this material. The greatest depth of marine clay encountered was twenty-six feet, and was found to lie on sand and gravel, which in turn rested on bedrock.

Ground water was found in borholes two and three; in borhole two an artesian head produced a free surface one foot above ground level. In borhole three, the free surface was twenty-two feet below ground level.

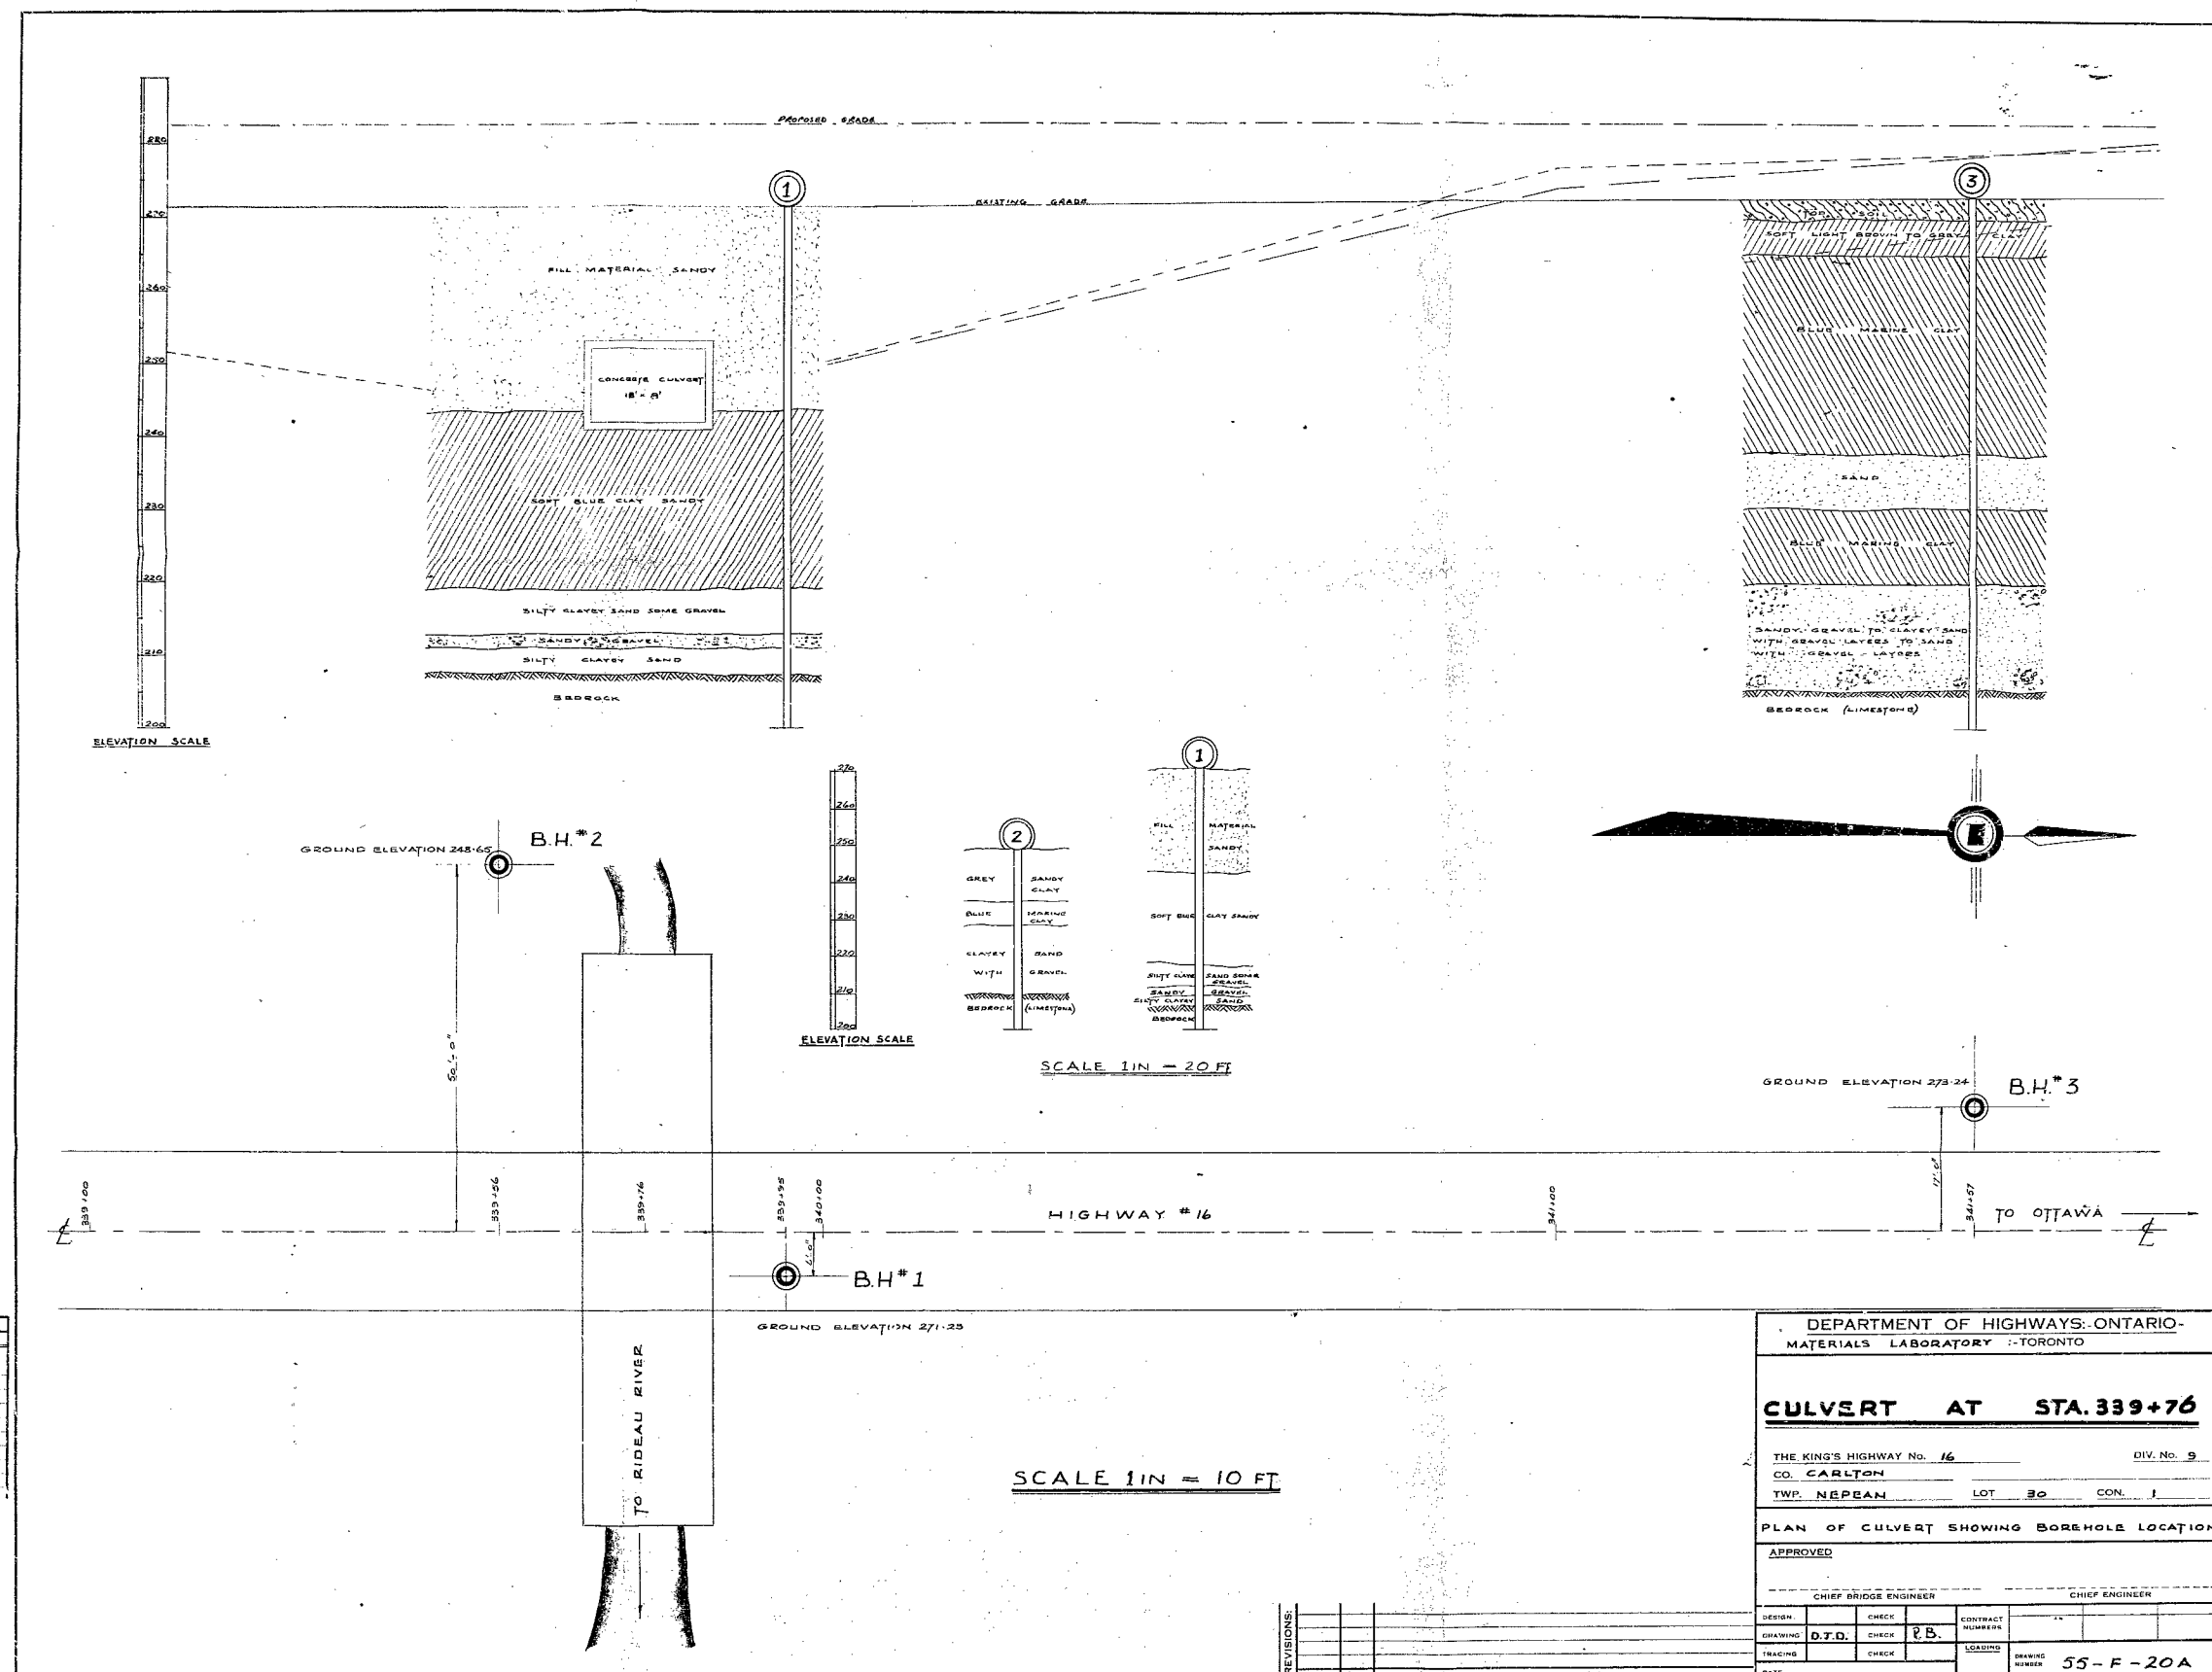
Three borholes were cut down at the positions shown on the attached drawing No. P-55-20A. All the relevant information concerning the soils encountered locations and levels etc. is shown in Appendix I.
