\*59-F-223C

BRIDGE #12

## FAIRMONT AVENUE - BRIDGE NO. 12

### 1. TERMS OF REFERENCE

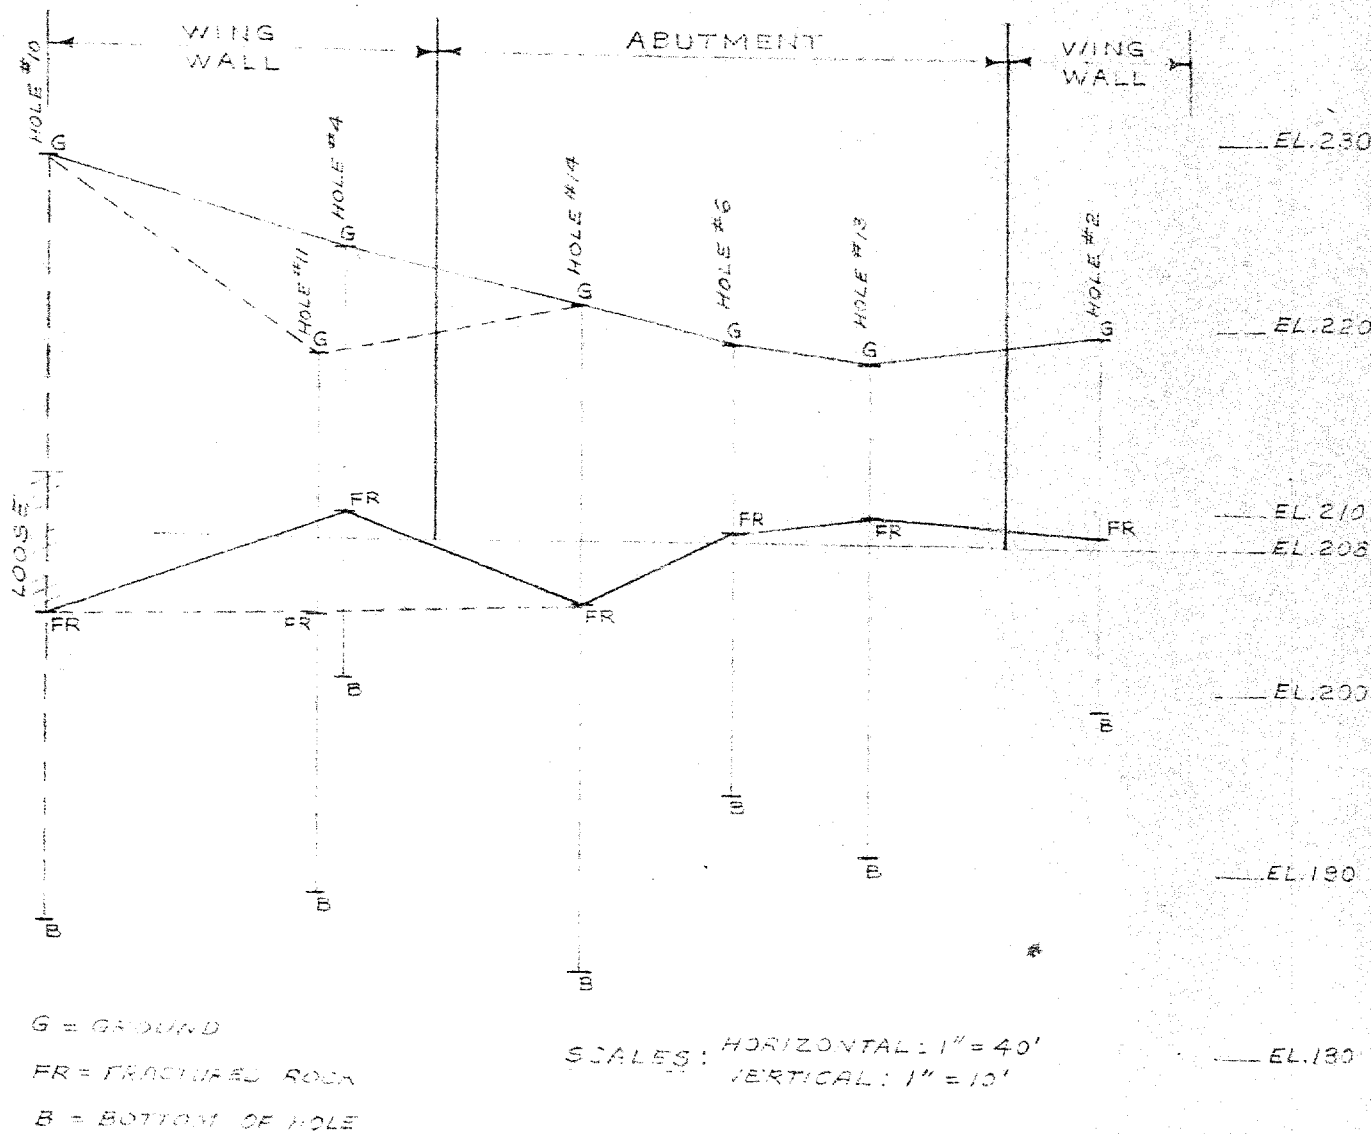
PLATE NO. 2

The preceding recommendations do not apply however to the southerly wing-wall of the west abutment. Loose till soils overly the fractured rock in this location and the wing-wall footings should therefore follow the fractured rock surface. Towards the westerly end of the wing-wall, where the embankment retained by the wall becomes small, a shallower wing-wall supported on the dense higher soil layers could be considered.

SECTION THROUGH WEST ABUTMENT AND AROUND WING WALLS
