REPORT
ON
INVESTIGATION AT GREENS CREEK BRIDGE
OVER MONTREAL ROAD
AND
THE USE OF FRICTION PILES
TO
DE LEUW, CATHER & CO. OF CANADA LTD.

REPORT NO. SF-368

12 AUGUST 1958

McROSTIE & ASSOCIATES
CONSULTING ENGINEERS
OTTAWA CANADA

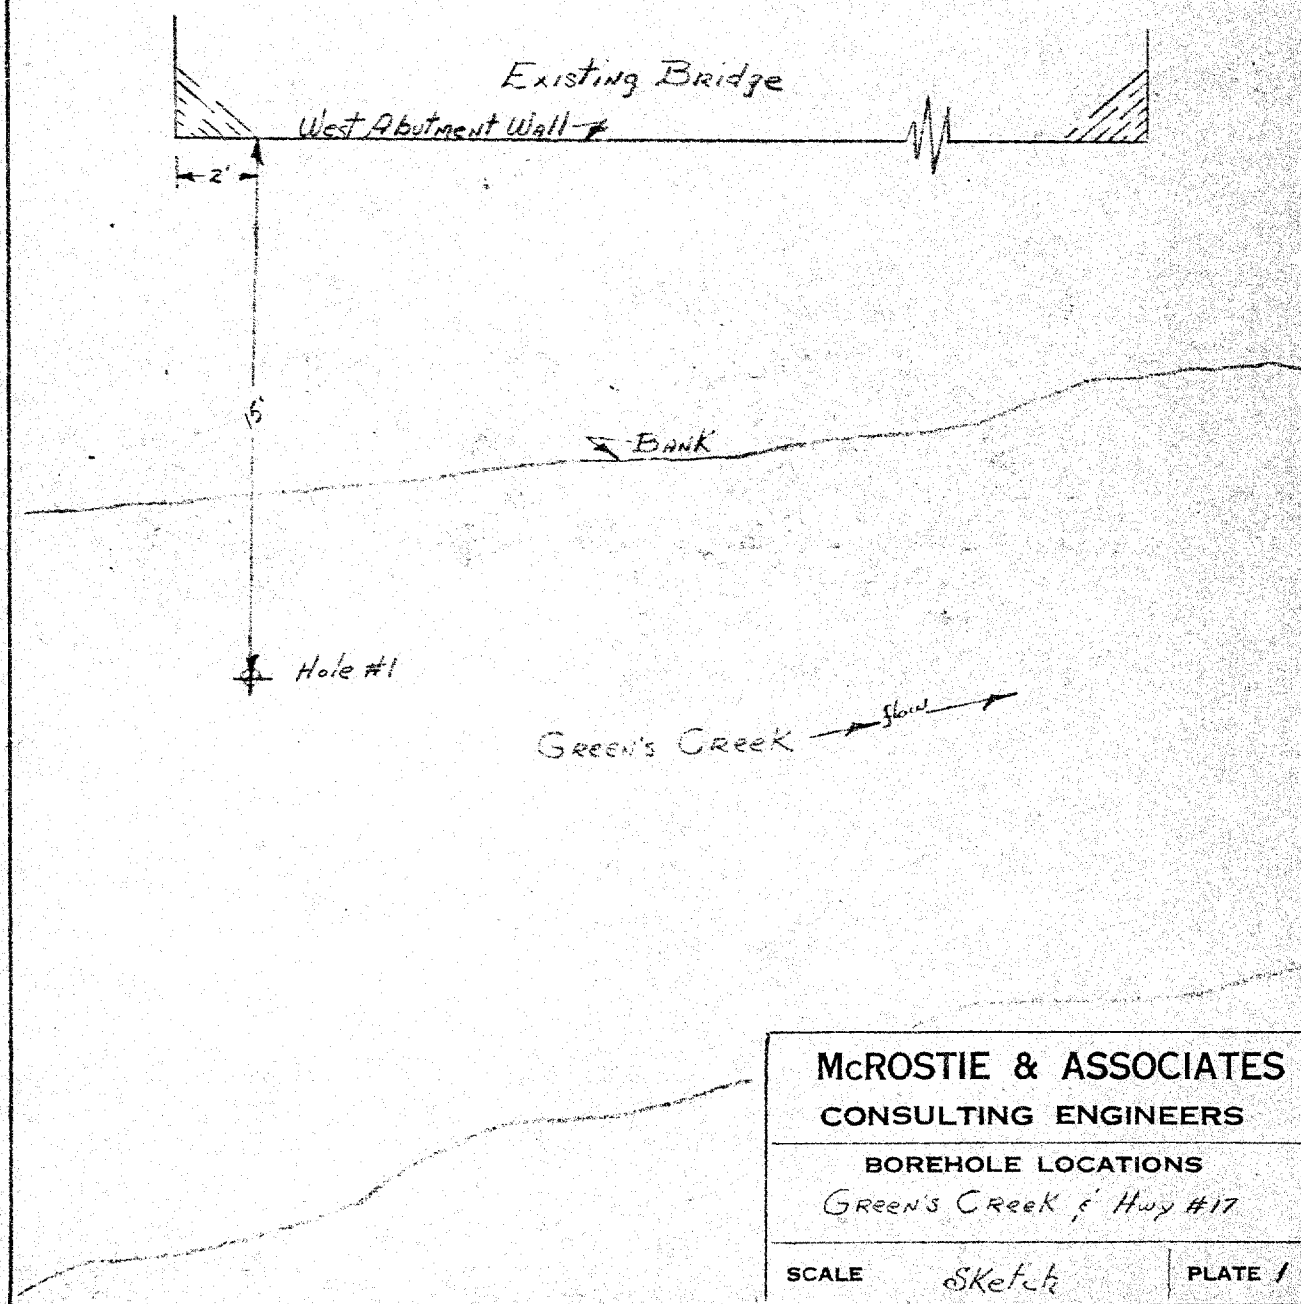
SCALE *Sketch* | PLATE 1

BOREHOLE LOCATIONS
Green's Creek & Hwy #17
