INTERIM REPORT
ON

GROUNDWATER LEVEL AND PRECISE
SETTLEMENT MONITORING
PROPOSED HIGHWAY 416
LYNWOOD SUBDIVISION
W.P. 121-87-00
DISTRICT 9 (OTTAWA)
NEPEAN, ONTARIO

December 1992

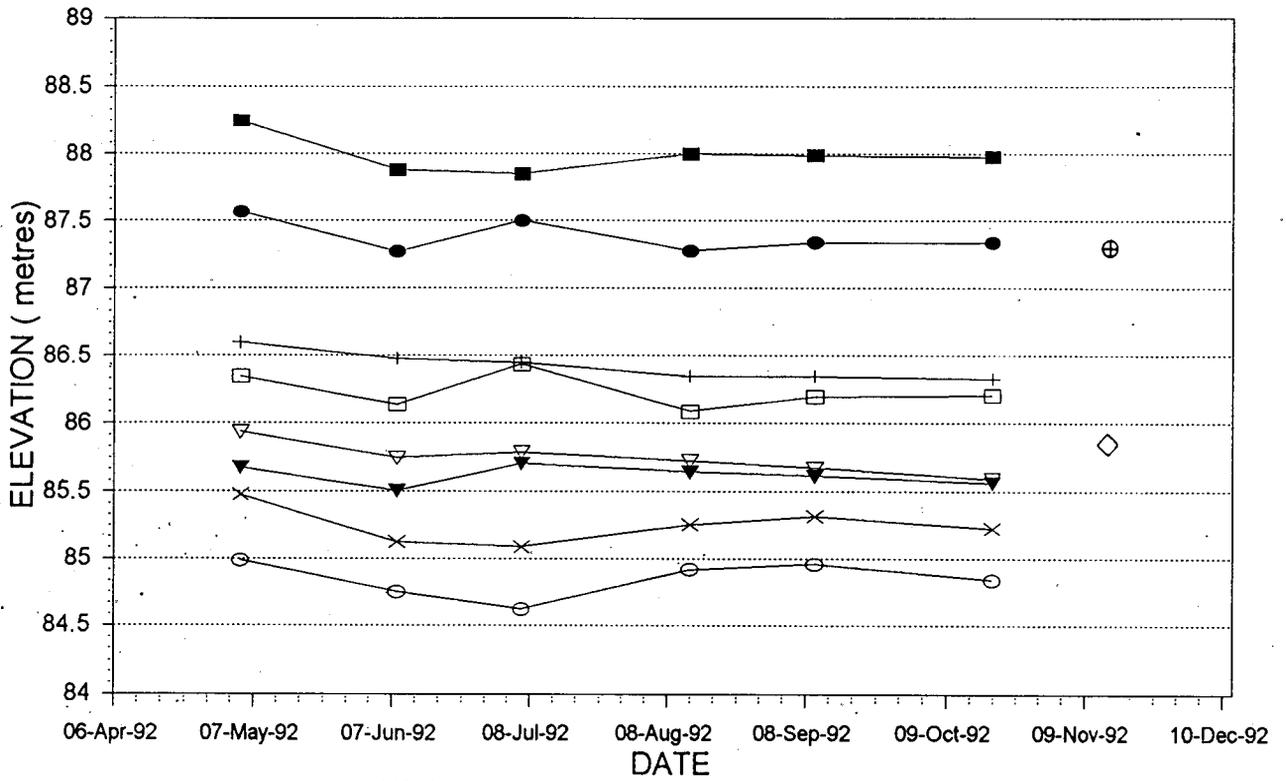
FIGURE 4

The groundwater level monitoring in standpipes sealed into the silty clay, sand, glacial till, and bedrock showed fluctuations of less than about 0.5 metres between May and November, 1992. Although there is normally a seasonal drop in groundwater levels around mid summer to September, the monitoring data show relatively constant groundwater levels during this period. This was likely due to the unusually wet summer experienced this year.

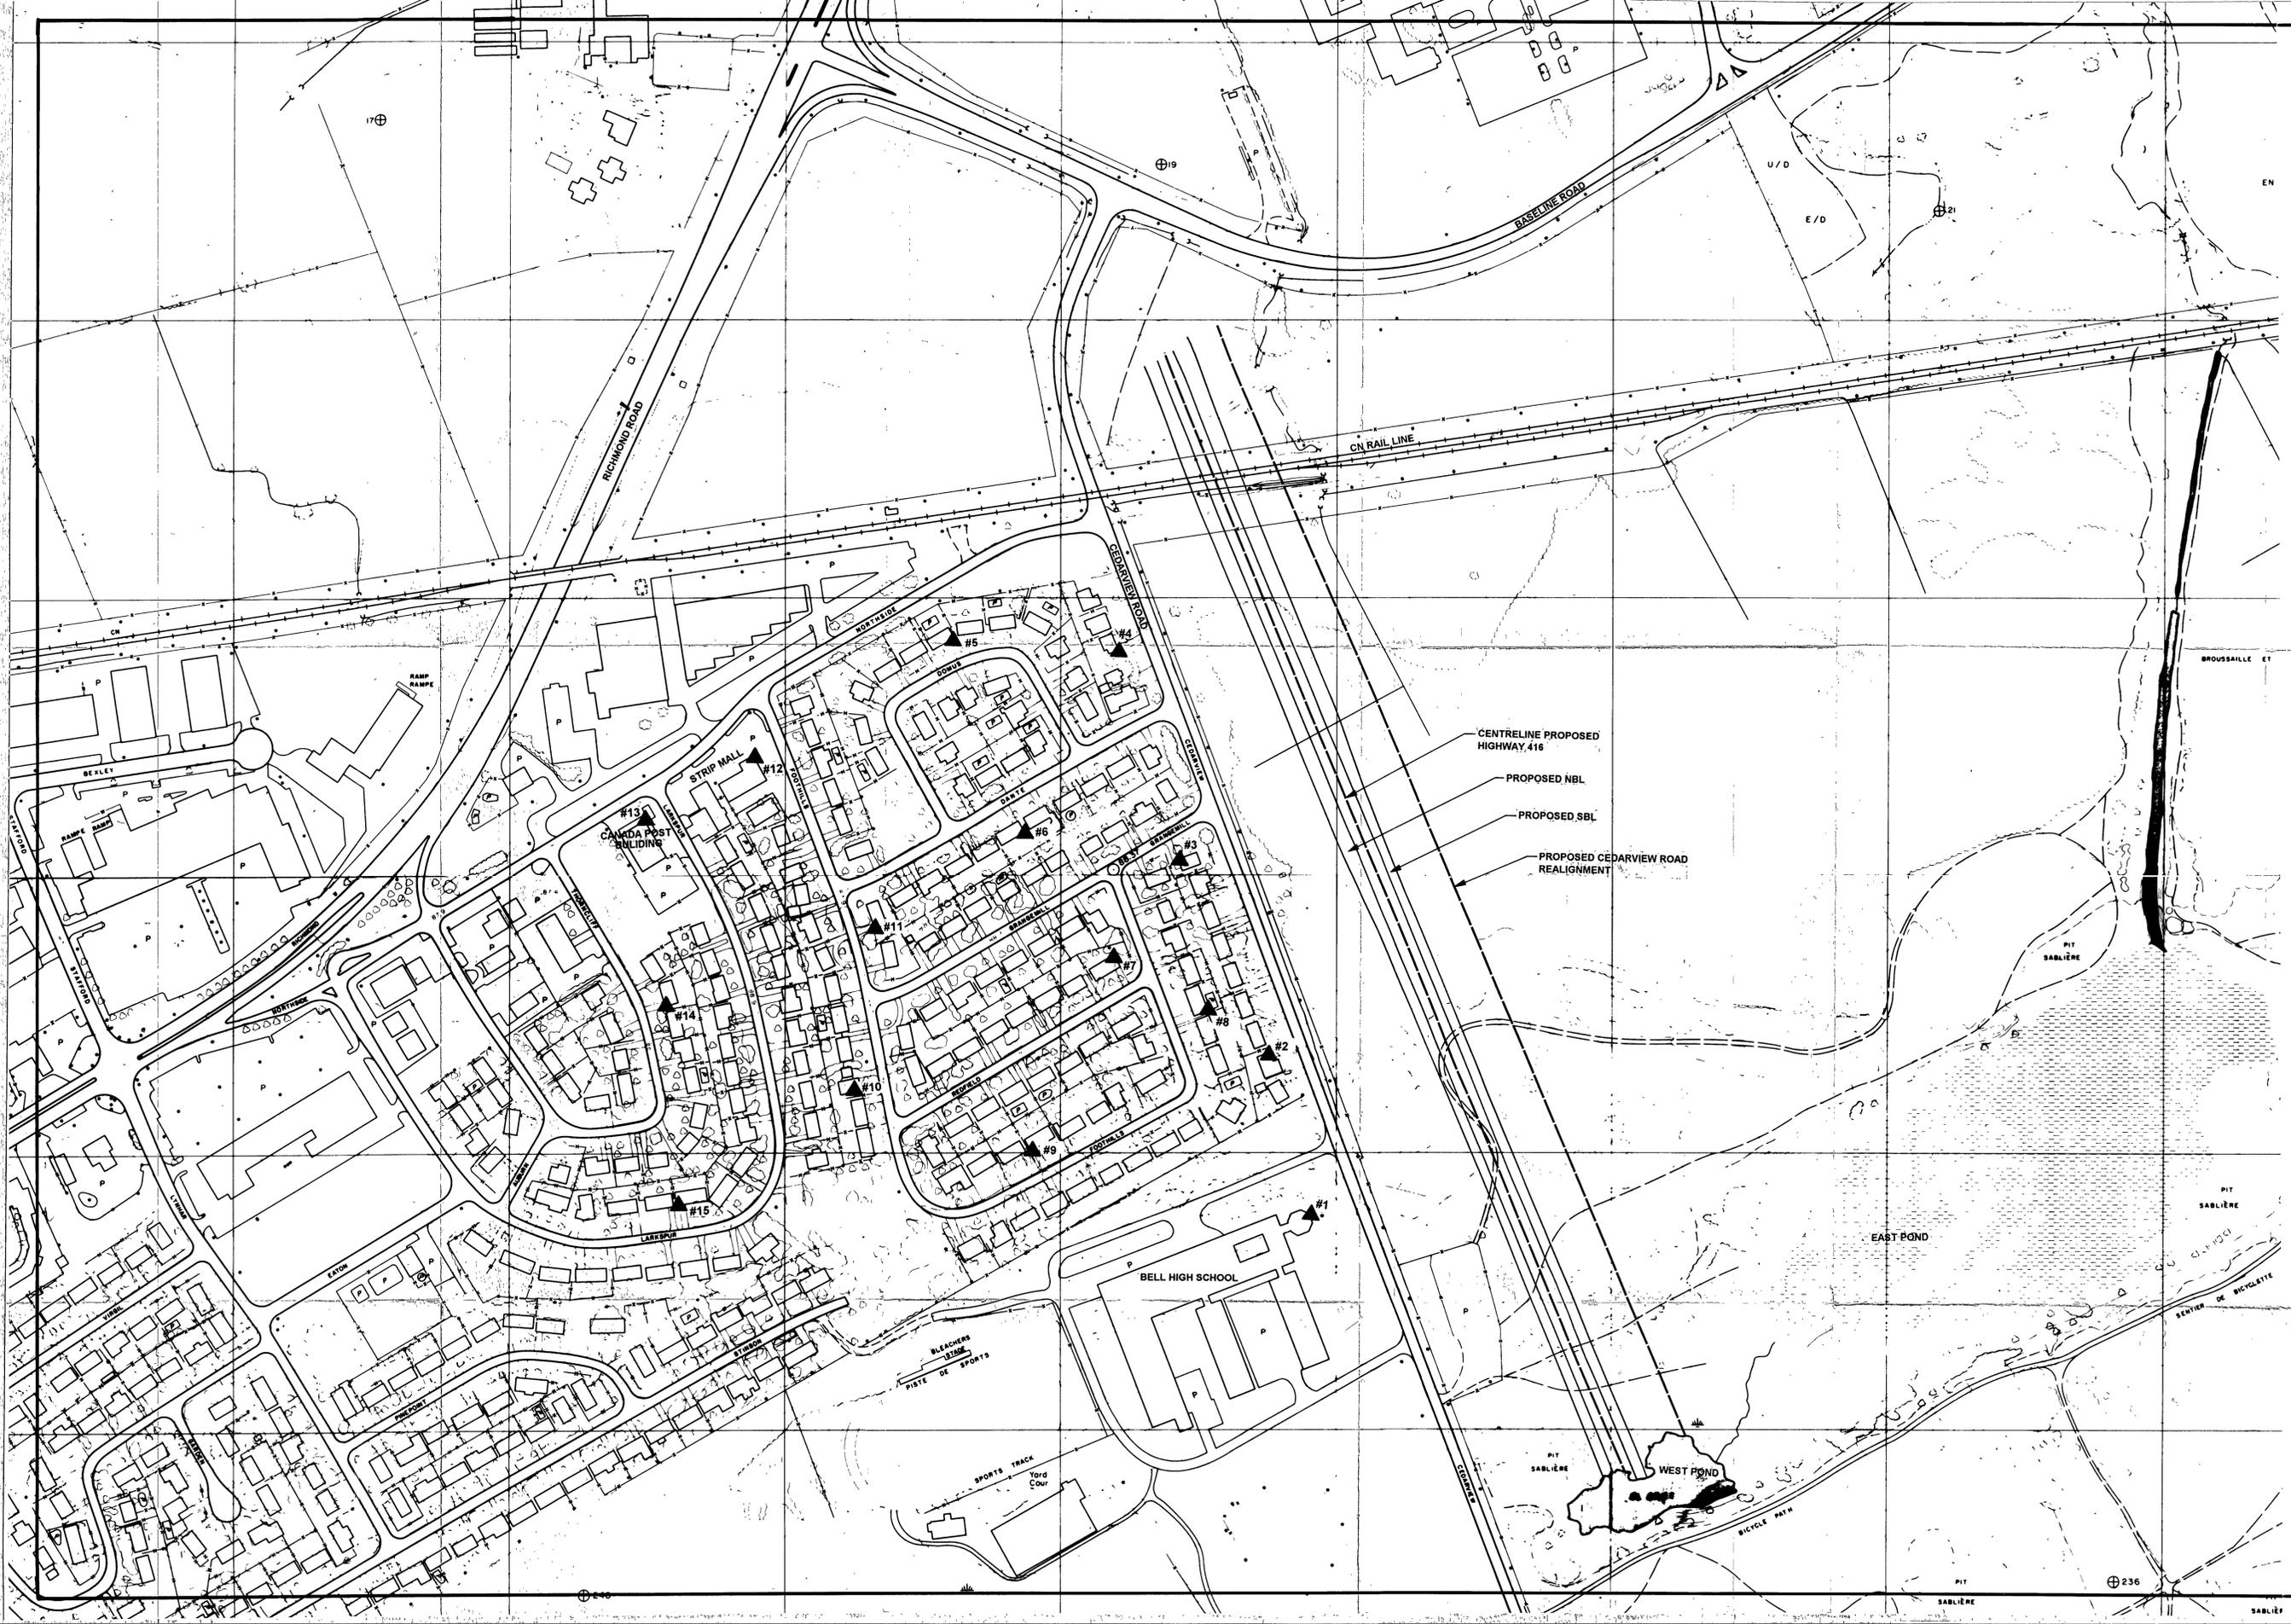
The differences in the elevations of the settlement points during October range from 0 to 5 millimetres (average of 2.1 at 15 settlement points). These differences fall within the attainable accuracy of the levelling process. There has been no significant movement of the monitoring points between July/August 1992 and October 1992. This is consistent with the observed groundwater conditions during this period.
