RE: W.P. 94-60,
Pautois Creek,
Hwy. #17, District #13.

Re: Proposed Enlargement of Bridge over Pautois
Creek on Hwy. 17, 12 miles West of Mattawa.
W.P. 94-60 Dwg. No. E-3809-1 (Dept. of Hwys.)
W.J. 60-F-98 Dwg. No. 60-F-98. (Dept. of Hwys.)
District #13, Mattawa, Ontario.

Foundation Investigation
For
Proposed enlargement of Bridge over Pautois
Creek on Hwy. 17, 12 miles West of Mattawa.

DEPARTMENT OF HIGHWAYS - ONTARIO		
MATERIALS & RESEARCH SECTION		
PLAN AND SECTIONS TO SHOW FOUNDATION CONDITIONS AT NEW BRIDGE OVER PAUTOIS CREEK & HIGHWAY 17		
ORIGINATED T. WIDDIS	DISTRICT NO. 13	DATE 23 JANUARY 1960
DRAWN D. MUMFORD	W.P. NO. 94-60	JOB NO. 60-F-98
CHECKED <i>[Signature]</i>	SCALE	DRAWING NO.
APPROVED <i>[Signature]</i>	1 inch = 20 feet	60-F-98A

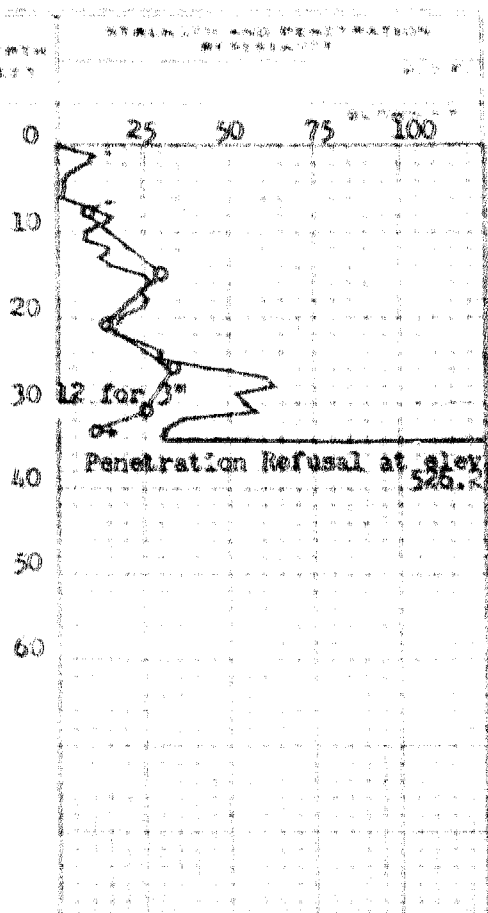
W.P. 94-60 BORE HOLE NO. 1
 JOB 60-F-98 STATION 420-07 (36.5 Rt.)
 DATUM 501.0' COMPILED BY B.K.
 BORING DATE Dec. 18/60 CHECKED BY T.W.

DEPTH FEET	DESCRIPTION	DEPTH FEET
0	Groundlevel	561.0
1	Silty sand with organic matter	557.0
5		556.5
	Fine uniform sand medium dense grey in colour.	
30		528.0
	Granite gneiss. Full recovery.	
40		518.8

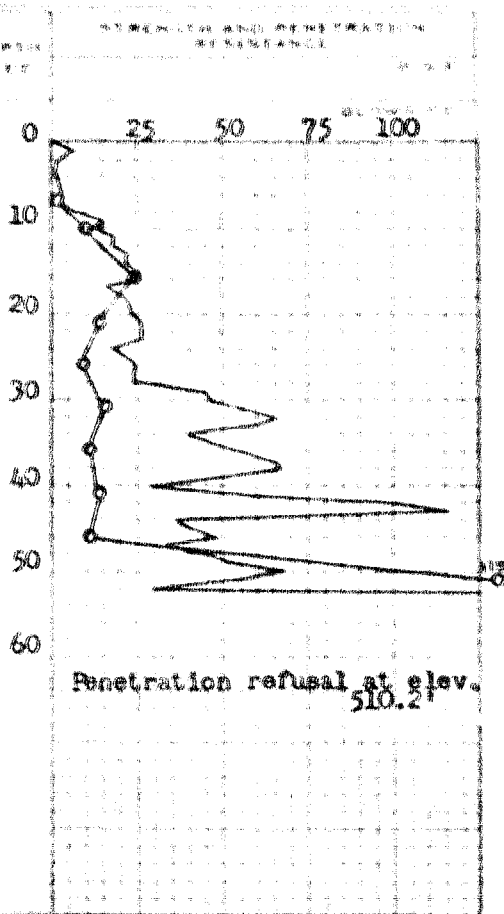
W F 94-60 BORE HOLE NO 2

DEPTH	DIAMETER	REMARKS	DEPTH
		↓ Groundlevel	563.0
		Silty fine sand, with organic matter	0
		Very loose. Grey-brown in colour	568.3
		Pine-coarse sand with organic matter.	574.0
		Loose grey-brown in colour.	588.0
		Fine uniform sand. Medium dense	20
		Grey in colour	30
		Fine-coarse sand with gravel medium	523.0
		dense grey in colour.	517.0
		Fine uniform sand, medium dense	50
		Grey in colour.	508.5
		Granite gneiss. Full Recovery	60
		End of borehole	497.5

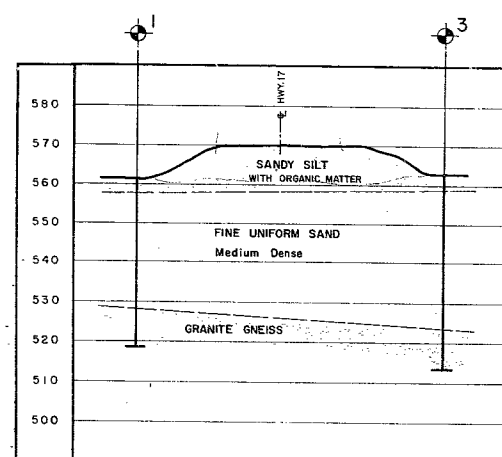
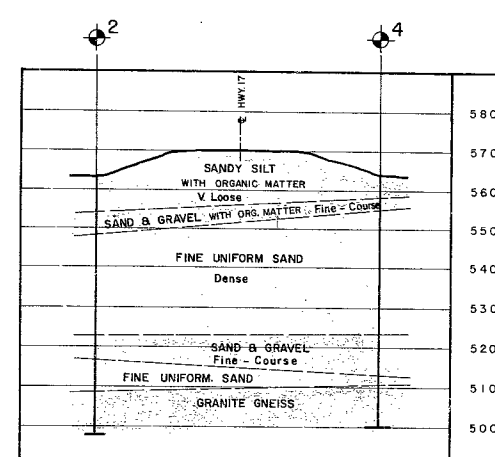
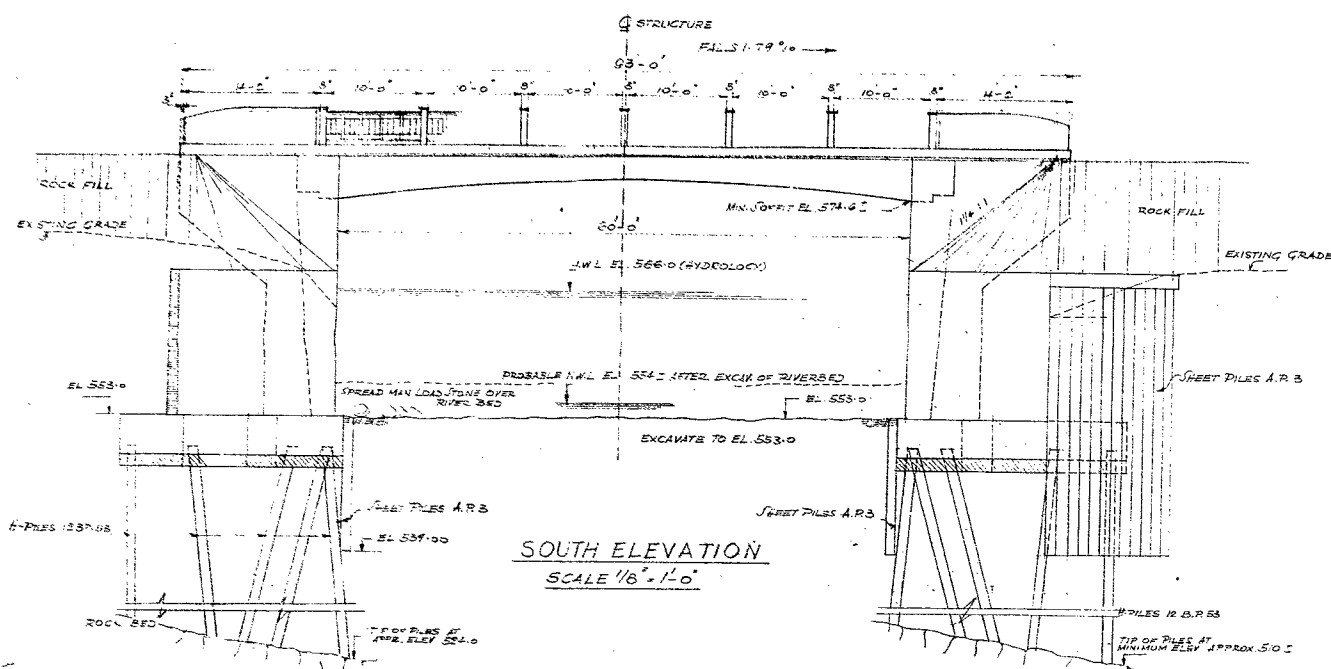
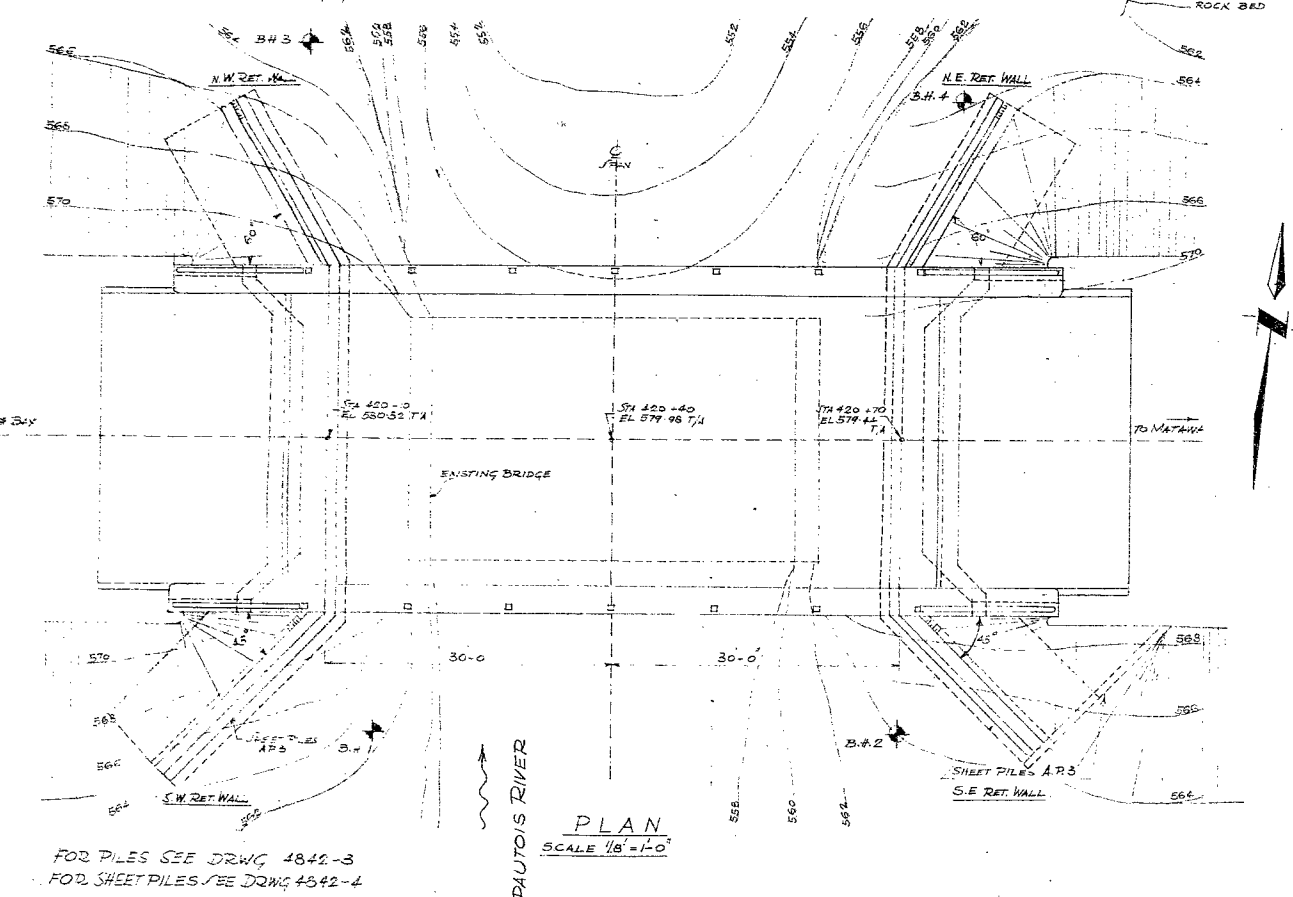
The foundation information on the drawings and in the foundation report shows the soil to be perfectly fine to coarse sand with some gravel. The foundation report also indicates that sheet piling would be required for unwatering purposes. There

is no indication that boulders would be encountered. Even the existing road bed up to the pavement is shown to be all sand. Obviously the contractor would gear his operation to the site conditions shown. These conditions didn't prove out and the operation had to be changed and resulted in a more costly and less efficient unwatering operation, contributed to the delay in driving the footing piles and delayed the concrete structure work into the severe winter weather.

The foundation report shows the soil to be a fine to medium to coarse sand and gravel with no mention of boulders.

The District report indicates that numerous boulders were encountered in the east footing excavation and some were encountered in the west footing excavation. In its interpretation of the foundation report the District feels that the information for the four test holes is correct and therefore the Department has not given incorrect information. This coupled with its opinion that the contractor worked very inefficiently has led it to conclude that consideration of the claim is not

The District is undoubtedly right in stating that the parent material is accurately described at the four bore hole locations. In addition to this description the foundation report has expanded this graphically to include the area between the bore holes and has indicated as well that the road bed material is all a fine sand although this latter is not the case. In the light of this it is evident that the contractor has been misled as to the actual nature of the parent material which turned out to be very bouldery rather than sandy.

Based on the foregoing it is the writer's opinion that the Department information did not properly describe the foundation conditions and in fact misled the contractor, and therefore the Department should accept the responsibility of the contractor's costs in excess of his revenue.
