Re: Proposed Bridge over Tomiko River,
Hwy. No. 11 - Approx. 21 Miles
North of North Bay, Ont., Dist. 13,
W.P. 95-60.

Report on
Foundation Investigation
Proposed Bridge over Tomiko River, approximately
21 miles north of North Bay, on Highway No. 11
District No. 13.
WP 95-60

Submitted by:
Dominion Soil Investigation Ltd.
88 Eglinton Ave. East
Toronto 12 Ontario

May 25, 1960

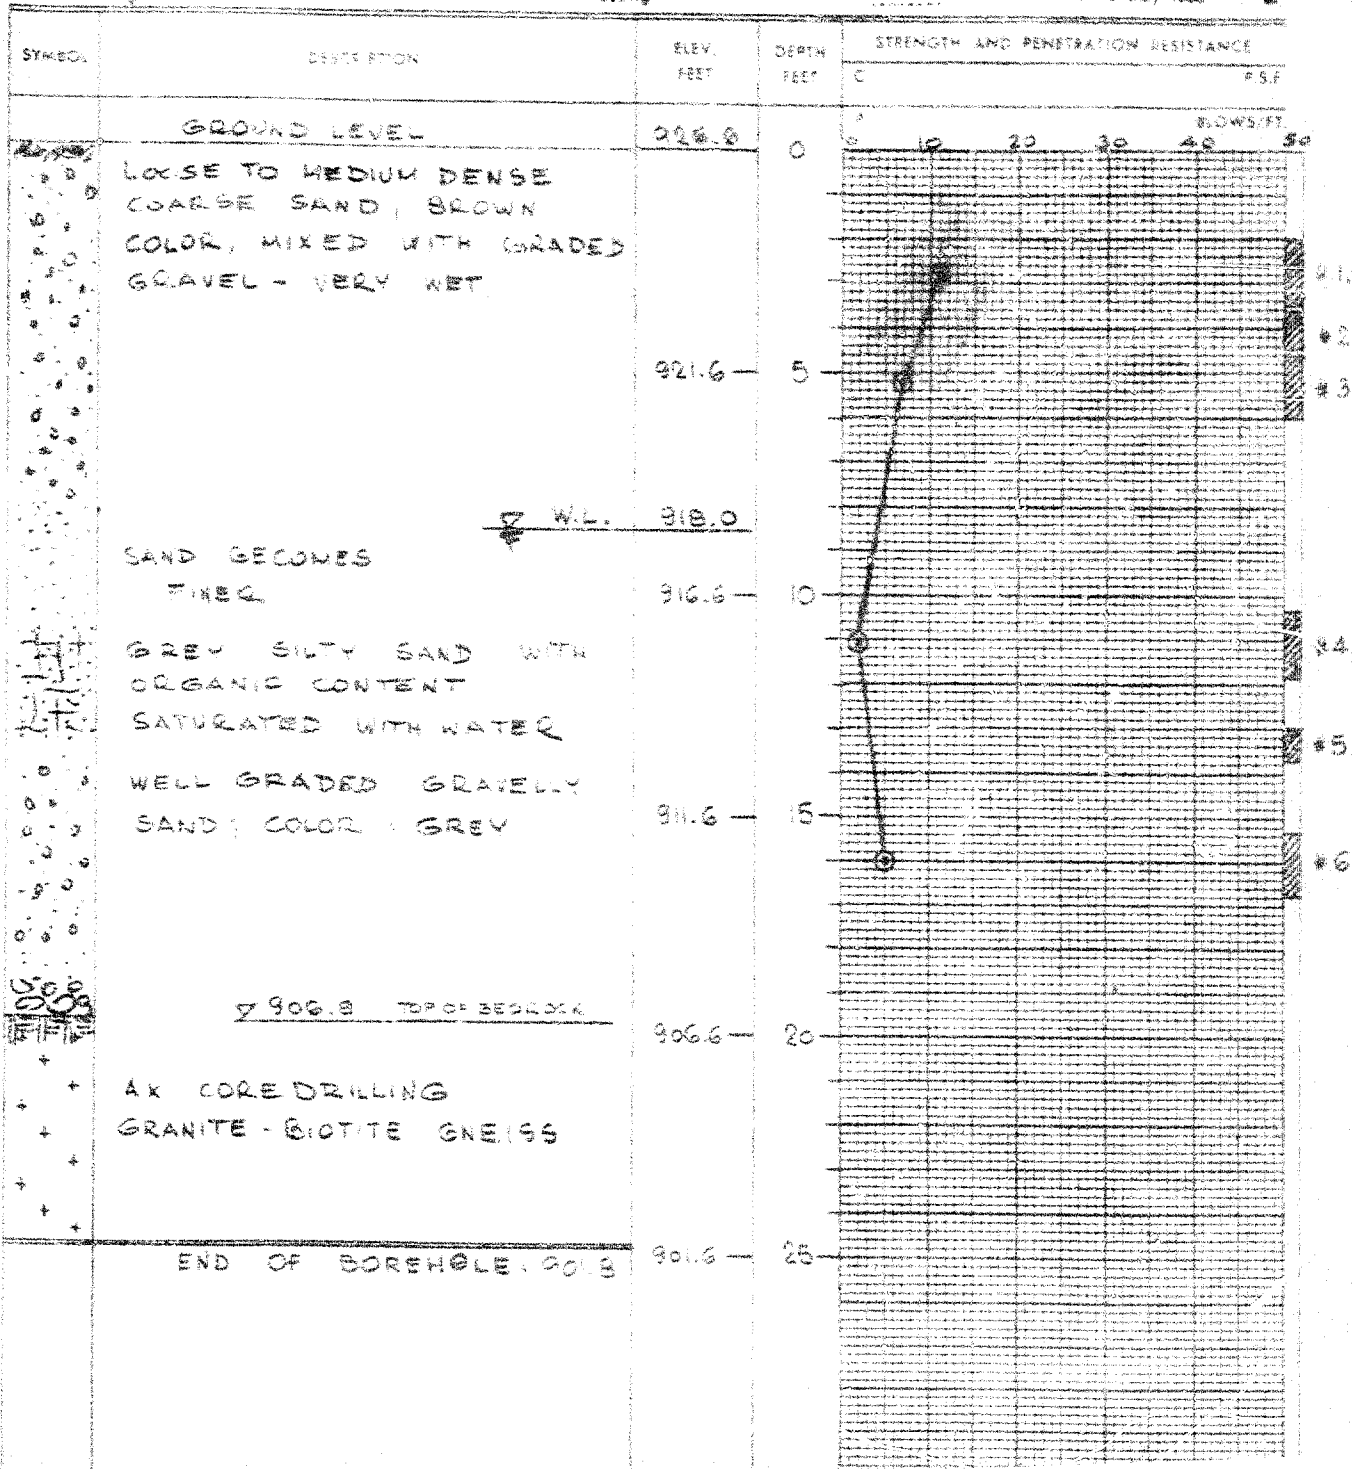
Engineering Data Sheet for Borehole: 1 OF 5

The first 10 ft. was of loose material, the casing was driven in the ground readily. Sample 1 was lost, the material was too soft. To get a picture of the subsoil close to the surface, sample #2 was obtained from the withdrawn casing and preserved in a jar.

It was impossible to get sample from the silty stratum around El. 915.0' also; sample #4 was lost. The split spoon was gently tapped into the soft material, so sample No. 5 contained some of it.

From 19'-2" depth, the casing could not be driven into the soil any more. Only diamond drilling reached the bedrock. 5 ft. core was obtained from the granite-biotite-gneiss.

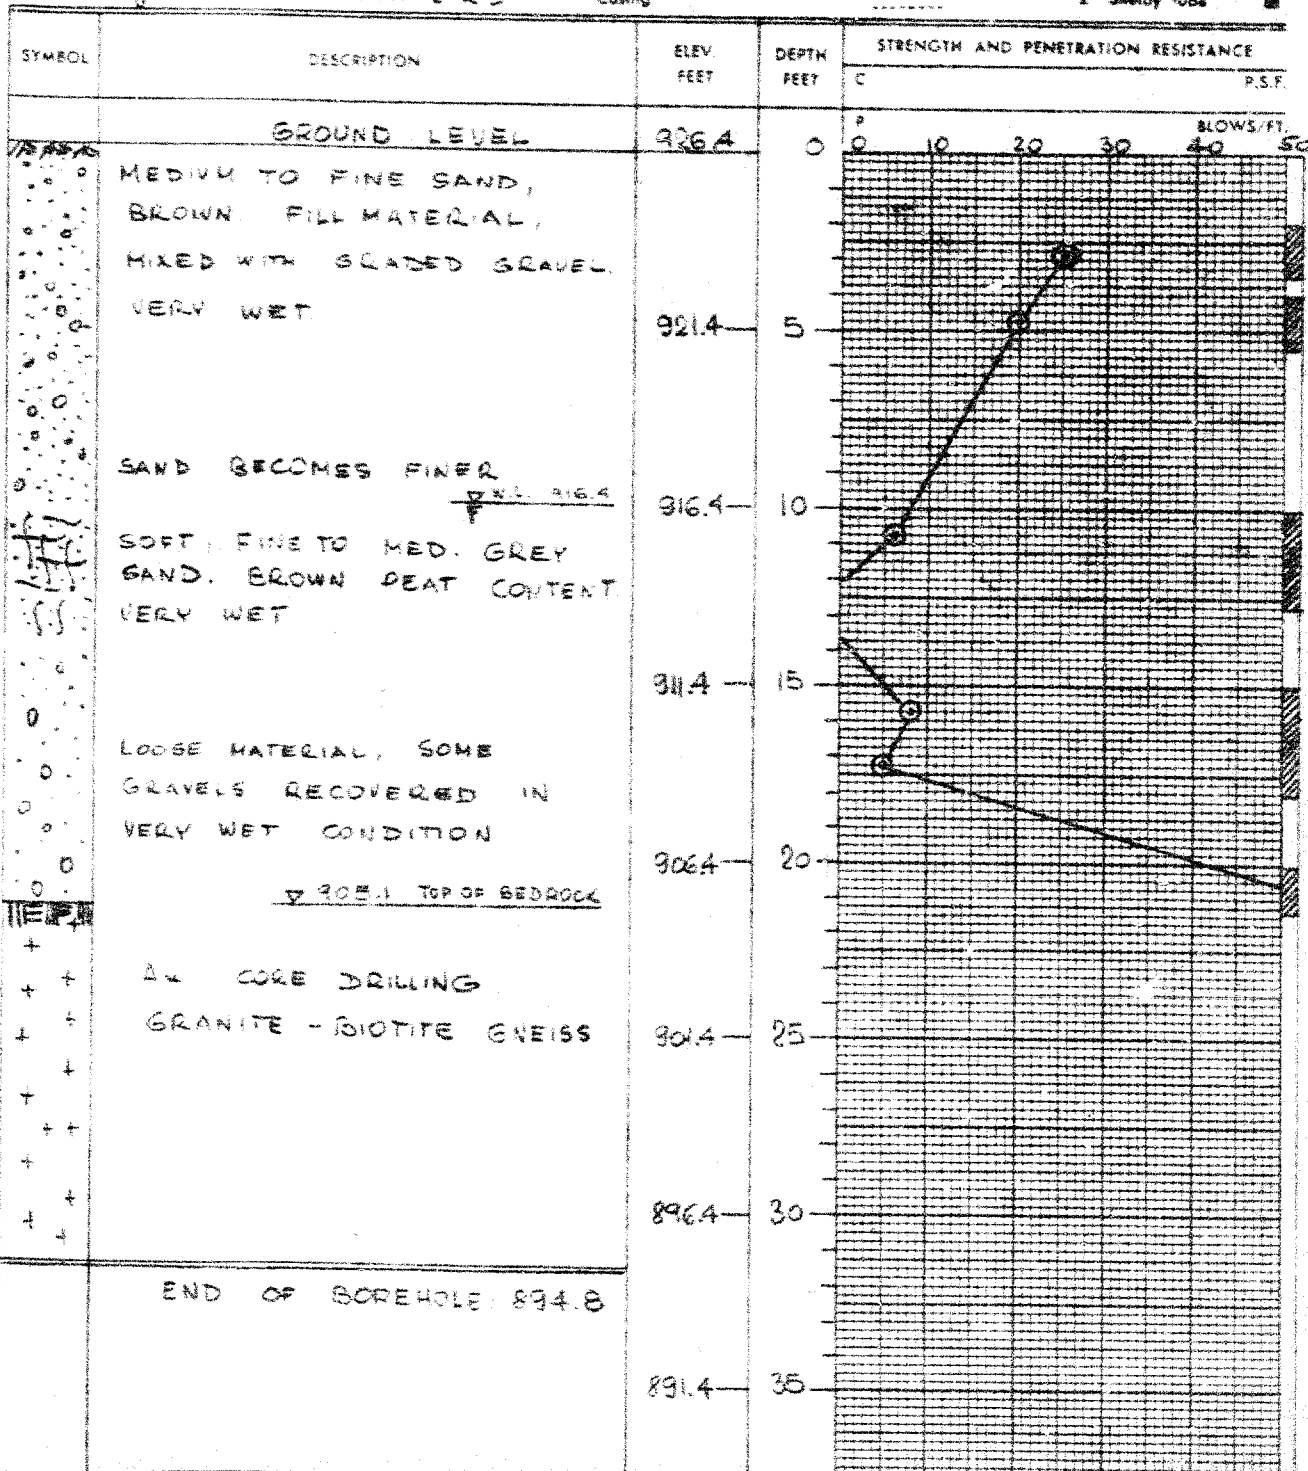
Engineering Data Sheet for Borehole: 2 of 5

At the first attempt, 2'-3" from the surface, the split spoon met refusal - probably on a boulder. So, the hole was relocated 1 ft. to the south. The boring operations were done unhindered at this new location. Sample #3 - very soft material - was lost. Sample #4 was pushed in, and about 8" was the recovery.

Water level was checked at the end of shift (May 4) and next morning, before beginning the work (May 5). It subsided 6" during the night.

At sample #5, gravel jammed into the mouth of the spoon, thus no sample was obtained. Sample #6 came up empty also. The material was too loose and saturated with water.

10.3 ft. diamond drilling was done in the bedrock.

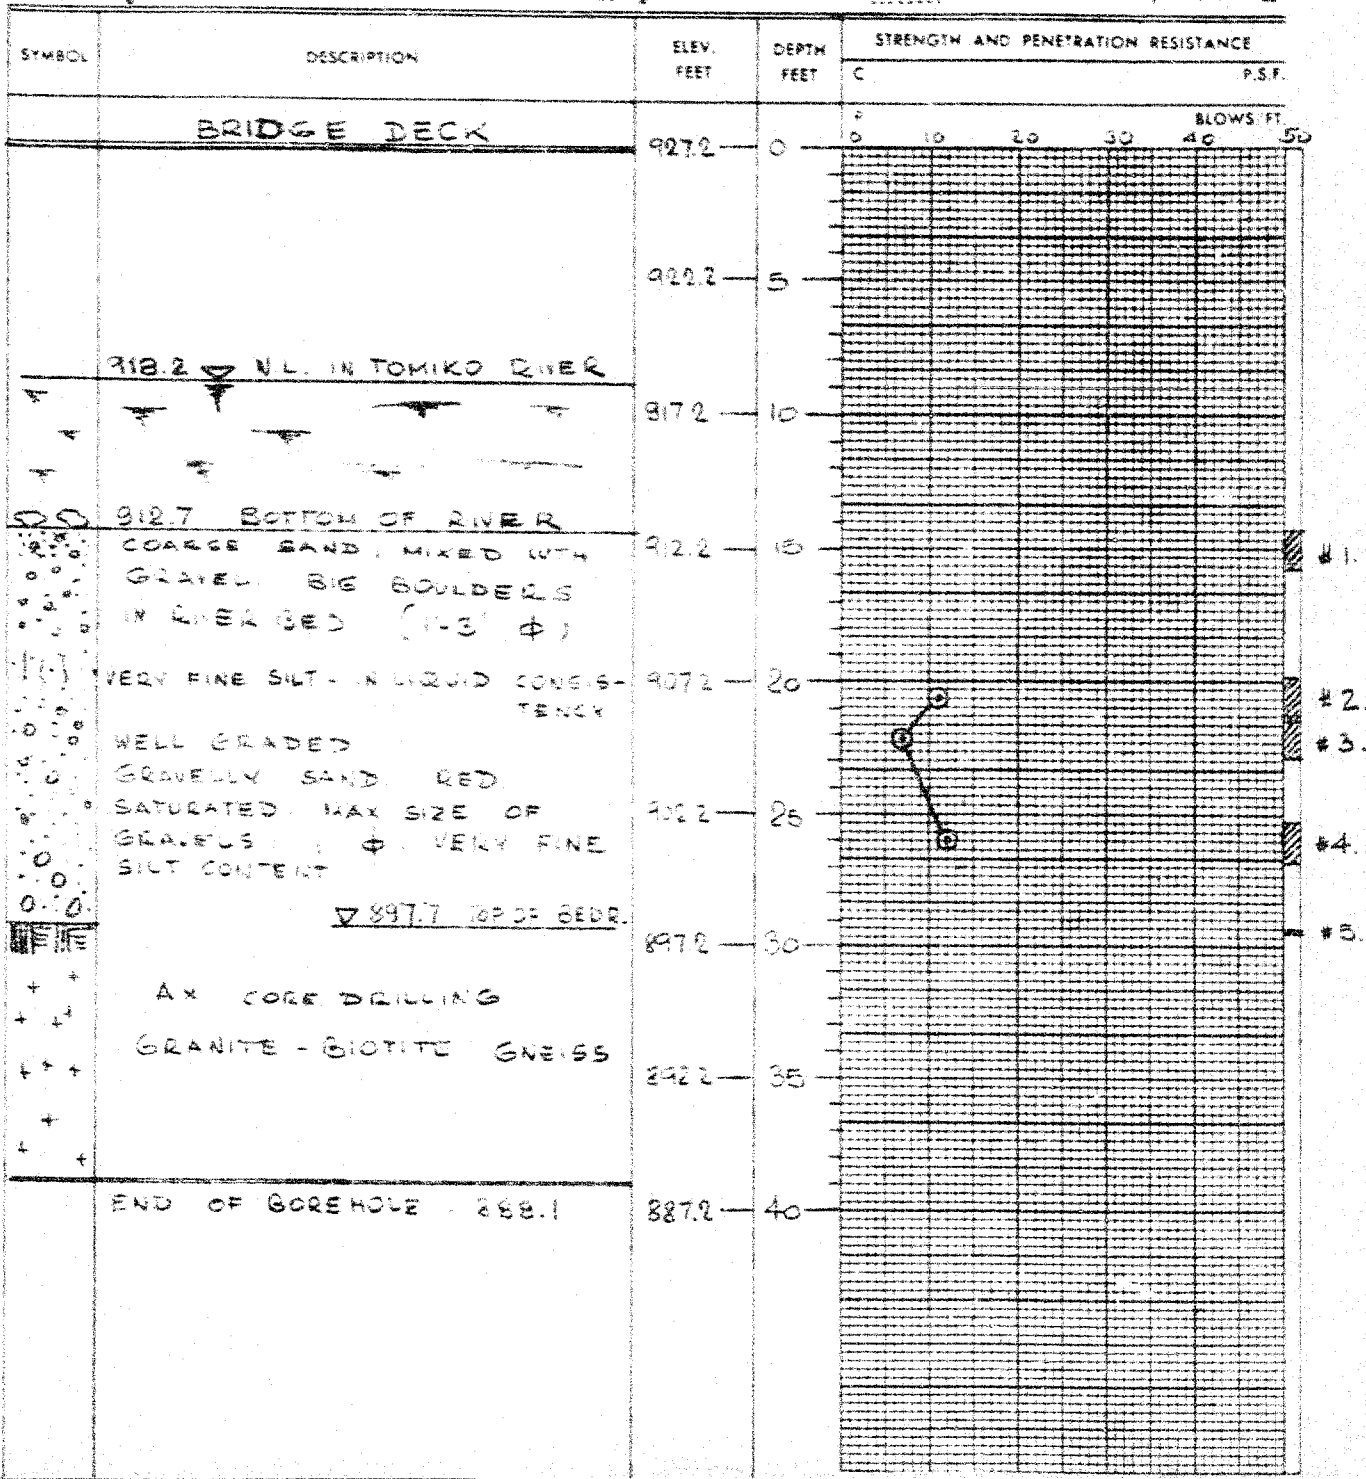
This hole was drilled straight through the bridge deck with the permission of Mr. Homer, Maintenance Engineer, D.H.O., Regional Office, North Bay.

Twice (Sa. #1 & Sa. #2) the split spoon came up empty. The material is in fluid condition, thus no recovery was possible.

The obtaining of the sample with bucket, from the riverbed was impossible because of the fast flow of the river. However, judging by the eye, the bottom of the river consists of coarse, gravelly sand and there are large boulders (1 to 3 ft. diameter) in the riverbed.

The washwater from El. 902⁺ was stored in a jar to check how fast the content settles. Even after 5 hours, the water was not transparent due to the content of fine particles. Thus, it is probable that from Samples #4 and 5, the fine grains were washed out while the spoon was withdrawn.

The number of blows required to drive in Sample #5 are not valid - after 2 inches, the spoon met refusal.

9.6 ft. of core was obtained from the bedrock.

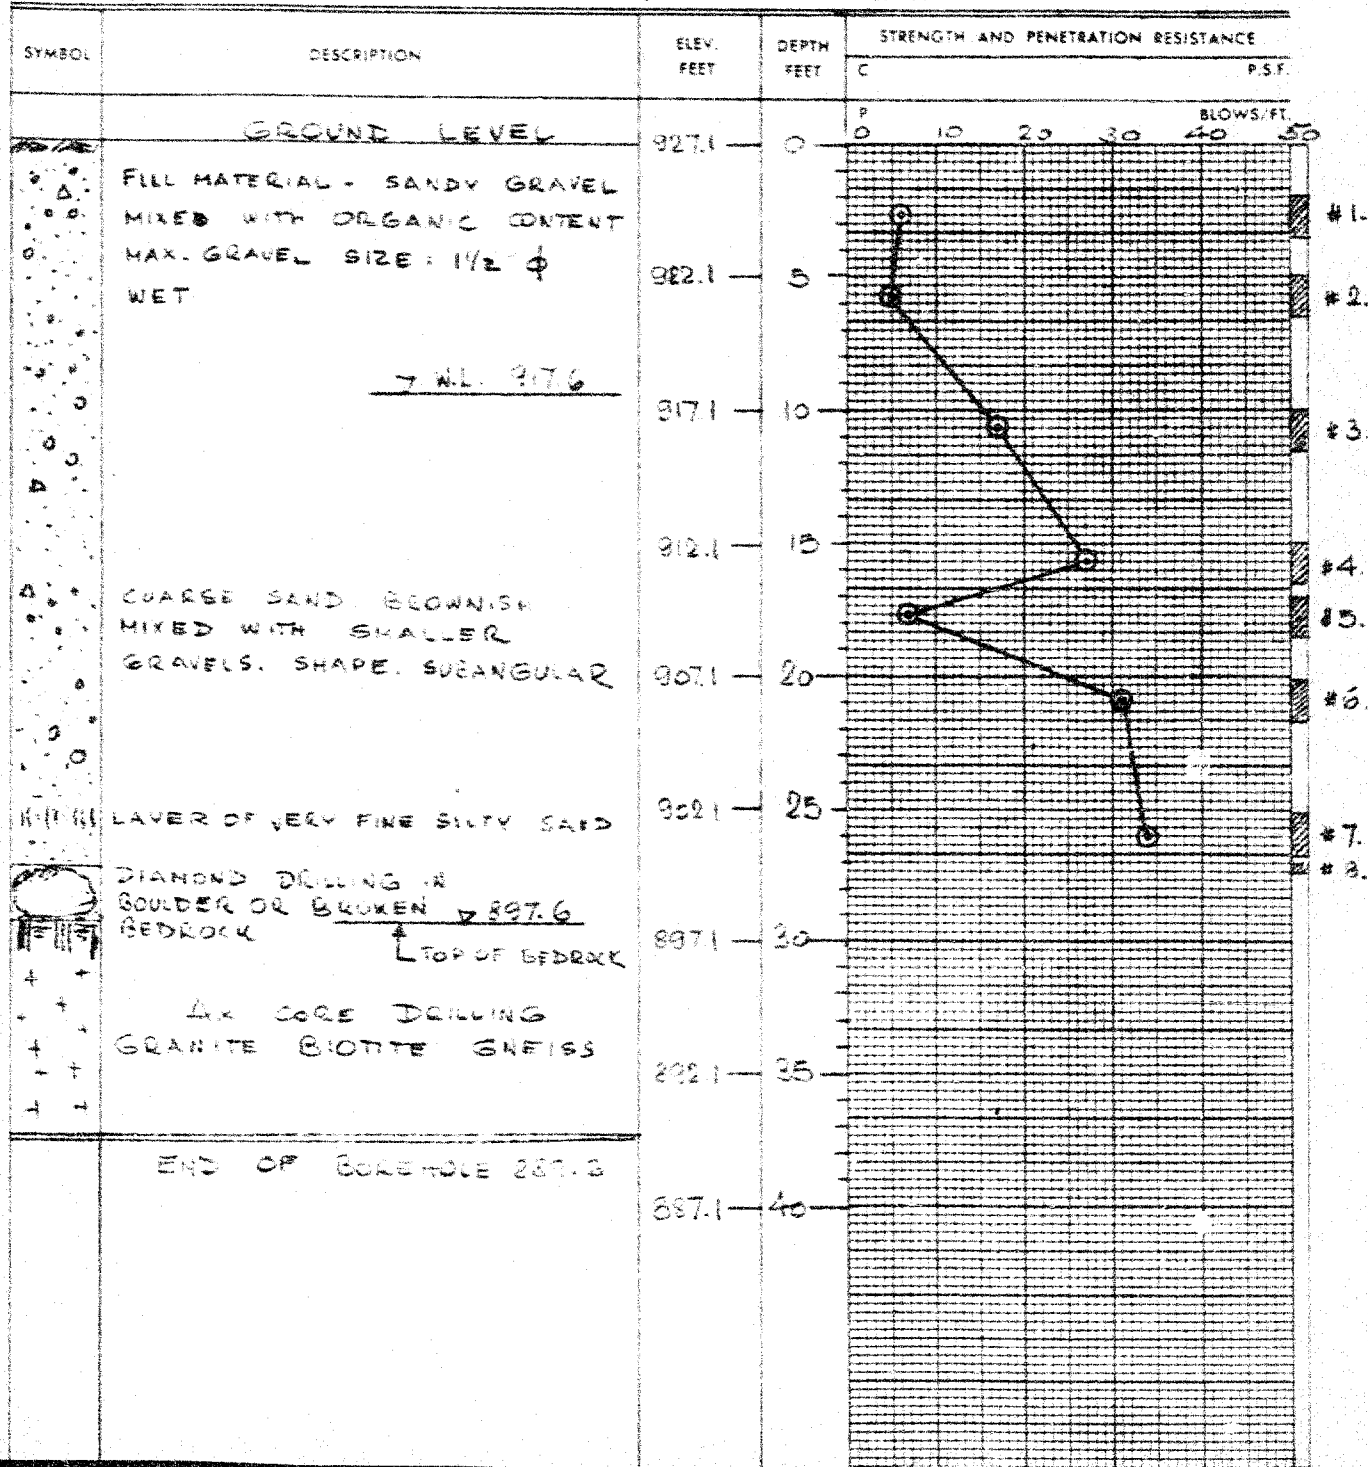
Engineering Data Sheet for Borehole: 4 of 5

This hole was twice relocated westward (the first two attempts have been made east of the Guardrail) because the casing met refusal 2 - 3 ft. from the surface. The rock fill against the erosion extends to the top.

Sample #2 showed no appreciable difference to the #1, thus it has not been stored. As gravel was squeezed into the mouth of the split spoon, nothing was recovered at Sample #4.

The washwater from El. 907⁺ was stored in a jar again to check the sediment. Eight hours later, the water was still not clear.

Nothing was recovered from Samples #6 and 7. The penetration value of sample #8 is not valid because after 3 inches penetration, the spoon met refusal.

From elevation 900'± diamond drilling was necessary. However, after approximately 2 ft., sand came up. Probably a boulder was encountered or broken bedrock.

8 ft. core was obtained from the solid bedrock.

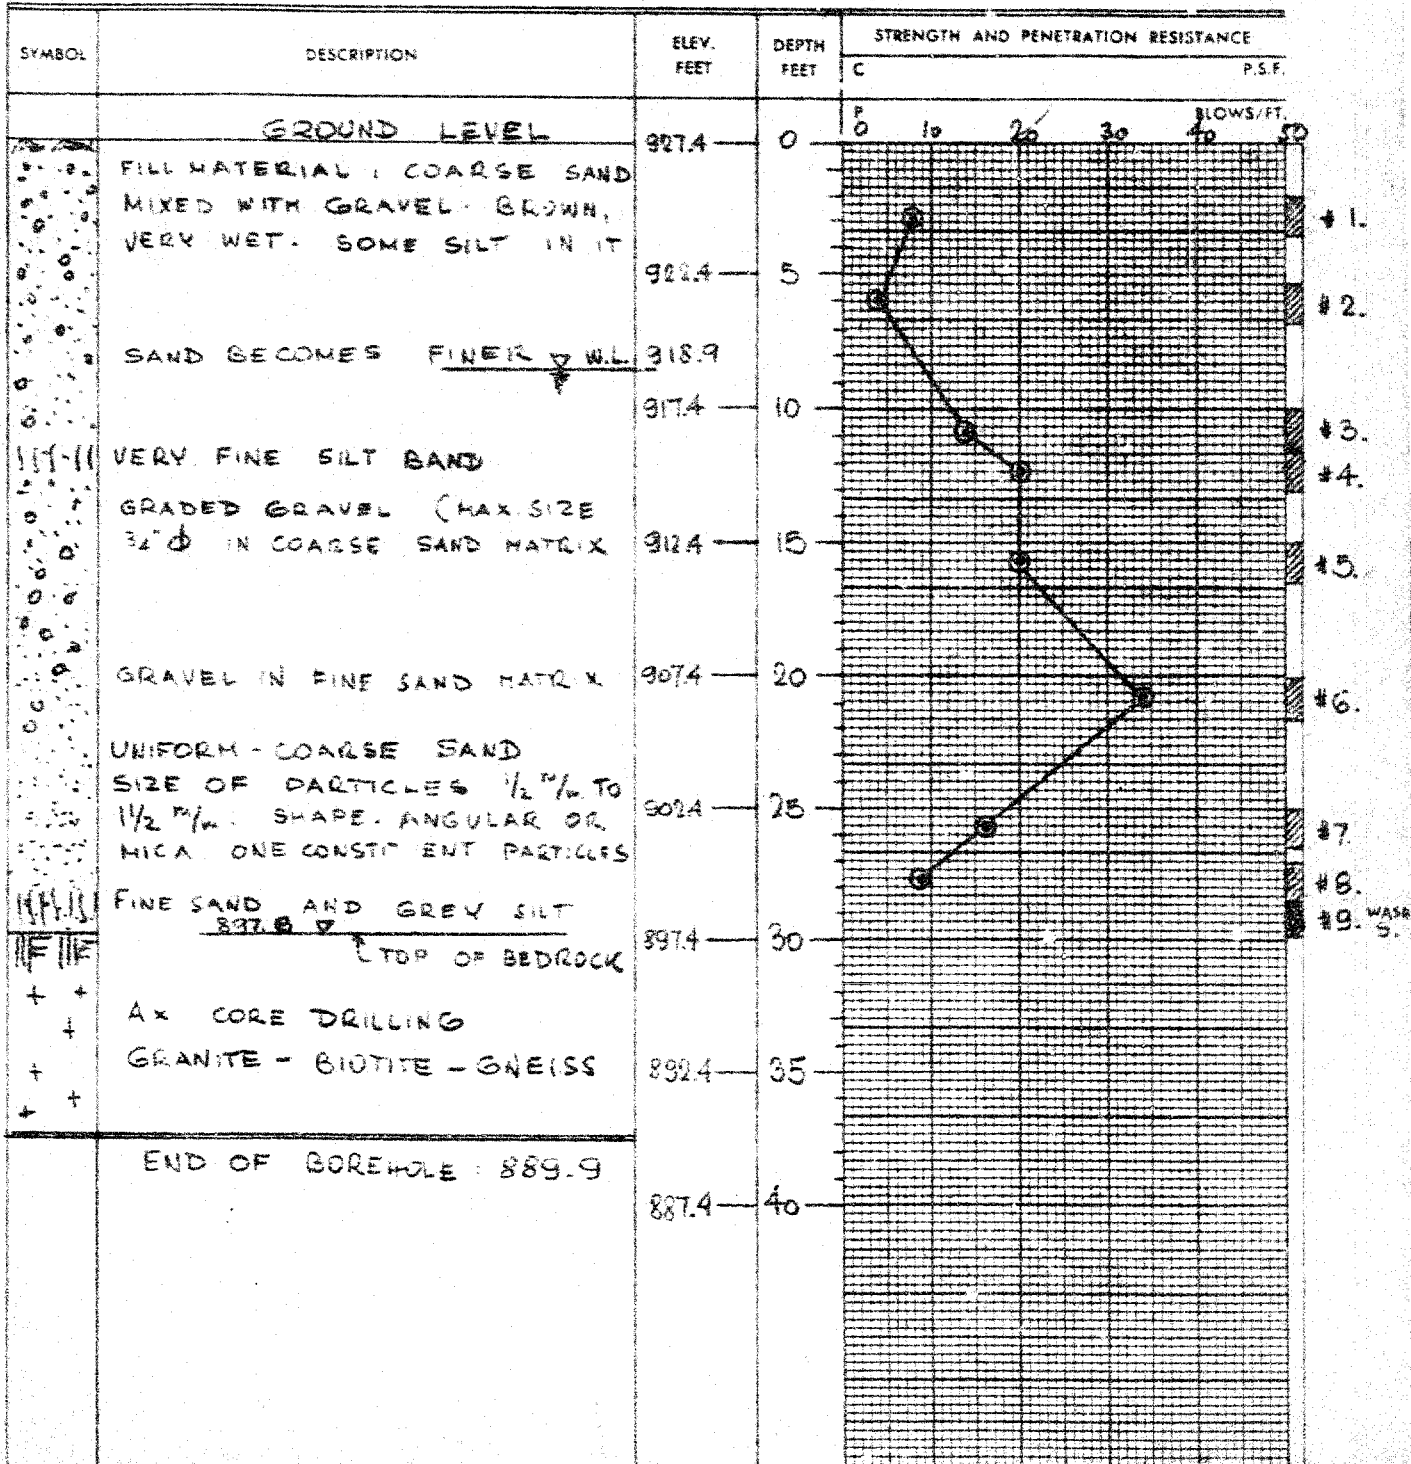
Engineering Data Sheet for Borehole: 5 of 5

The rain poured the whole day when this hole was drilled. However, the operations proceeded undisturbed.

Sample #3 was empty. Gravel was squeezed into the mouth of the split spoon. The washwater from El. 912'± was clear after an hour. The sediment was coarse sand.

No recovery was obtained from Sample #7. The material slipped out of the split spoon.

Sample #9 was taken from the washwater.

7.9 ft. of core drilling was done in the bedrock.

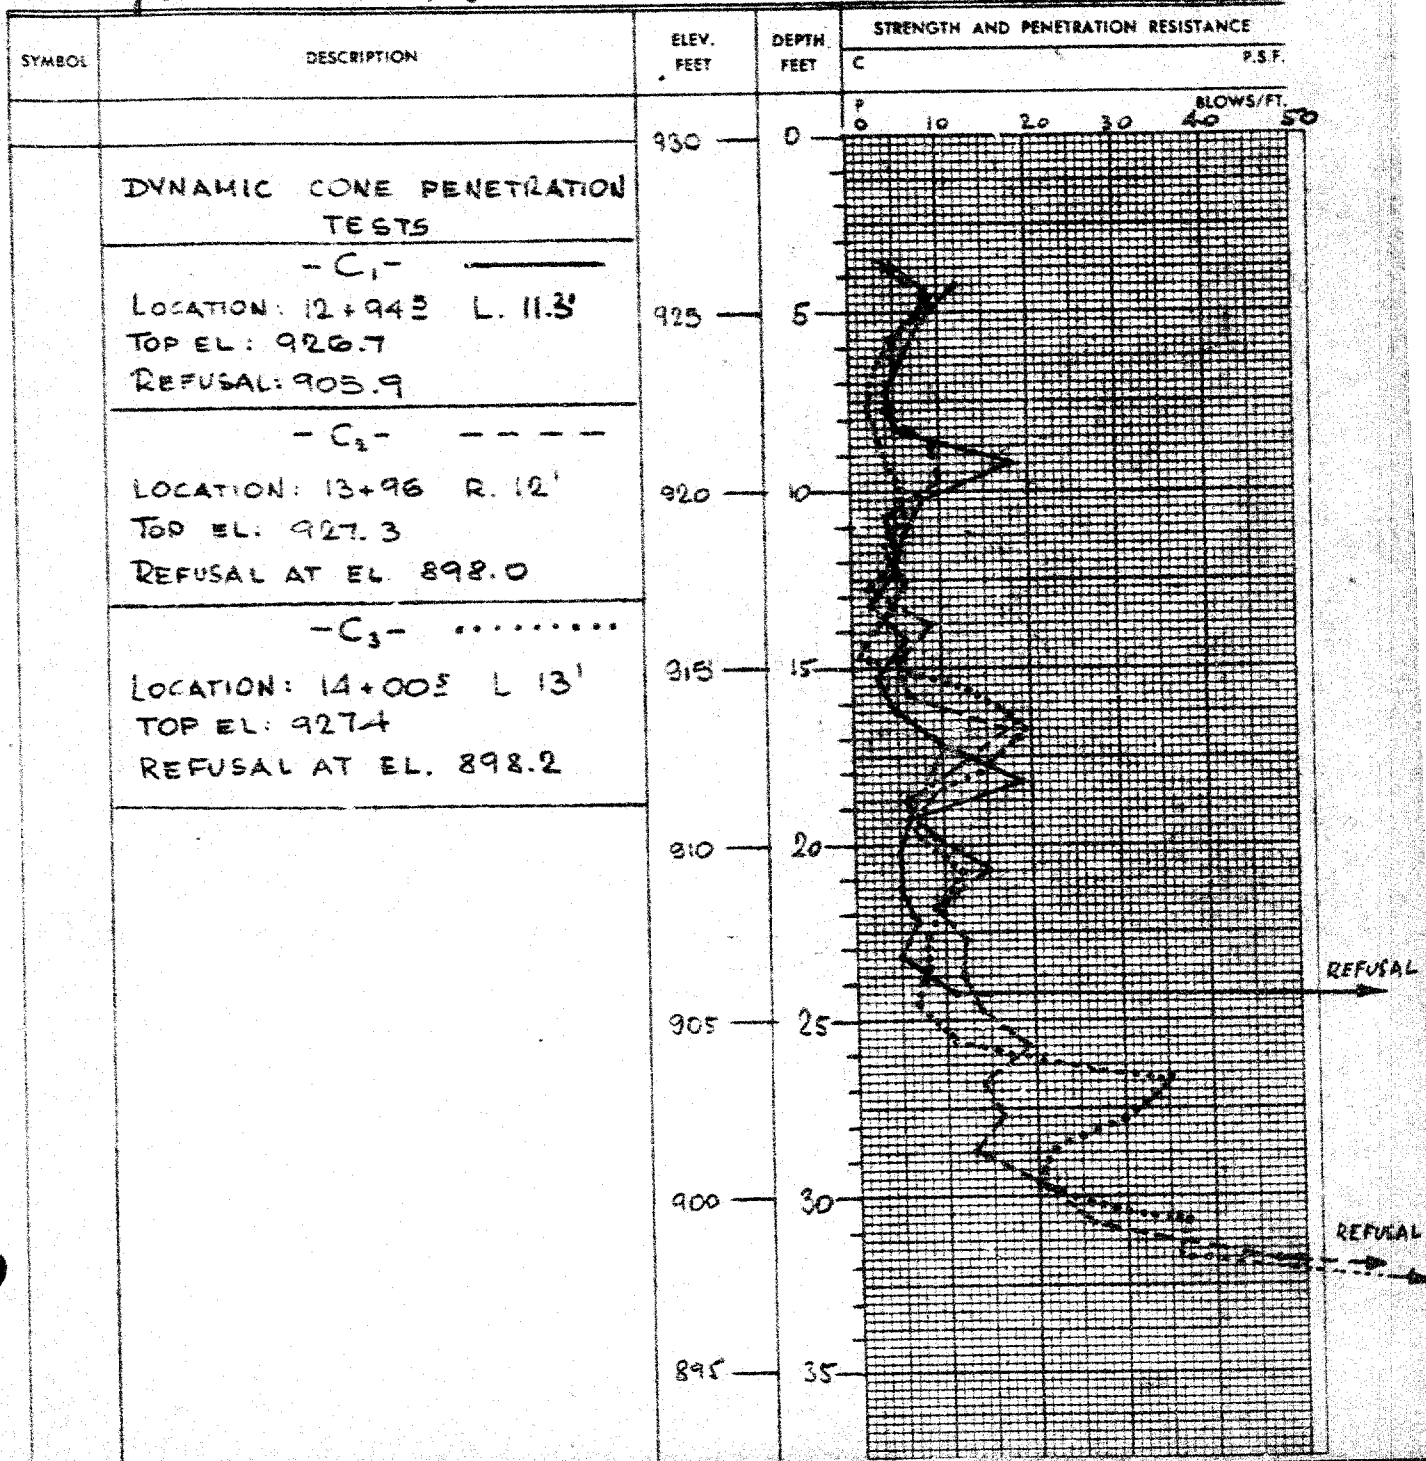
DYNAMIC CONE PENETRATION TESTS Nos 1, 2 & 3.

These tests were carried out as close to the abutments as possible. C#1 was driven next to BH#2, C#2 near BH#4 and C#3 in the neighbourhood of BH#5. The cones met refusal at about the same elevations where the boreholes proved the top of bedrock.

The shape of the curves (number of blows required per foot to drive in the cone) is very similar to each other, which proves also the uniformity of the subsoil at the site.
