Re: O.J.H.R.P. Project No. 24,
New Liskeard Embankment
W.J. 62-F-99.

Re: Installation at O.N.R. Overpass - Tri-Town By-Pass

SUGGESTED APPROACH EMBANKMENT CONSTRUCTION

FIG. 3: VIEW OF FAILURE TOWARDS EAST

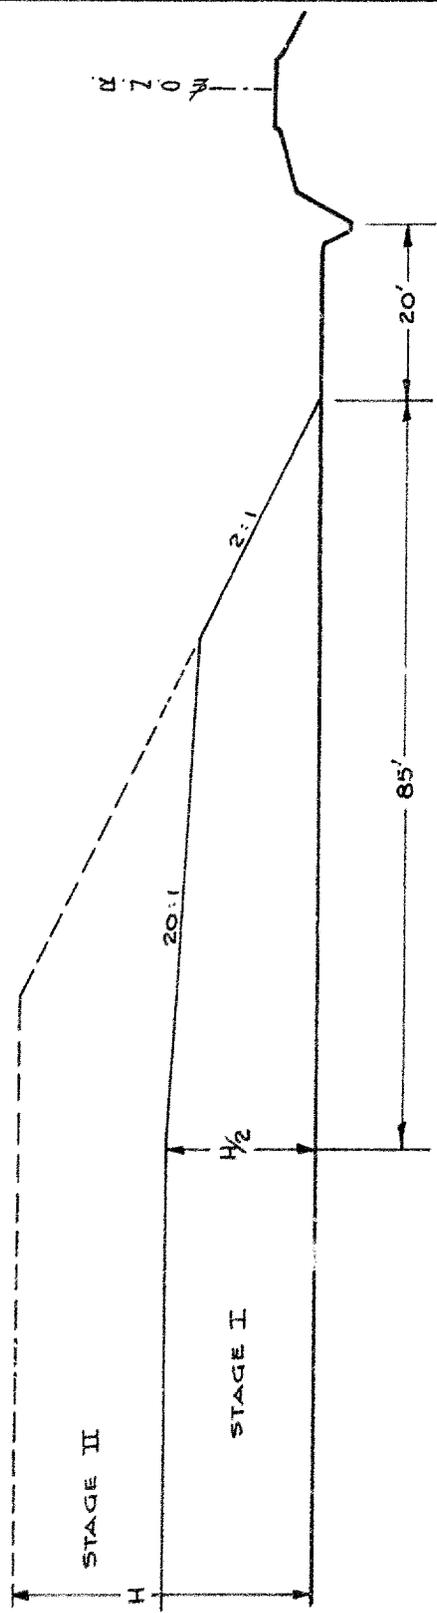
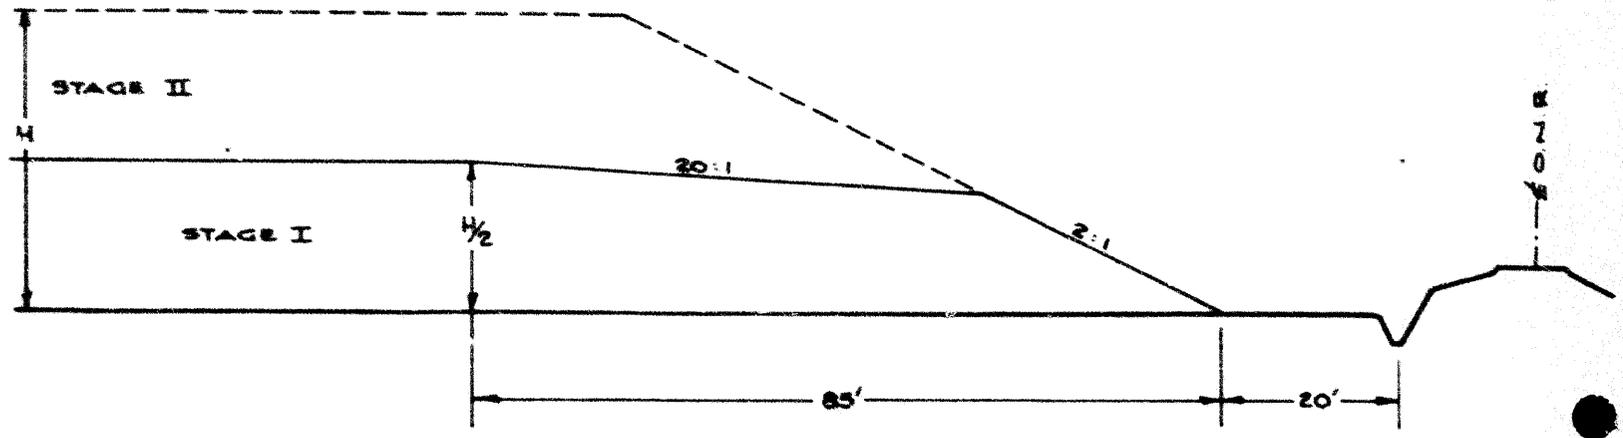
Attached to this memo, you will find Drawing No. X-29 showing the recommended construction sequence of the approach embankments. Stage No. 1 can be started whenever desirable or convenient, while the time for the start of Stage No. 2 will be determined by the Foundation Section.

NOTE: The time of Stage II construction will be determined by the Foundation Section

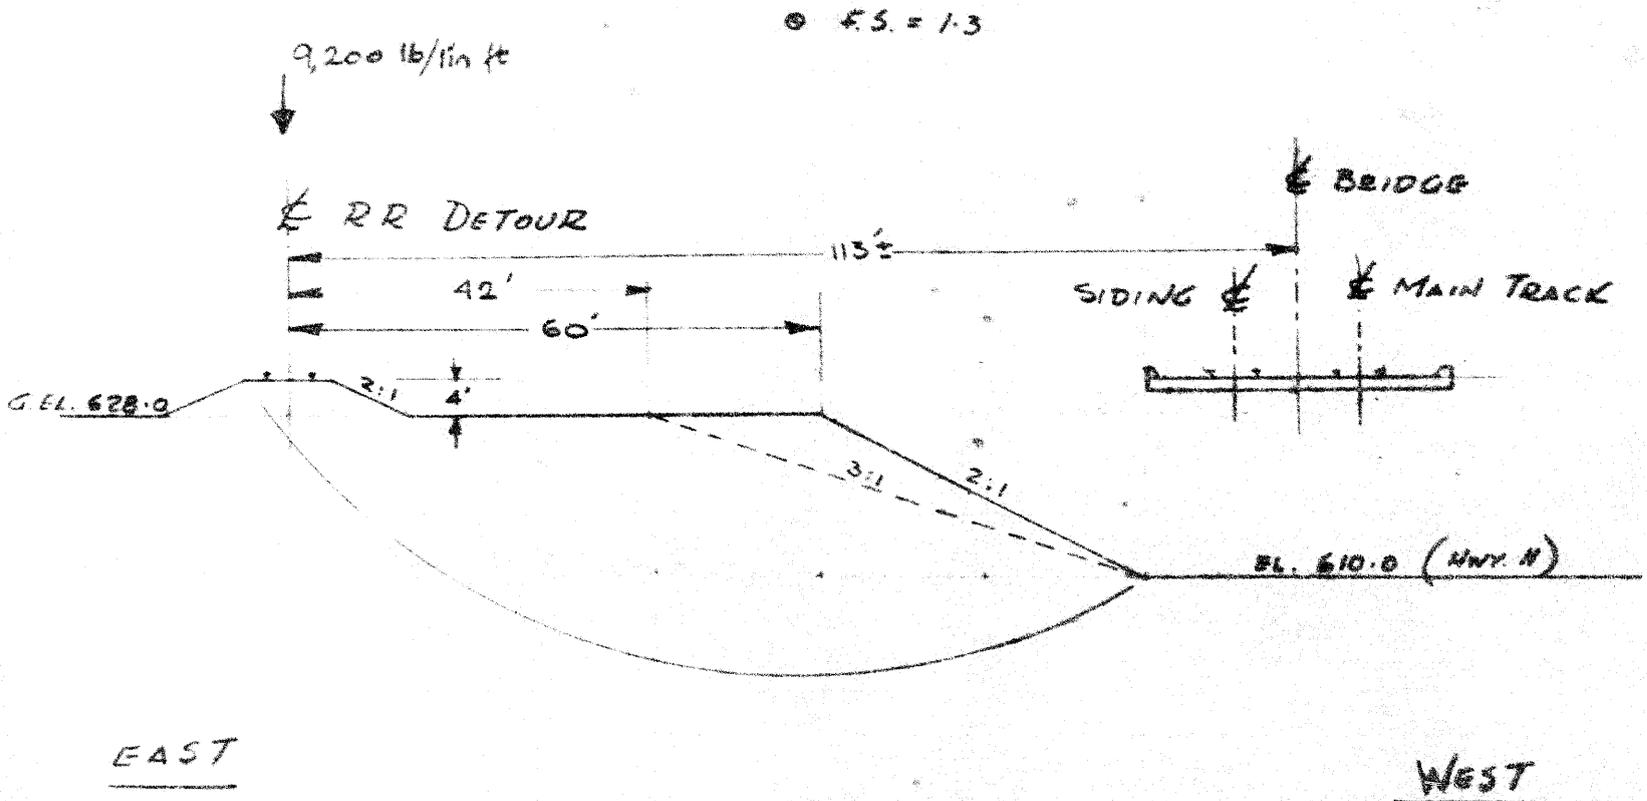
Attached to this memo, you will find a sketch showing the required distance between the existing and the detoured railway tracks. The distance was determined on the basis of a factor of safety of 1.3. Ten more feet were added to provide some additional safety necessary because of vibrations caused by the passing train.

⊙ F.S. = 1.3

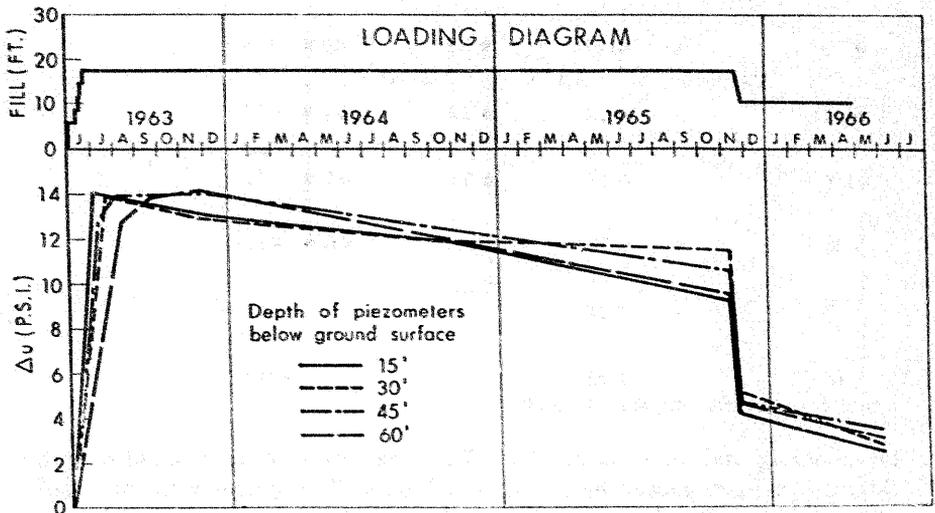
FIGURE 9. Variation of excess pore pressure, Sta. 802 + 50

the history of construction. The full height of 18 ft. of embankment was completed in approximately three weeks within 100 ft. on either side of Stat. 802+50. The load was put on in 2 to 3 ft. lifts running from toe to toe. The fill material was granular with pebbles and boulders. It will be seen from Figure 9 that there was very little dissipation of pore pressure during the first few months after the full load was put on. In fact, the average degree of dissipation after 2½ years was only 25 per cent for this group. The maximum pore pressure registered was 14 lb./sq. in.

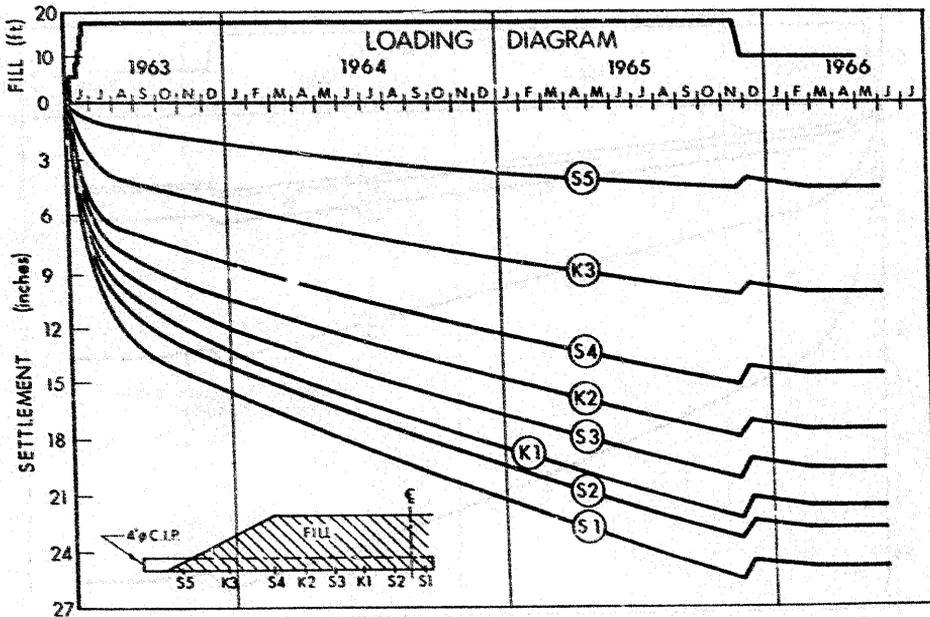
Figure 10 depicts the surface settlements versus time at Sta. 802+50. The settlement forms a regular pattern with its magnitude decreasing from the centre to the toe of the embankment. The largest settlement below the centre of the fill during the period from June 1963 to November 1965 was registered as 25 in. (settlement plate no. S-1). The "immediate" settlement, which

FIGURE 10. Variations of surface settlements versus time

occurred during the construction period, was approximately 8 in. As can be seen, the settlements proceeded at about the same rate, without any noticeable slowing down until half of the fill was removed (in November 1965).

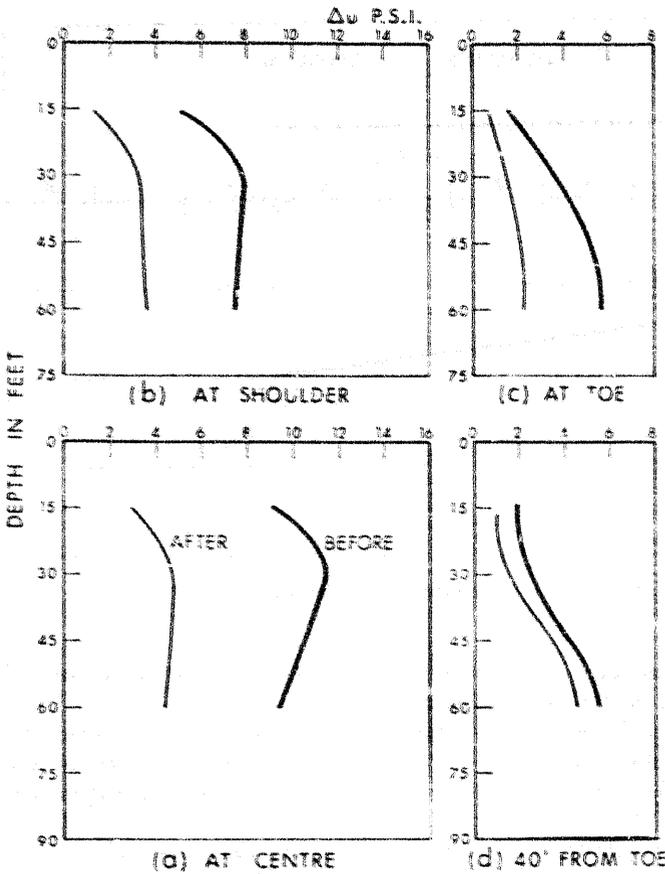
The drop of the excess pore pressure (Δu) registered by the centre group of piezometers was in the order of 5 lb./sq.in. (Fig. 9). Figure 14*b, c*, and *d* illustrate the drop of Δu during the time of load removal at the other three locations. It can be observed that beneath the centre, shoulder and toe of the fill the drop of pressure was 50-60 per cent of the pressure registered just

before the stress release. However, at the location outside the fill the pressure decreased less than 20 per cent. It is quite obvious that the rate of dissipation during the period from November 1965 to June 1966 was somewhat faster than before the removal of the embankment load.

FIGURE 14. Drop of excess pore pressure due to the removal of 9 ft. of fill

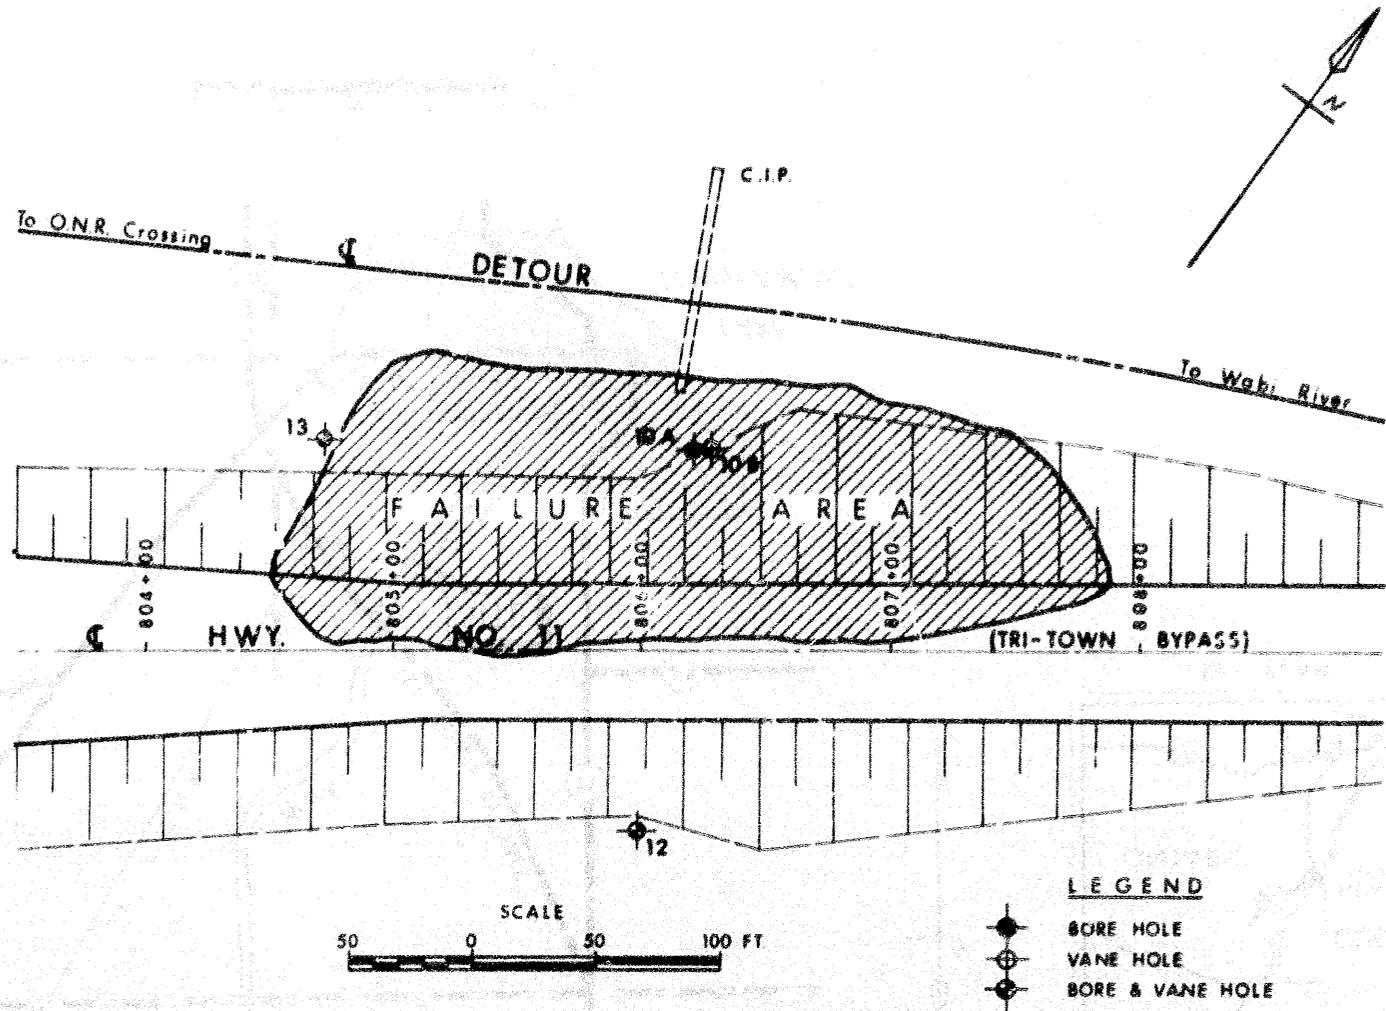
FIG. 2: PLAN OF FAILURE

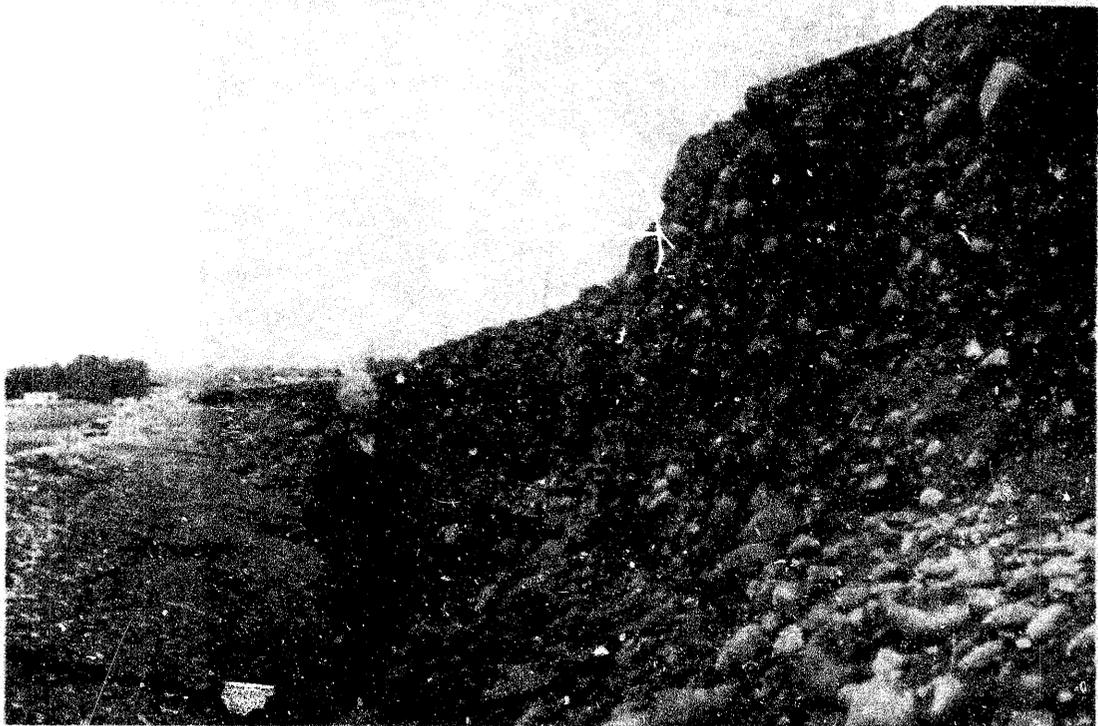
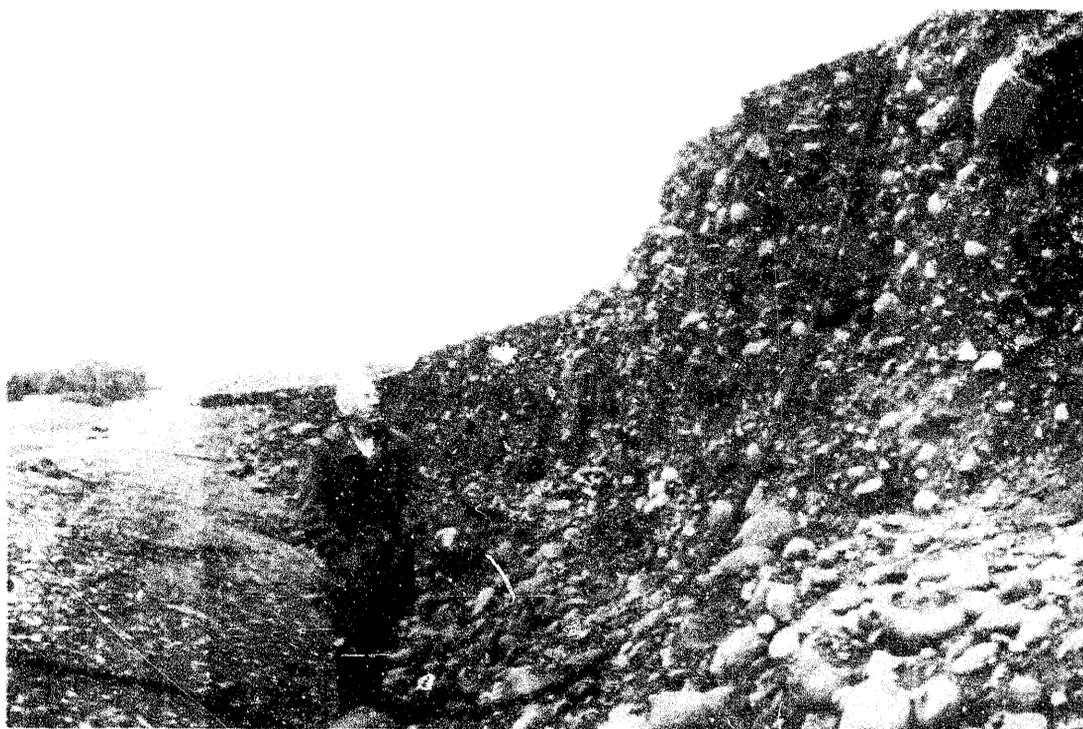
FIG. 4: VIEW OF EXPOSED PORTION OF EMBANKMENT AFTER FAILURE

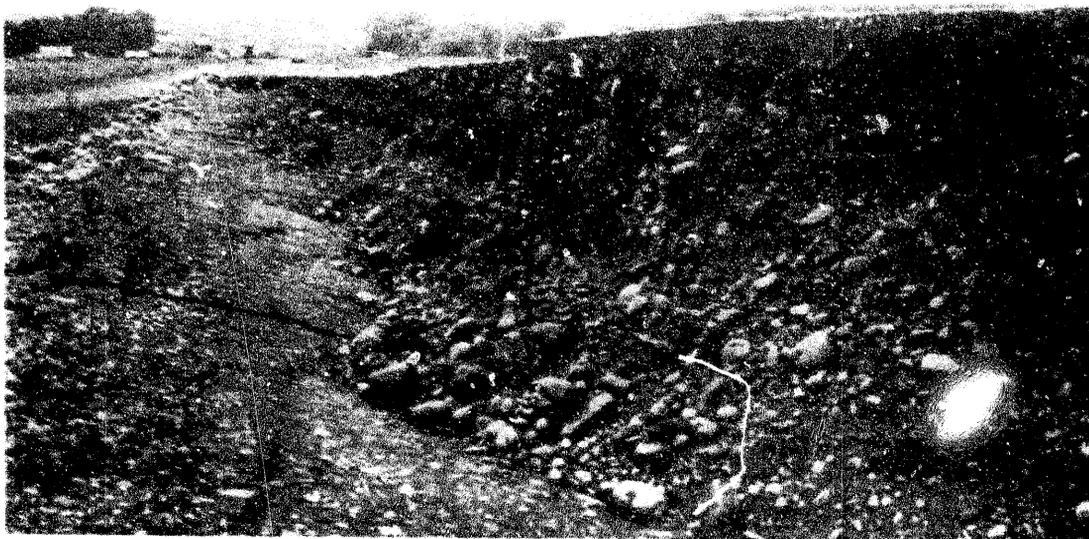
During construction of the first stage, in June 1963, a failure took place some 500 ft. east of the crossing. The height of the fill at the failure was approximately 18 ft. A short berm was designed by this Section to increase stability, and the fill was brought back to 18 ft. in height. Further placement of the fill was called to a halt.

FIG. 3: VIEW OF FAILURE TOWARDS EAST

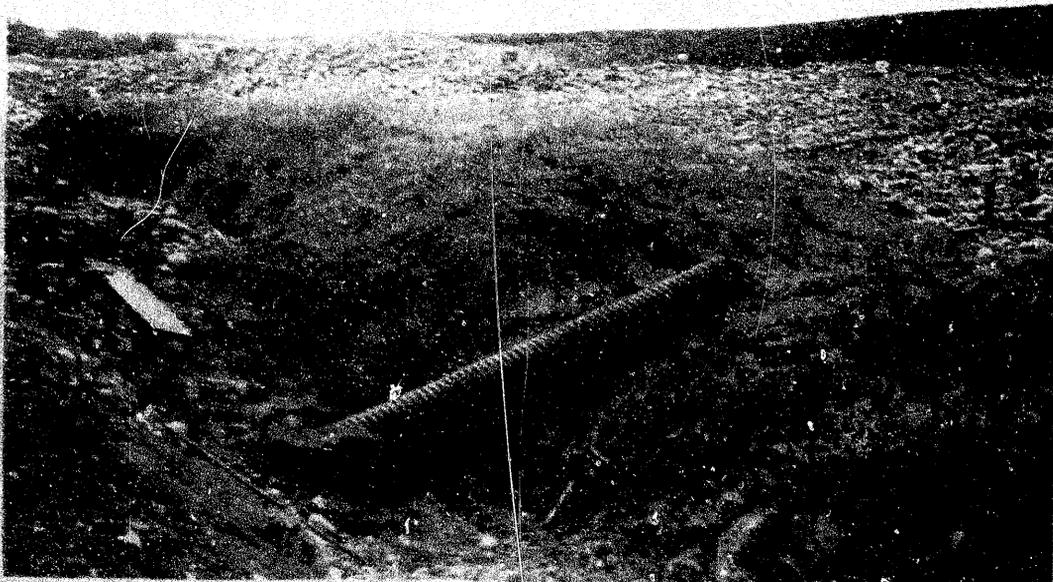
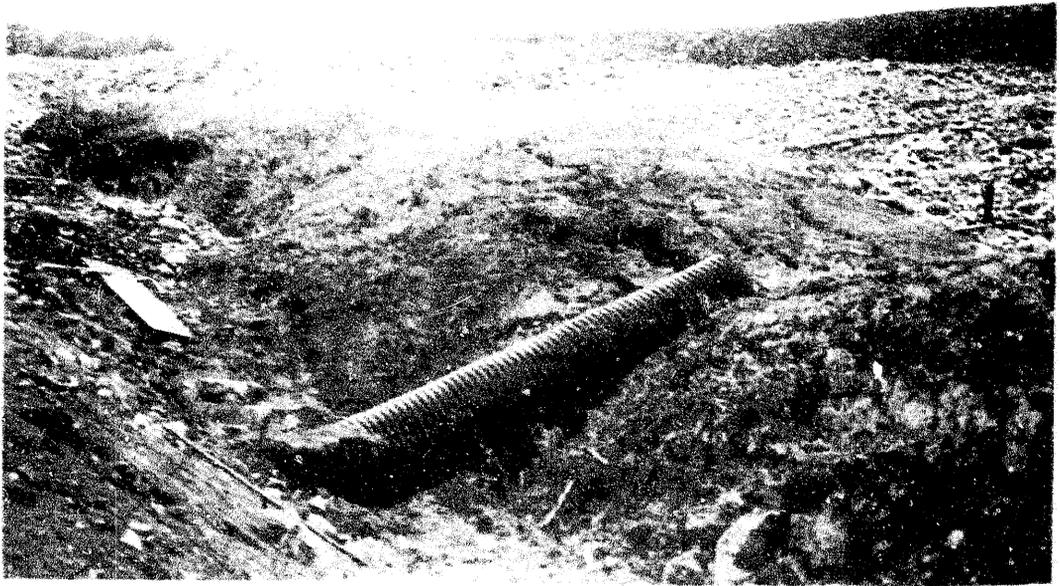
FIG. 5: VIEW OF TOE OF SLIDE TOWARDS EAST

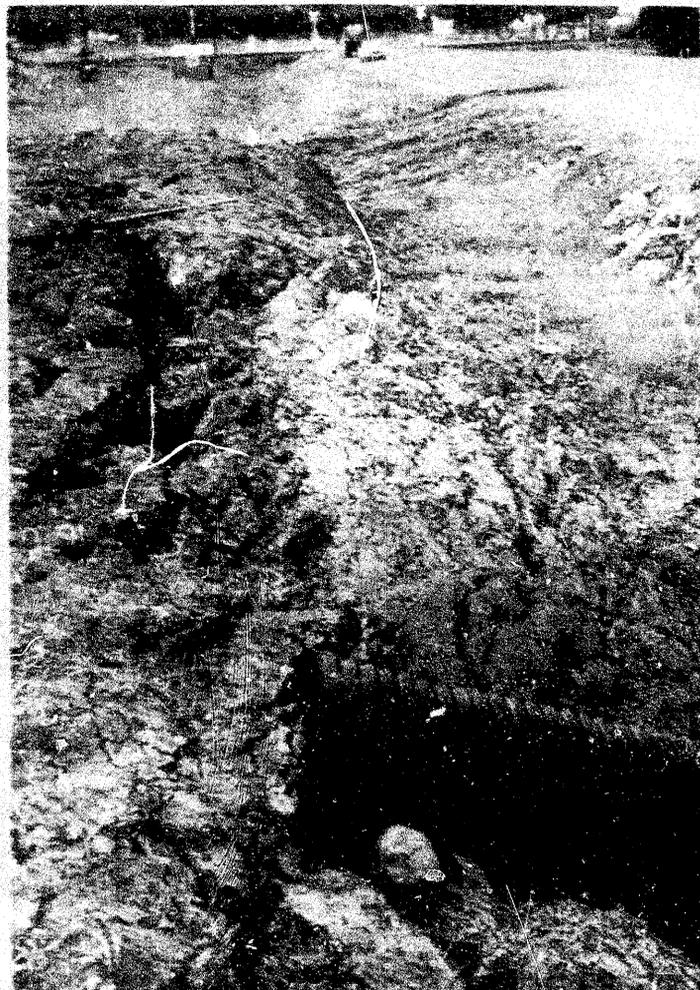
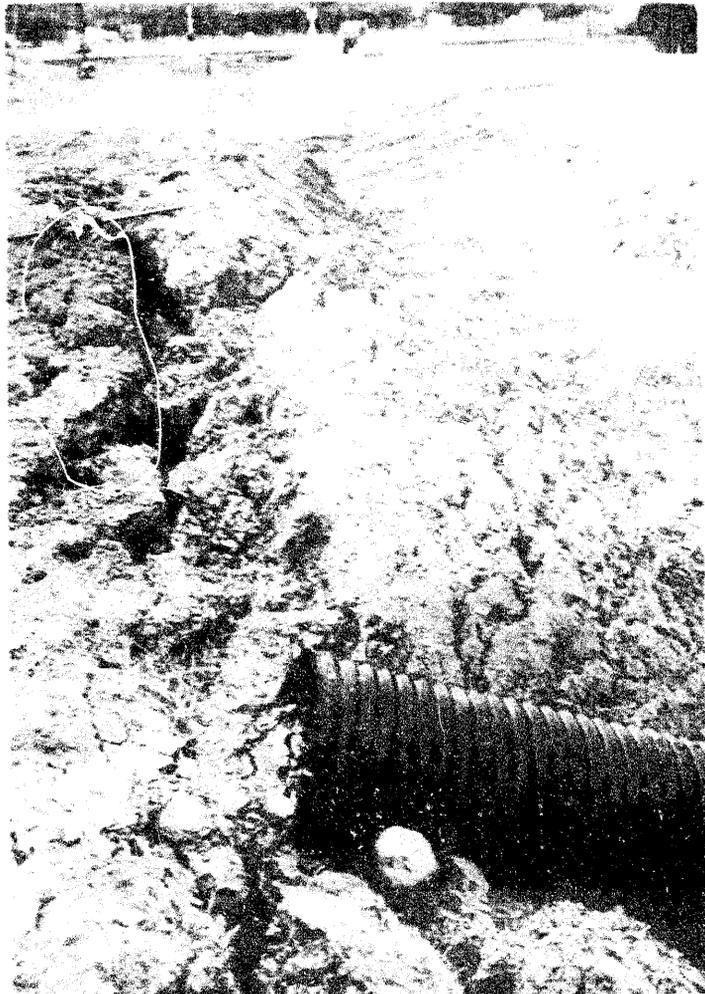
FIG. 6: VIEW OF TOE OF SLIDE TOWARDS WEST

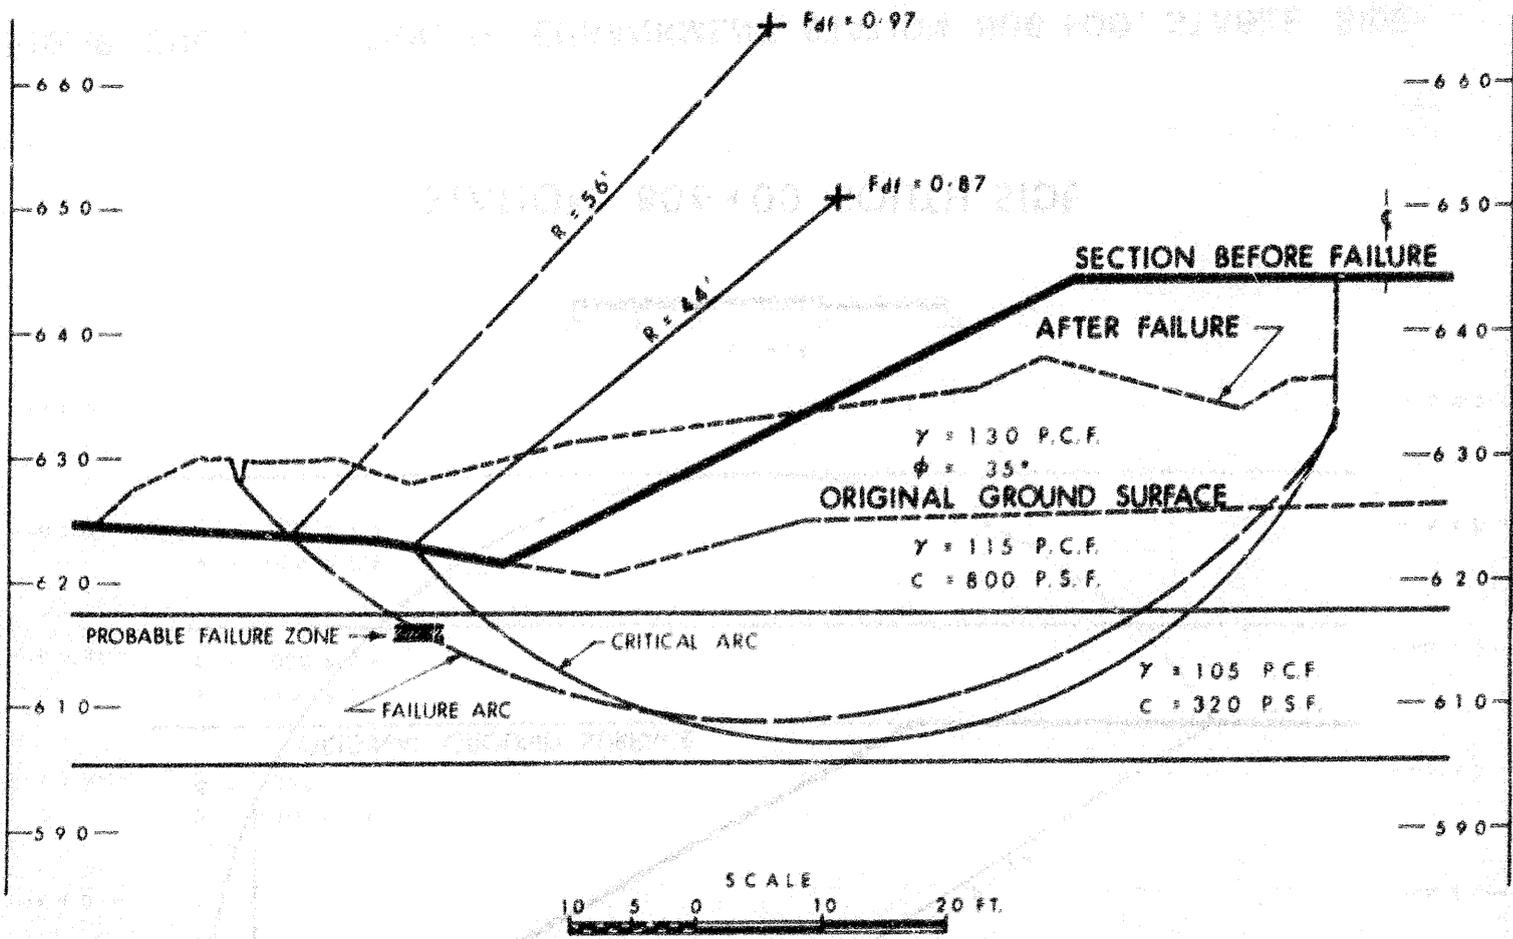
STATION 806 + 00 NORTH SIDE

Cross Section	Factor of Safety				C PSF
	F_{oo}	F_{of}	$F_{d\theta}$	F_{df}	
806 + 00 Failure Arc	0.74 0.81	0.83 0.93	0.80 0.88	0.87 0.97	$C_1 = 800$ $C_2 = 320$
806 + 00 Stable Side	1.07	1.13	1.12	1.19	$C_1 = 1,000$ $C_2 = 360$
802 + 50 (Stable)	0.97	1.07	1.05	1.13	$C_1 = 800$ $C_2 = 340$

FIG. 17: CROSS-SECTION OF SLIDE, STATION 806 + 00
