FOUNDATION INVESTIGATION REPORT

Proposed Sec. E. #560 Realignment
Twp. of Dack - Dist. of Timiskaming
Lot #2 - Concession VI
District #14 (New Liskeard)
W.J. 68-F-61-2 -- W.P. 144-67-01

FOUNDATION INVESTIGATION REPORT
For
Proposed Sec. Hwy. #560 Realignment
Twp. of Duck - Dist. of Timiskaming
Lot #2 - Concession VI
District #14 (New Liskeard)
W.J. 68-P-61-2 -- W.P. 144-67-01

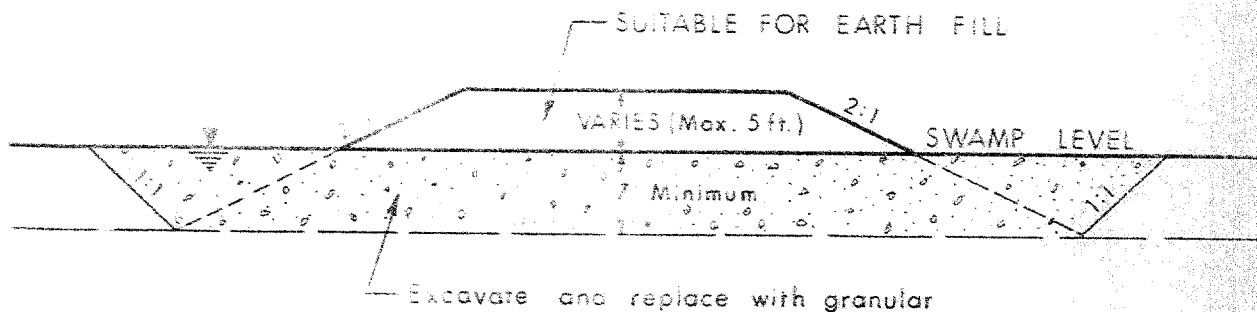
TYPE SECTION THROUGH EMBANKMENT

This method requires that all soft material be removed down to a minimum depth of 7 ft. and replaced with suitable granular fill. If organic soil is found below this depth, it must also be removed. The width of excavation should be as shown in the diagram below. Stability analyses, in terms of total stresses, have been carried out which show the safety factor to be satisfactory in this case. Future settlements are likely to be in the order of 8 to 12 inches over a long-term period. If paving is delayed for one year, future settlements will probably be less than 6 inches. This method may prove to be the most costly, but from a performance point of view, it should be the most satisfactory.

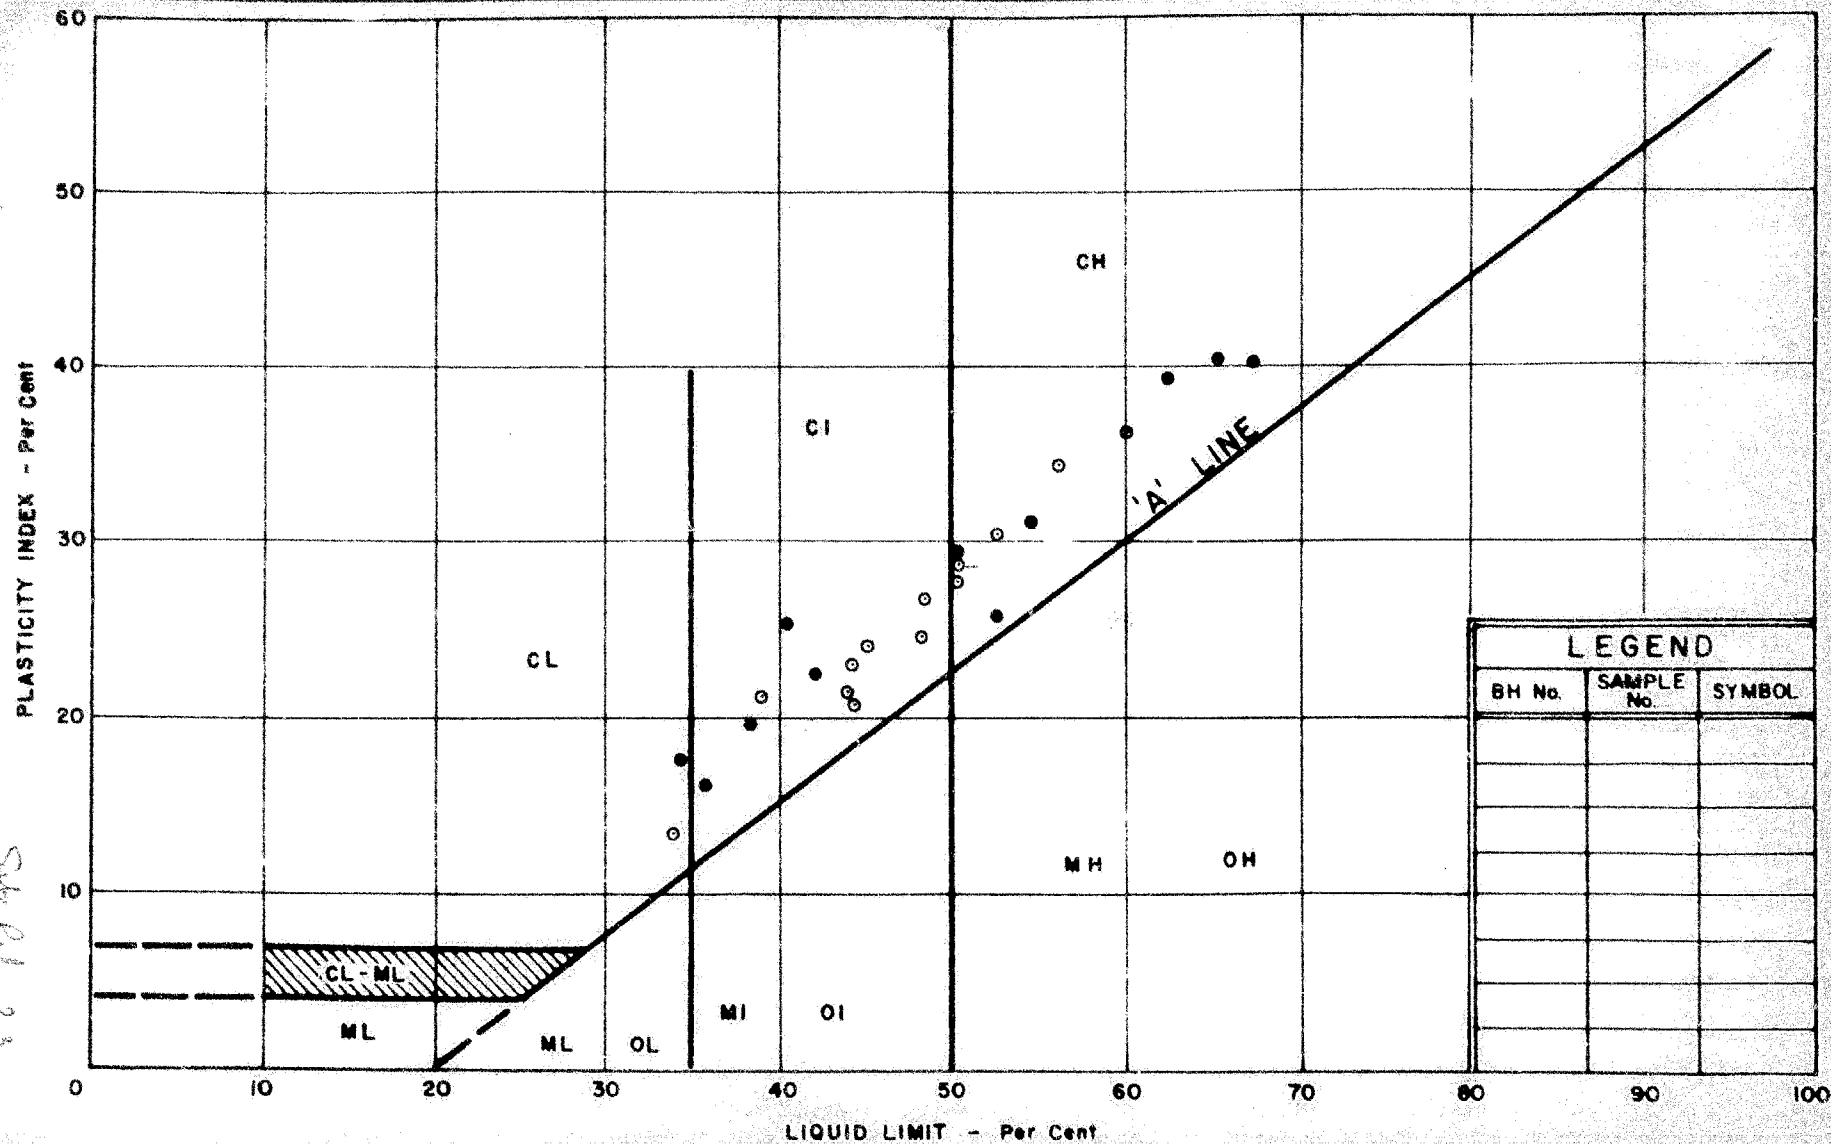
FIG. No. 1

The material in the deposit is predominantly a mixture of clay and silt with traces of sand and occasional pockets of thin layers of silt. A plot of Plasticity Index versus Liquid Limit (Fig. 1) shows the great majority of the points to fall within the CI and CH range.

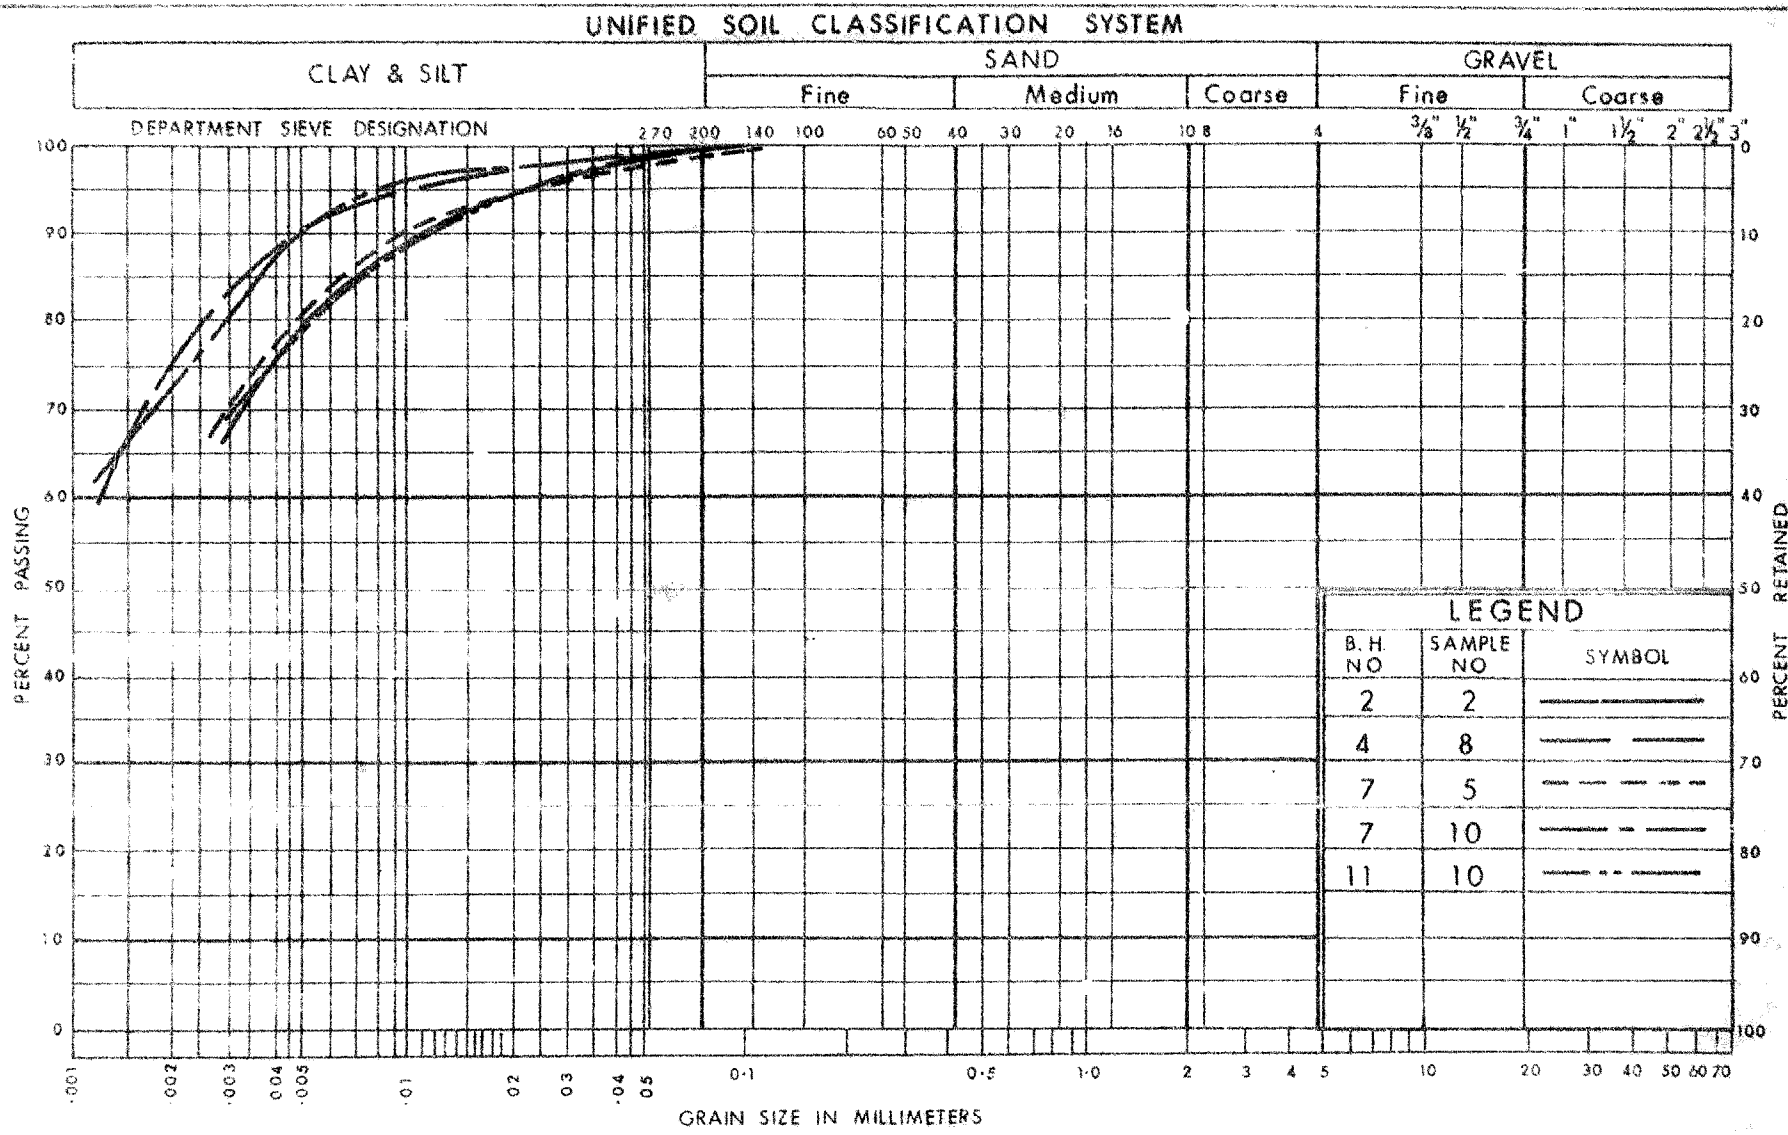
FIG. 2

Typical grain-size distribution curves are included in the Appendix of this report.

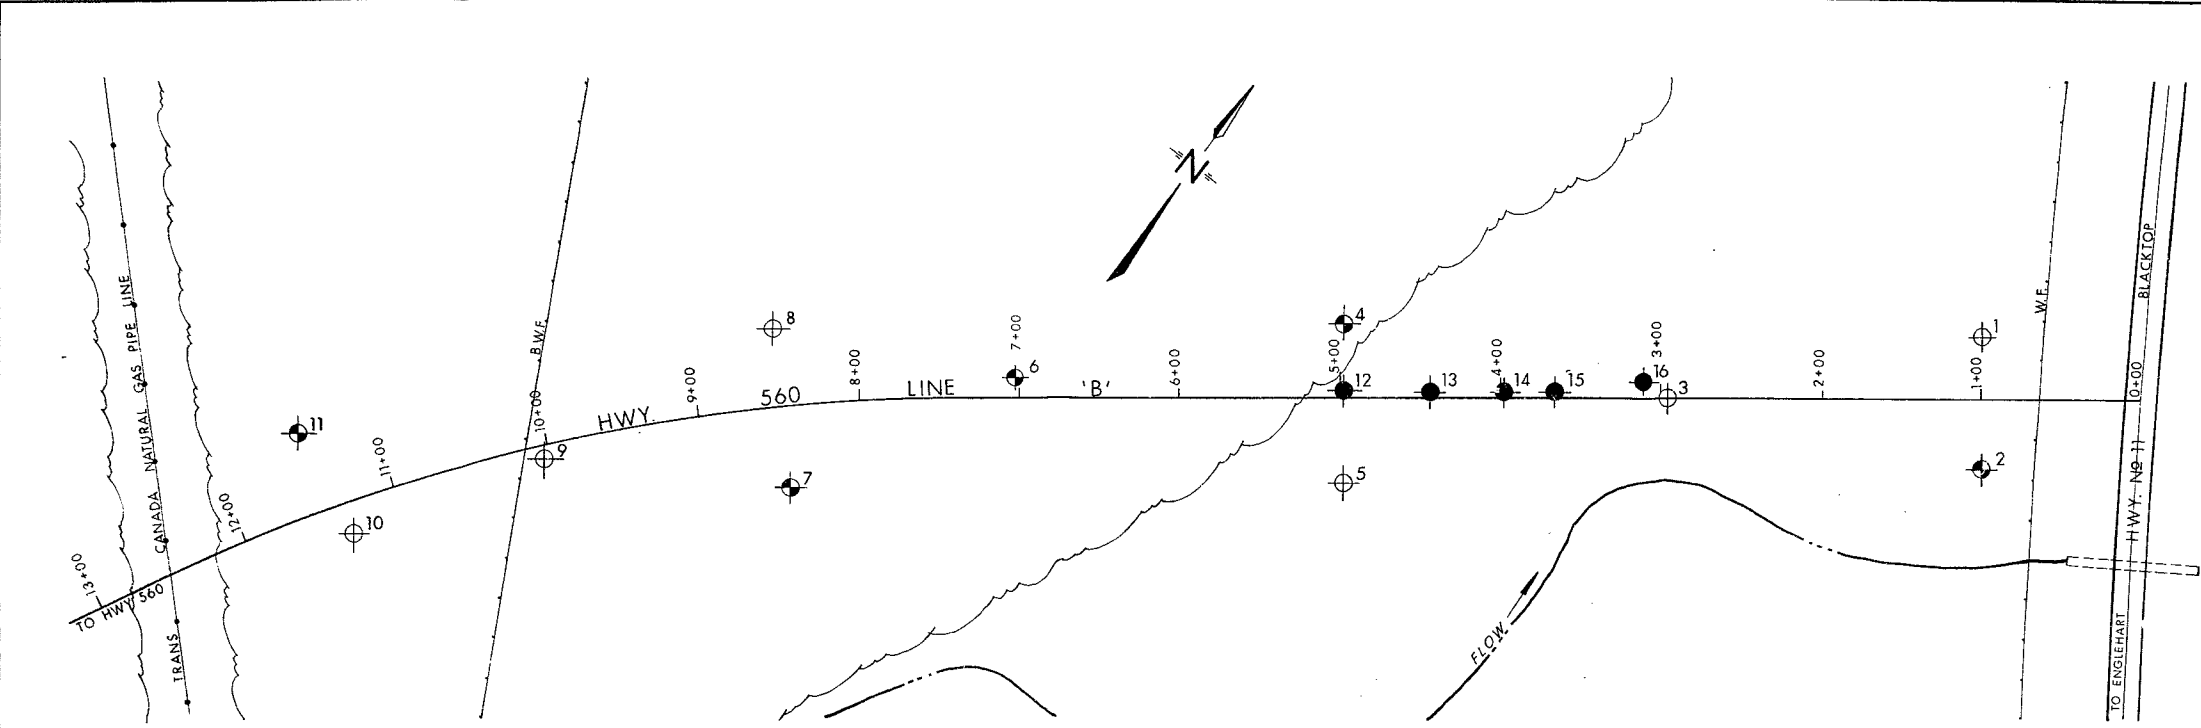
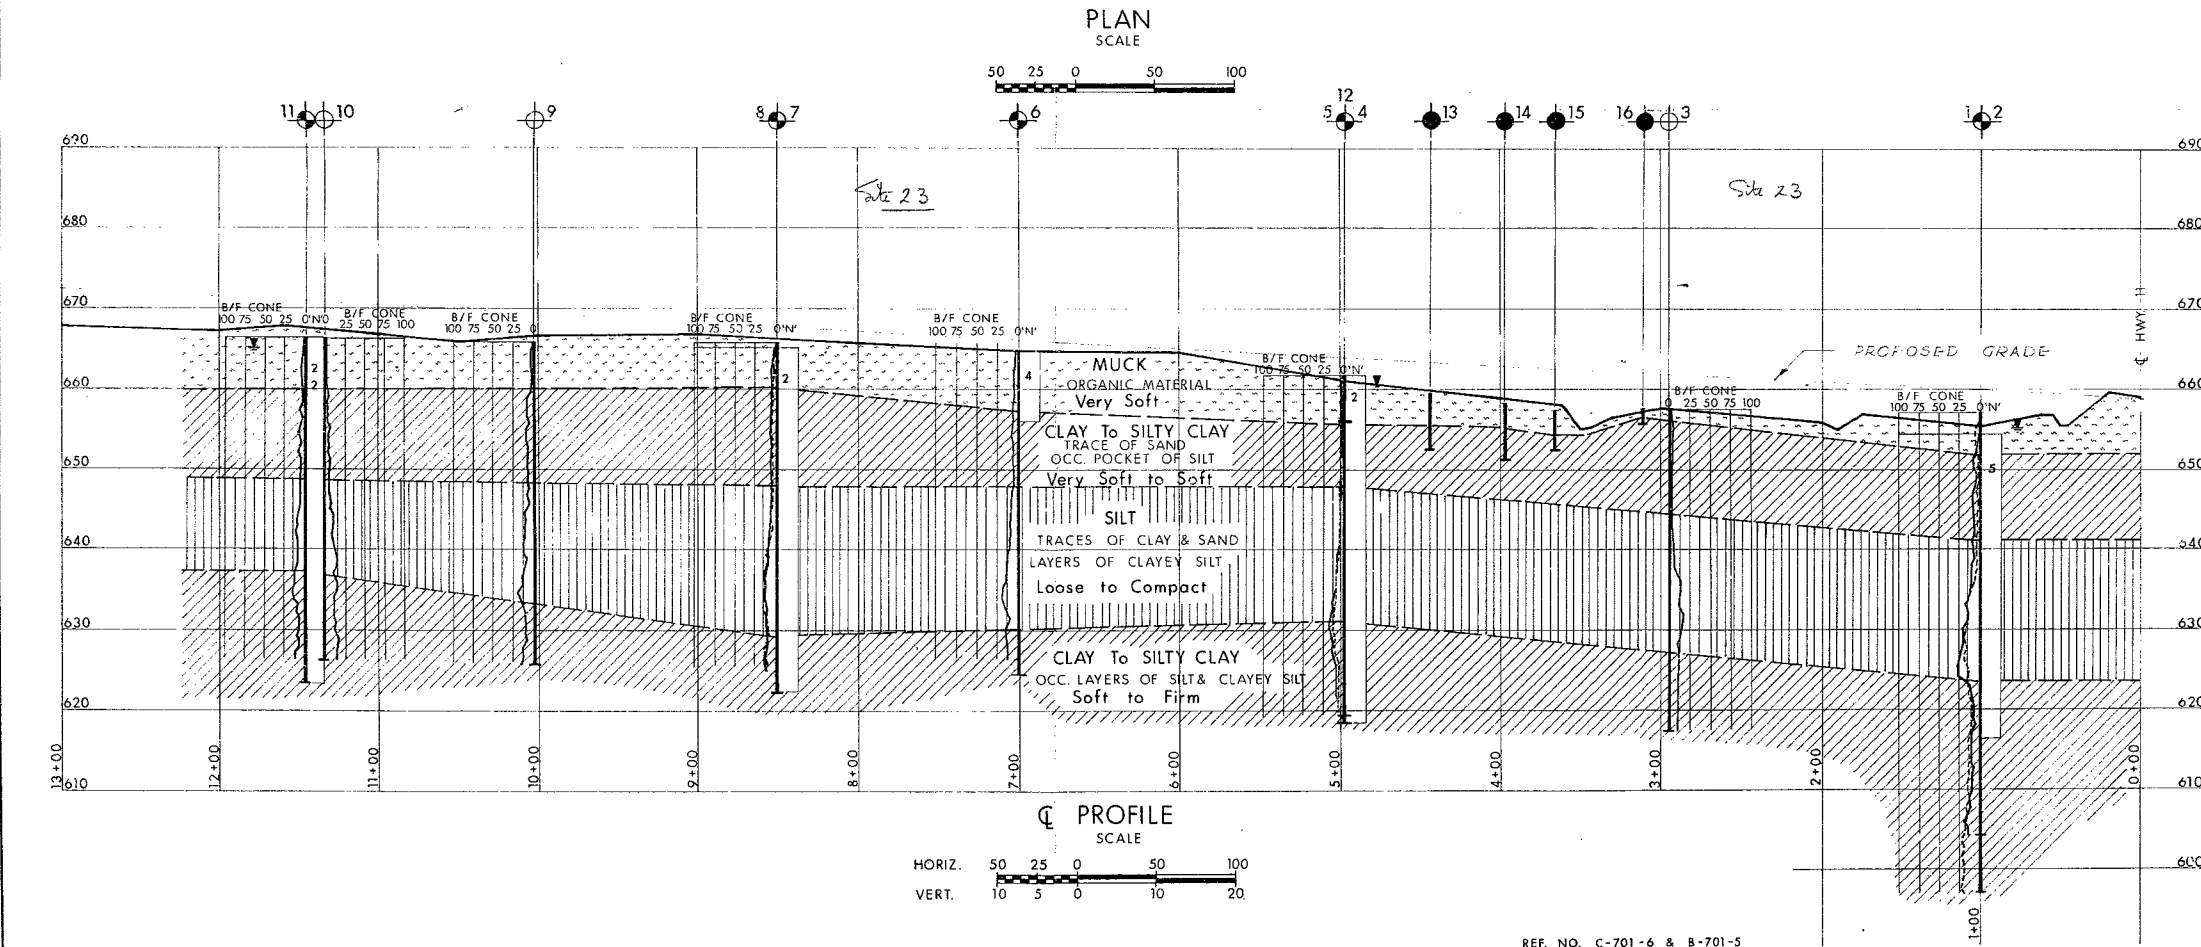
The locations and elevations of all boreholes are shown on the attached Drawing #68-P-61-2A.
