BLANCHE RIVER

BRIDGE

69-F-72

Blanche River Bridge --
Twp. Road, Site Index 47-96
Pacaud Twp., Lot 11, Conc. II & III
W.J. 69-F-72, Dist. #14 (New Liskeard)

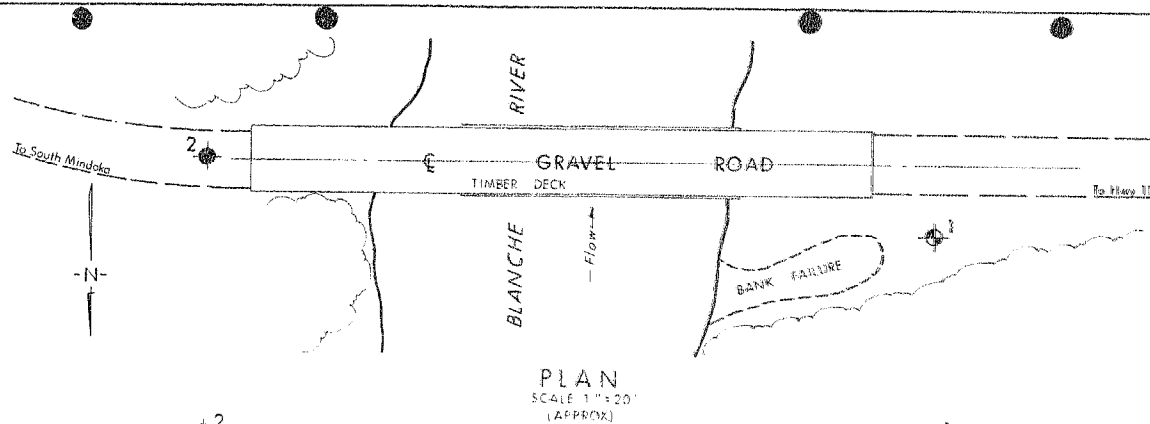
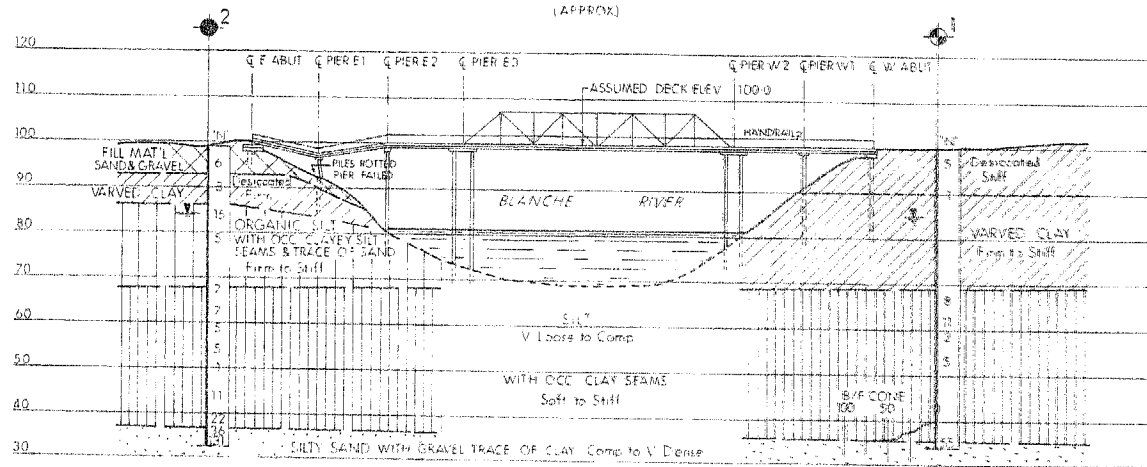
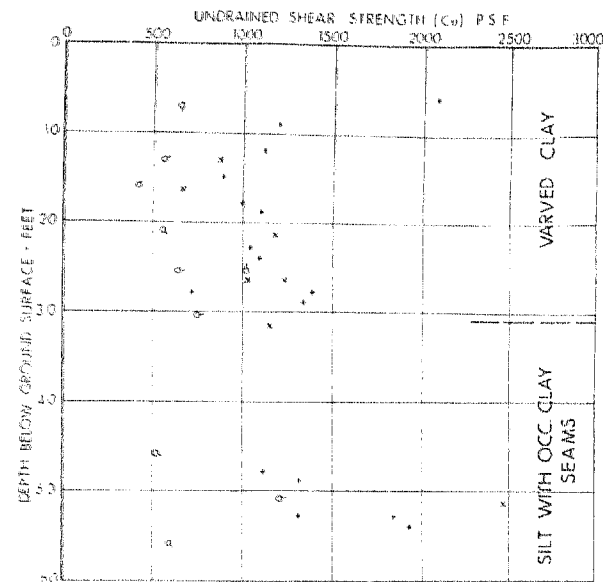
DRAWING NO 69-F-72A

The field investigation consisted of two sampled boreholes, one at each end of the structure. These borings revealed the following stratigraphy:

At the east bank, fill up to 10 ft. has been placed over the original river bank. This fill is underlain by 25 ft. of firm to stiff varved clay and organic silt followed by 32 ft. of very

loose to loose silt. The silt deposit is underlain by a compact to very dense sand and gravel stratum extending at least 6 ft. below the silt stratum.

At the west end of the structure, the soil consists of 30 ft. of firm to stiff varved clay (undrained shear strength 900 p.s.f. to 2000 p.s.f.) followed by 34 ft. of very loose to loose silt, which is underlain by at least 4 ft. of dense sand and gravel.

The locations and elevations of borings are shown on the attached Drawing No. 69-F-72A, together with the inferred stratigraphical profile.

VARIATION OF UNDRAINED SHEAR STRENGTH WITH DEPTH

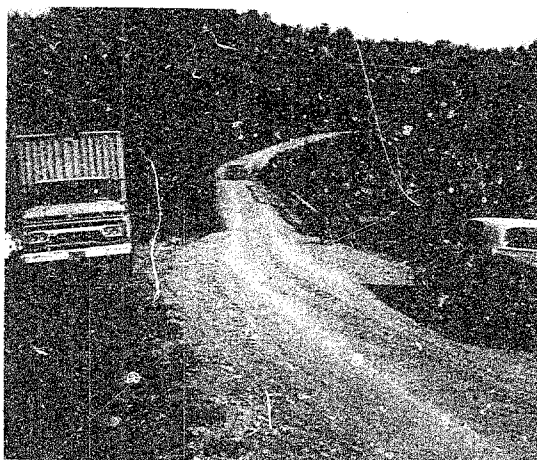
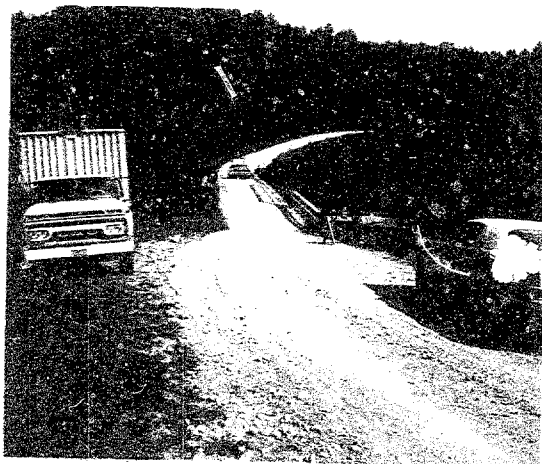
VIEW LOOKING EASTERLY ALONG
STRUCTURE AUTOMOBILES ARE STILL
ABLE TO NEGOTIATE V-SHAPED
DEPRESSION IN DECK AT THE EAST END.

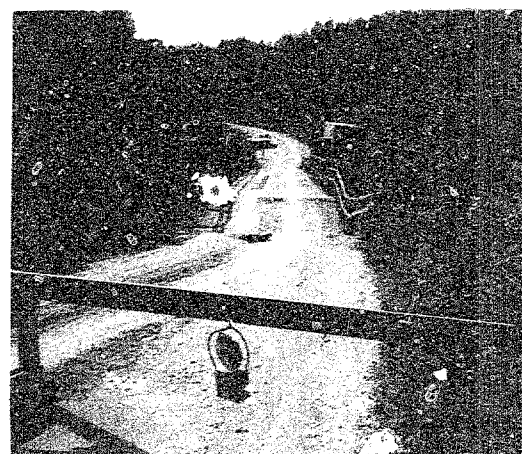
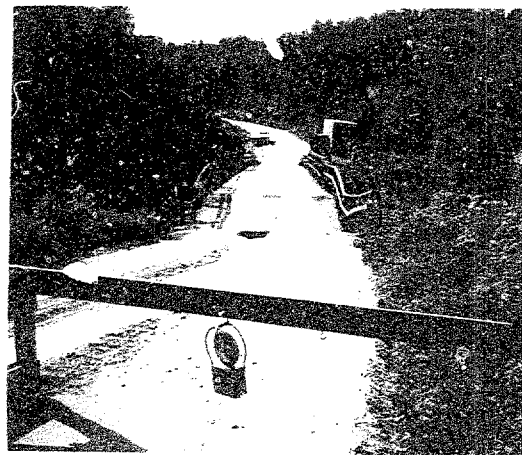
VIEW LOOKING WESTERLY ALONG
STRUCTURE SHOWING DEPRESSION IN
THE DECK. EROSION OF GRANULAR
FILL BEHIND ABUTMENT HAS CREATED
CAVITY ALONG ROADWAY CENTRELINE

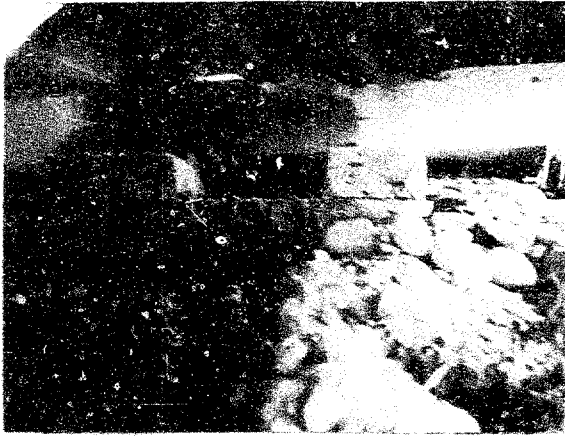
INTERIOR DETAIL OF EAST ABUTMENT
SHOWING CRIB TYPE FOOTING. CRIB IS
FILLED WITH COARSE GRANULAR MAT'L.

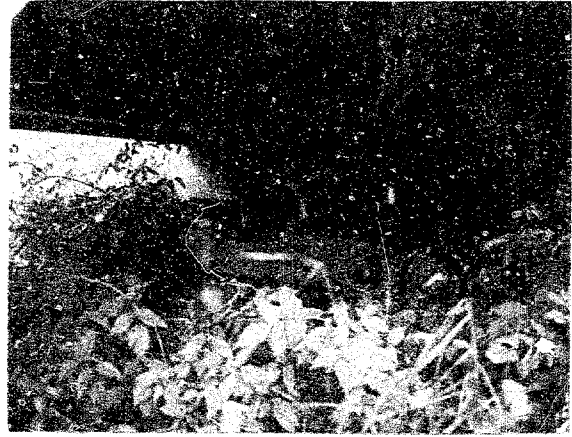
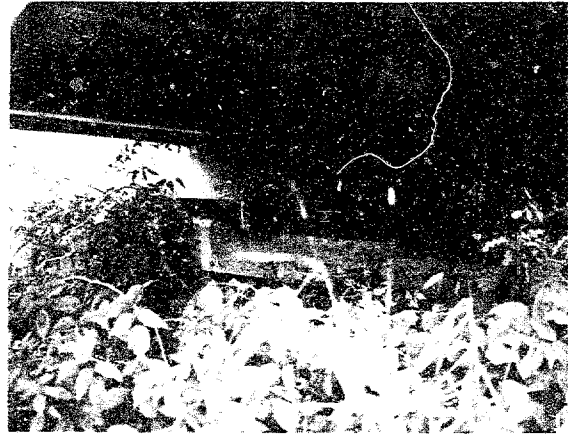
INTERIOR VIEW OF WEST ABUTMENT.
ABUTMENT SILL BEAM RESTS ON 8 TO 12
INCH DIA. TIMBER PILES

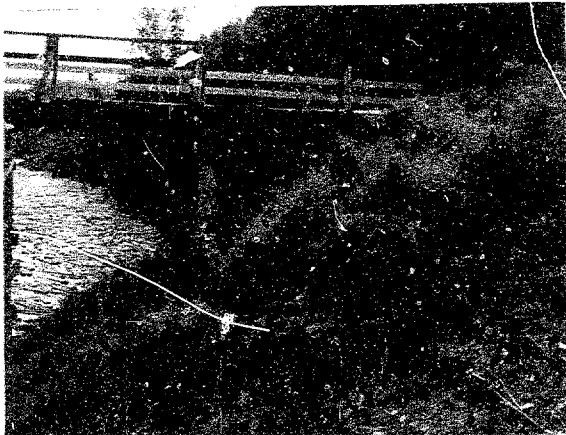
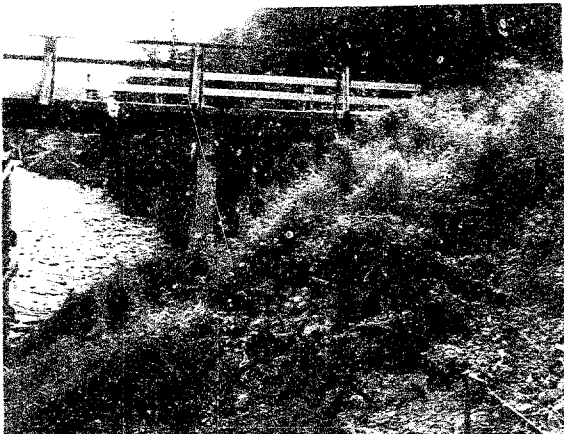
WEST APPROACH OF STRUCTURE
LOOKING DOWNSTREAM (SOUTHERLY)
SLOPE FAILURE IN FOREGROUND.

It is suggested that the minor bank failures which have taken place on the north of the west approach, be reconstructed. This can be achieved by removing all softened material in this local area and bringing up to grade with locally available granular material. In addition, adequate rip-rap, up to the high water level for the river banks within structure limits, would be advisable.

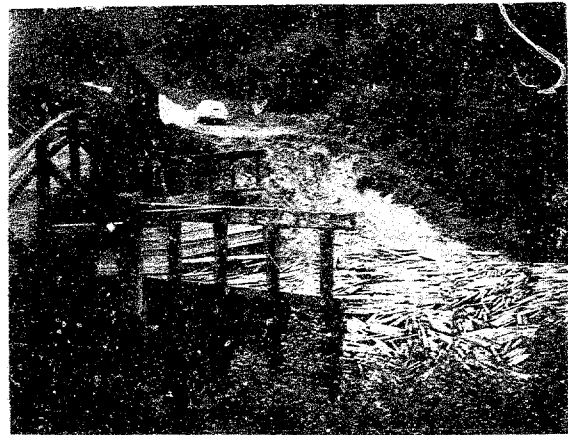
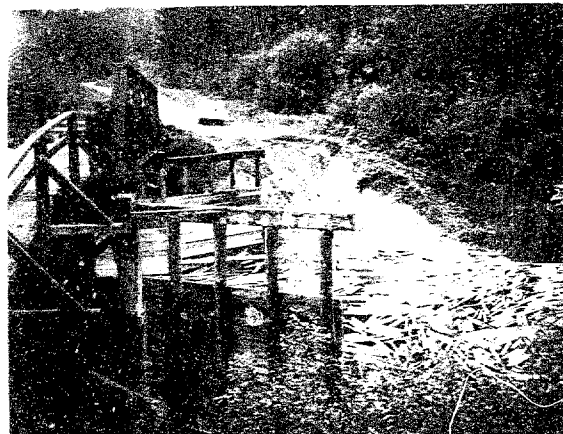
VIEW OF SLOPE FAILURE JUST NORTH
OF WEST APPROACH. SOIL IS FISSURED
VARVED CLAY. FAILURE IS ATTRIBUTED TO
EROSION & UNDERCUTTING OF
NATURAL SLOPE

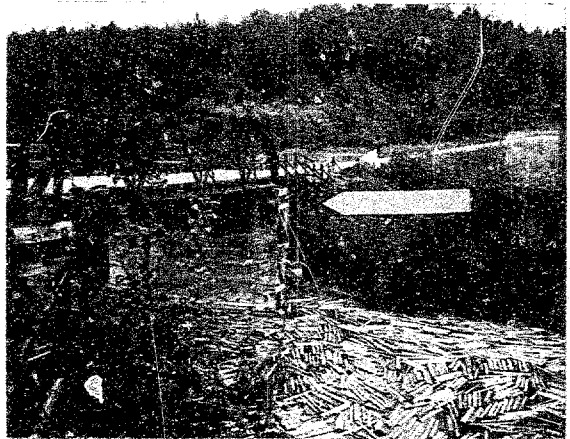
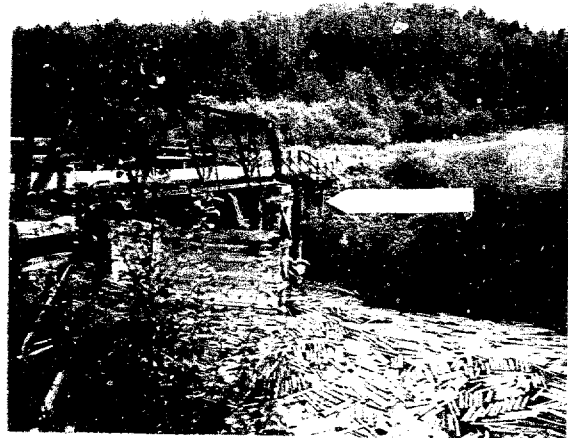
STEEL TRUSS SPAN IS 60 FT IN LENGTH
ARROW POINTS TO 1st. PIER AT EAST
END WHICH HAS FAILED

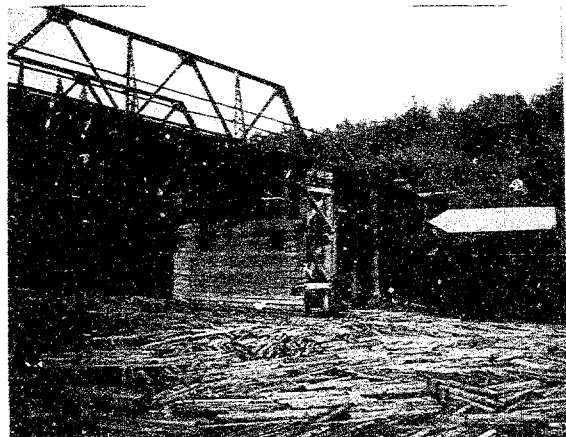
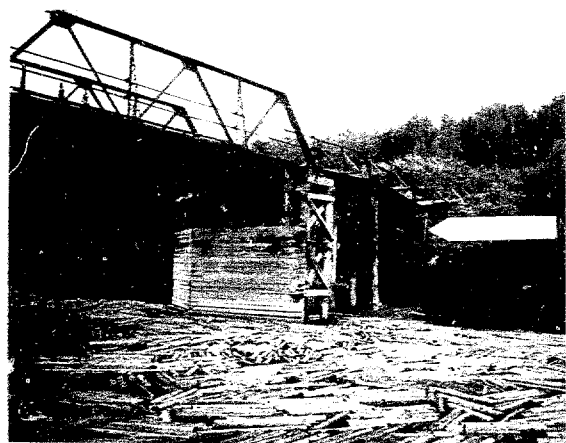
CLOSER VIEW OF EASTERN HALF OF
STRUCTURE. ARROW POINTS TO PIER
WHICH HAS FAILED

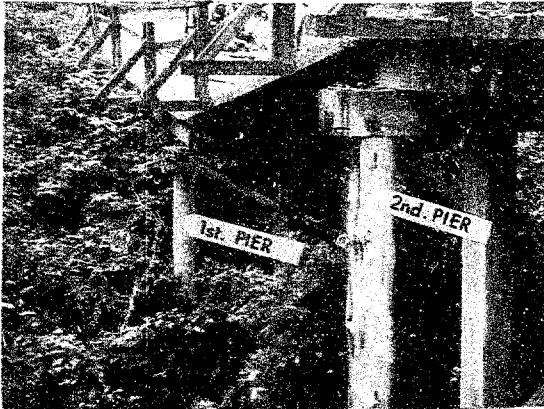
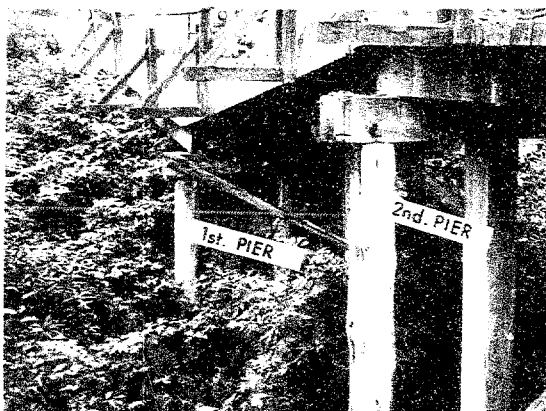
FAILURE OF FIRST PIER AT EAST END
HAS RESULTED IN THE DECK DROPPING
DOWN 3 FT. DRILL RIG IS LOCATED
JUST EAST OF EAST ABUTMENT

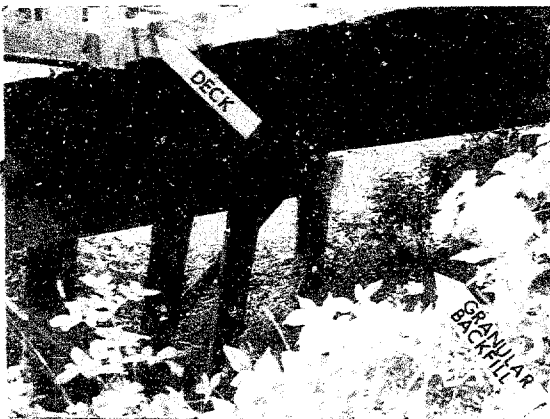
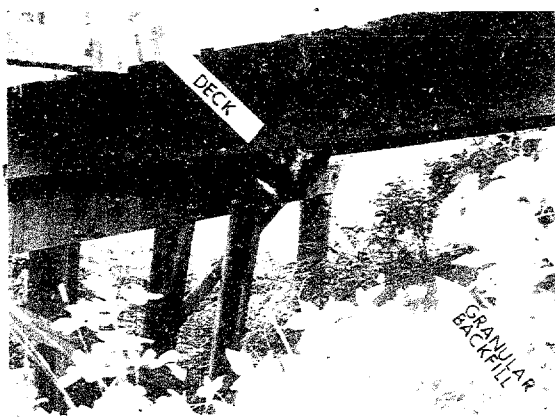
VIEW OF PILES COMPRISING THE
1st. PIER. PILES HAVE SHIFTED
DOWNSLOPE TOWARDS RIVER

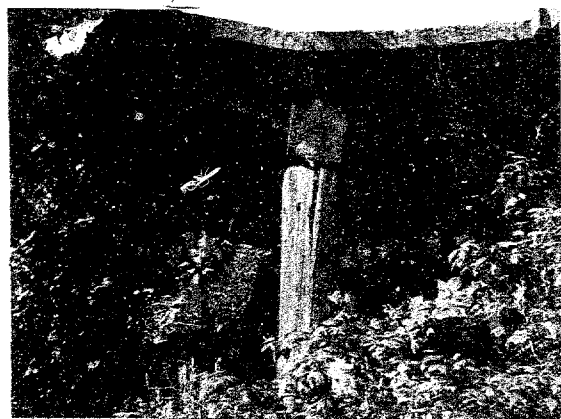
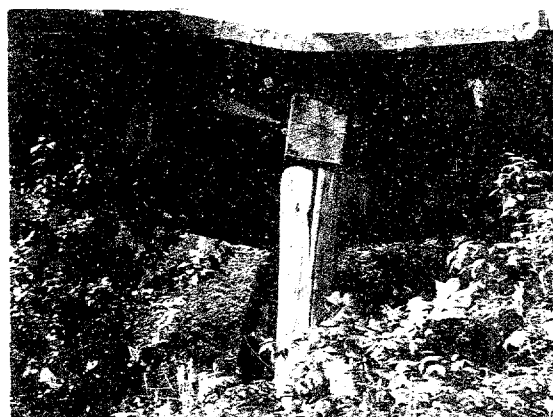
EAST ABUTMENT IS TO THE RIGHT OF
THE PHOTOGRAPH. THE 1st. PIER PILES
ARE TILTED TOWARDS THE WEST
(i.e. TOWARDS THE RIVER)

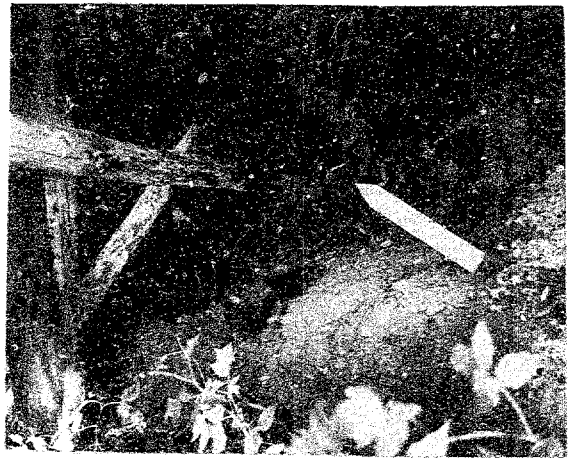
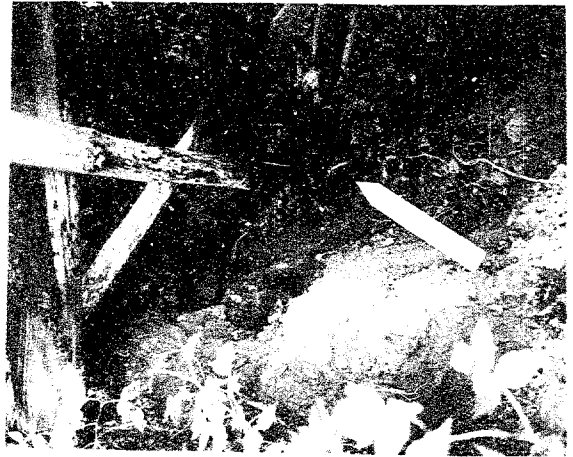
PILES SHEARED OFF. ARROW POINTS TO
BREAK IN CROSS MEMBER. PILE REMNANT
IN FOREGROUND

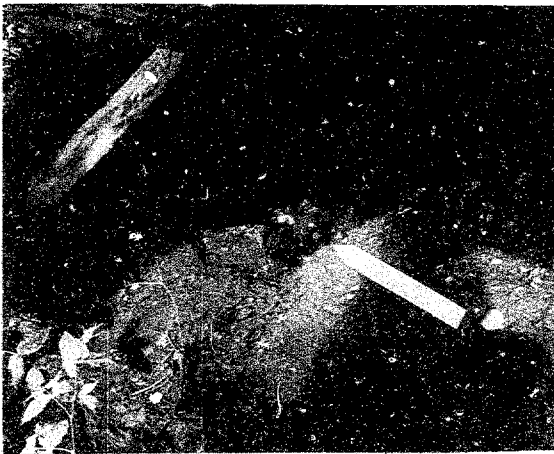
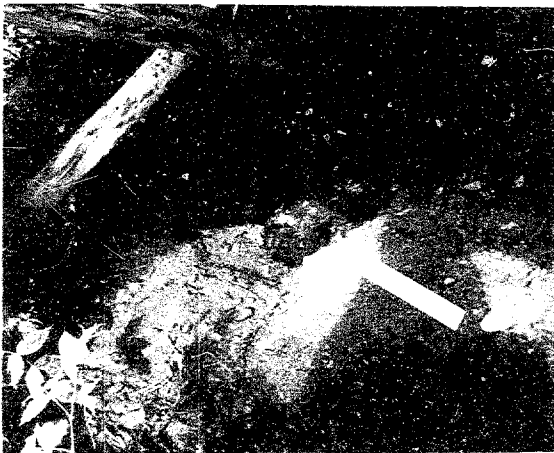
ARROW POINTS TO PILE REMAINING IN
GROUND. THE UPPER PORTION OF THE
PILE IS BURIED FORWARD OF ITS
ORIGINAL LOCATION WITHIN THE
GRANULAR BACKFILL

ARROW POINTS TO PILE REMAINING IN
GROUND. THE UPPER PORTION OF THE
PILE IS BURIED FORWARD OF ITS
ORIGINAL LOCATION WITHIN THE

GRANULAR BACKFILL

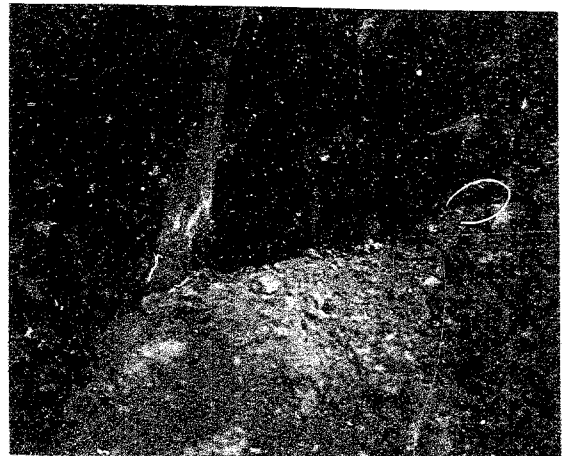
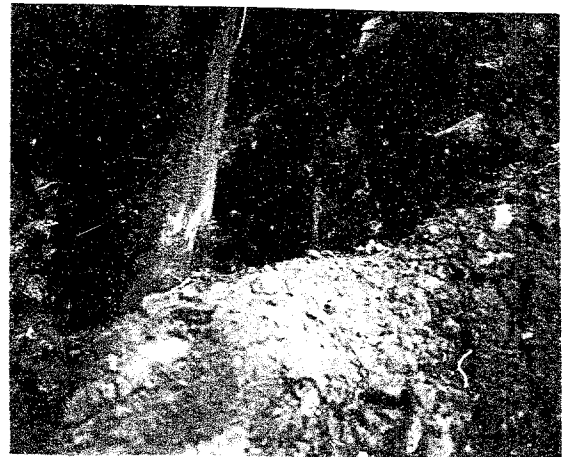
Based on the foregoing, it is our opinion that the failure of piles is not due to the instability of the river bank, but mainly due to the decay of untreated timber above ground or river water level. In order to restore the structure, foundations for the east end pier should be reconstructed. In addition, since existing timber piles elsewhere may further decay with time, it is advisable to replace these untreated timber piles also.

CAUSE OF PILE FAILURE APPEARS TO
BE DUE TO TIMBER ROT. CLOSE-UP
VIEW OF ONE PILE REMNANT

i) The existing timber-steel structure can be supported on friction piles driven to tip elev. 55. Such piles should be treated timber piles, and each pile can be loaded up to 10 tons.

ii) Alternatively, the existing structure can be supported on new foundations composed of steel 'H' or steel tube piles driven to end bearing in the sand and gravel stratum. These piles should meet refusal at approximate elev. 35 or below. Pile capacities will be dependent upon the pile section chosen and may be 90 tons per pile in the case of 12 BP 74 steel 'H' piles.

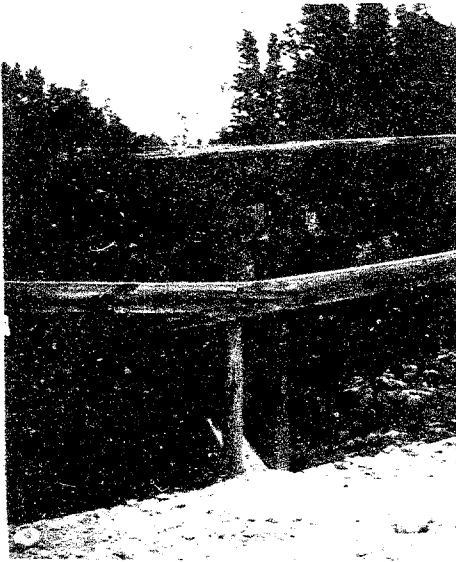
FAILURE OF PIER RESULTED IN
SHEARING OF HANDRAILS
