NEW LISKEARD RE-VISITED

Settlement, Pore Pressures,  
Shear Strength Observations  
in 1973

Settlements, Pore Pressures and Shear Strength  
Observations at the Site of the Instrumented  
Section of the New Liskeard Embankment  
Hwy. #11, District #14  
W.O. 73-11099 W.P. 104-60-02

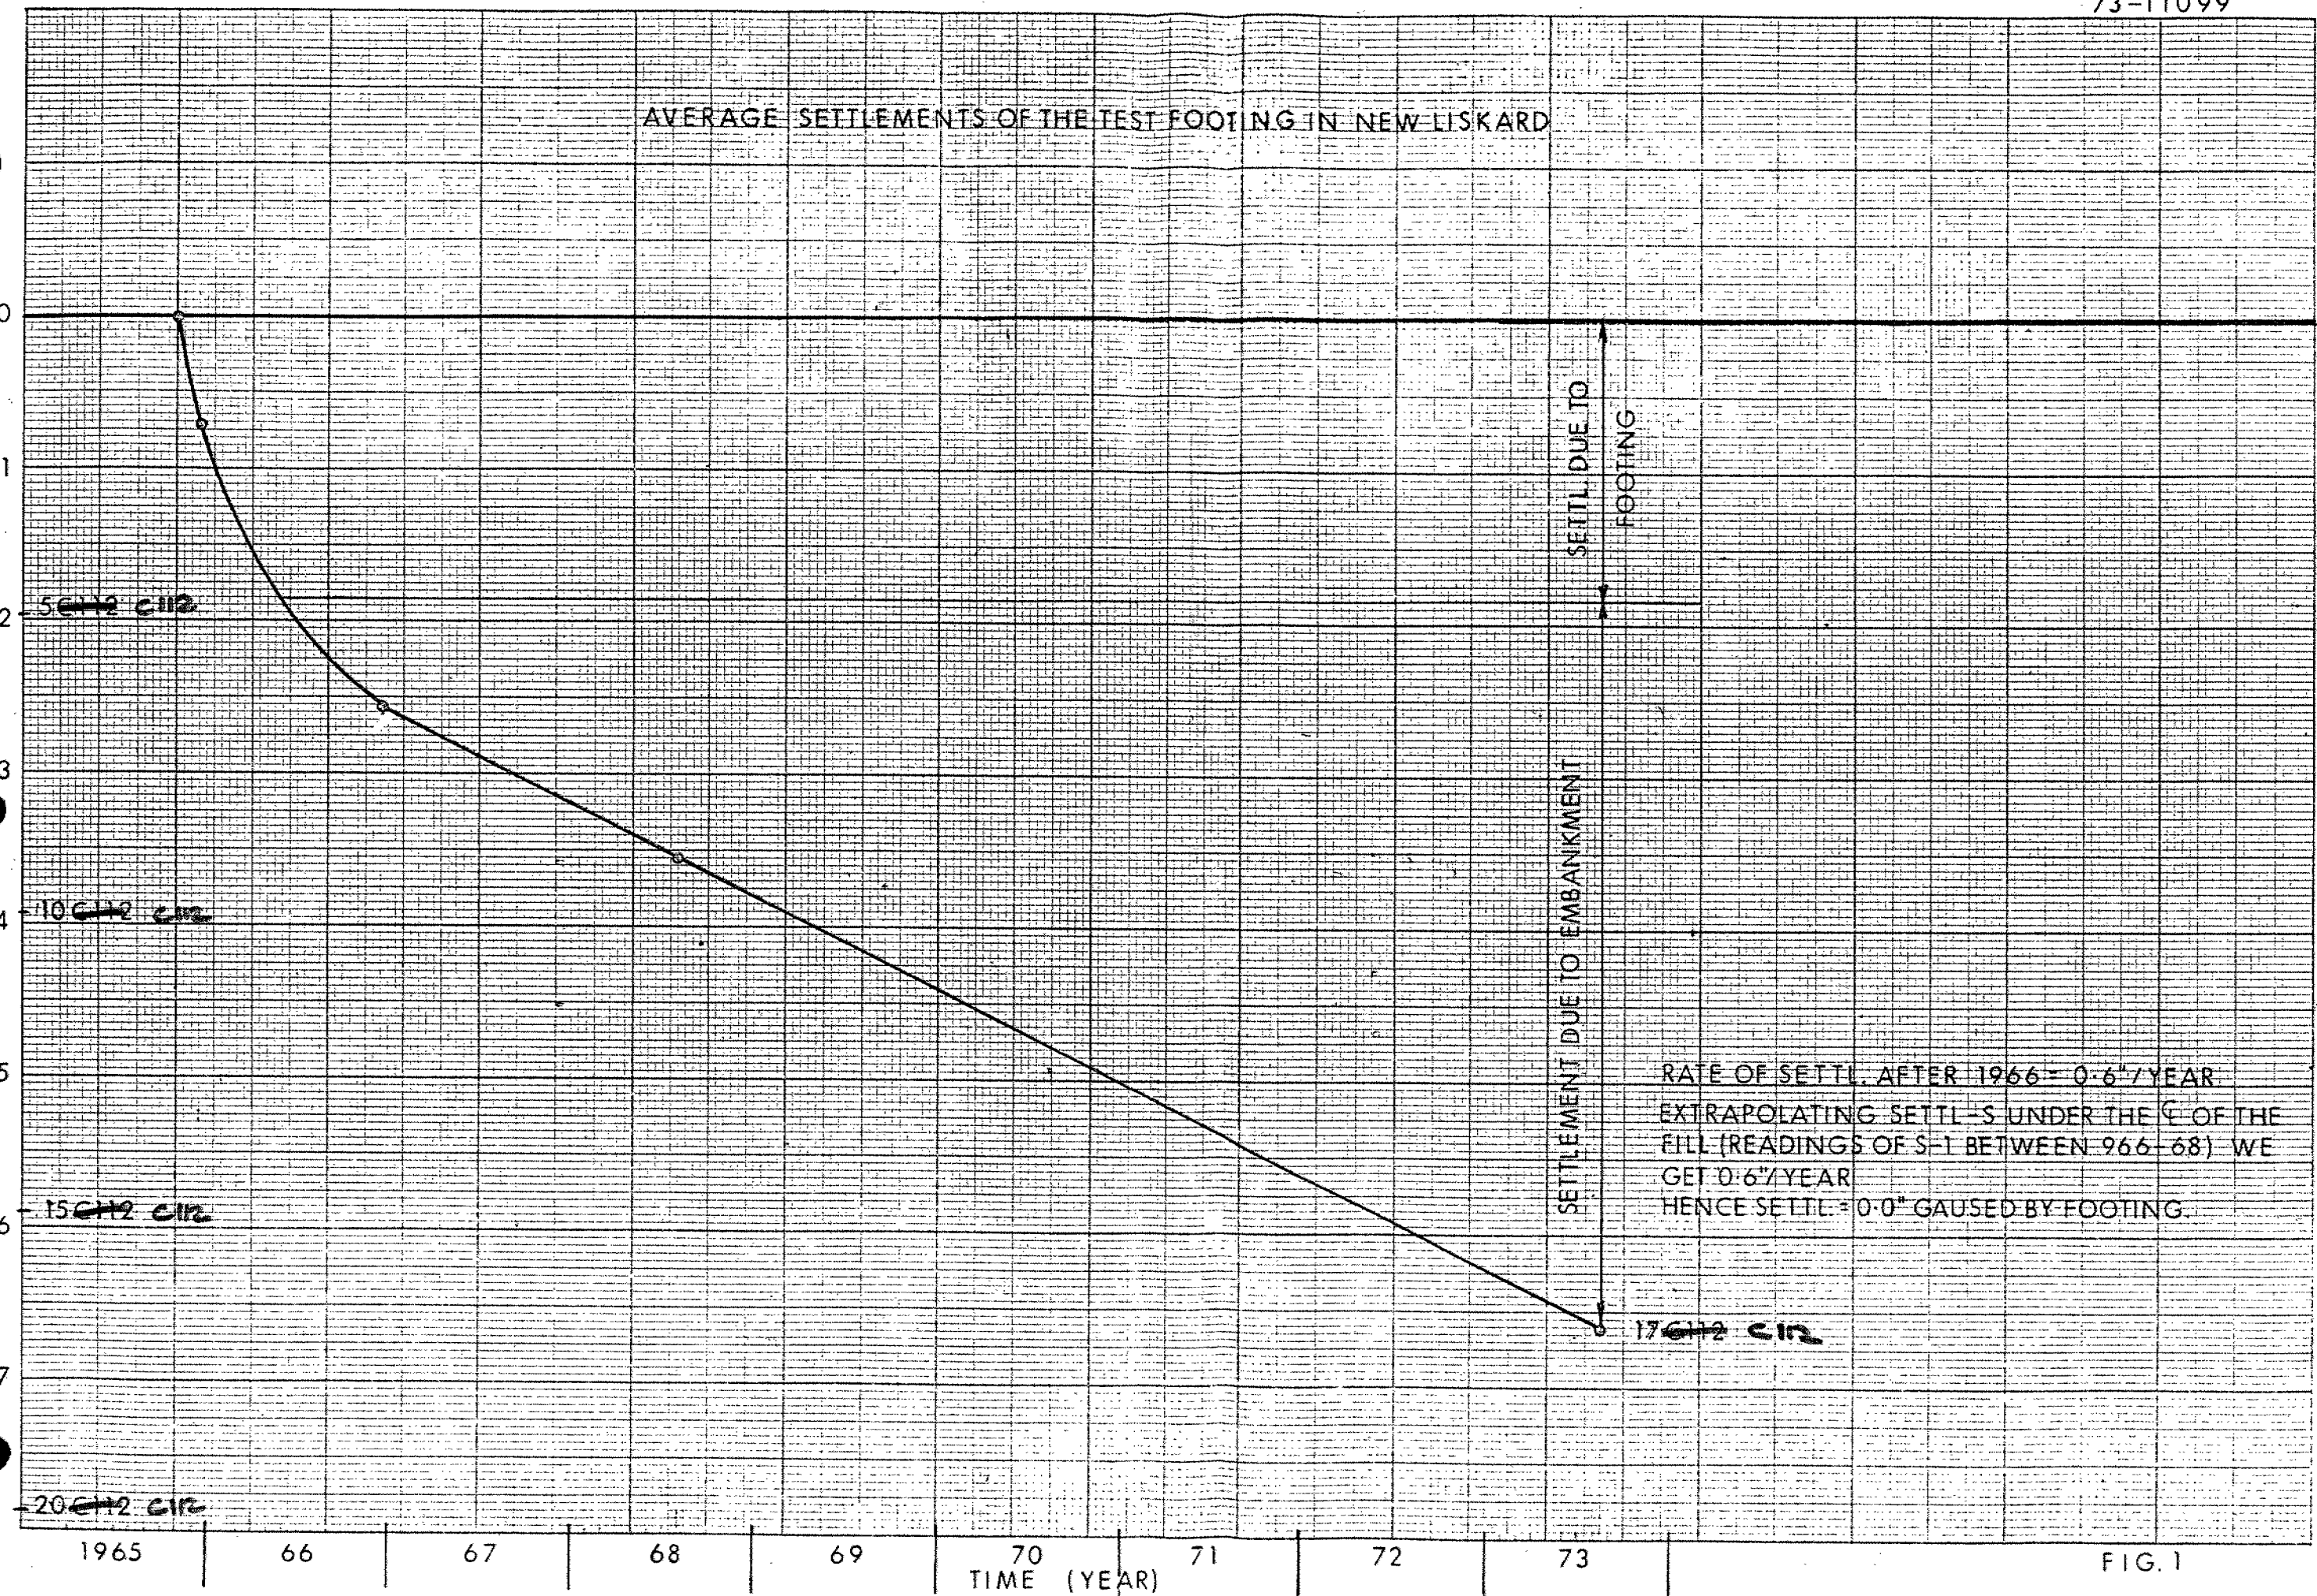
FIG. 1

2.1) A full scale spread footing was built in November 1965, and loaded to approximately 200 tons, being the estimated weight of a pier and one span of the proposed bridge. The bottom of the footing is six ft. below the top of fill, having four ft. fill under the base. Settlements under the footing in the order of 2.5 inches occurred during the first year after constructions. After 1966 up to the recent survey (August 1973) the settlements proceeded with a constant rate, averaging 0.6 in./year (see Figure #1).

## AVERAGE SETTLEMENTS OF THE TEST FOOTING IN NEW LISKARD

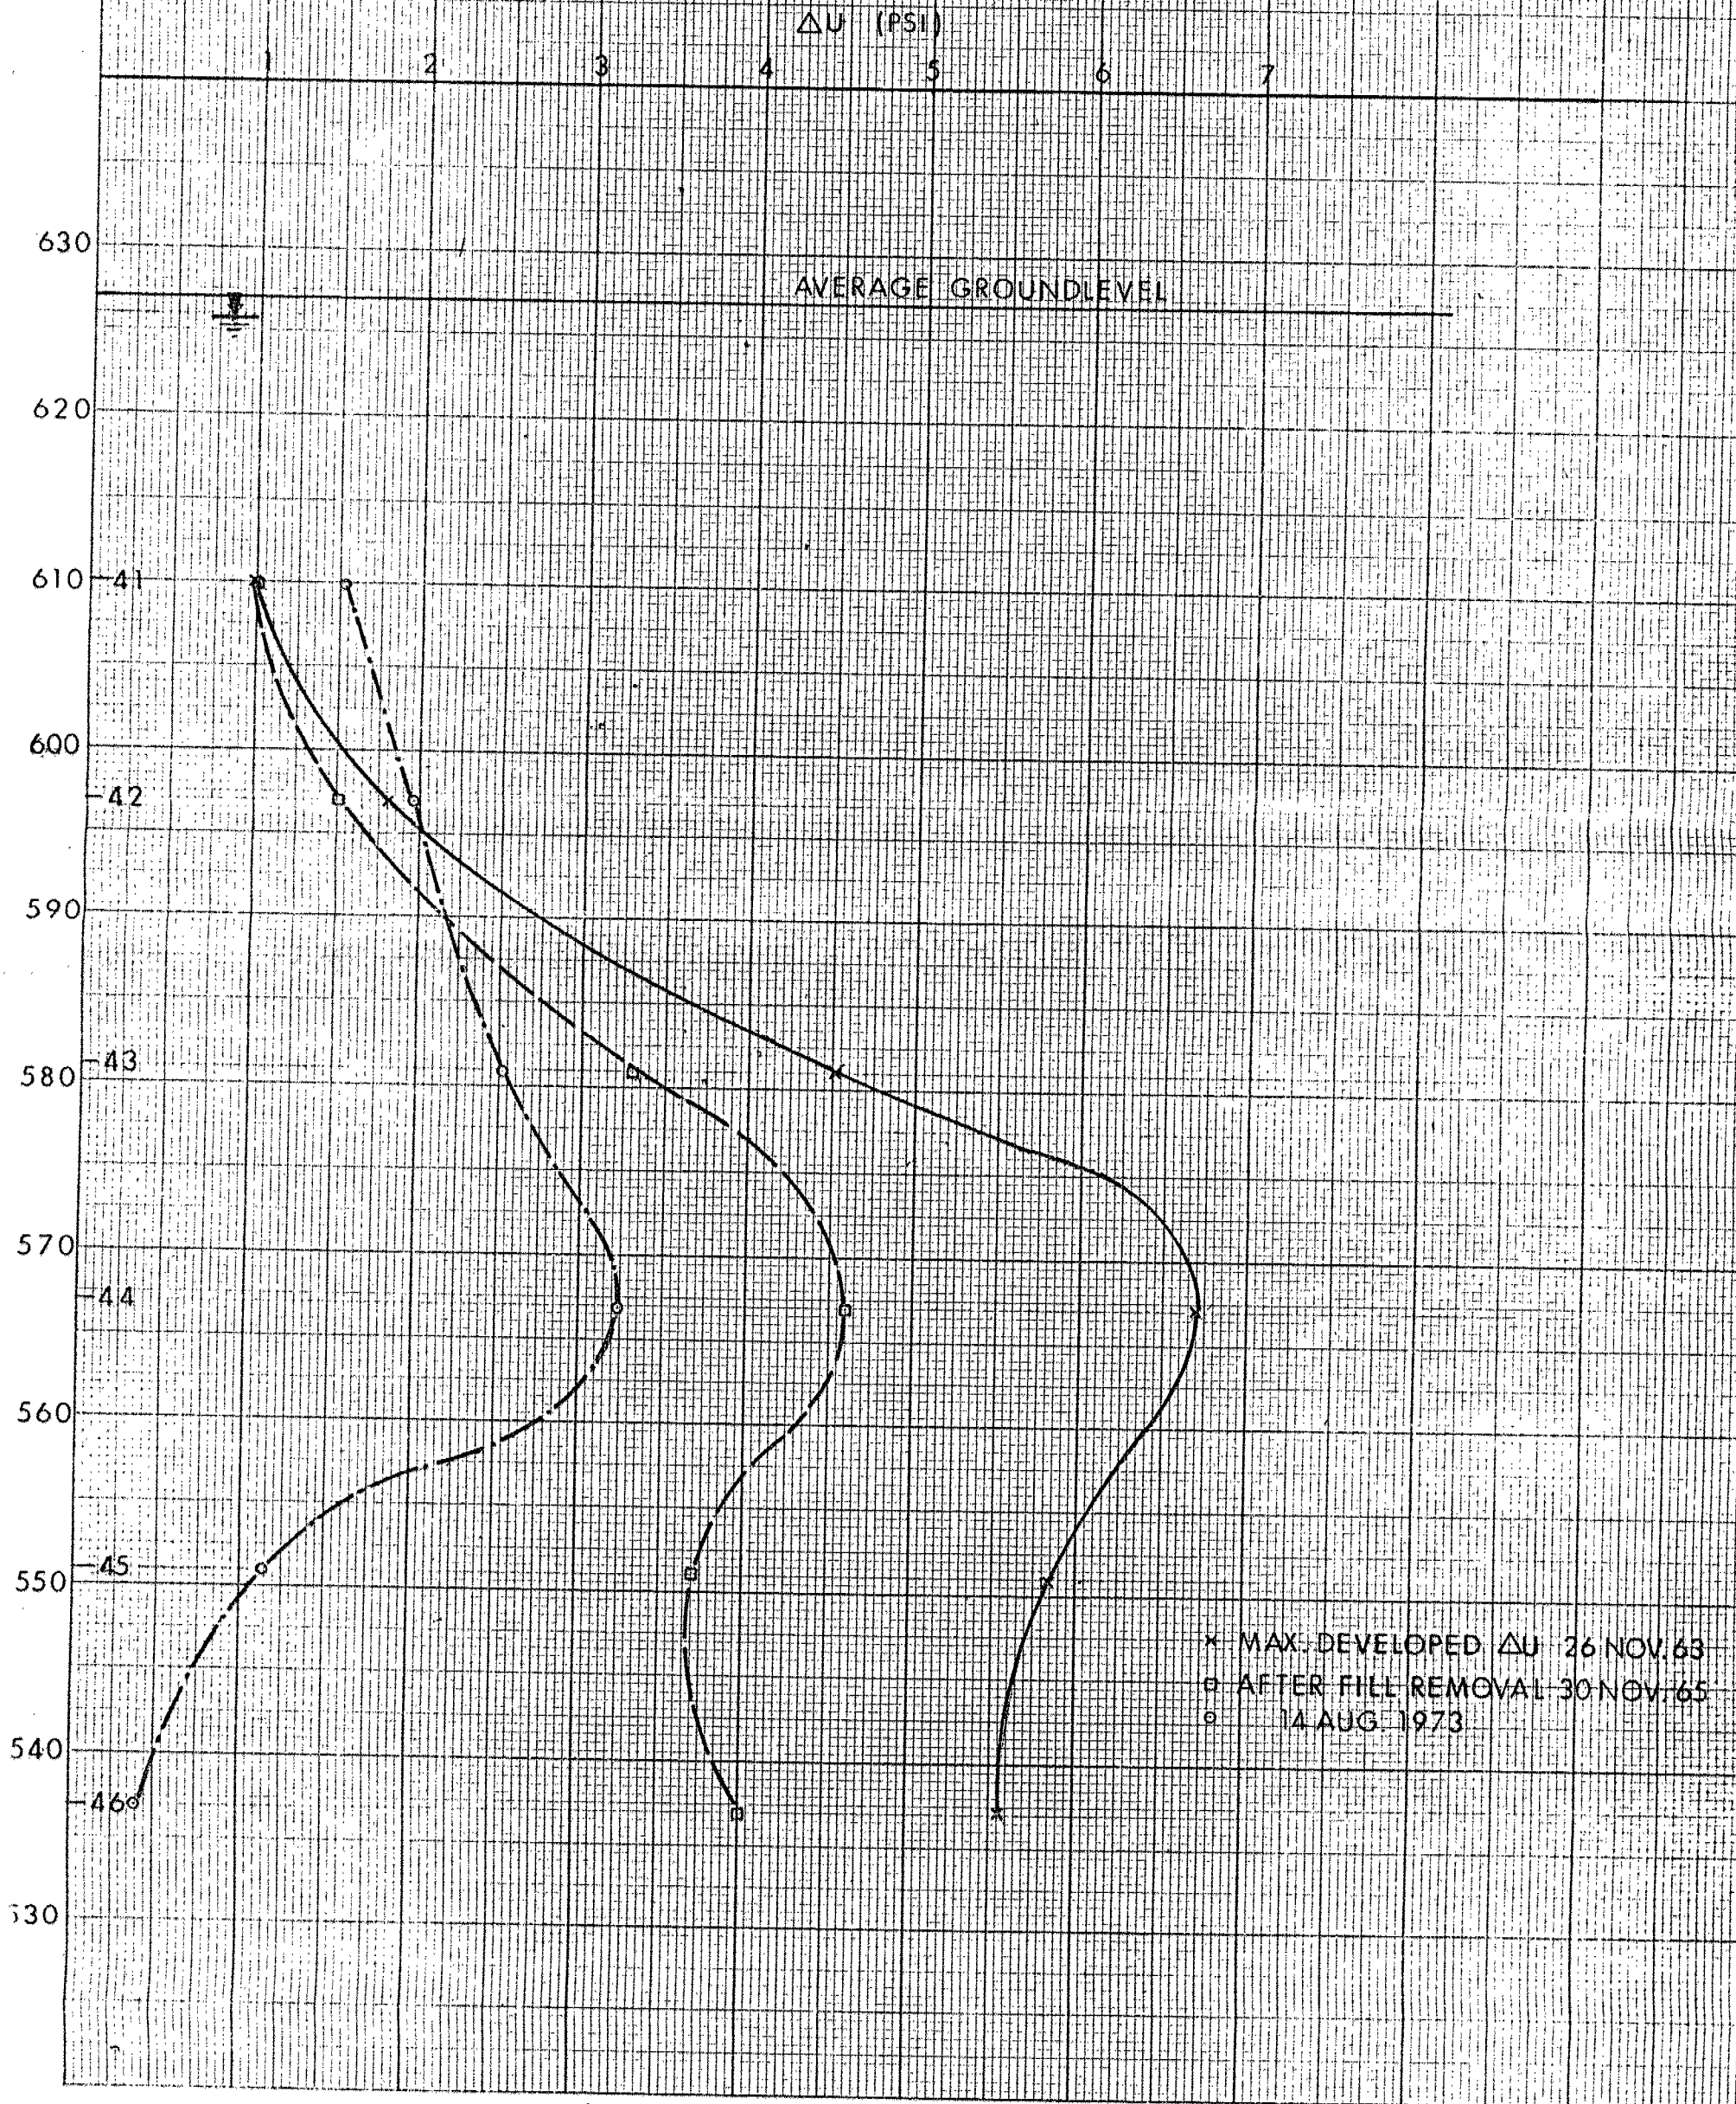
FIG. 5

The variations of excess pore pressures ( $\Delta u$ ) during the principal stages of fill construction, expressed in PSI, are shown on Figure #5. The initial pore pressure distribution on this diagram is considered to be zero. As it may be seen at the 60 ft. depth, the existing  $\Delta u$  is still approximately half of the value of the maximum observed  $\Delta u$  a few months after the construction of the high embankment.

It is to be noted that piezometers near the ground surface (P-41 and 42) have been effected by the seasonal variations of the free ground water level. No such variations were ever noted below the 45 ft. depth.

FLUCTUATION OF EXCESS PORE PRESSURE  
40 FT. LT. FROM THE TOE OF FILL  
GR. NO. 4 PIEZ-S
