FOUNDATION INVESTIGATION
HIGHWAY #17 BY PASS, EARLTON, ONT.

Trow Soderman and Associates

April 22 1958

FOUNDATION INVESTIGATION
ONTARIO NORTHLAND RAILWAY OVERPASS AND EMBANKMENTS
HIGHWAY #17, EARLTON, ONT

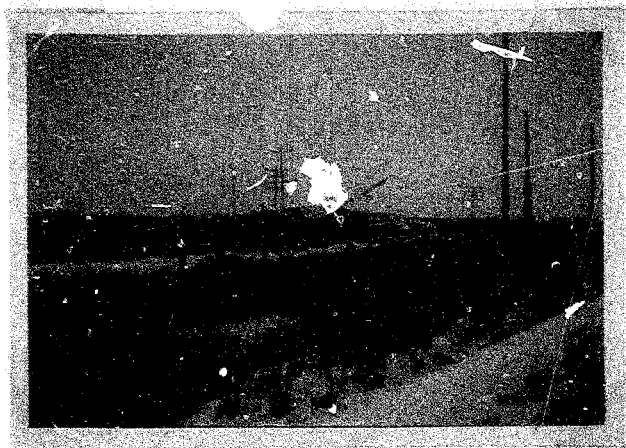
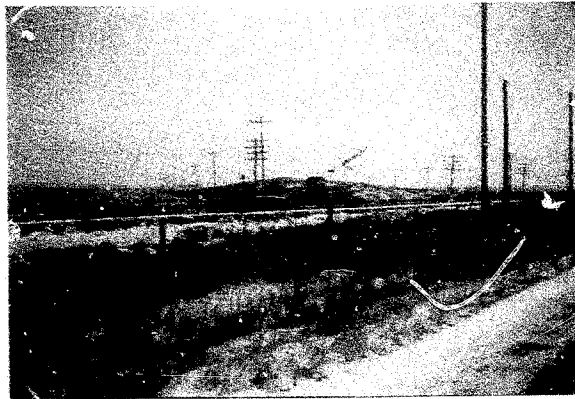
View looking North-west
(railway signal reference indicated by
arrow)

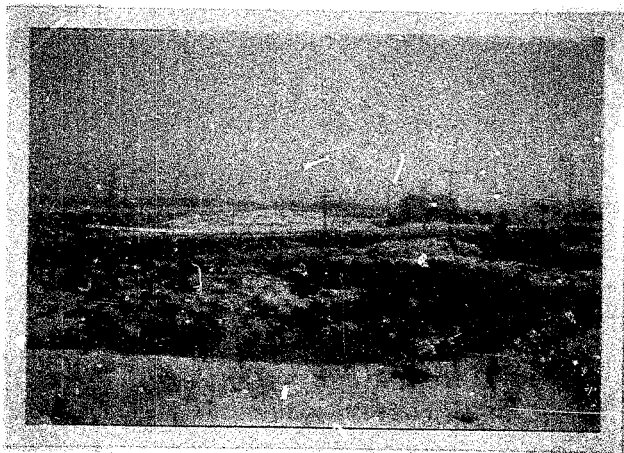
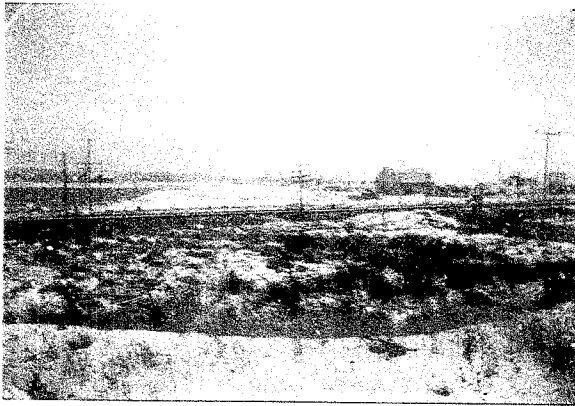
Looking East from Station No. 254

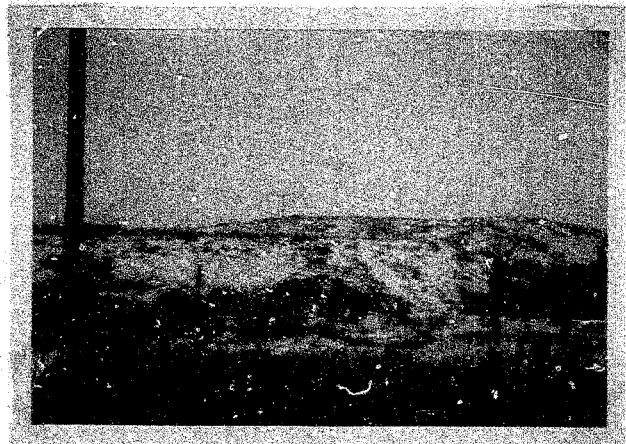
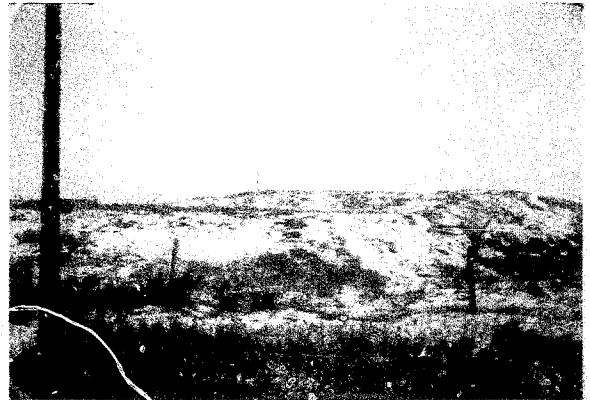
Looking South-west from railway toward
west embankment

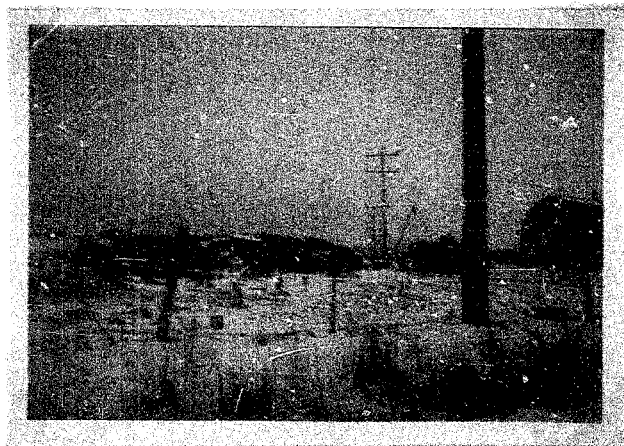
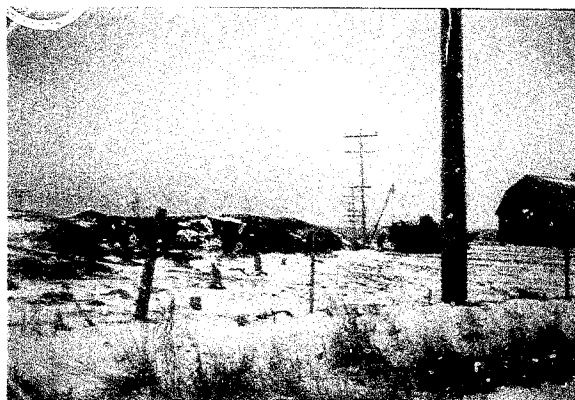
Looking east - drill on hole No. 3

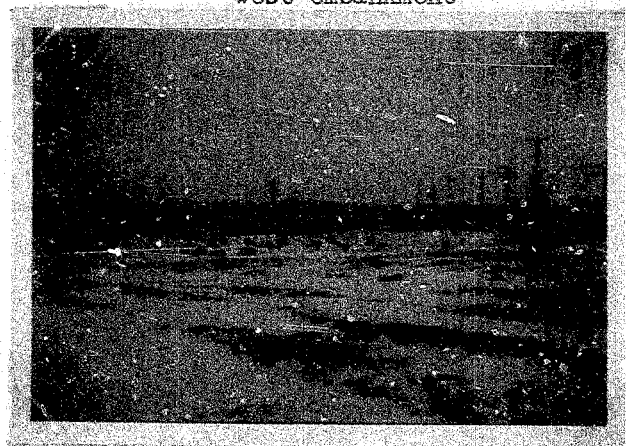
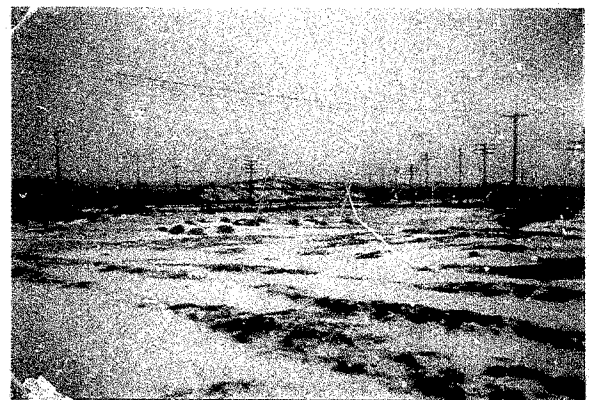
Looking west from Station 248

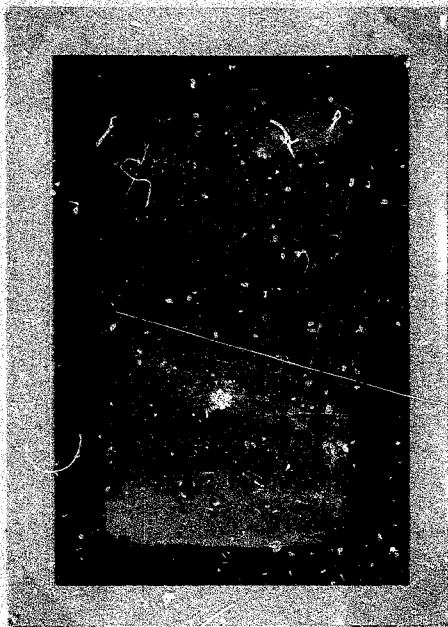
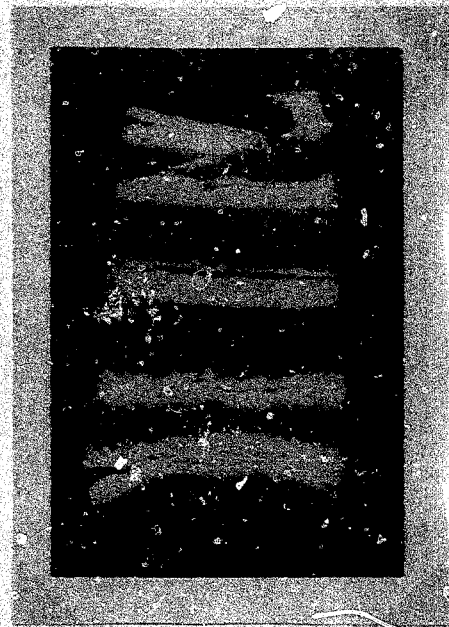
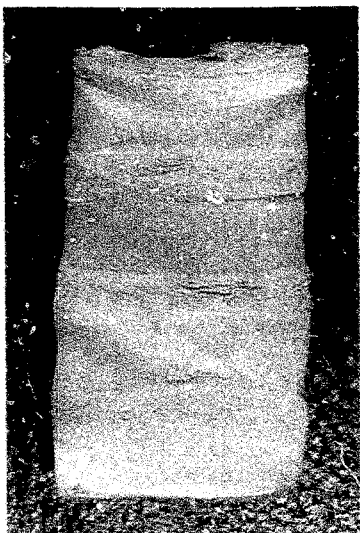
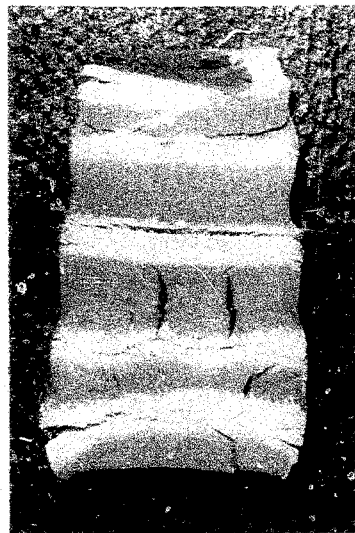
Reference to this latter drawing shows that the predominant soil type is a thick deposit of varved clay consisting of alternate layers of soft, very plastic clay and non-cohesive silt or rock flour. The thickness of each phase of a varve ranges up to a maximum of about 0.6 inches, with the clay somewhat thicker than the silt. Views of partially dried samples illustrating the varving are shown at the end of the report. The upper levels of the clay have been dessicated due to surface drying as evidenced by the sharp increase in shear strength and corresponding reduction in moisture content, by the decrease in thickness of the varves and by the predominant brown colour toward the ground surface. The consistency of the clay phase is defined by a liquid and plastic limit of approximately 74% and 27% respectively, and a moisture content below the dessication zone, of about 90%. The silt portion of each varve had little or no plasticity. Chemical analyses indicated a slight basic condition and a free sulphate content well within tolerable limits for concrete. The test results for a depth of 6 feet in hole 3 are: pH = 8.23, free sulphate = 140 ppm.

Two sections of typical sample of undessicated
varved clay

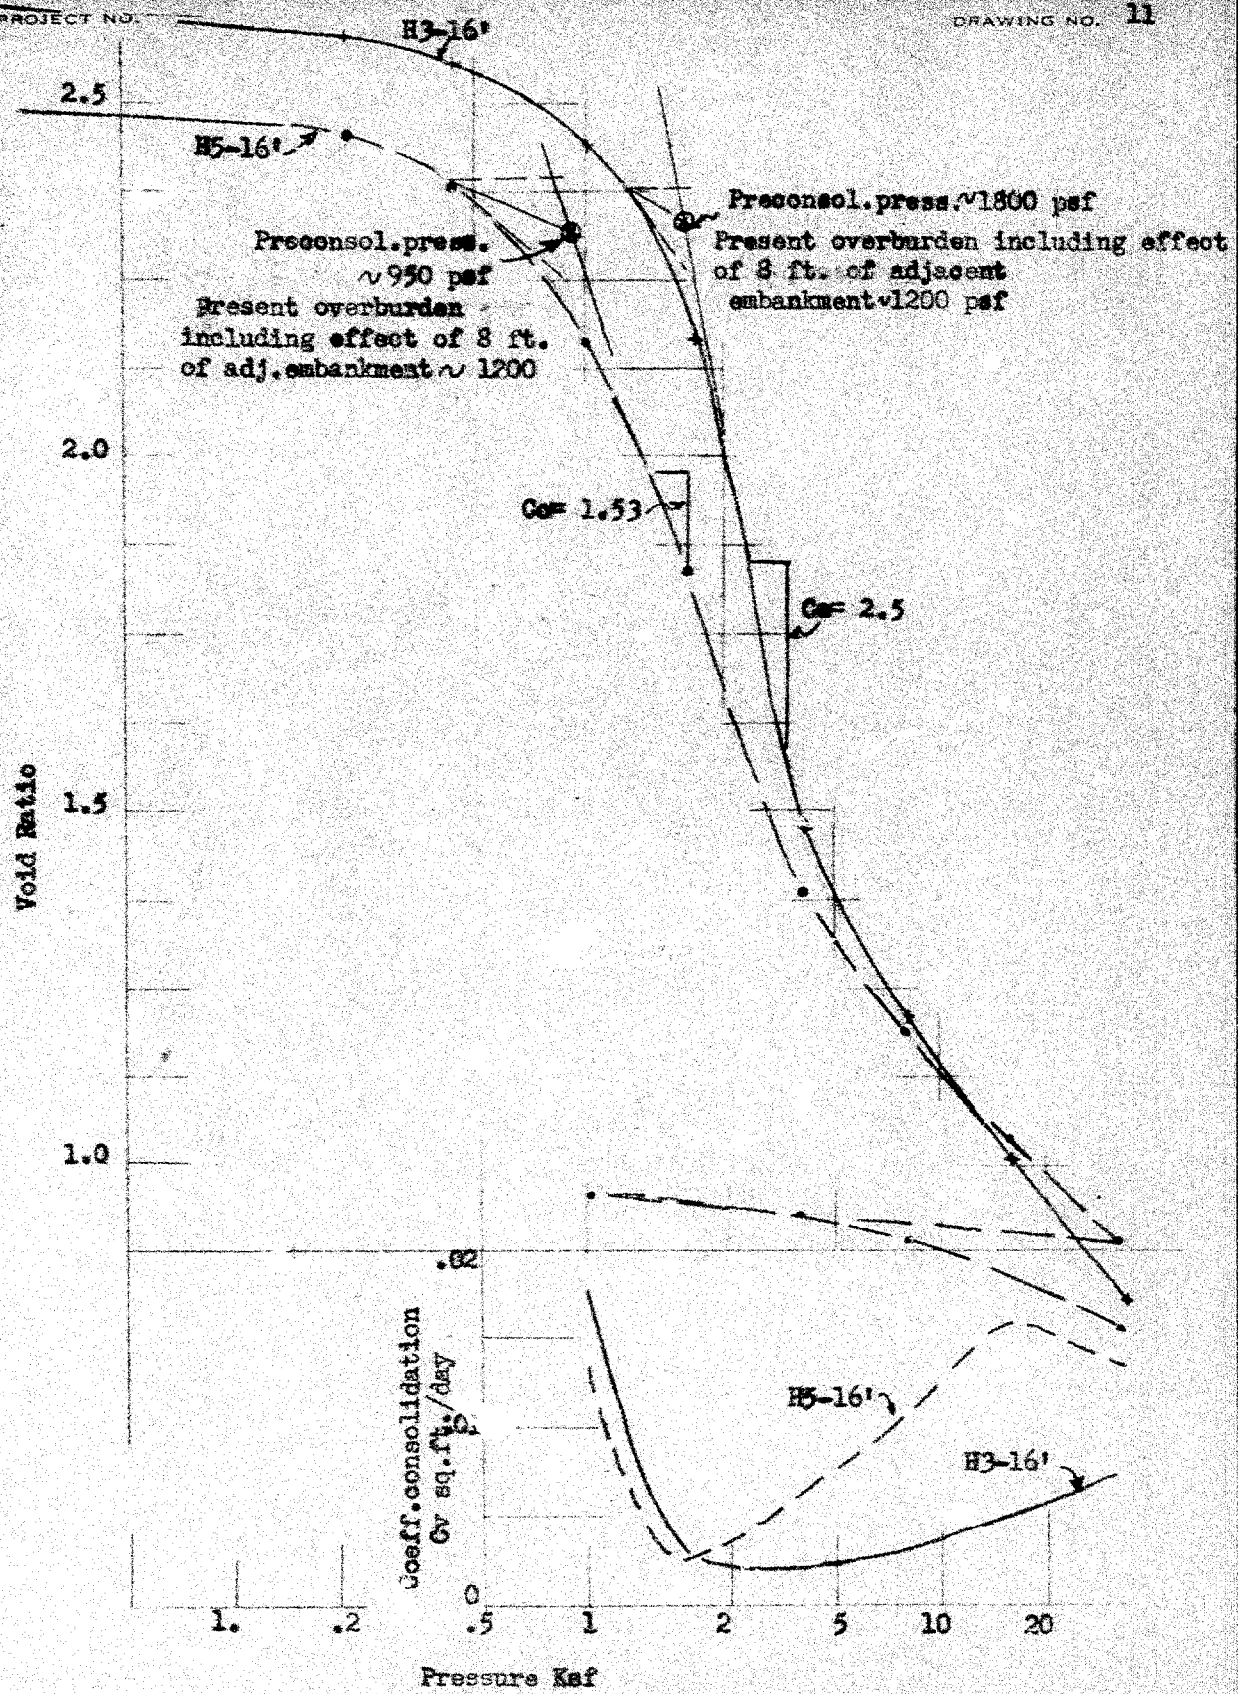
CONSOLIDATION CHARACTERISTICS FOR CLAY PORTION OF A VARVE

Another factor favouring the use of a multispan bridge concerns the compressibility of the underlying varved clay. The two consolidation tests for the clay phases of the varved clay, shown in drawing 11, indicated a compression index ranging from 1.5 to 2.5, values comparable to the very compressible Leda clay of the Ottawa valley. They are not unreasonable considering that the liquid limit of the clay is about 71% and the natural moisture content reaches 90%. No consolidation test was performed on the silt, but experience indicates that it should be greater than about 0.2.

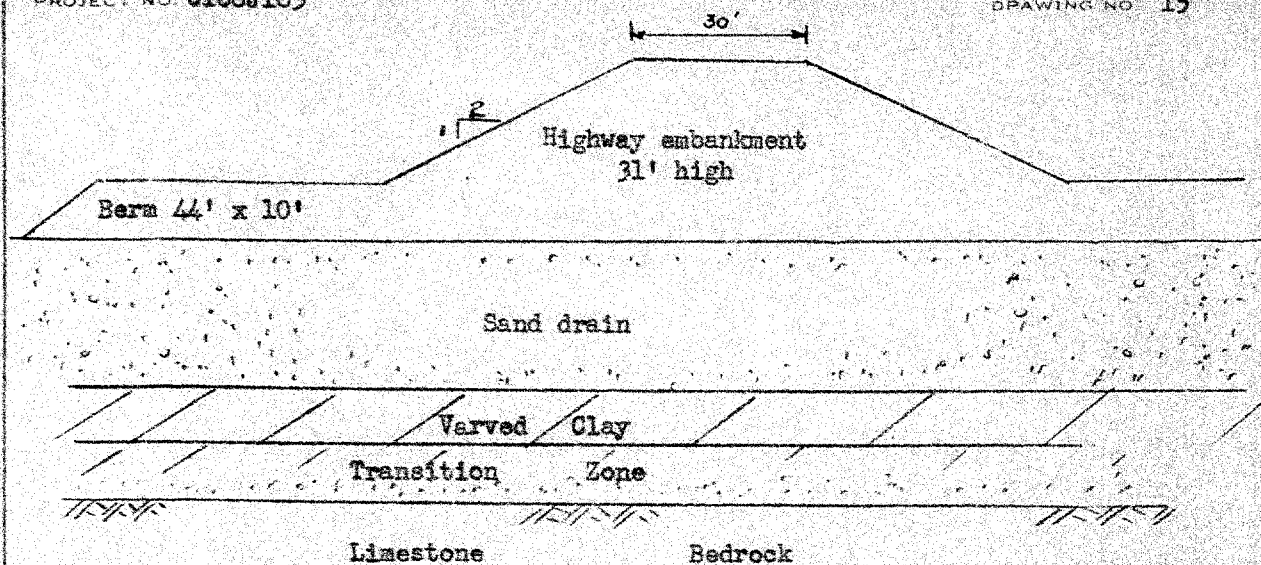
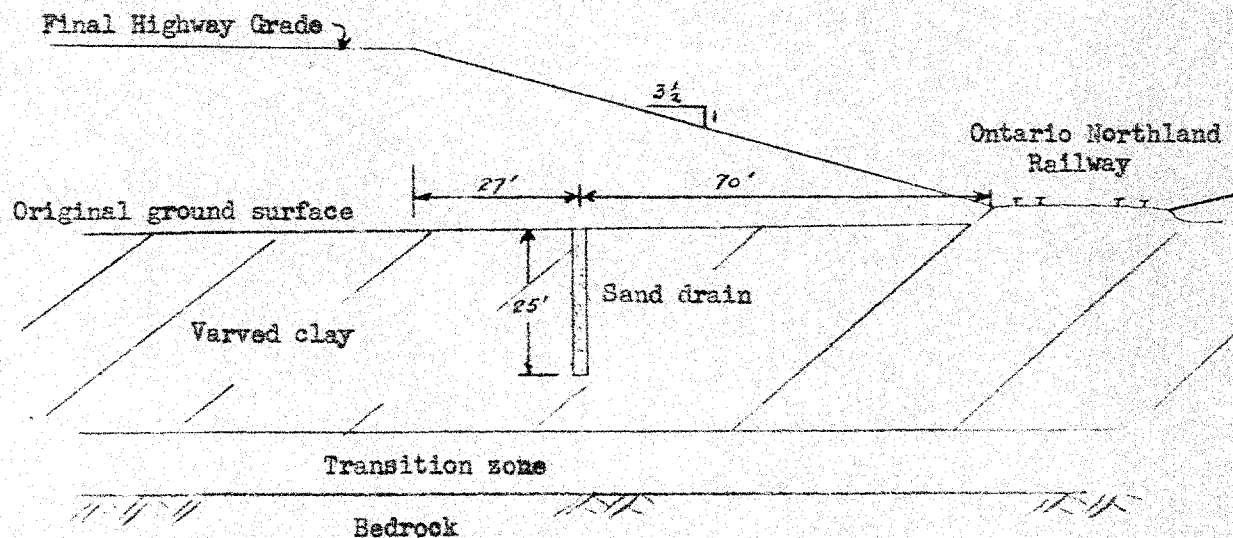
LONGITUDINAL PROFILE SHOWING RECOMMENDED EMBANKMENT AND DRAIN REQUIREMENTS ADJACENT TO THE RAILWAY

In order to provide a minimum factor of safety of 1.3 immediately after construction, the embankment height of 31 feet adjacent to the railway will require slopes of $3\frac{1}{2}:1$. The factor of safety for failure in the silt is slightly less than this for conditions of instantaneous loading, but some horizontal dissipation of excess pore pressure can be anticipated as the embankment is built to final height. Berms 10 feet high and 44 feet wide placed out from the sides of $2:1$ embankment slopes would provide equivalent protection to $3\frac{1}{2}:1$ slopes. These berms could be reduced in width uniformly to zero at Stations 247 and 255 respectively. Due to redistribution of fill load after the original embankment failure, some of this berm material is already in place.

As an additional precaution against failure, it is recommended that a trench drain be installed to a depth of approximately 25 feet at the upper quarter point of the embankment slope, as shown in drawing 15. This drain will be at right angles to the road centre line and it should be carried laterally beyond the embankment. All trenches should be back-filled with coarse sand and gravel as the excavation work progresses.

face. The capacity of the piles will be determined by their structural capacity considered as short columns. As an additional precaution against embankment failure, a trench drain should be dug under the front face of each embankment at right angles to the road centre line at or close to the upper quarter point of the spilled-through fill. This trench should lead out beyond the sides of the embankment in order to permit the free drainage of pore water. The trench should be back-filled with coarse sand and gravel and this operation should be carried on as the excavation work proceeds. Sketches of the suggested embankment approaches are shown in drawing 15.

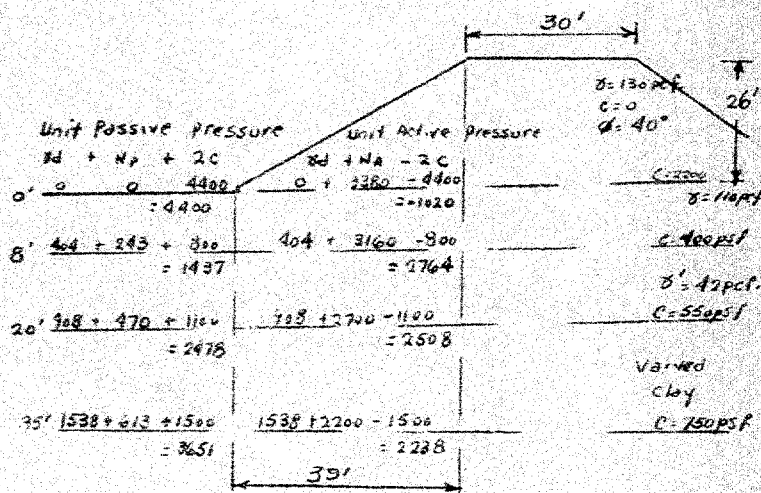
Sliding Block Analyses of Existing Embankment Failure

Reference to design sheet number 1 shows that the most probable path of failure was along a silt layer at a depth of about 8 feet. This is the approximate lower limit of the zone of dessication and the level where the shearing resistance is least. When allowance is given for the distribution and dissipation of embankment pressures with depth, the clay layers are found to be somewhat more stable for this height of 26 feet.

and therefore the only value of N , effective in developer friction, is the weight of overburden existing prior to construction. At 8 feet this value of N is approximately 404 p.s.f., and therefore the corresponding frictional resistance in the silt at failure was 233 p.s.f. Although a lesser value of N is available at shallower depths, conditions of prestress due to dessication exist at these levels which hold the silt in a denser state. The lower moisture content measurements in the silt at a depth of 5 feet in all holes confirm this view.

Reference to design sheet No.1 and to the Summary of Factors of Safety in Table 3, shows that an embankment height of 26 feet on $1\frac{1}{2}:1$ slopes is just safe although the factor of safety is somewhat too low. According to the embankment grades indicated, a height of 26 feet is exceeded only between Stations 247 and 255. The present fill heights, effective for about 18 years, at these Stations, ranges from 9 to 20 feet respectively. At Station 246, 12 feet of fill presently exists. It therefore, will be quite safe to continue construction on $1\frac{1}{2}:1$ slopes to final grade west of Station 255 and east of Station 246. The increment of additional fill is too great for the use of $1\frac{1}{2}:1$ slopes between Station 246 and 247, however, and a value of $2:1$ is recommended.
