72-F-86

HWY. 11 & ENGLEHART RIVER

Blanche River Bridge at Sargents  
 Highway 511 -- Site Index 7-03  
 District 516 (New Liskeard)

FOUNDATION INVESTIGATION REPORT  
For  
The Proposed Englehart River Bridge  
(Blanche River West) of Hwy. #11  
District #14, New Liskeard  
W.O. 72-11086 -- W.P. 40-70-01 ✓  
*cont 74-105*

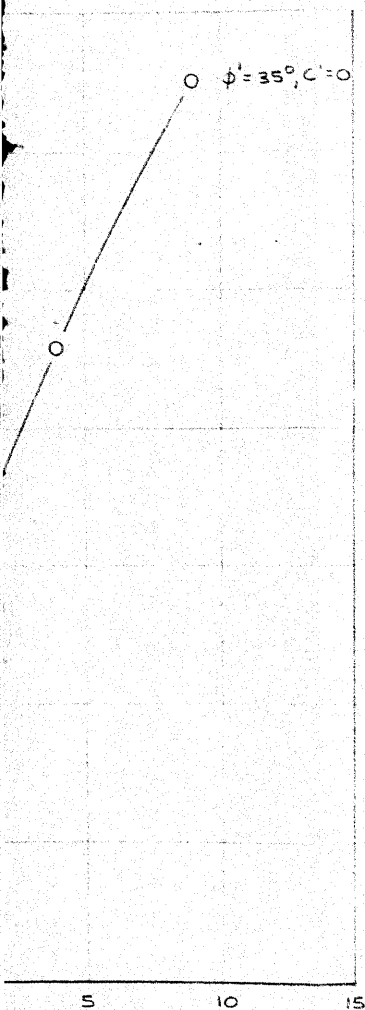
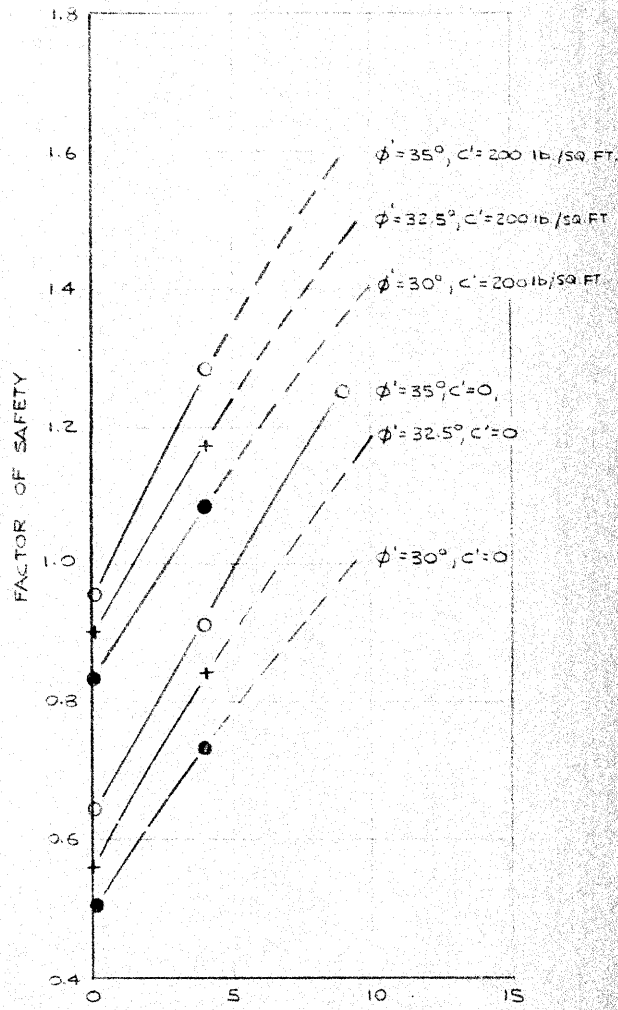
FIGURE 3

5. River channel slope stability a) West Bank	Gravel Pad + Crane	0	35	0	120	-	-	-	1.2	6	
		4	35	0	120	-	-	-	1.6		
		0	30	0	120	-	-	-	1.1		
		4	30	0	120	-	-	-	1.4		
		0	27	0	120	-	-	-	0.9		
		4	27	0	120	-	-	-	1.2

b) East Bank	Gravel Pad + Crane	0	35	0	120	-	-	-		1.3
			4	35	0	120	-	-	-		1.7
			0	30	0	120	-	-	-		1.1
			4	30	0	120	-	-	-		1.4
			0	27	0	120	-	-	-		0.9
			4	27	0	120	-	-	-		1.2
0	30	0	120	25	0	110	0.8				
0	30	0	120	25	200	110	1.2				
0	30	0	120	25	400	110	1.5				
4	30	0	120	25	0	110	1.0				
4	30	0	120	25	200	110	1.3				
4	30	0	120	25	400	110	1.7

3 FT. GRAVEL LAYER ON  
SLOPE WITHOUT CRANE

3 FT. GRAVEL LAYER ON  
SLOPE + CRANE

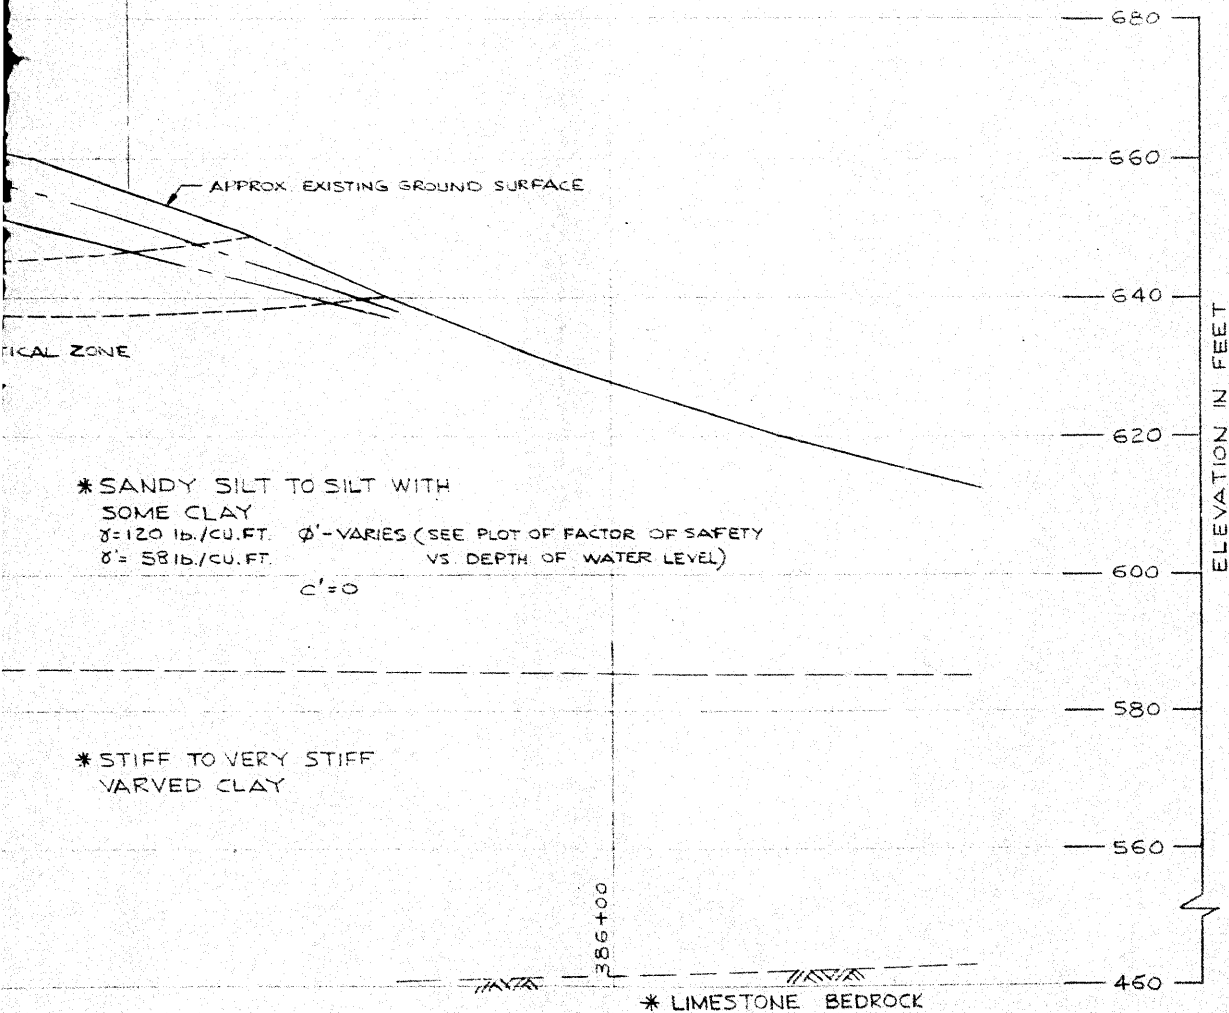
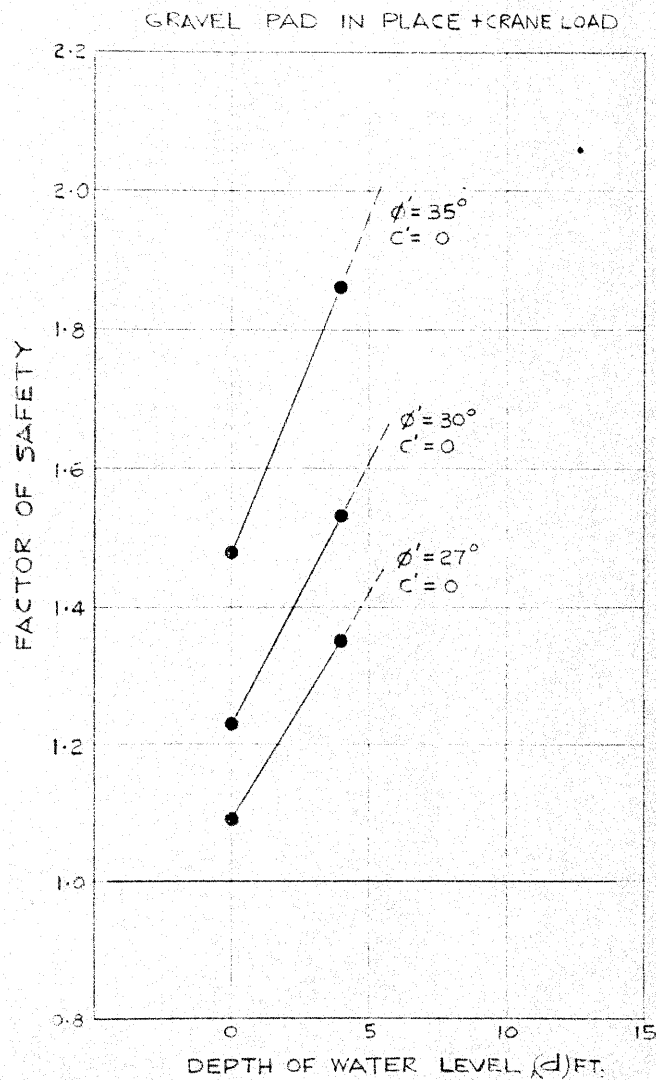
FIGURE 4

STABILITY ANALYSES - CRANE ON  
UPPER PART OF SLOPE  
(BETWEEN ABUTMENT AND FIRST PIER)

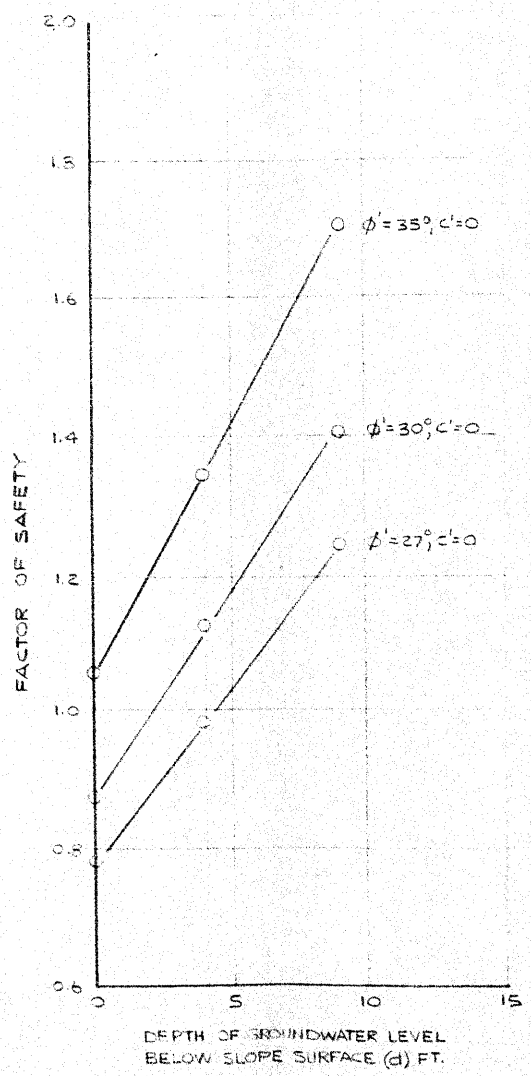
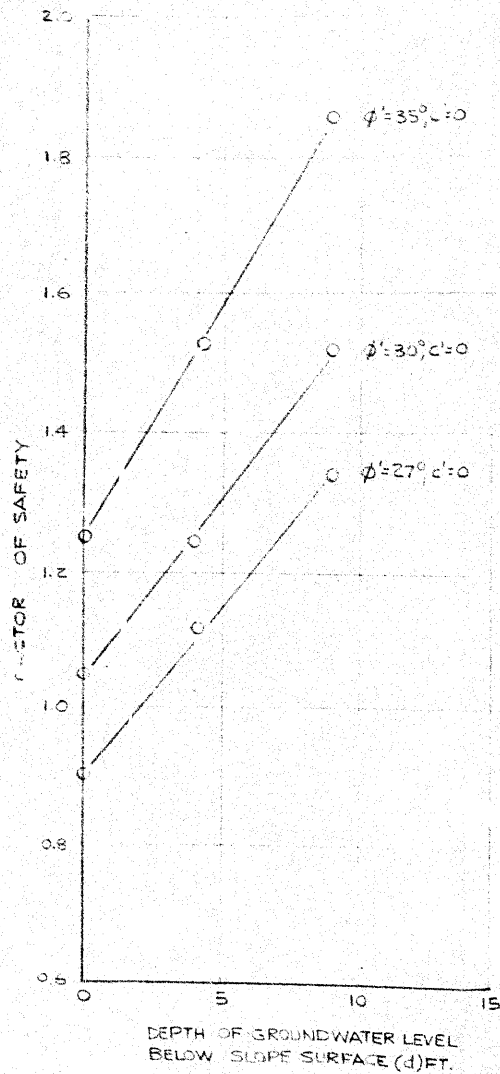
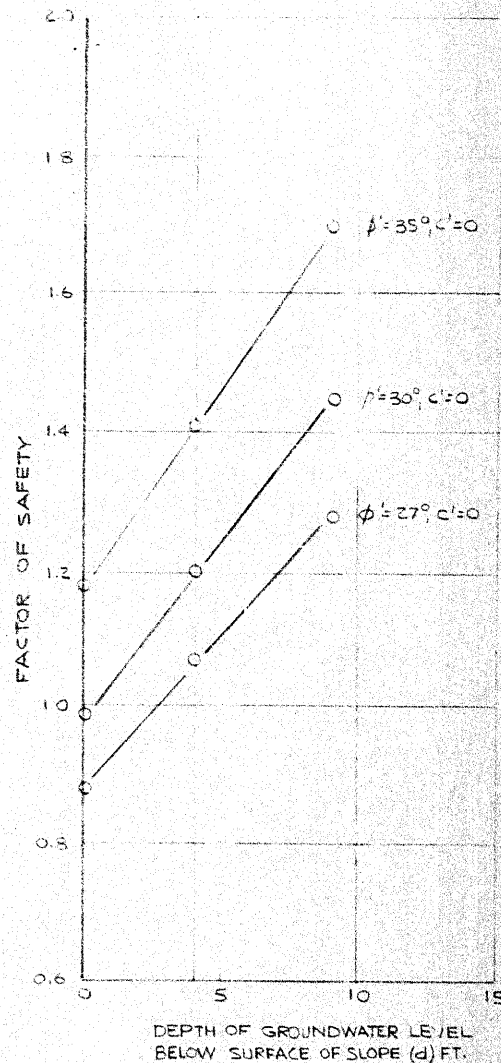
FIGURE 5

CASE 1: GRAVEL PAD IN PLACE,  
WITHOUT BERM OR CRANE LOAD

CASE 2: GRAVEL PAD IN PLACE WITH  
10' WIDE BERM, NO CRANE LOAD.

CASE 3: GRAVEL PAD IN PLACE WITH  
10' WIDE BERM + CRANE LOAD (430 LB/SQ.FT.)

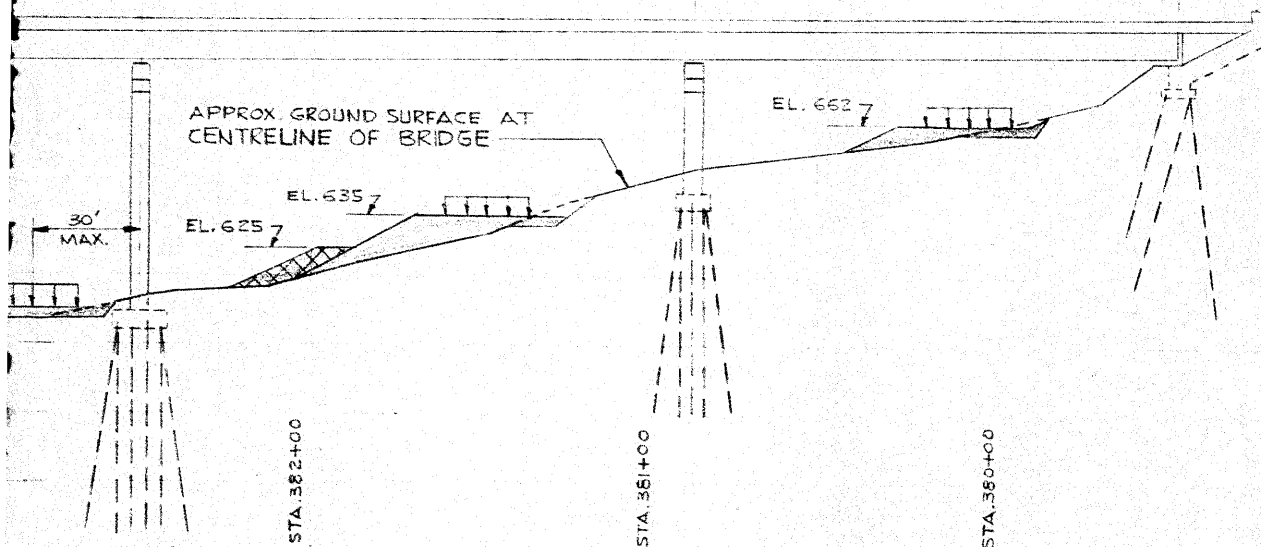
FIGURE 7

SECTION THROUGH RIVER BANK SHOWING  
GRANULAR PADS AND BERMS FOR CRANE
