SITE INVESTIGATION

BEAR CREEK BRIDGE

REPORT  
ON  
SITE INVESTIGATION  
FOR  
PROPOSED BRIDGE  
OVER  
BEAR CREEK  
HARLEY-DYMOND TOWNSHIP LINE, ONTARIO

OUR REFERENCE NO: 6-12-3

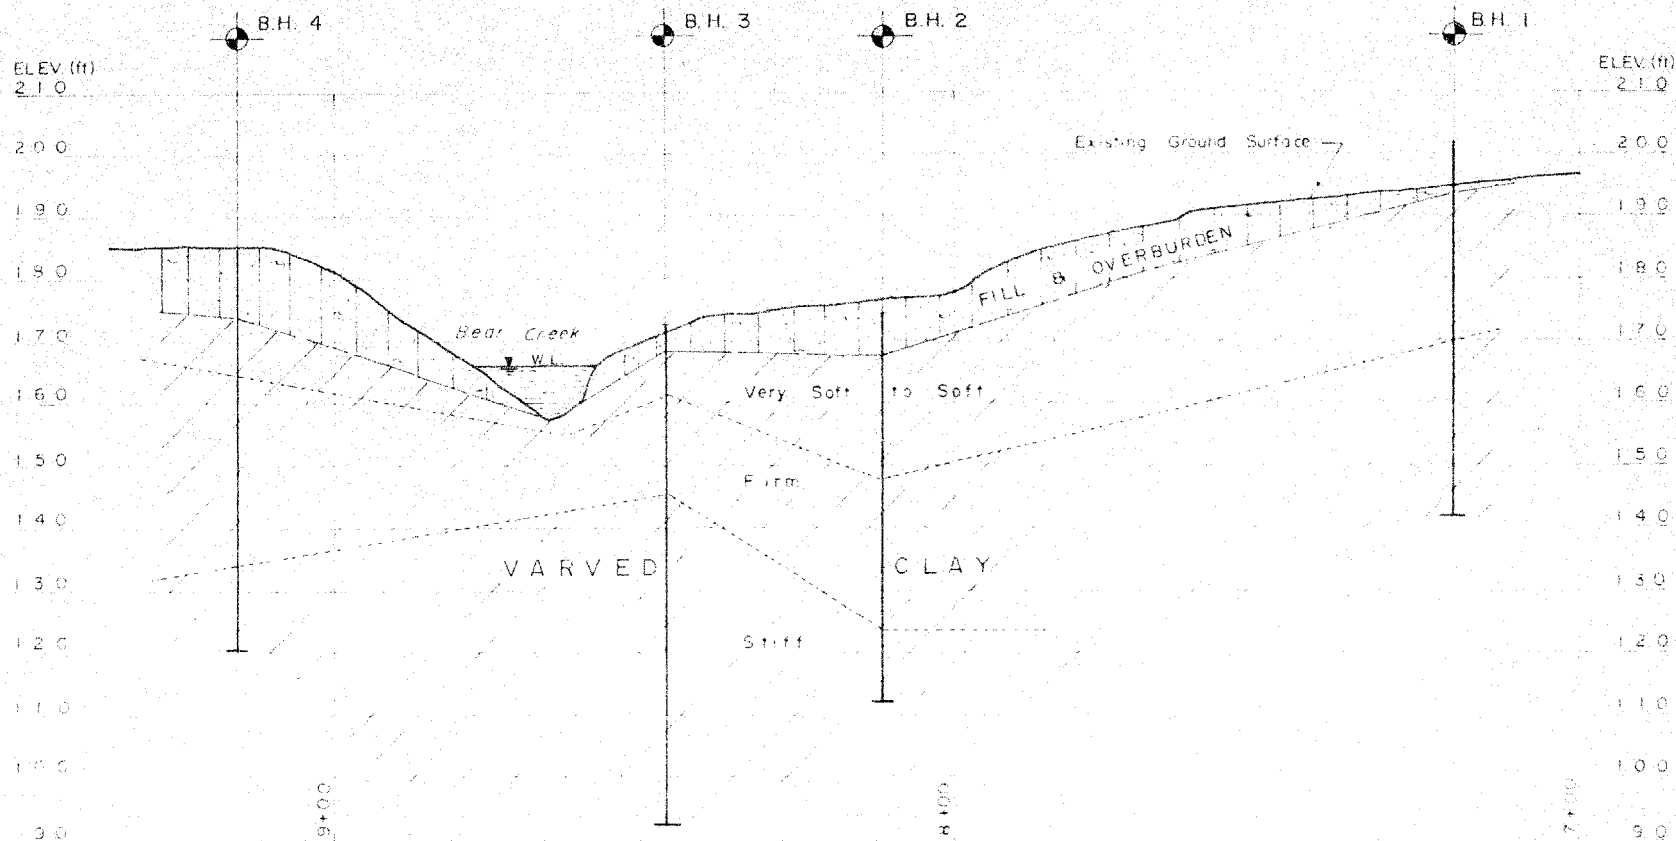
# SUBSURFACE PROFILE

It is understood that water wells in the area penetrate to the bottom of the varved clay at about elevation 40 ft. where an Artesian aquifer is encountered. A subsurface profile along the alignment is included in Enclosure No. 7.

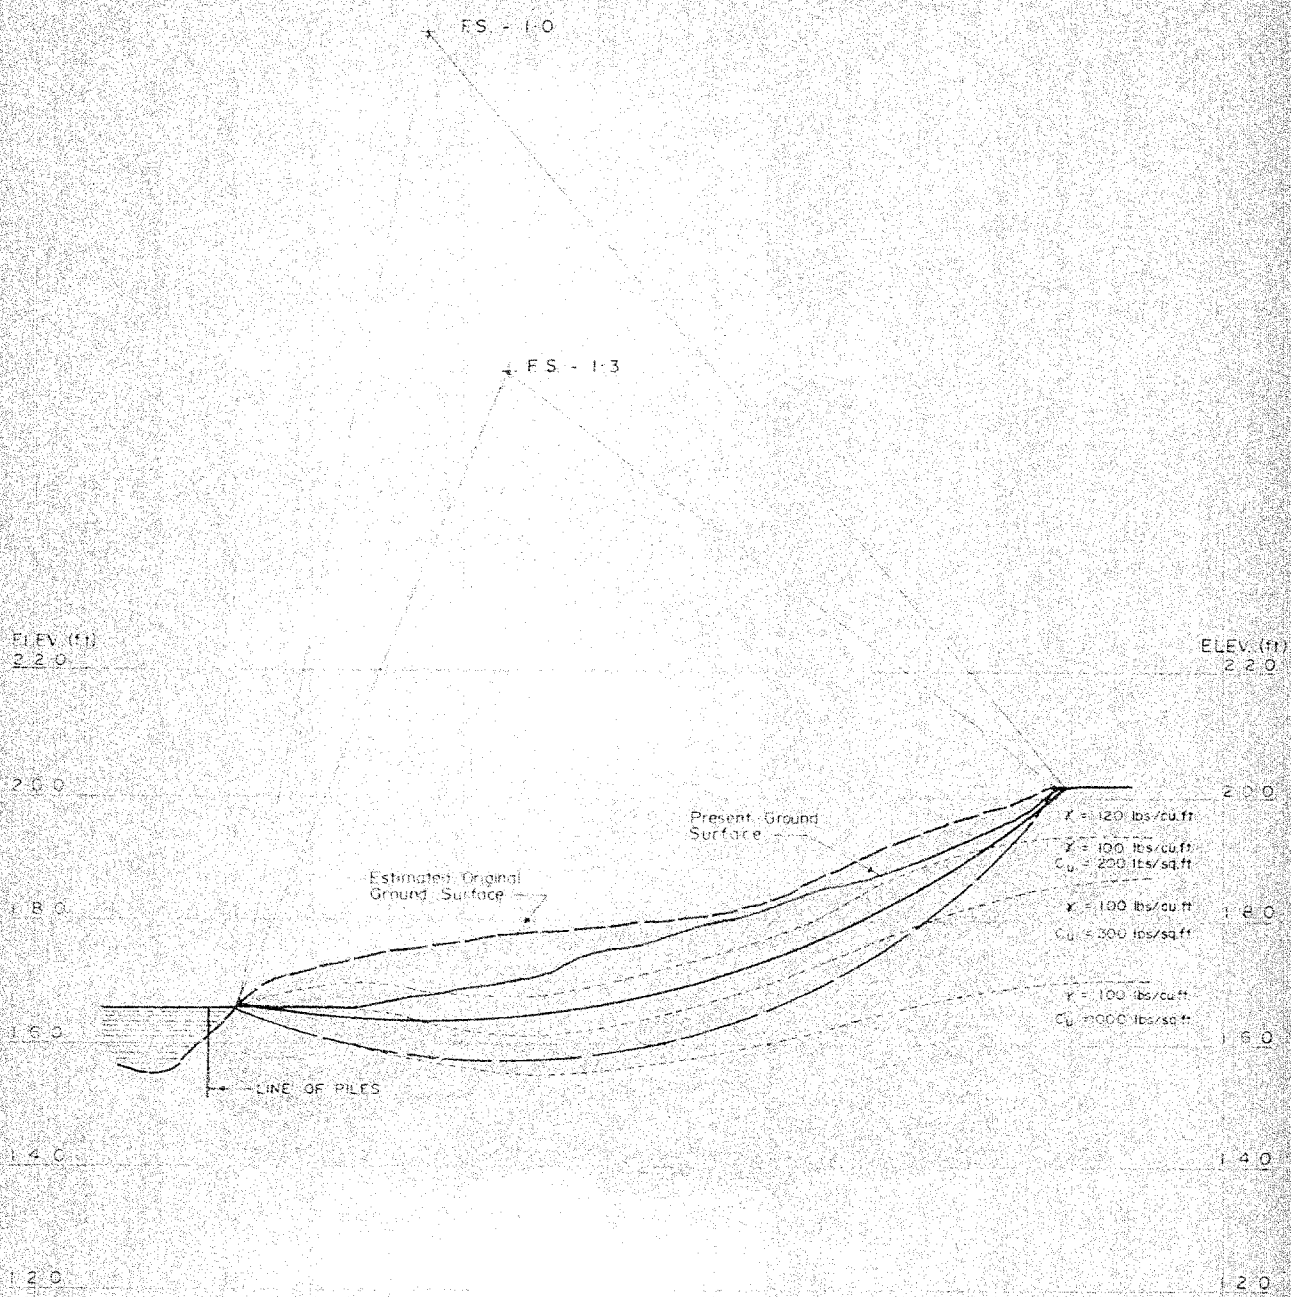
STABILITY - SECTION A-A THROUGH SLIDE

the safety factor than effective stress analyses. Using the reconstructed profile along the axis of the slide before failure and assuming zones of constant unit weight and shear strength as shown on Enclosure No. 8, the factor of safety was calculated for two circular failure sections. The rather low shear strength of 200 lbs/ft.<sup>2</sup> was assumed for the upper clay zone because shear strength and moisture content measurements indicate very soft zones near the surface of the clay. The calculated factors of safety were 1.3 for the deeper circle and 1.0 for the shallow one, indicating that failure is likely to occur near the ground surface whereas there is a sufficient safety factor against a deep seated slide.

The evident conclusion, therefore, is that the slope failed by sliding along, or just below, the very soft upper zone of the varved clay. In this zone the shear strength would be adversely affected by ground water seepage and it seems probable that softening of the clay in an exceptionally wet period caused a local failure which triggered the observed slow progressive movement.

Under these conditions, the factor of safety can only be increased by flattening the slope. Theoretically, the maximum safe slope against shallow type of failure is half the effective angle of shearing resistance which, for this varved clay deposit, has been found to range from about 20° to 28° (References: 1 and 2).

Since the slope which failed was about 1 in 4 ( $14^{\circ}$ ), it is recommended that for this project the lower limit of this range should be used which would then give a slope of  $10^{\circ}$  or 1 in 6. This agrees well with the measured value of the flatter and stable slopes on the west side of the creek.
