Our Ref. No. 8-11-4.  
February, 1969.

FOUNDATION STUDY  
FOR THE  
PROPOSED RECONSTRUCTION OF  
UNO PARK BRIDGE OVER WABI RIVER  
TOWNSHIP OF HARLEY.

Prepared for:  
THE SUTCLIFFE COMPANY.  
Consulting Engineers,  
NEW LISKEARD.

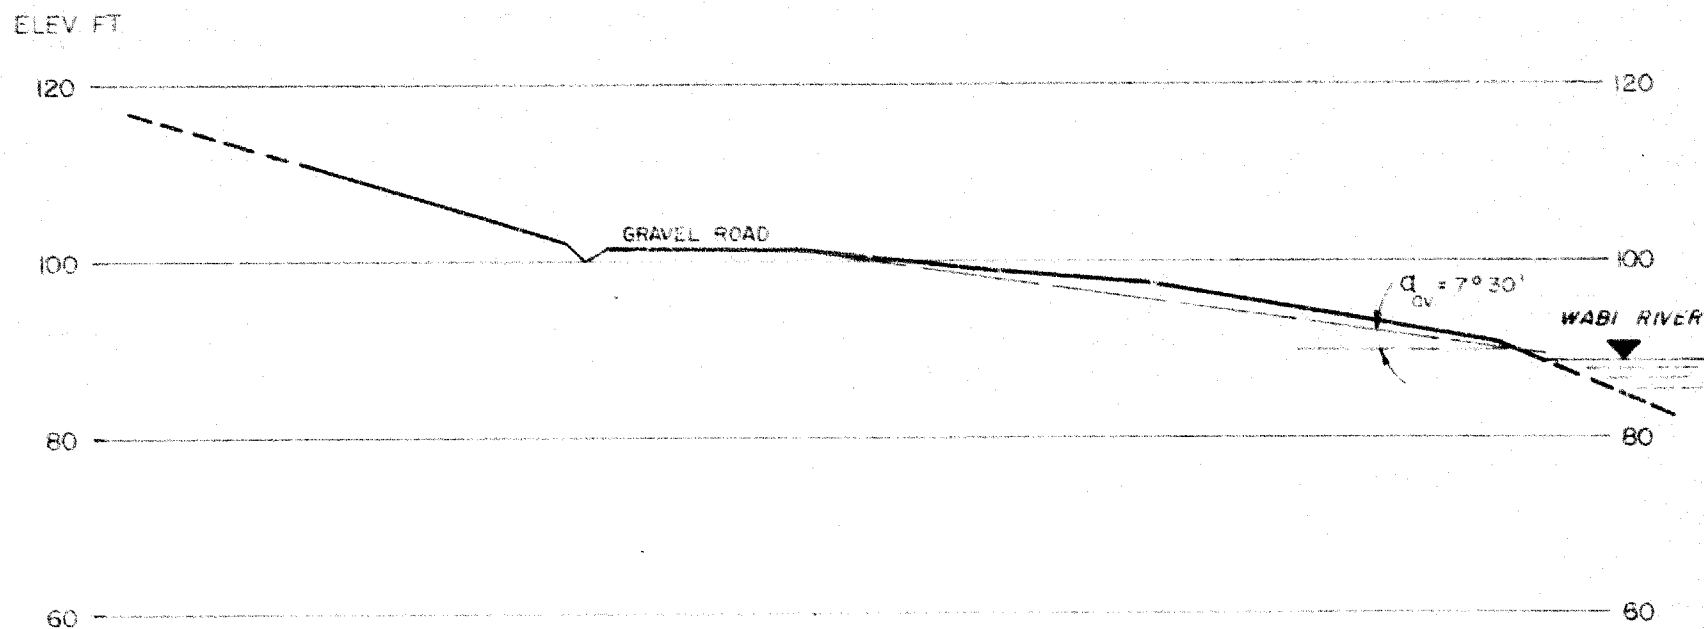
## TYPICAL CROSS-SECTION OF WEST BANK

Although a detailed analysis of the failure was not carried out, calculations based on total and effective stresses indicate that the failure of the approach fill was inevitable, as the weak subsoil was unable to support the weight of the embankment. Stability calculations also indicate that with an effective angle of shearing resistance of  $21^{\circ}$  (see enclosure No.5) the west bank of the river is stable at its present 7 to 10 degree slope (see enclosure No.6 and Drawing No.1).

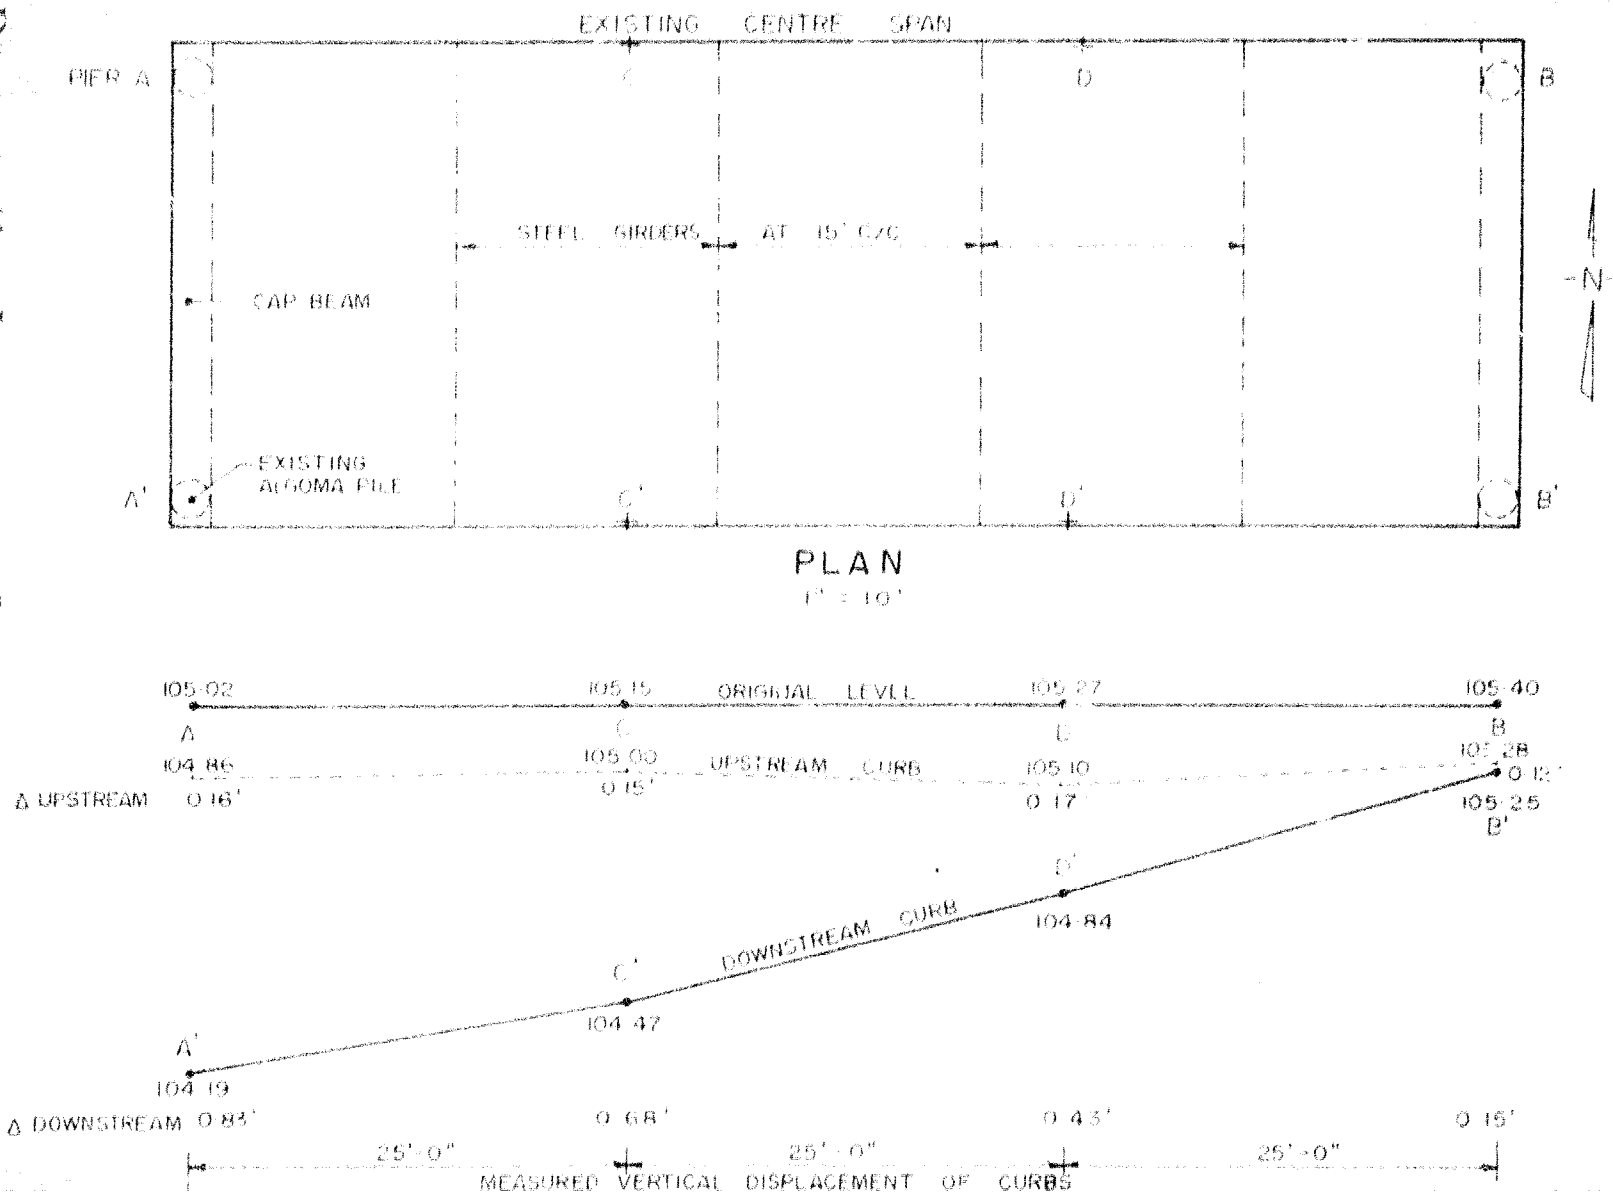
Levelling records taken by the Sutcliffe Company have indicated however, that excessive settlements were noticed only at the downstream south west pier. The vertical displacement of the centre truss span from the original, as designed, plane is shown on Fig.1.

As shown on Fig.1, piles A, B and B', that is the two east piers and the north west pier, have suffered relatively small and nearly uniform settlements (about 2 inches). The south west pier (A<sup>1</sup>) however, underwent a total vertical displacement of 0.83 ft., that is 10 inches, resulting in a differential settlement of about 0.64 ft. The difference in elevation between the curbs of the truss and the span is an indication that settlement is still in progress. The settlement pattern shown on Fig.1 also indicates that from the four pier supports of the truss, it was only the south west pier which suffered excessive settlements and the other three piers may be considered safe. It is therefore possible that the eastern and the north west piers were in fact driven to hardpan or till as indicated by the D.H.O. borings and the inferred subsoil profile shown on drawing No.1 attached to this report.

Analysing the settlement pattern shown on Fig.1 it is observed that points A', C', D' and B', all located on the lower chord of the south steel truss, can be connected with a straight line without considerable break in the lower chord axis of the truss. Such break would indicate excessive deformation and possible yielding of the steel superstructure. Naturally in the repair work all connections of the cross girders to the lower chord and primarily that of between A and A' must be thoroughly inspected and all loose and damaged connections must be repaired.
