REPORT TO
KNOX MARTIN KRETCH LTD.
ON

TOWN OF COBALT
MINING HAZARD ASSESSMENT
PHASE IV A
COBALT ONTARIO

March 1988

881-1702

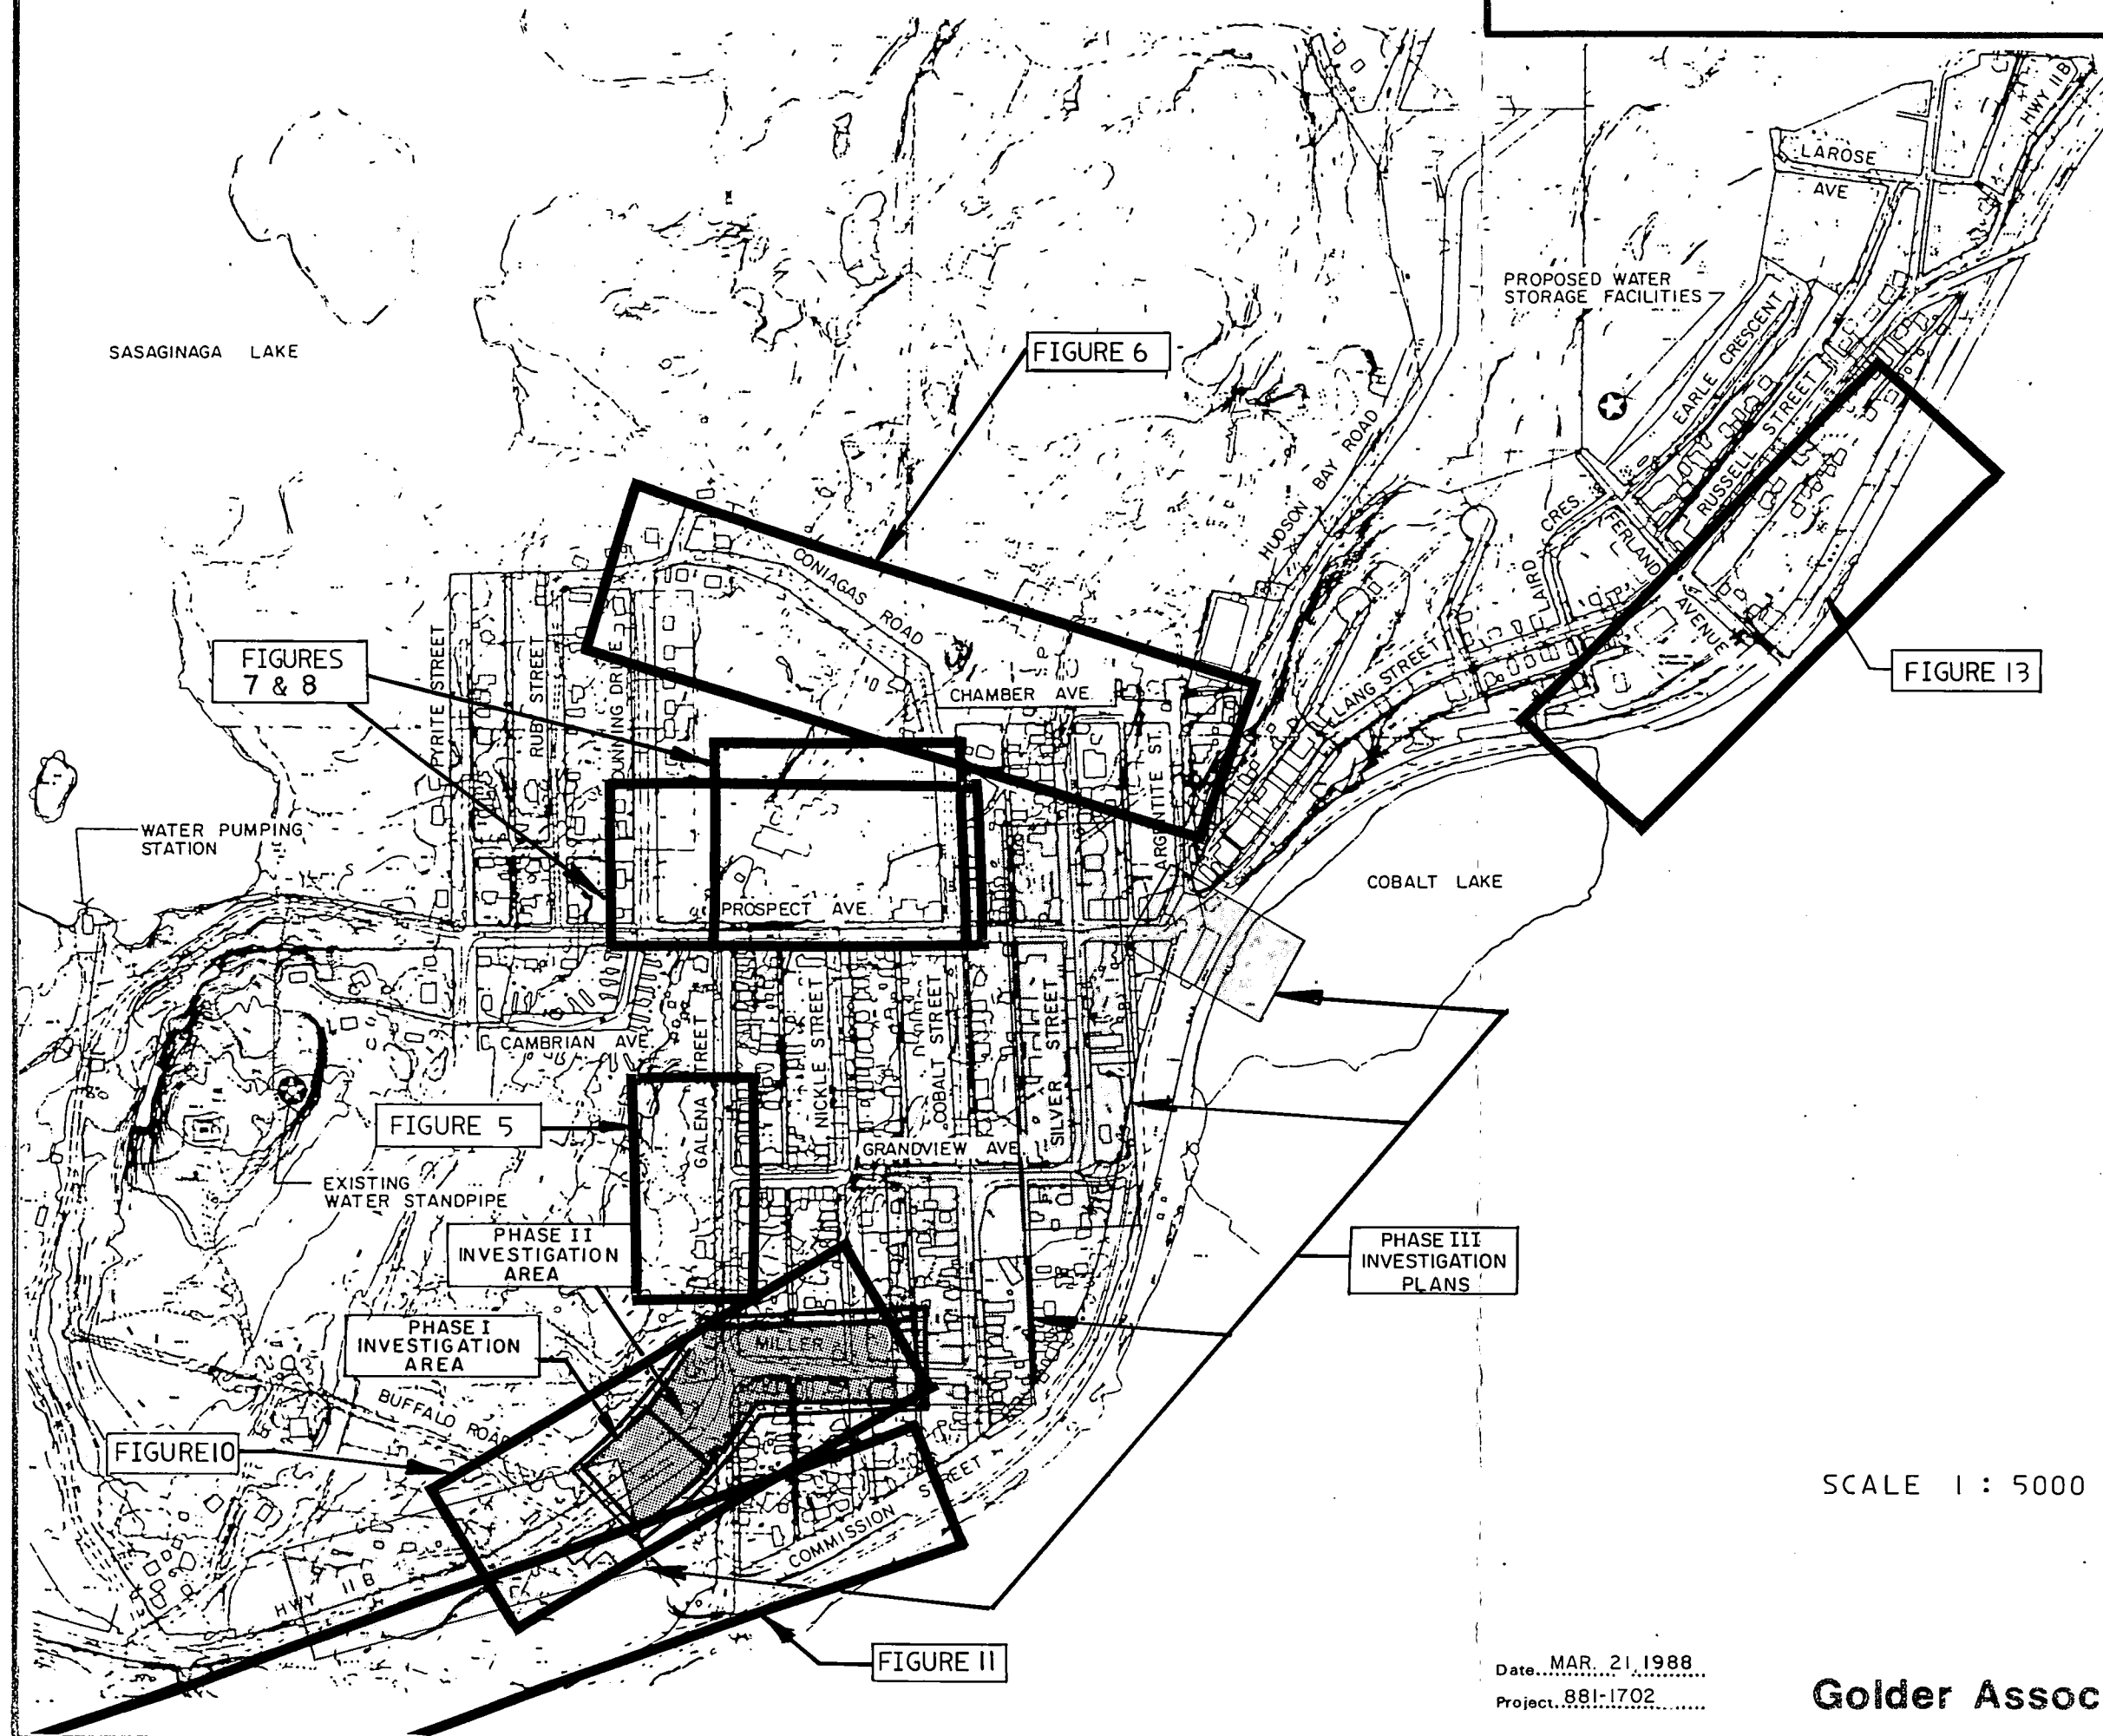
FIGURE 5

Very little information is available on the geometry of the underground workings which currently exist beneath the Street or under the houses in the immediate area. However, as shown on Figure 5, several zones of stoping are known to extend across Galena Street and under some of the adjacent properties. Furthermore, as indicated in the records collected from Agnico Eagle Mines Limited, two areas of the old workings have, in the past, caved through to surface - one directly beneath the roadway and another (related to the old mine shaft) into the back garden of the property at #56 Galena Street. Cunningham in his 1981 report indicates that the section of the roadway in this area was capped in 1980, (see Figure 18 of Golder Associates report #851-1172 for details of capping). The precise date of the capping of the old stoped out shaft area (Figure 17 of report #851-1172) is unknown, but presumed to be in the early 1970's.

Although one diamond drillhole was put down on Galena Street as part of the 1986 watermain investigation programme, to date insufficient information exists on stope geometries or on crown pillar conditions to adequately evaluate the long-term stability of the crown pillars and mine workings in this area. A comprehensive programme of diamond drilling to establish rock mass conditions is therefore required coupled with grid pattern airtrack probing to determine underground opening geometries.

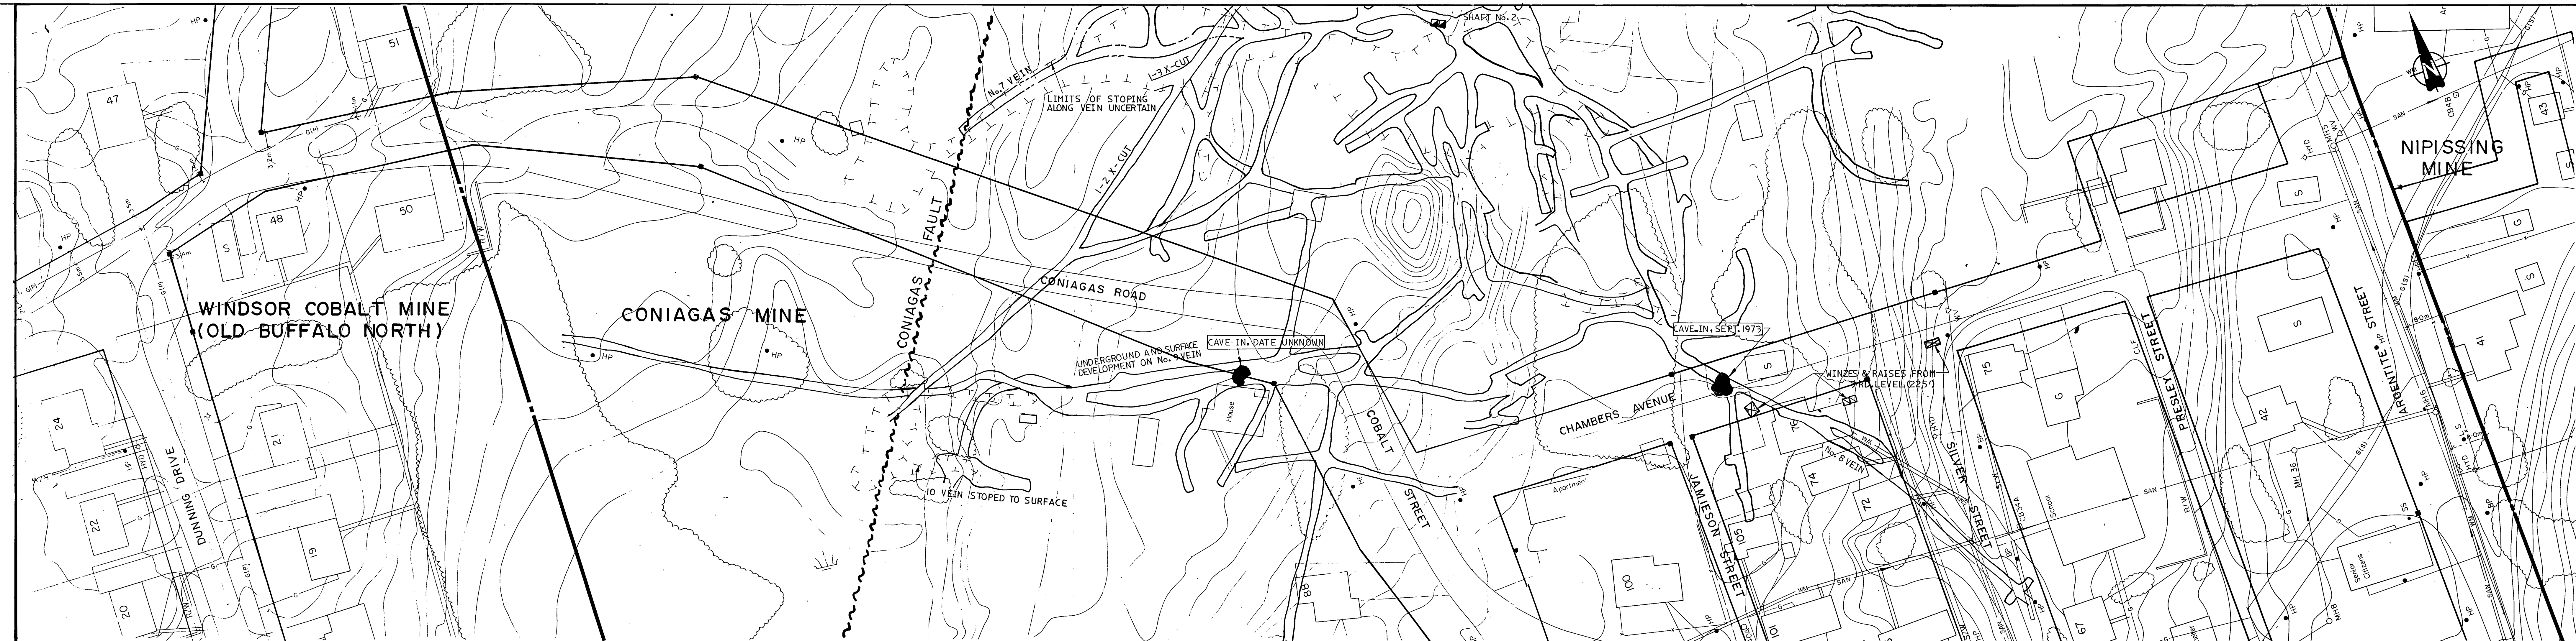
Although all the publicly accessible surface open cuts have been fenced, the fact that at least two incidences of ground subsidence have been documented in the area outside those sections that have been fenced, gives rise to concern regarding stoping that may have been carried out, either by the original mining company prior to the 1920's, or by the lessors. One of the areas which is reported to have caved through to surface occurred beneath the driveway of the house on the corner of Cobalt Street and Coniagas Road. Based on the information obtained from the drift plans (Figure 6), it is considered that this cave-in likely was associated with stope development on the #9 Vein.

The other cave-in, which was recorded on a plan acquired from H. Sutcliffe Ltd., occurred in September 1973 adjacent to House #76, Chambers Avenue (see Figure 6). Capping details for this cave-in, which was thought to be associated with a raise, are shown on Figure 20 of Golder Associates report #851-1172.

Several near surface stopes exist in the vicinity of Coniagas Road and adjacent dwellings (Figure 6). The #8 and #9 Vein stopes occur close to and probably under the road. Drilling to determine crown pillar rock conditions and overburden depths over these vein complexes is recommended, (for locations of veins - see Figure 3).

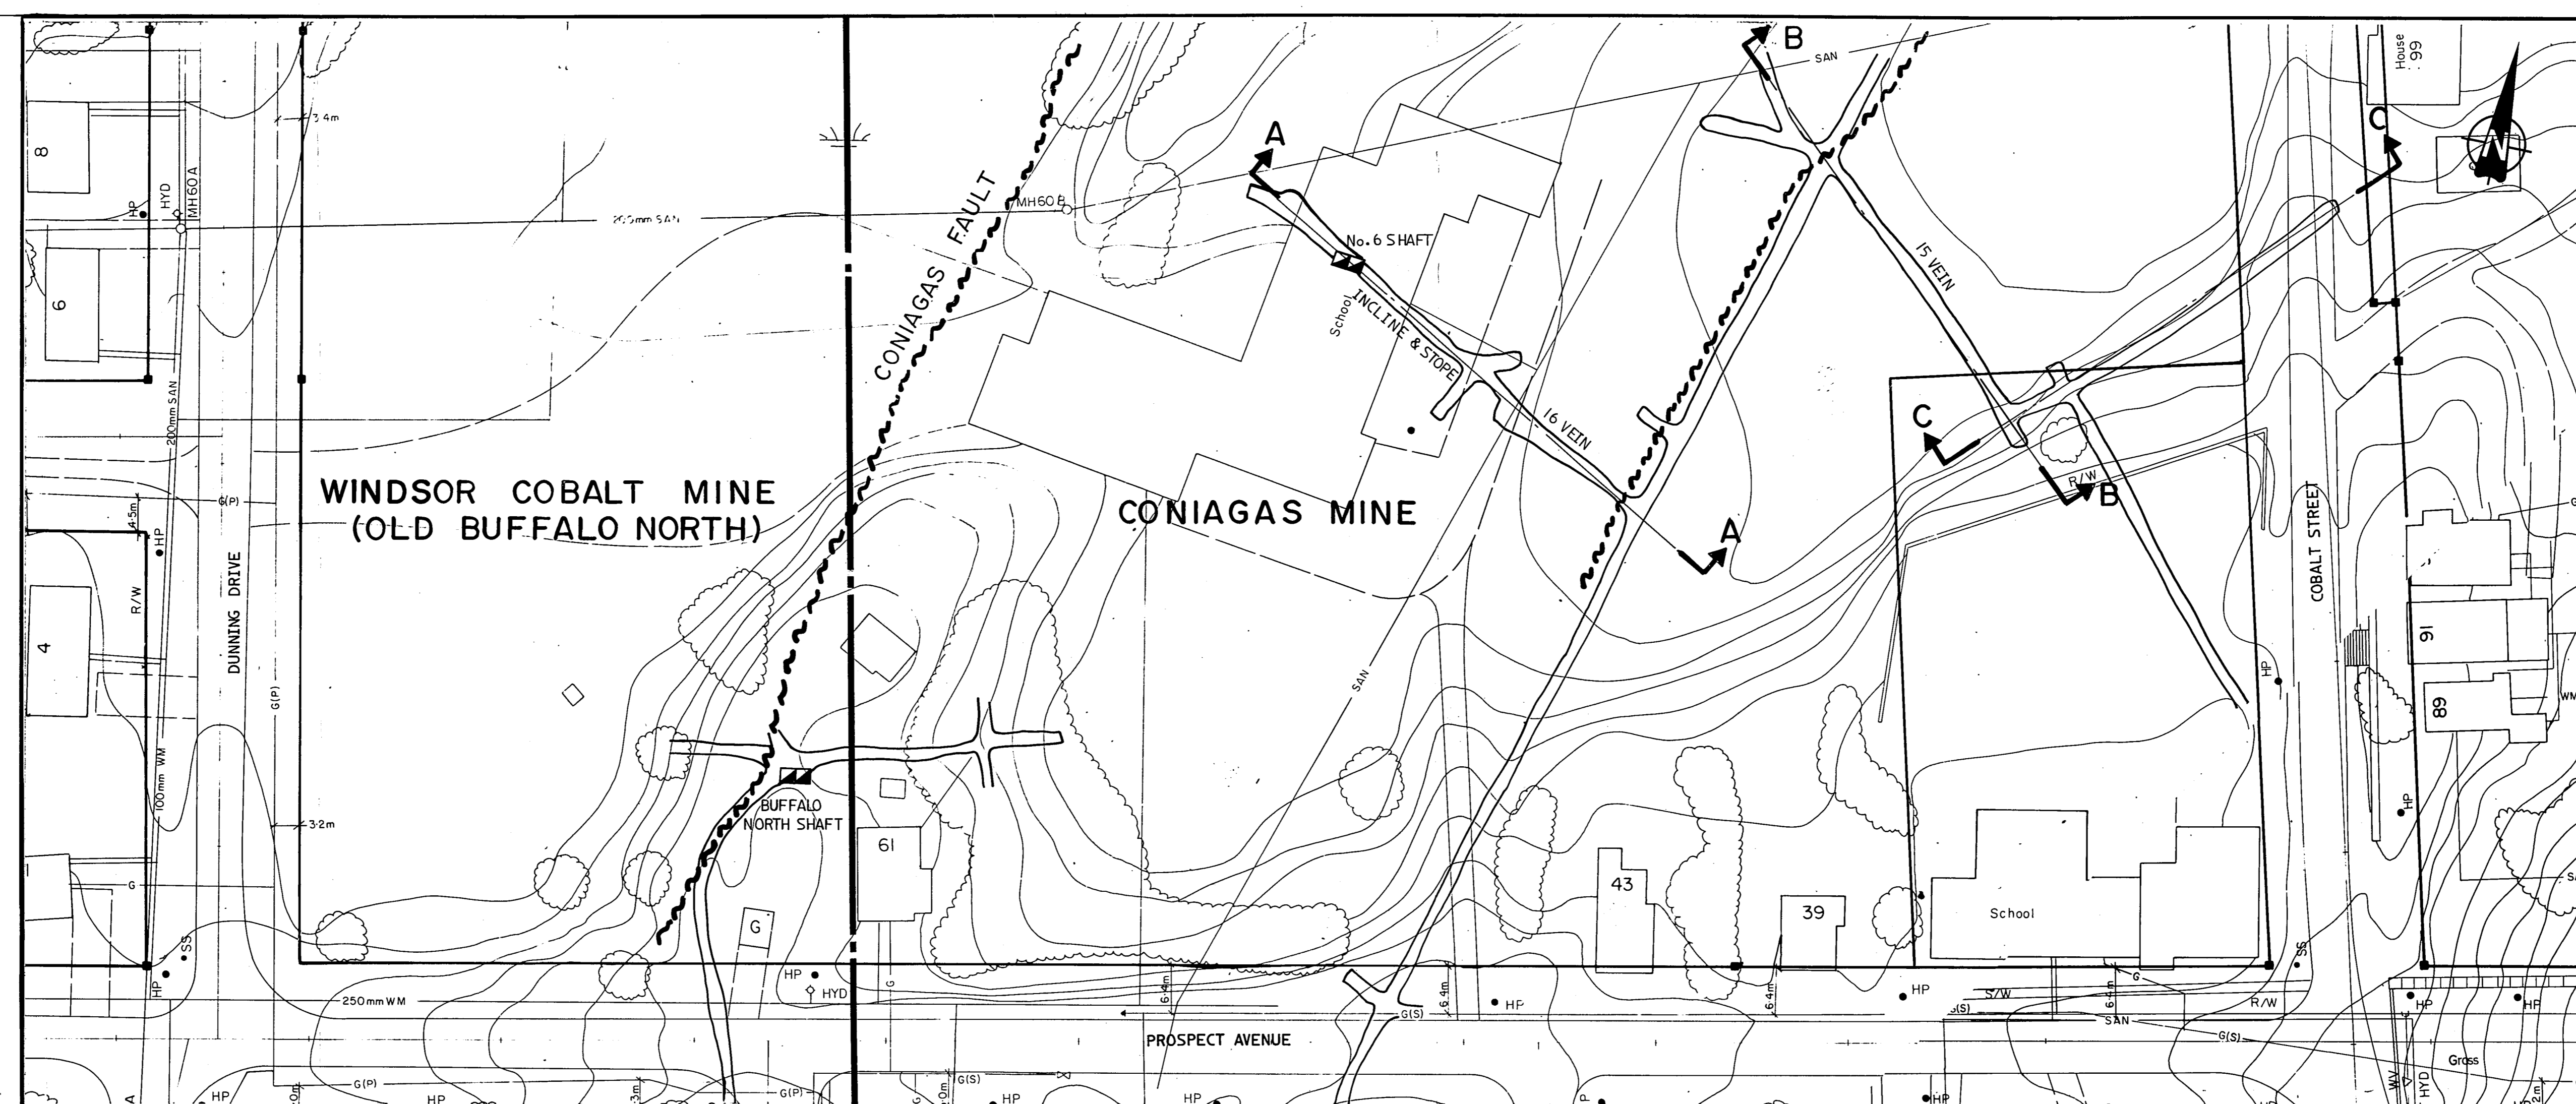
This shaft, which is shown directly under the school building is reported by Cunningham (1981) to have been filled with mine waste rock. The information on Figure 8 however, suggests that the shaft at least in 1956, was open to 53 ft. depth, but that it was concrete capped. Further, the cross section shown on Figure 9 (a 1916 drawing, obtained from Agnico Eagle Mines Limited records), suggests that the shaft had been at least partially stoped out and that the Vein #16 stope extends close to surface both to the west and to the east from the shaft under the school building and adjacent school-yard.

In consequence, attempts were made to collect any available data regarding rock conditions in the crown pillars of these stopes or indeed on any site investigations for the school. No information other than the sounding information shown on Figure 8 is apparently available. In addition, discussions with representatives of the Timiskaming School Board and with the two architectural firms that were involved with the construction of the school have not shed much additional light on the pre-1956 investigations. However, attempts are being made by the School Board to find out if any additional information exists other than that shown on Figure 8.

The lack of information on the geometry of the crown pillars remaining over the two stopes known to exist under the Public school and school-yard and the lack of data on overburden and tailings thicknesses over the stopes is also of concern. Investigation by geophysical profiling backed up by correlation drilling is therefore recommended for determining subsurface conditions in sufficient detail to adequately assess the stability of the workings.

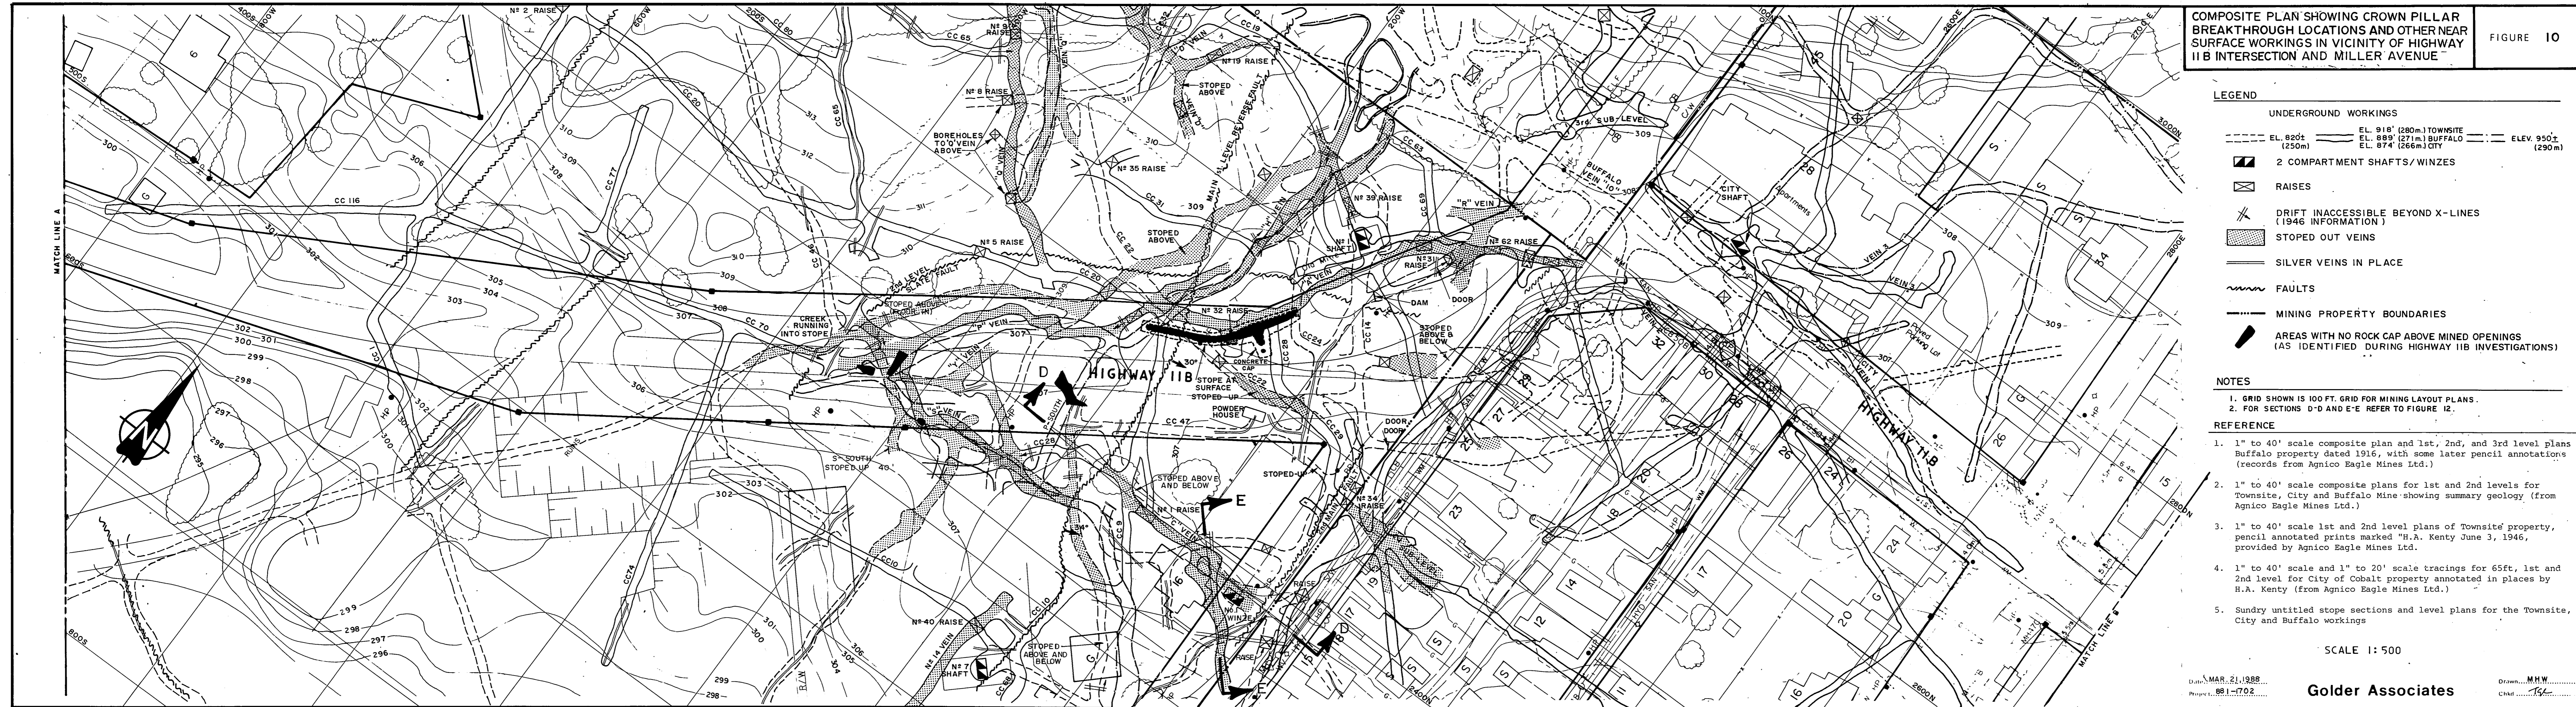
PLAN OF DOCUMENTED MINE WORKINGS
IN THE AREA OF THE COBALT STATION GROUNDS
(TOWNSITE, TOWNSITE EXTENSION AND CITY
OF COBALT MINES)

Most of the critical zones of open stoping within the area have already been fenced, but, as also shown on Figure 11, numerous cross cuts and exploration drifts also exist. Published data suggests that little exploitable ore was found underneath the old mill complex north of the X-vein stope workings on the Townsite property (Figure 14), south of the S-Vein stope (ie. the stope that came to surface right under Highway 11B (refer reports #871-1289 and 871-1289-1). Extensive workings were however completed in the boundary areas between the Townsite Extension and the Right of Way south, Cobalt Lake and McKinley Darragh properties (see Figures 2 and 3). Several major veins were encountered. Some were mined from surface, by open cut. Some were developed from underground by stoping. Several shafts were sunk and numerous raises were developed, some right up to the bed of Cobalt lake.

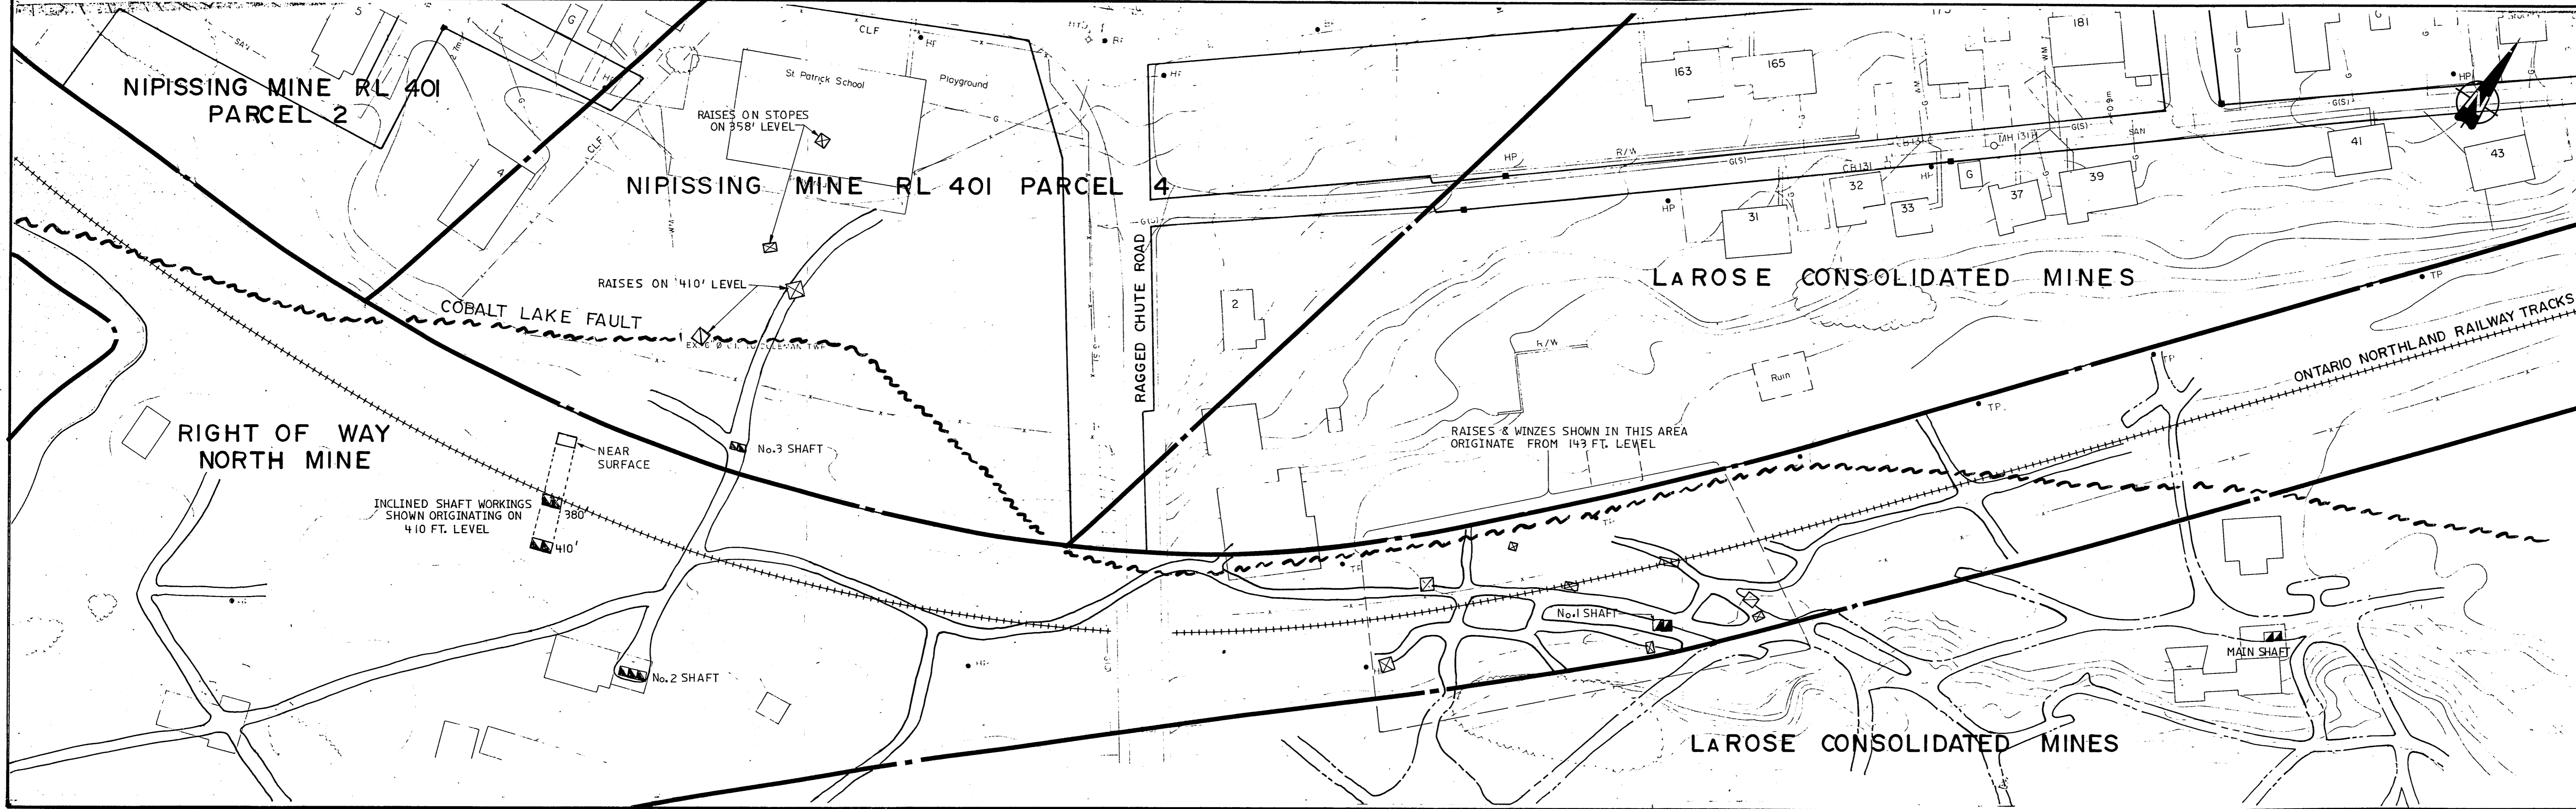
The area underlying the present alignment of the railway tracks to the north east of the Ragged Chute Road Bridge was heavily mined on the LaRose and Right of Way North Mine properties. Mineralization, and hence most of the stoping, was predominantly focussed on the south and east side of the Cobalt Lake Fault (see Figure 3). Information from various sources suggests that stoping in this area came close to surface along the fault (ie., in the area directly under the railway lines). In fact, it is reported that during the 1960's period when attempts were being made to drain Cobalt Lake a deliberate breakthrough to the lake was created at the south-west end of the Right of Way North Mine Property on the boundary with the property of the Cobalt Lake Mine (see Figure 13).

Unfortunately, no records have been found illustrating the geometry of this breakthrough area. The locations of the two shafts that were put down on the Right of Way to gain access to the mineralization along the fault and the geometry of the known upper level drifts are however shown on Figure 13. Again, detailed information on the geometry of the stoping undertaken from these drifts has not been found, nor has any information been located on the depth of overburden and tailings/waste rock infilling the natural valley formed along the trend of the Cobalt Lake Fault.

The area between the #1 and #2 shafts on the Right of Way North Mine underneath the railway tracks has been extensively stoped. In fact, the #1 shaft, which occurs close to or even under the existing track is reported to have itself been stoped out. Based on the available records, back elevations of the top of the stoping under the railway tracks are within 10m. of ground surface; however, the depth of overburden is unknown. Drilling of this area is recommended.
