## Golder Associates

GEOTECHNICAL INVESTIGATION

PROPOSED TRUNK WATERMAINS

CENTRAL PART OF COBALT

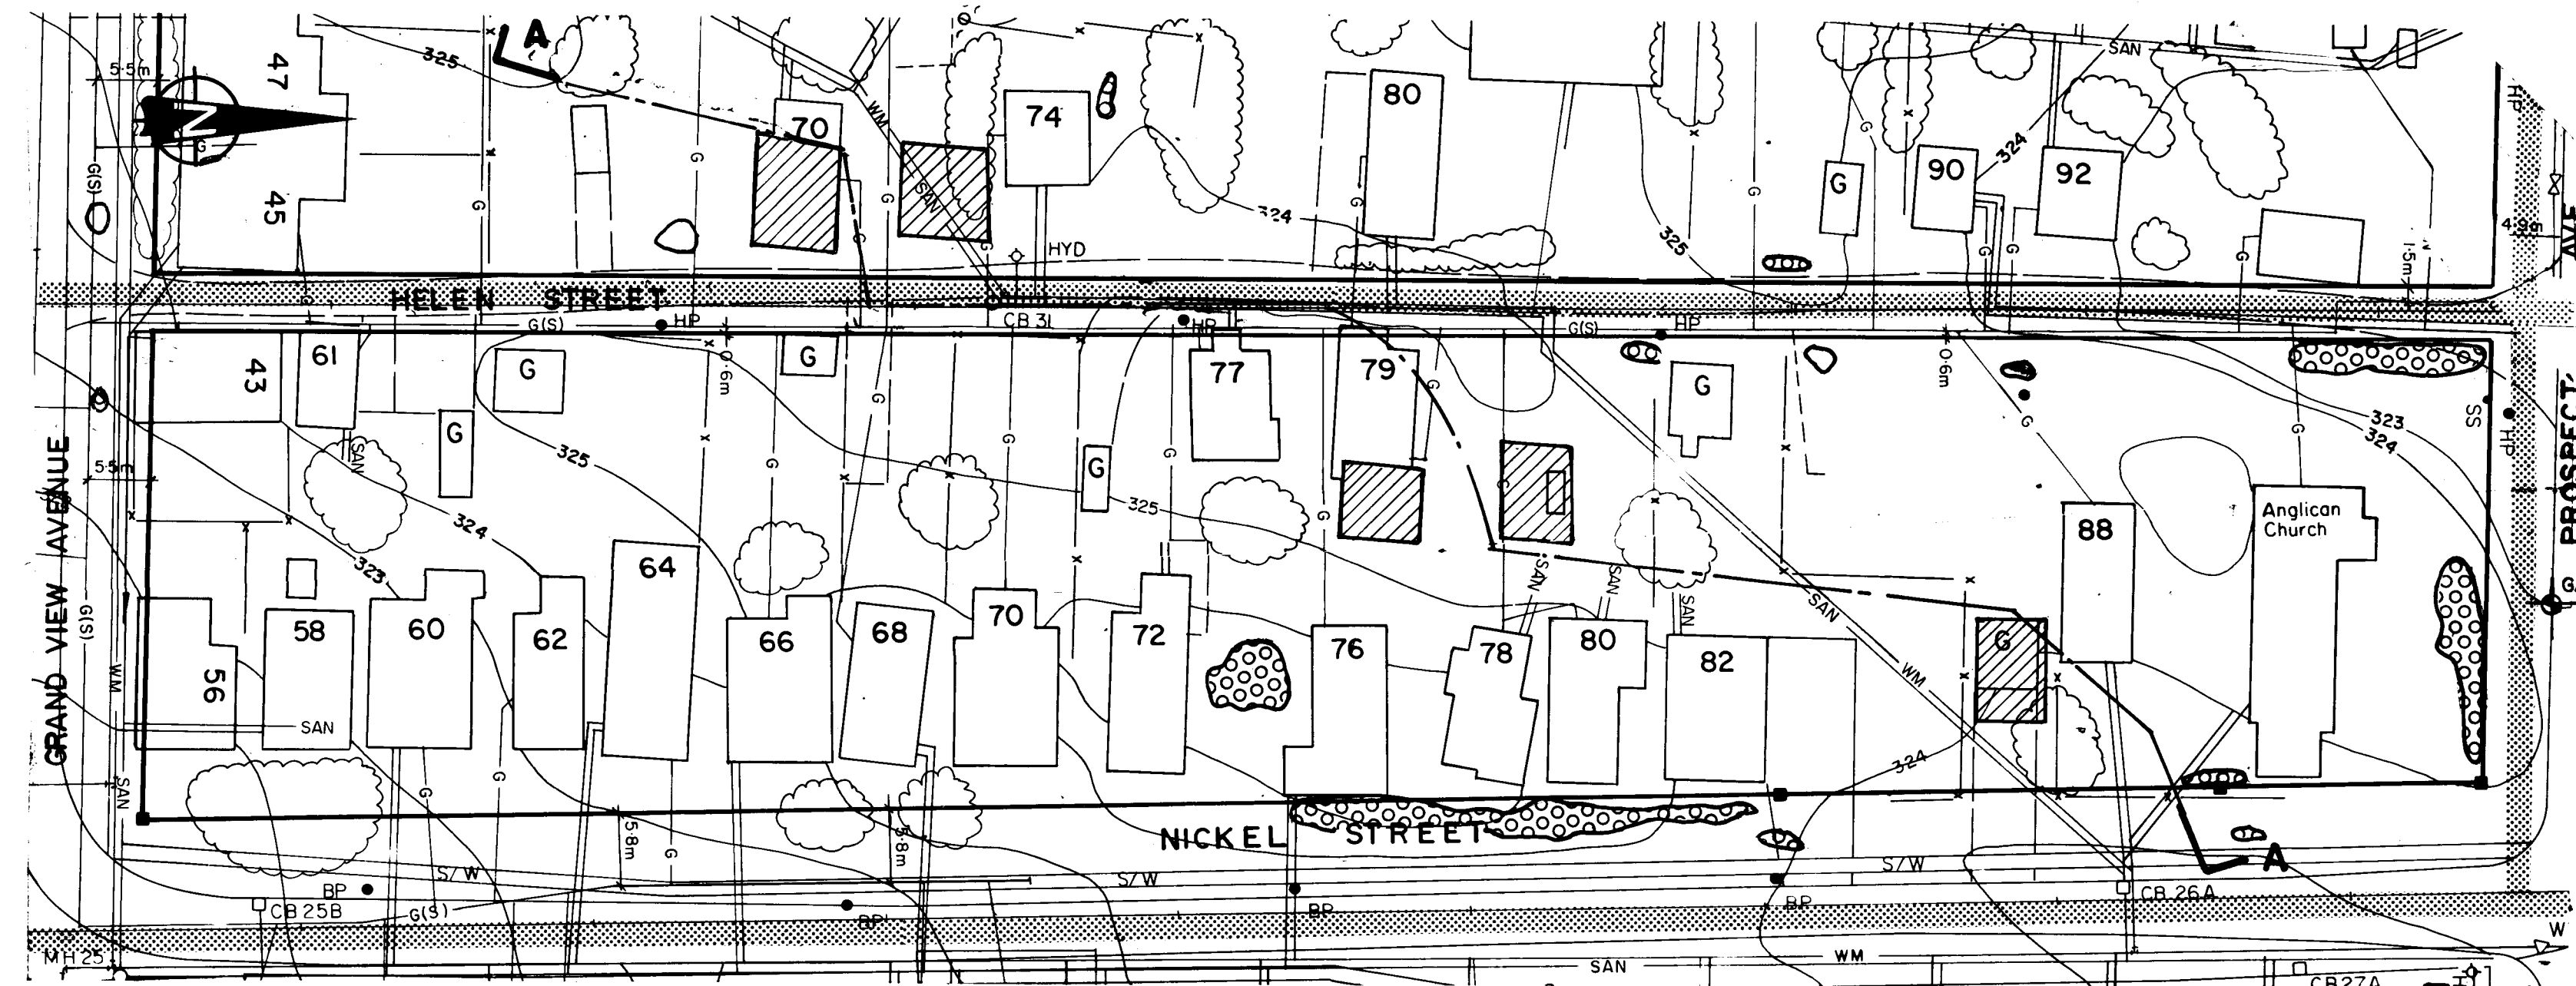
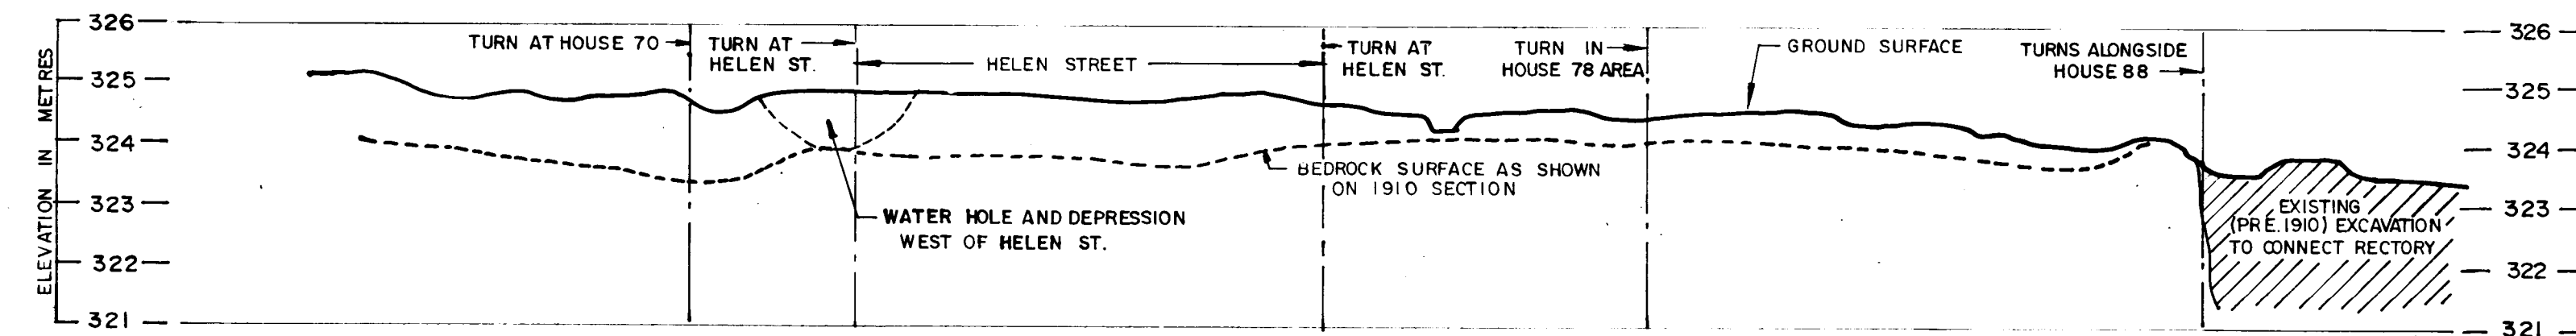
FIGURE 2

PLAN AND SECTION OF  
HELEN & NICKEL STREET AREA BETWEEN  
GRANDVIEW AND PROSPECT AVENUES

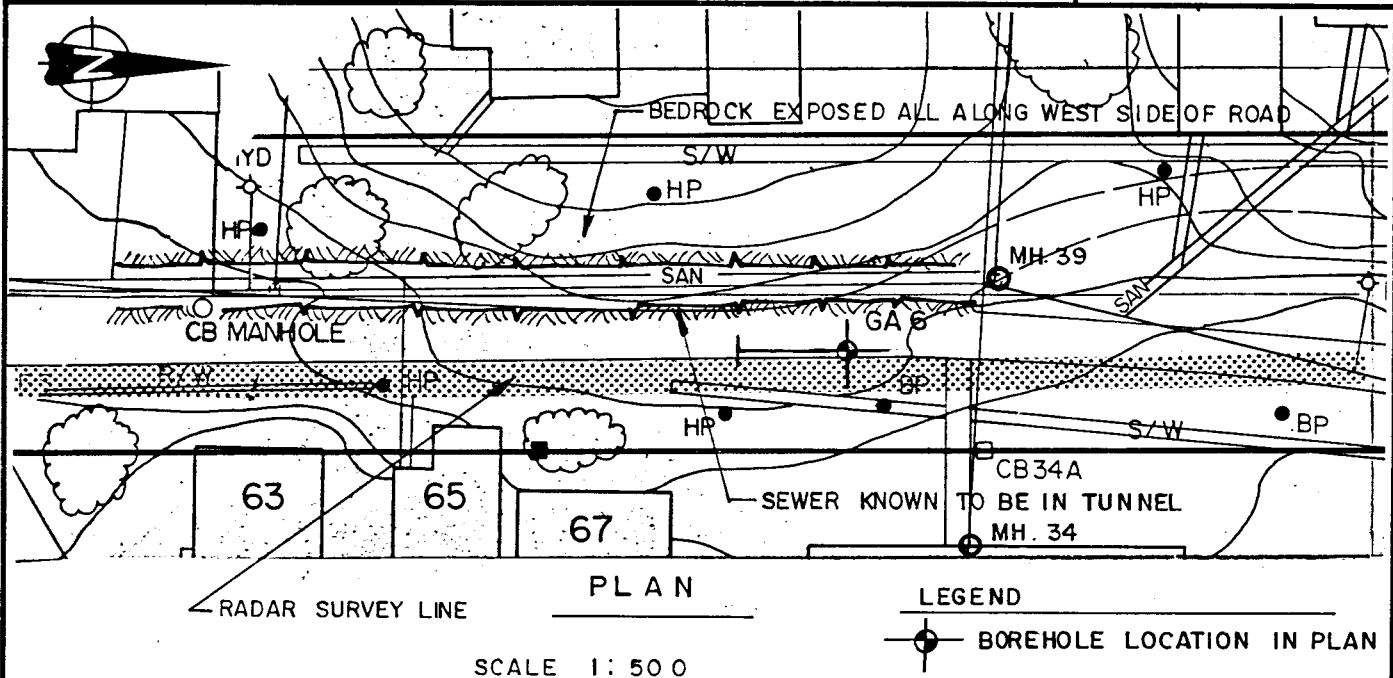
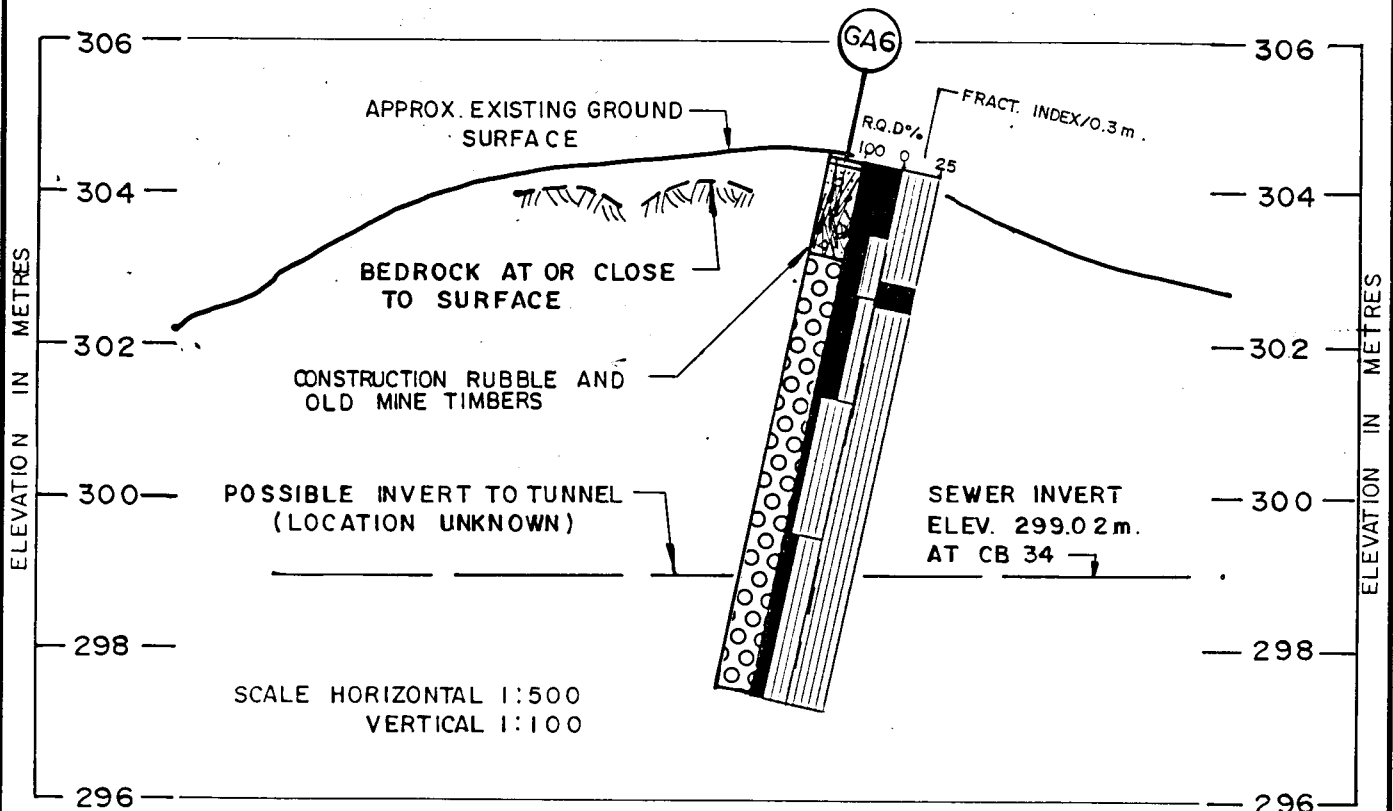
FIGURE 7

The highly variable nature of the bedrock topography to the north of this area is a further complication as shown on Figure 7. Here, as at the Presley Street location adjacent to the supermarket (ref. Figure 2 of report #851-1172), the sewer is known to be in tunnel. In order to assess rock conditions alongside this tunnel, hole GA-6 was put down inclined to the south and located in front of Ecole Ste. Therese at the north end of Silver Street. Drilling began in the afternoon of August 28th and was completed the following morning. After penetrating an asphalt layer, considerable difficulty was experienced in drilling through material consisting primarily of construction or old mine timbers. Bedrock was encountered almost immediately below this at an inclined depth of 1.4 m.

# PLAN AND SECTION OF SILVER STREET ADJACENT TO ECOLE STE. THERESE SHOWING KNOWN SUBSURFACE CONDITIONS

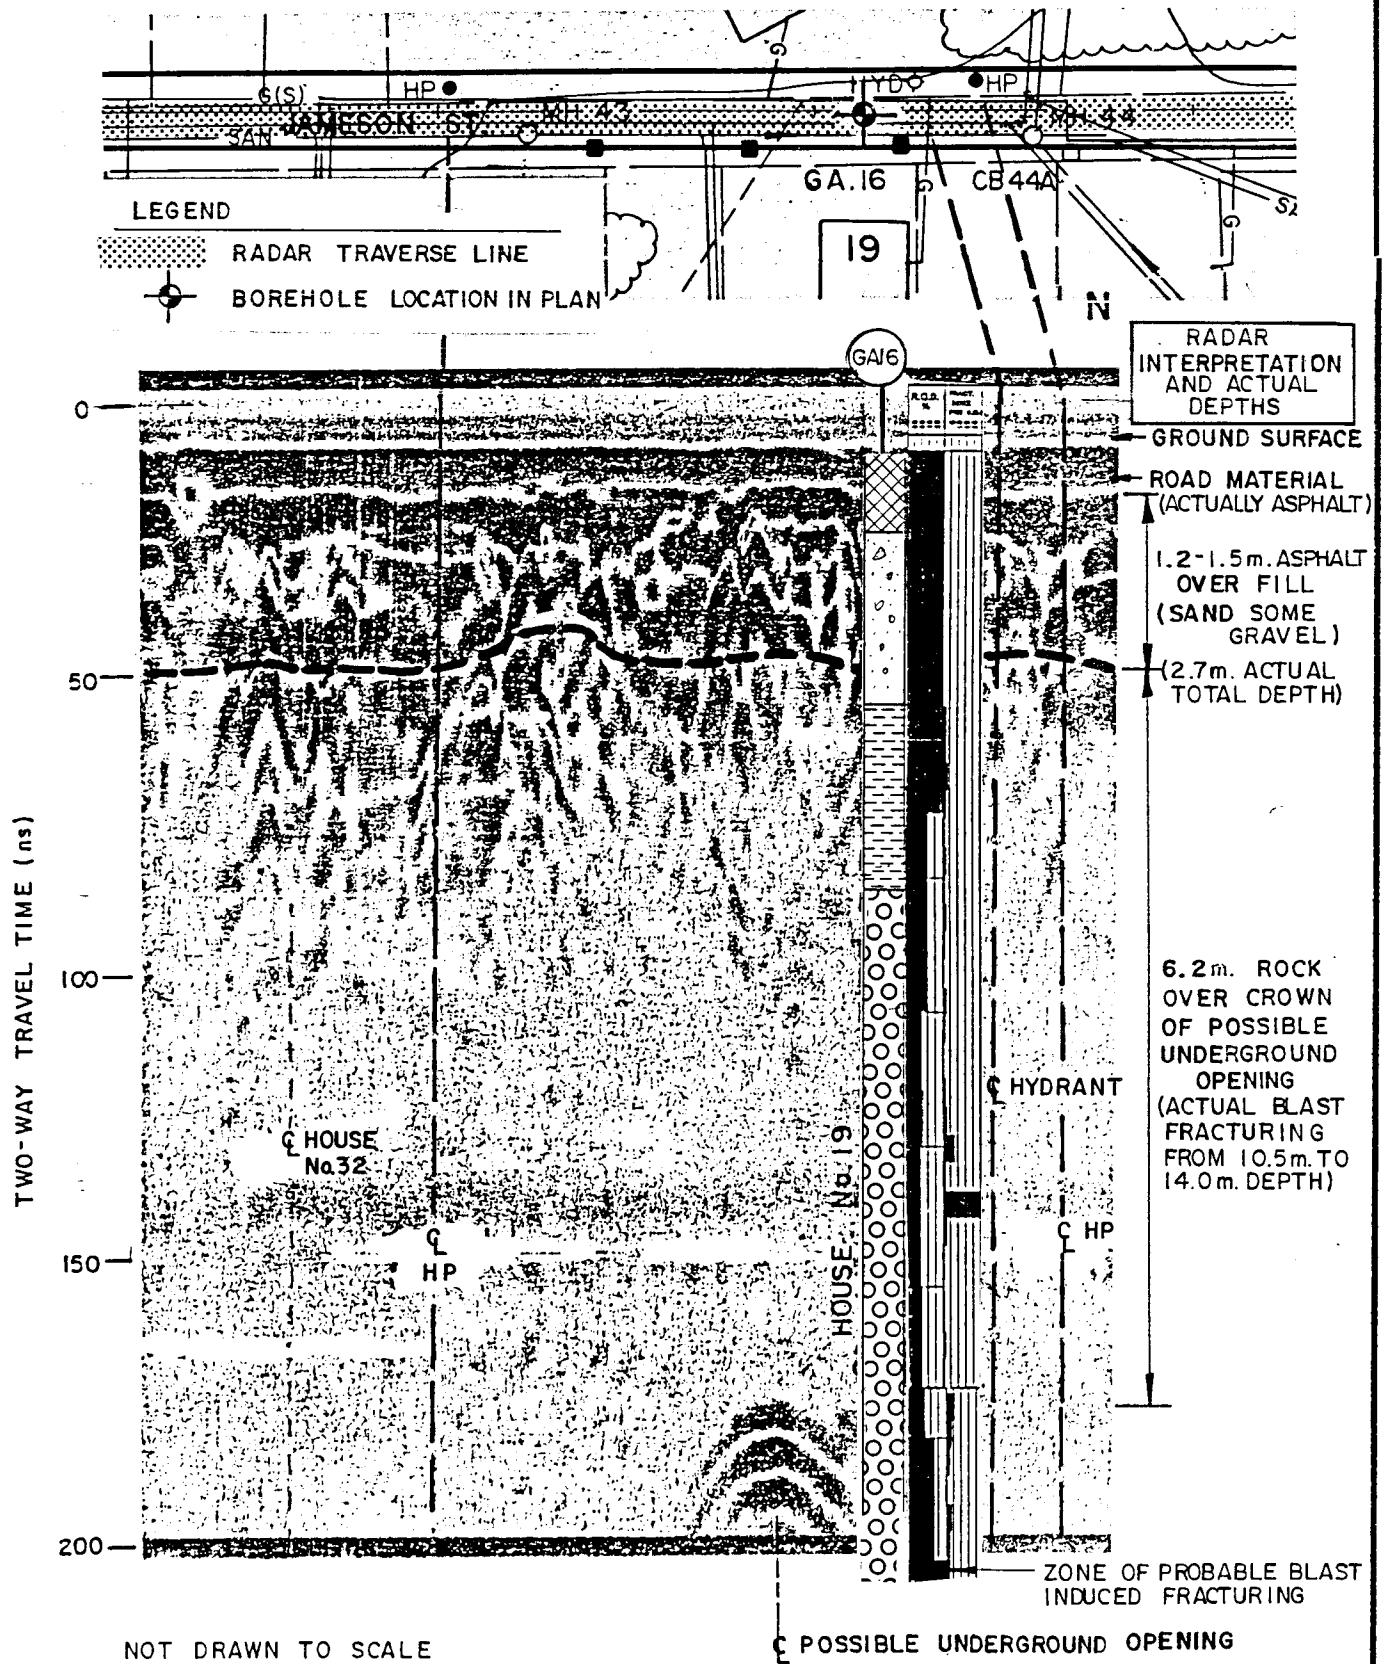
FIGURE 8

The summary information from the drilling of hole GA-16 is shown on Figure 8 superimposed on the interpreted radar traverse record for the location. The radar interpreted subsurface conditions and depths, and the actual soil and rock conditions and depths from the drilling are both shown on the diagram for comparison. As can be seen, the interpreted depths are appreciably less than those actually determined from the drilling. This is most probably due to inaccuracies in assumed subsurface radar velocities complicated by groundwater

conditions. However, the variation in rock mass response characteristics seen by the radar profiling (Figure 8) appears to correspond closely to that found by the coring. (This is particularly well illustrated by the RQD% histogram).

# INTERPRETED RADAR RECORD AND BOREHOLE INFORMATION FOR PART OF JAMIESON STREET
