REPORT TO
THE MAYOR AND COUNCIL
TOWN OF COBALT
ON

PRELIMINARY ENGINEERING ASSESSMENT
AND SUGGESTED REMEDIAL MEASURES
"P-S" STOPE INTERSECTION CROWN PILLAR,
HWY #11B
COBALT, ONTARIO
WO: 2002-11005

August 1987

871-1289

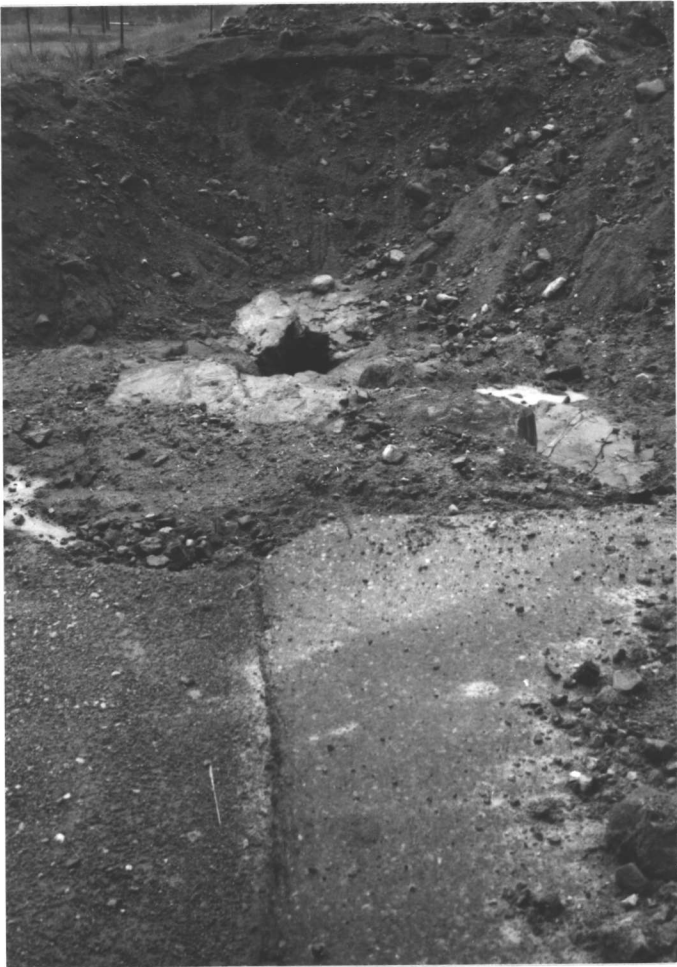
View south-west looking along Highway 11B pavement shoulder - note "hole-through" position on S-vein stope lines up with edge of roadway.

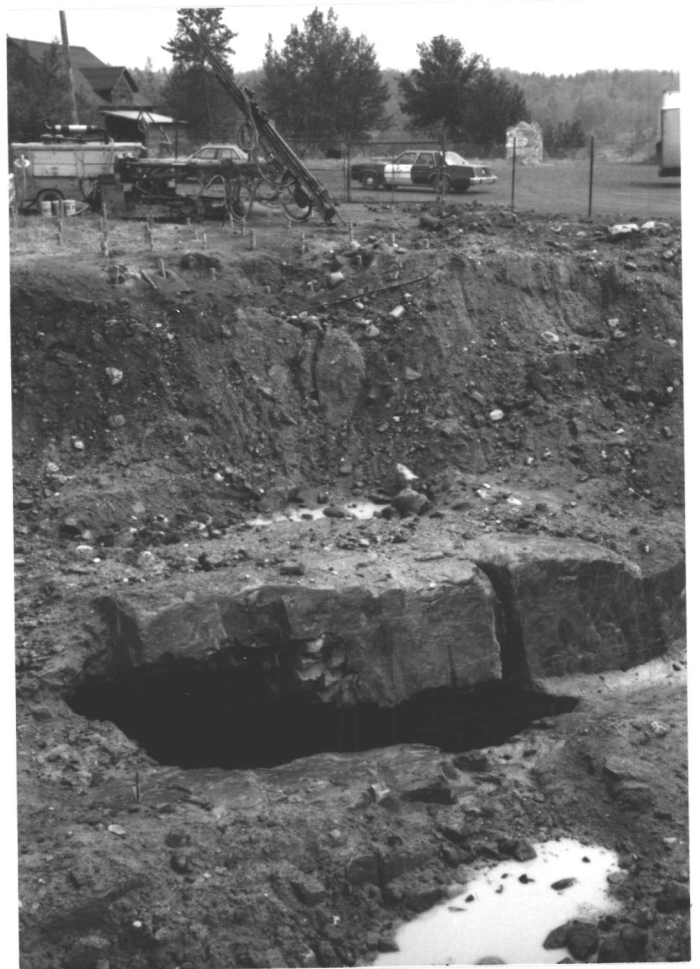
View east showing 3-5 ft thick rock cap over S-Stope Crown and air-track holes where stope continues off highway right of way.

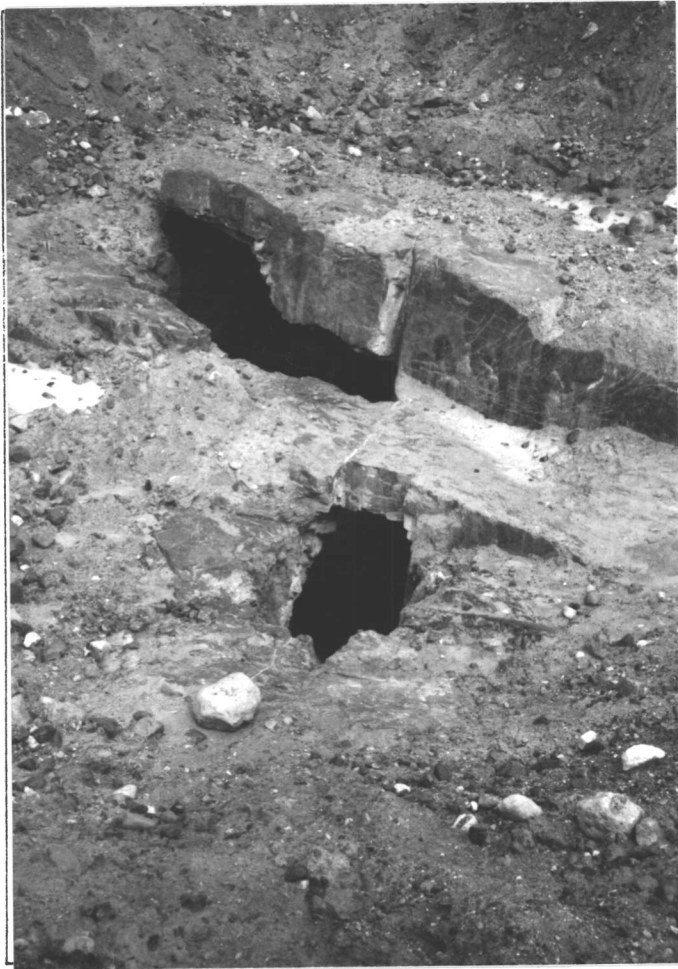
View north-east showing 1 ft.
thick rock cap on S-vein in
intersection area.

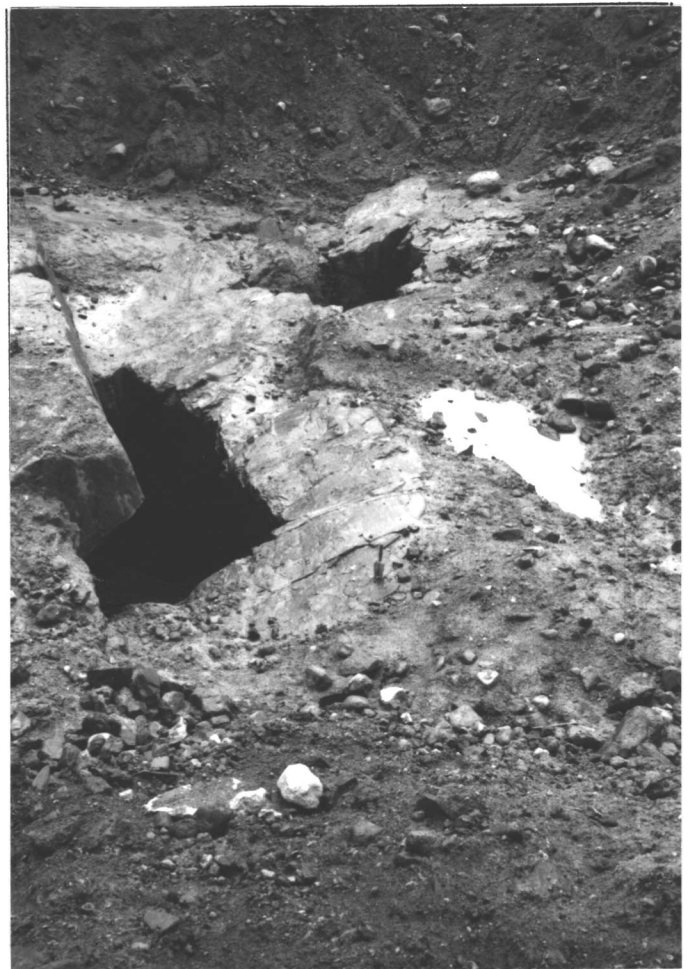
View south-east along strike of
P-vein stope showing both openings
into stope intersection.

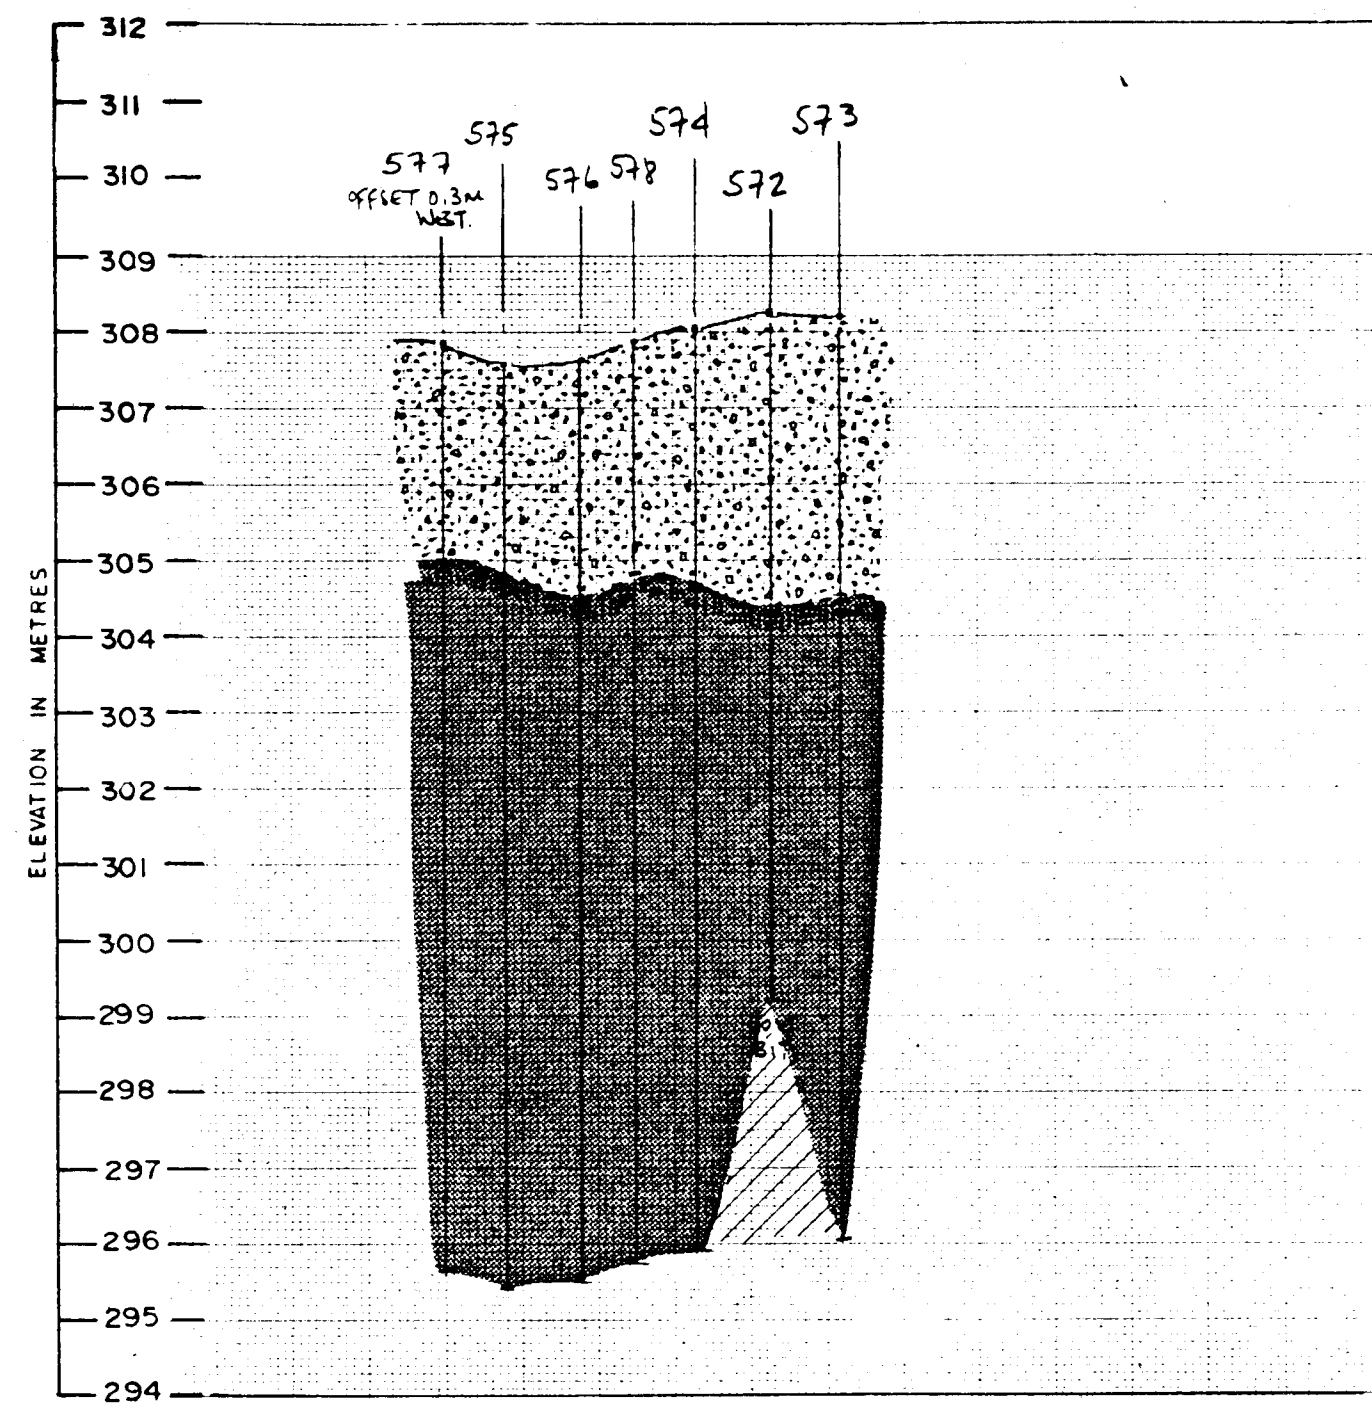
SECTION G-G
SECTION PERPENDICULAR TO HWY 11B, N.E. OF CAVE IN

Figures 9 to 12 present cross-sections drawn through the various boreholes to illustrate the geometry of the stope crowns and the overburden/bedrock conditions in the immediate vicinity of the "cave-in".

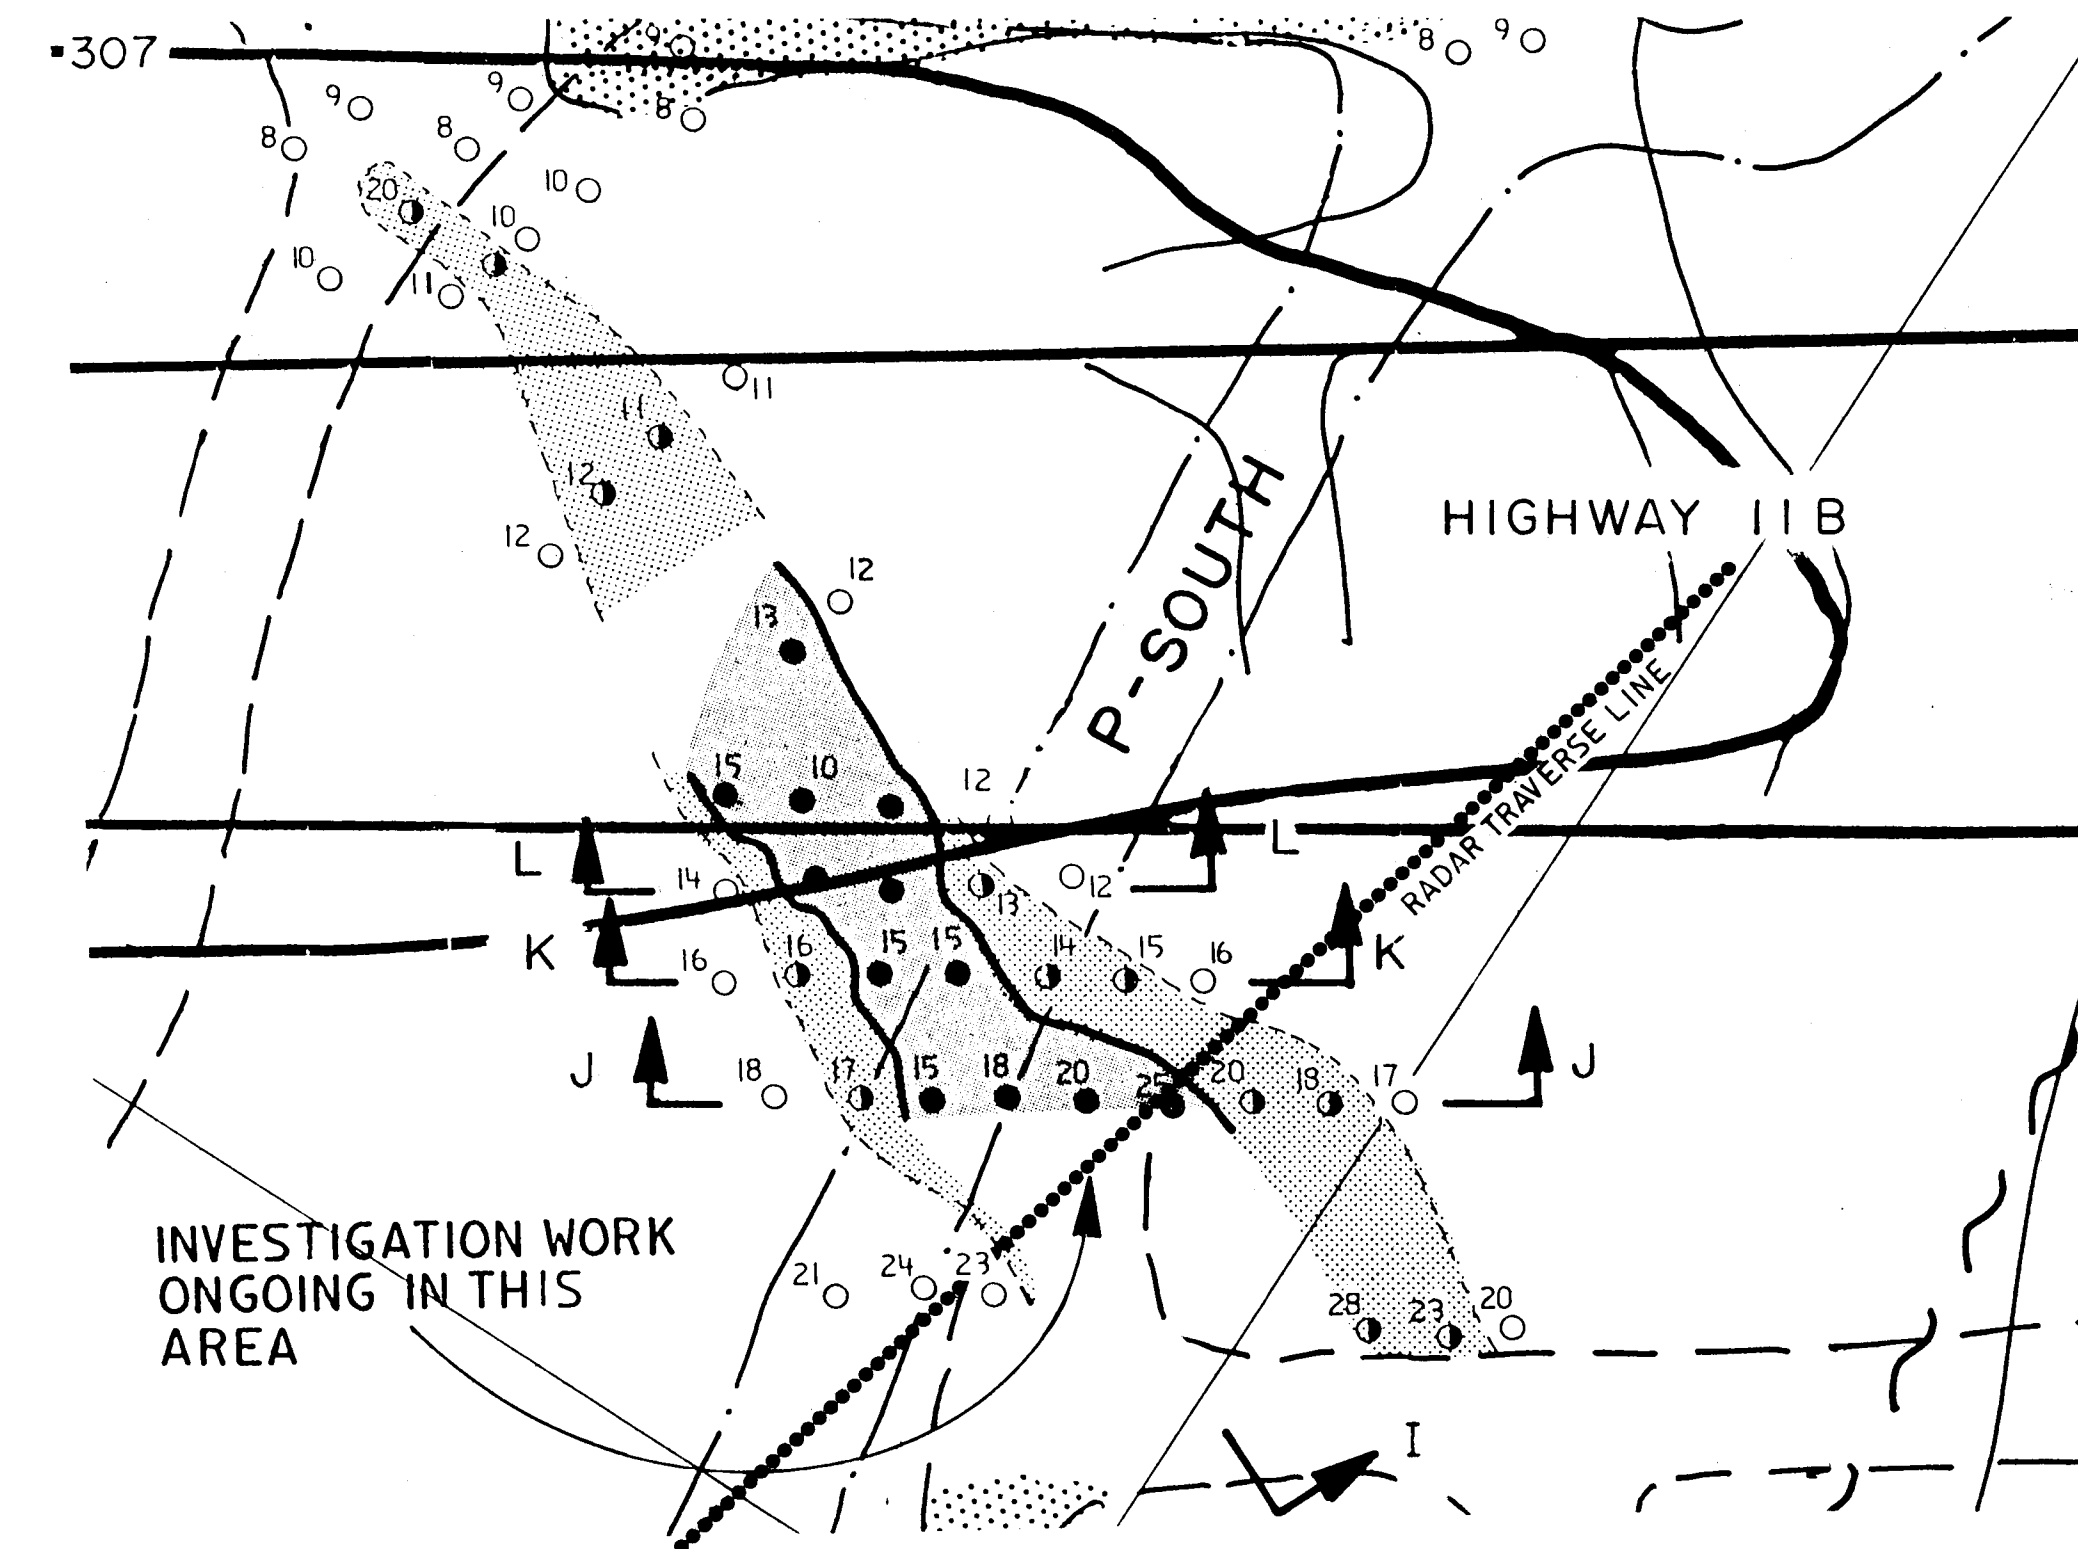
LINE 4S/23E to 30N/BL

Unfortunately, the utilization of geophysical techniques to target drilling is not without complications. Many of the anomalies that show up on the radar, for example, are difficult to interpret because of disturbed overburden ground conditions and overhead power lines; in many cases the anomalies do not represent underground workings; rather they reflect variations in the overburden or reflect random fill containing obstructions. In consequence, only by careful validation using drilling techniques is it possible to establish the precise cause for each of the geophysical anomalies. Figure 14, for instance, shows the locations of all significant radar anomalies and major zones of reflectivity, as currently being used for positioning the drilling. It should be noted that not all of the anomalies shown on this drawing are associated with underground workings. However, some clearly indicate subsurface workings, as for example that shown on Figure 15.

This drawing shows the type of response typical of that now known to reflect an uncharted stope. This stope also occurs under the highway and slightly to the northeast of the area of the original June 22nd "cave-in" (see Figure 8). It should be noted that it does not appear on any of the old mining records (Figure 4), and was therefore probably developed by the lessors in the 1930's. As indicated on Figures 11 and 12, (sections II, JJ, KK and LL) no rock crown pillar was found over much of the central section of the stope. Some timber was however found at the bedrock/overburden interface suggesting that mining had probably been taken right up to a frozen overburden interface and that over the intervening years only the timber supported the overburden.
