RE: INSTABILITY OF PIER EXCAVATION,
GHOST RIVER BRIDGE, WP 73-60

REPORT ON INSTABILITY OF PIER EXCAVATION
GHOST RIVER BRIDGE, MATHESON, ONTARIO.

DEPARTMENT OF HIGHWAYS, ONTARIO
TORONTO ONTARIO
EXCAVATION FOR WEST PIER
PROPOSED GHOST RIVER BRIDGE
MATHESON ONTARIO
SHOWING MOVEMENTS OF SHEETING

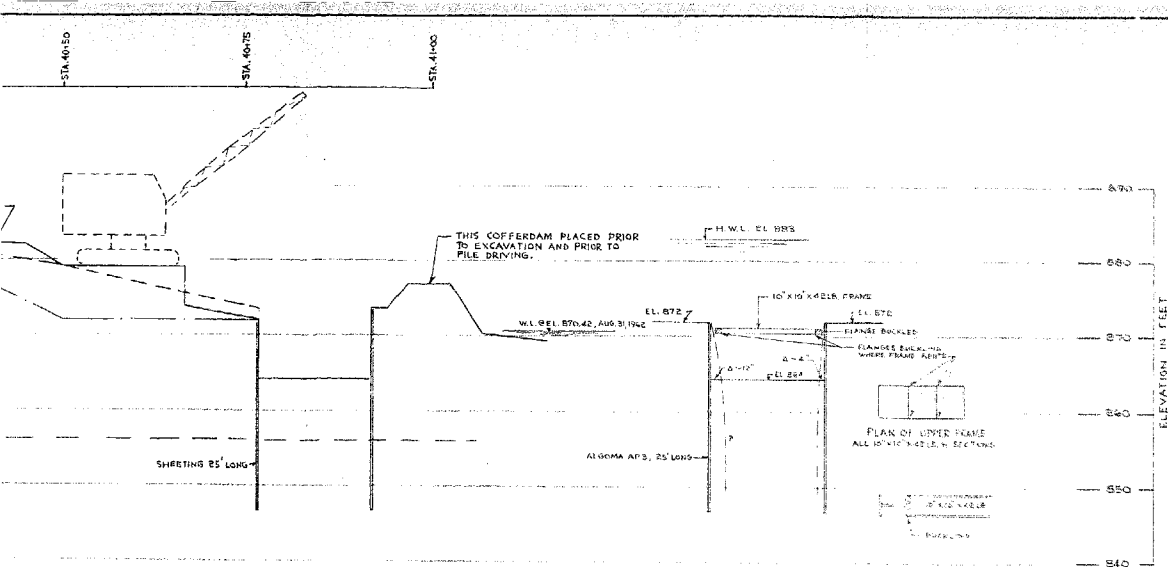
GOLDER & ASSOCIATES	
CONSULTING CIVIL ENGINEERS	
DATE: SEPT. 20, 1962 SCALE: 1" TO 10'-0"	
MADE J.A.	CHKD. APPD. FIGURE 1

Following the driving of sheet piling around the approximate perimeter of the proposed west pier, the placing of an upper strutting frame and excavation to about 8 feet depth, five H-section steel foundation piles were driven within the excavation along the west face adjacent to the sheeting. During driving and immediately after these piles were driven some inward deflection of the sheeting at the base of the excavation was apparently observed. This deflection was not measured as the excavation was then flooded by a rapid rise of Ghost River. Upon pumping out the excavation several days later the sheet piling was observed to be deformed quite markedly, the foundation piles had also moved and two had been twisted from their original alignment and the base of the excavation was 'boiling' in several locations. The sequence of events as compiled from records at the site by Mr. R. Marin, D.H.O. is given in Appendix I. Significant details of the excavation, the site conditions and the measured deformation of the piles is shown on Figures 1 and 2. The maximum displacement of the sheet piles was along the west face of the excavation and was approximately 12 inches. Part of the waler flange at the west face of the sheeting was buckled; a photograph of this is shown on Figure 4.

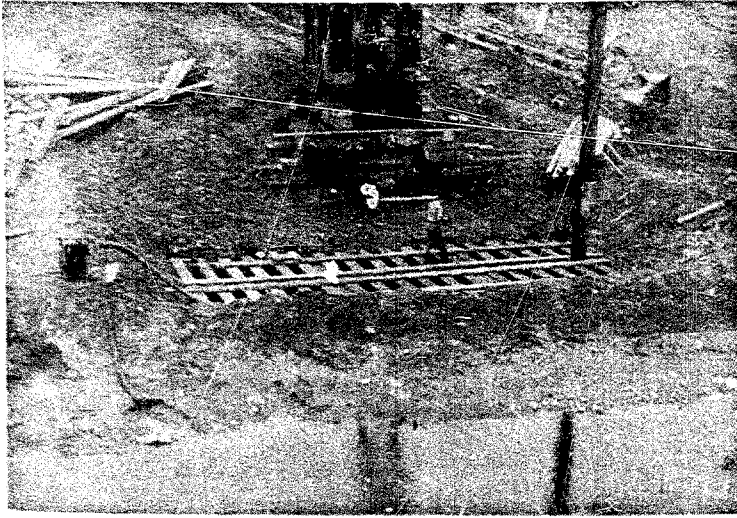
General view of excavation, looking west

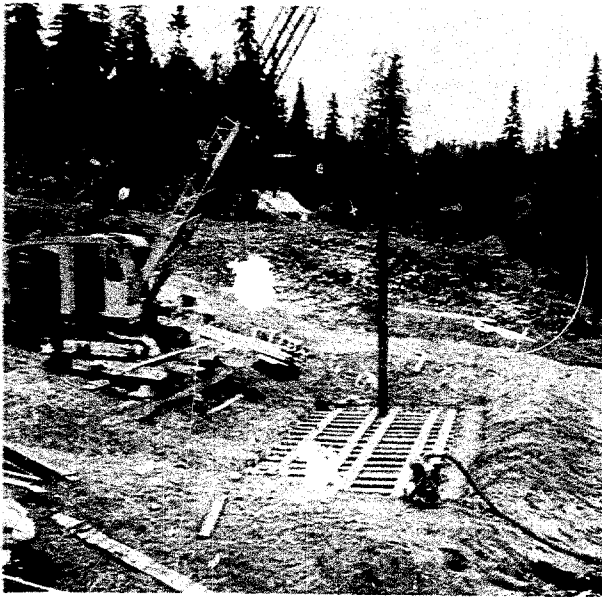
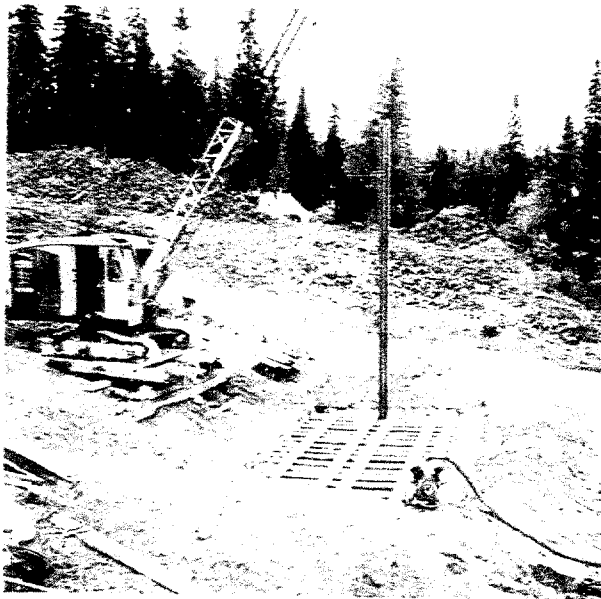
View of excavation, looking north

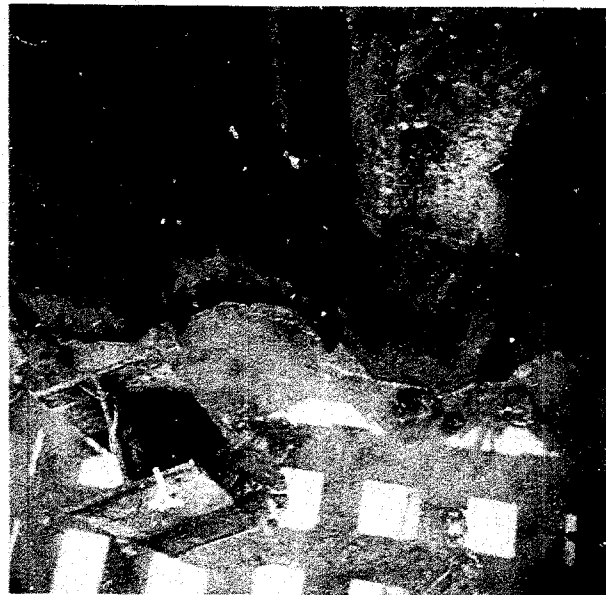
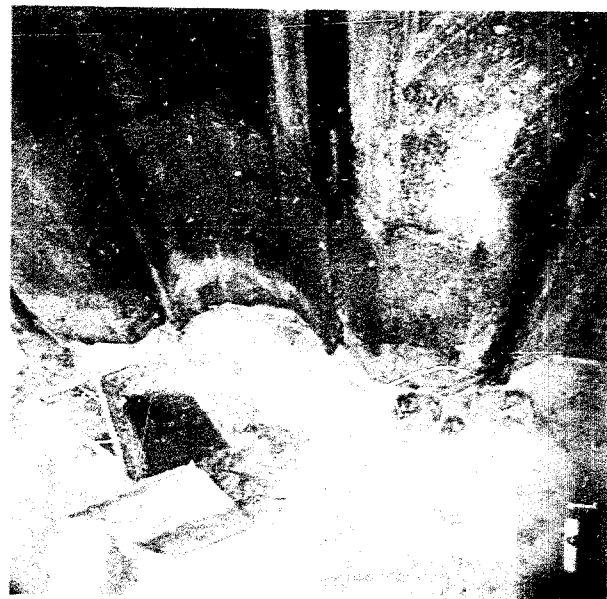
- 23 Sheet Piles at Pier No. 1 are coming in at bottom of excavation after H-Piles were driven in. This matter was referred to Mr. Ford, Mr. Keyes and Mr. Aitken.

**Portion of H pile No. 3
in relation to sheeting, west face**

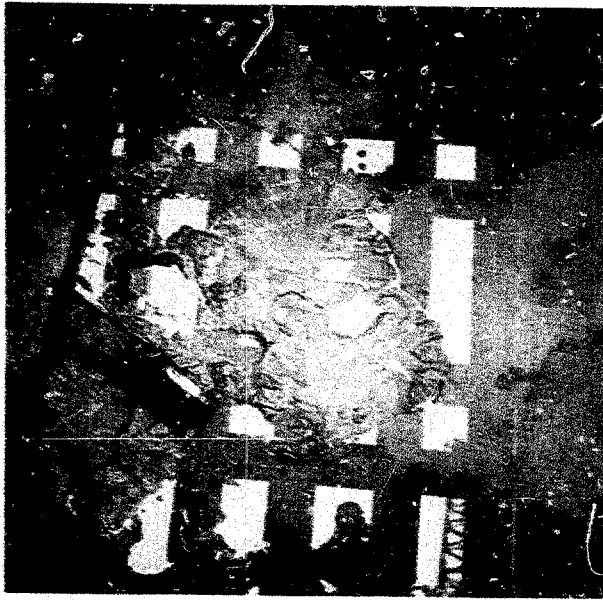
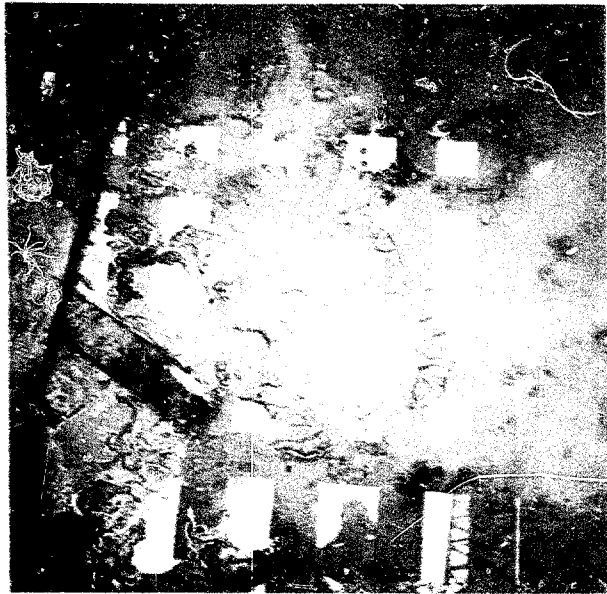
of P cannot explain the movement of the sheeting unless we assume that the average shear strength around a failure surface is reduced to 200 pounds per square foot. This is probably too severe an assumption and would imply a large degree of remoulding caused by pile driving both inside and outside the excavation. Further, the marked evidence of 'boiling' inside the excavation indicates anything but an undrained condition.

- iii) The observed deformation of the sheet piling and the boiling of the base of the excavation could be explained by considering that the passive earth pressure retaining the toe of the sheeting would be reduced markedly by the remoulding of the clay, silt strata inside the excavation in the driving of foundation piles and/or by excess hydrostatic pressures acting on the base of the excavation. These excess hydrostatic pressures could result partly from the pile driving or from another source.

Boiling at base of excavation

- 4) The general site should be drained of surface water to a sump dug to the north of the pier excavation.
- 5) At least three wells, 9 inch in diameter should be put down into the lower sand, gravel stratum some 5 feet to the west of the pier excavation. The spacing between wells would be about 8 feet on each side of the bridge centre-line. The wells are to be put down in cased holes filled with water and slowly filled as the casing is withdrawn with concrete sand to within 4 to 5 feet of the top where they should be filled with fine gravel. It is

- 6) Similar wells to (5) above should be put down within the excavation as far as is practicable. (There is some precedent in the use of relief wells to relieve water pressure at the base of excavations. See Ward, 1957). It is hoped that wells within the excavation would also serve to dissipate possible excess pore water pressures set up by pile driving. Excess water within the excavation is to be removed by pumping SLOWLY from a gravel filled sump within the sand and gravel case.
- 7) The pile driving equipment should be moved from the west edge of the pier excavation to the north edge.

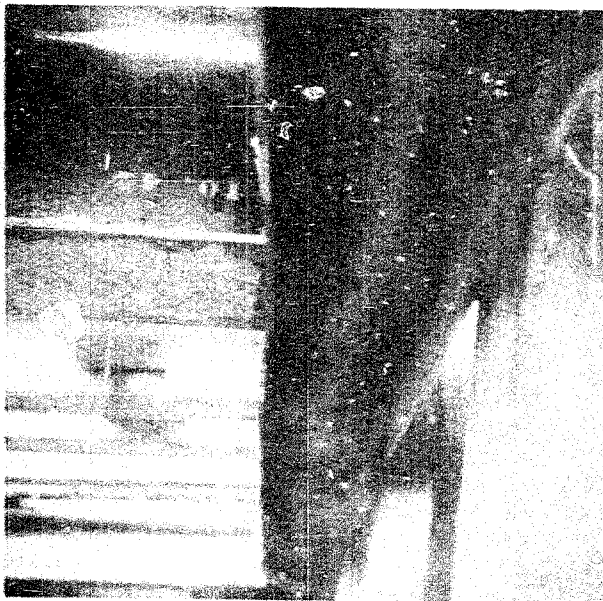
Buckling of flange, top strutting
west face of excavation

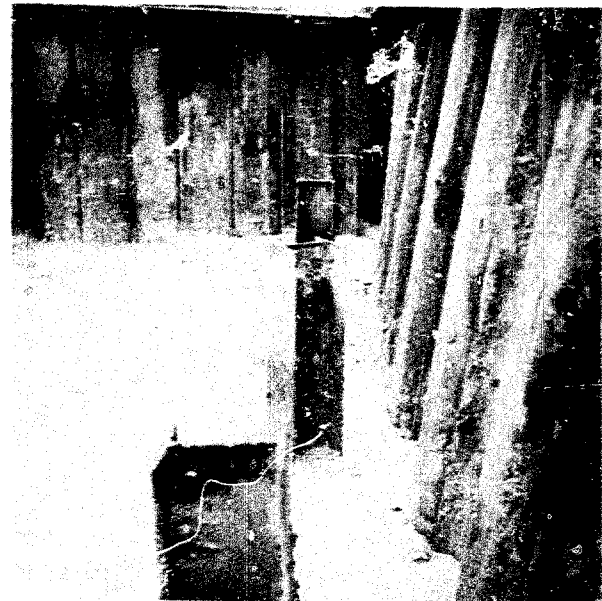
West face of excavation
sheet piles looking south

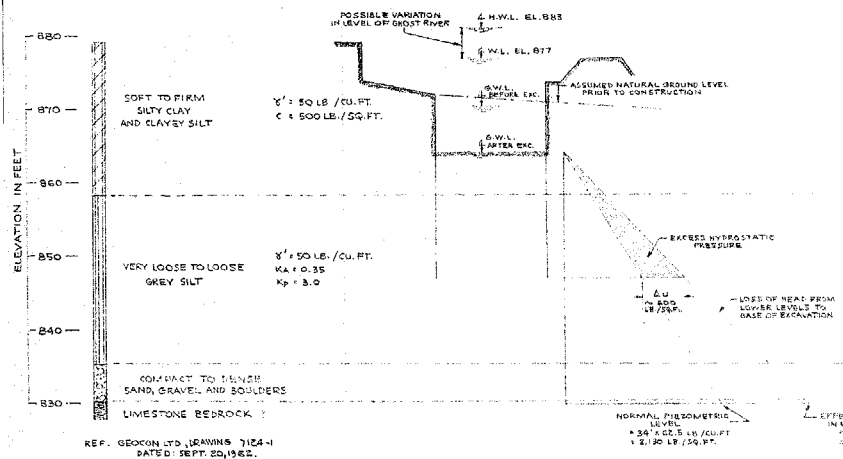
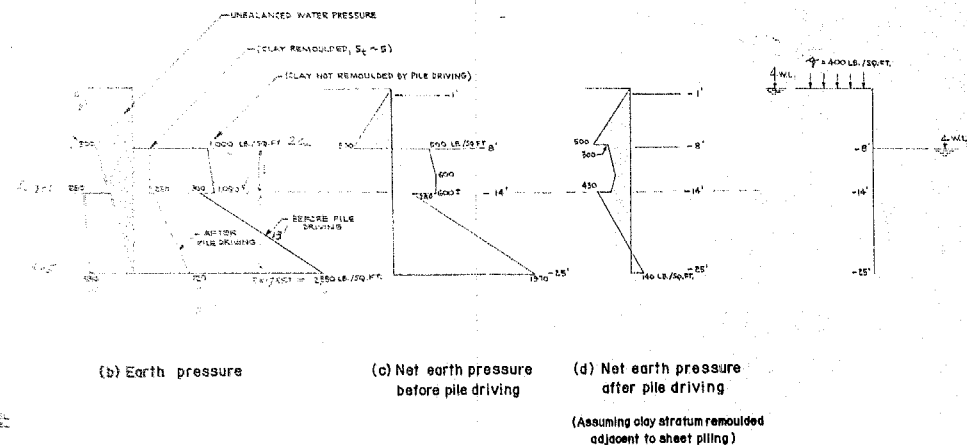
In Figure 5, the effect of a hydraulic gradient at the tips of the sheet piling between 0.5 and 0.6 (equivalent to a piezometric level of 883 at depth) is examined in detail. The passive resistance of the silt stratum is reduced to a negligible amount and if the clay stratum within the excavation is remoulded by the driving of foundation piles then the factor of safety of the sheeting against rotation about the top strutting is reduced to well below unity. The question of whether the clay stratum would be remoulded by pile driving or not is debatable; however the varved clay is quite sensitive (Liquidity index, $L_I \geq 1$ for the silty layers), the bulk sensitivity, S_t , of the stratum has been measured at from 2 to 5 and the sensitivity of individual layers could well be much greater than 5. Further, field evidence has shown that in similar sensitive clay soils (S_t from 2 to 5), the remoulding caused by driving foundation piles within a sheeted excavation has reduced the shearing strength of clay restrained at the base of the excavation by 85 percent of its initial value. (Skempton, Ward, 1952). Consequently the net earth pressure diagram sketched on Figure 5(d) can explain the extreme deformation of the sheeting.

If the varved clay at the site is impermeable, then the gradient sketched on Figure 5(a) through the silt stratum would be steeper. Where the water pressure in the silt is high then the base of the excavation could fail by heaving. This mode of failure is examined in Figure 6. It may be seen that, for a
