# FOUNDATION INVESTIGATION REPORT

Mattawasaga River Bridge  
Hwy. 101, District 14, New Liskeard  
W.P. 68-70-2201

FOUNDATION INVESTIGATION REPORT  
For  
Mattawasaga River Structure  
Highway #101  
District No. 14 (New Liskeard)  
W.O. 70-11072 -- W.P. 68-70-01

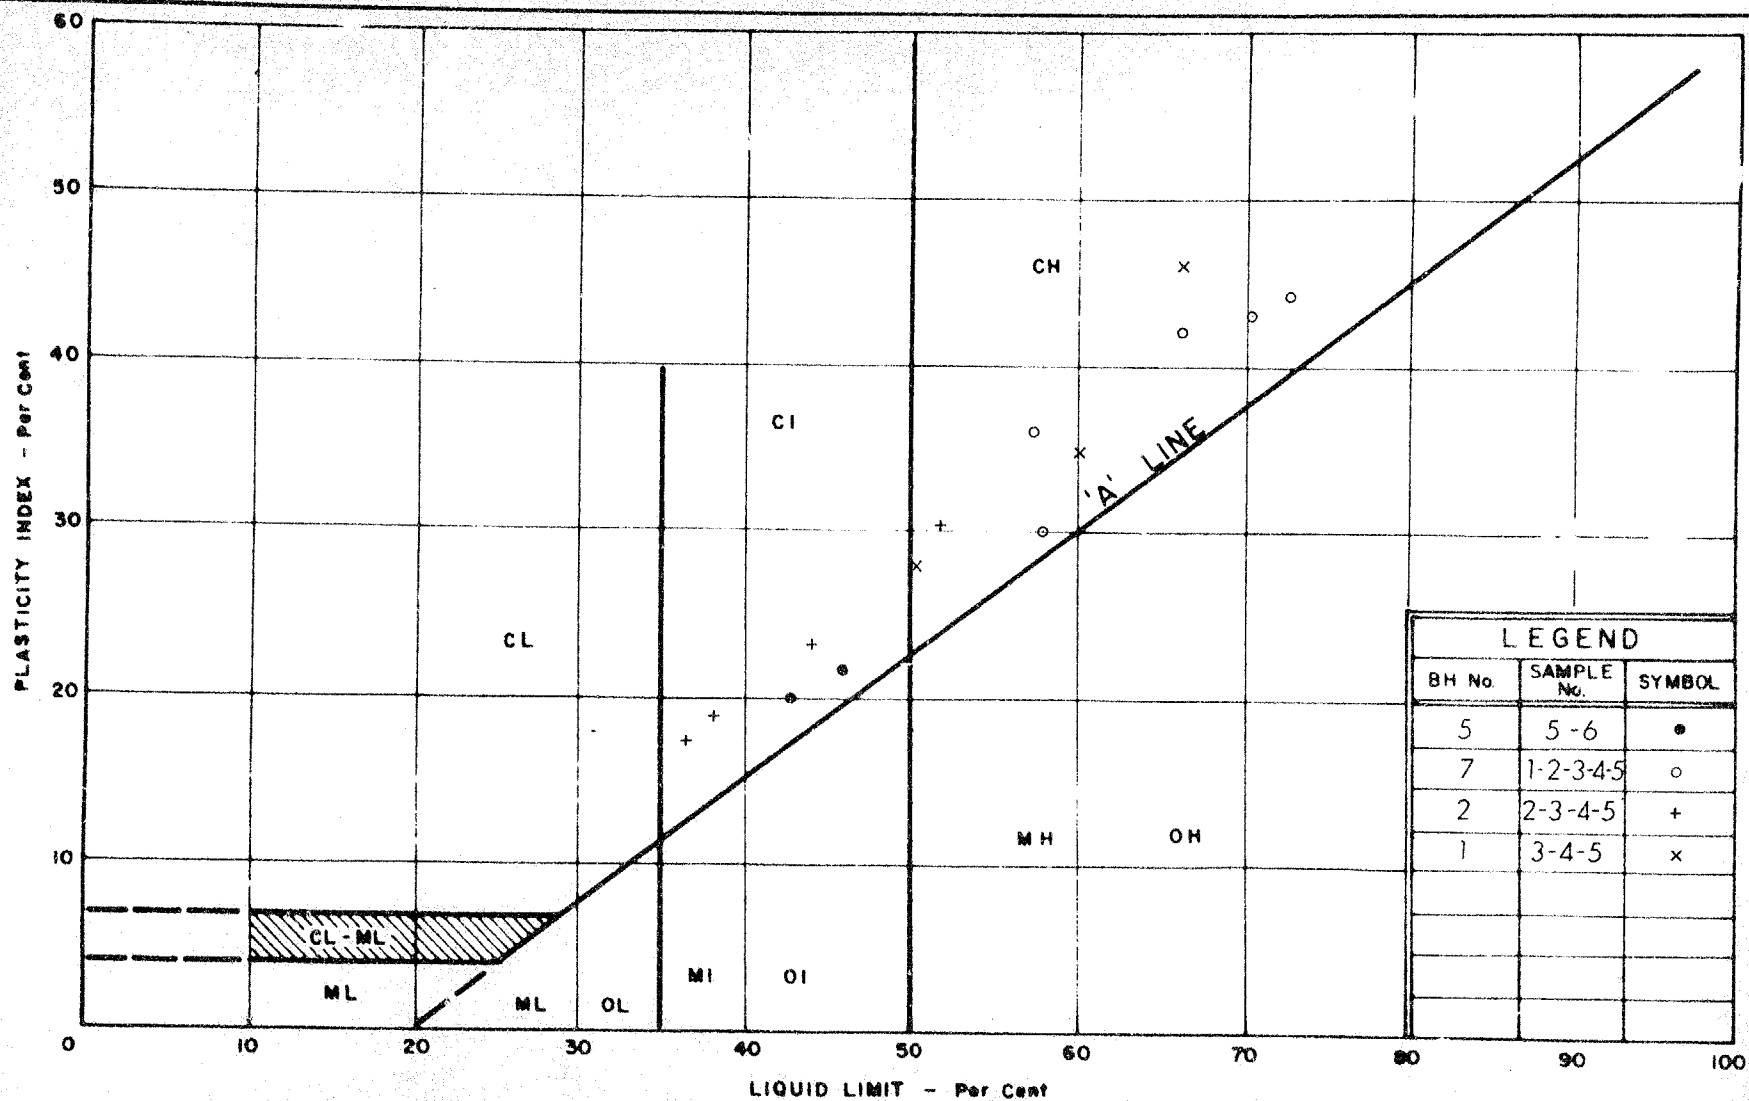
FIG. 4

Traces of organic material were found in the portion of the deposit lying in borehole #5; here the organic content varied from 1.2% to 3.8%. A plot of Plasticity against Liquid Limit is shown in Fig. #4 in the Appendix.

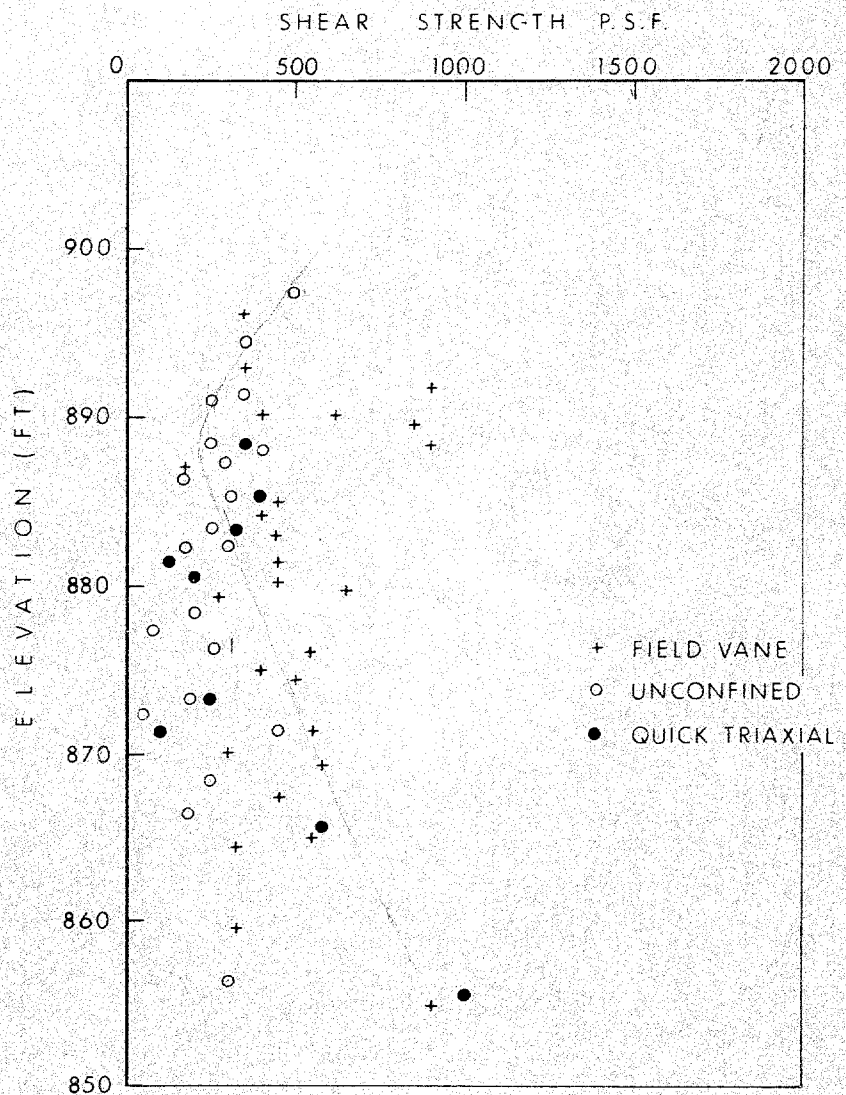
FIG. 6

A general plot of shear strength against depth for the subsoil is shown in Fig. #6.

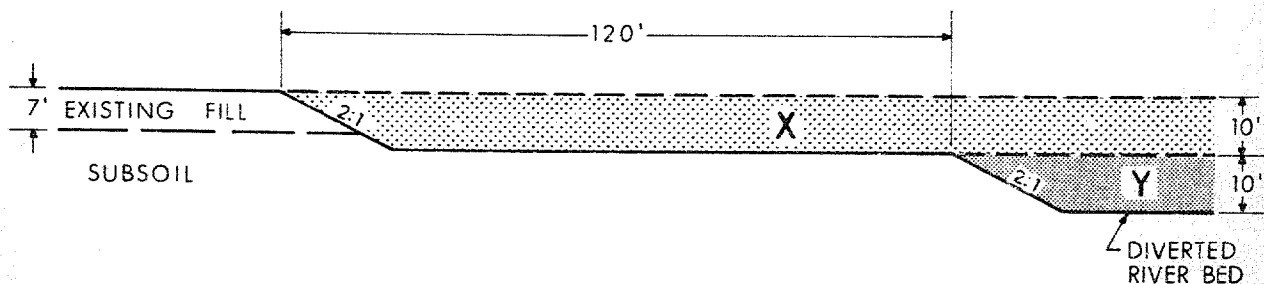
FIG. 7A - PERMANENT BENCHING REQUIRED FOR STRUCTURE

Stability analyses in terms of total stresses, were carried out for the forward slopes. A design strength of 300 p.s.f. and a density of 105 p.c.f. were assumed for the subsoil. It was found that mid-height benches of length 100 feet would be required to give the necessary minimum factor of safety; this arrangement is shown in Fig. #7A.

consideration to constructing a bridge with forward slopes as shown on Fig. #7A of the foundation report. The sequence of construction should be as follows:

Due to the fact that a somewhat lower grade would be possible at the site of the existing structure shorter berms than are shown on Fig. 7A would be required. The exact length of berm required may be interpolated from the graph on Page 3. It should be noted that the height H is the difference between elevation of stream bed and the elevation of the road  $\phi$  just behind the bridge abutment.
