#67-F-29

Hwy. #73

PORT BRUCE

SLOPE FAILURE

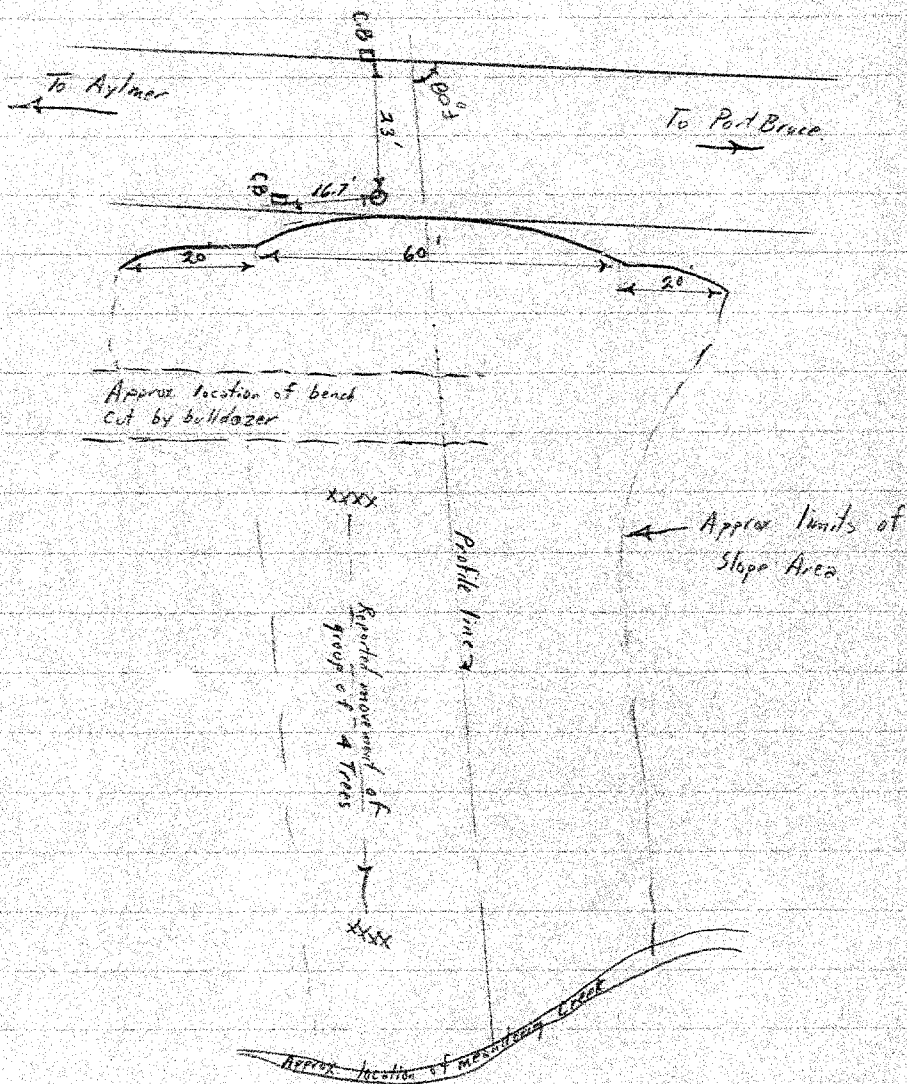
Sketch of Plan of Failure Area

The failure site was visited on April 7 in the afternoon and appeared as indicated on the enclosed sketch. It was not possible to walk on most of the slide area due to the softness of the material.

It would appear that the natural slope of about  $1\frac{1}{2}$ :2 to 1 is subjected to progressive superficial creep (as indicated by the typical displaced and curved shape of the trees adjacent to the failure). The ground surface immediately south of the failure zone was very soft and spongy and appeared to be saturated and on the verge of failure.

From the general topography it seems possible that the failure has occurred down an old tributary valley of the main creek valley. The initial failure which caused concern may have been superficial in nature similar to the movement indicated south of the

slide combined with some local failure of the embankment itself (a loose sand fill)

Subsequent attempts at remedial measures may have aggravated the slope stability by trimming the upper slope as well as piling debris on the lower slope. In any case, the material slide seems to involve both original ground and the fill in the "presupposed valley".
