HWY. No. 2LOCATION Failure of Embankment4 km W of WardsvilleNo of PAGES - 1

**Re: Inspection of Highway 2 Embankment  
4 km West of Wardsville  
Highway 2, District 32, Chatham**

Re: Restoration of Embankment (Stn. 14 + 567 to Stn. 14 + 625)  
W.P. 300-92-00, Highway 2, District 32, Chatham

Re: Failure of Embankment (Stn. 14+563 to Stn. 14+635)  
4 km West of Wardsville  
W.P. 300-92-00  
Highway 2, District 2, London  
Geocres No: 40I12-24

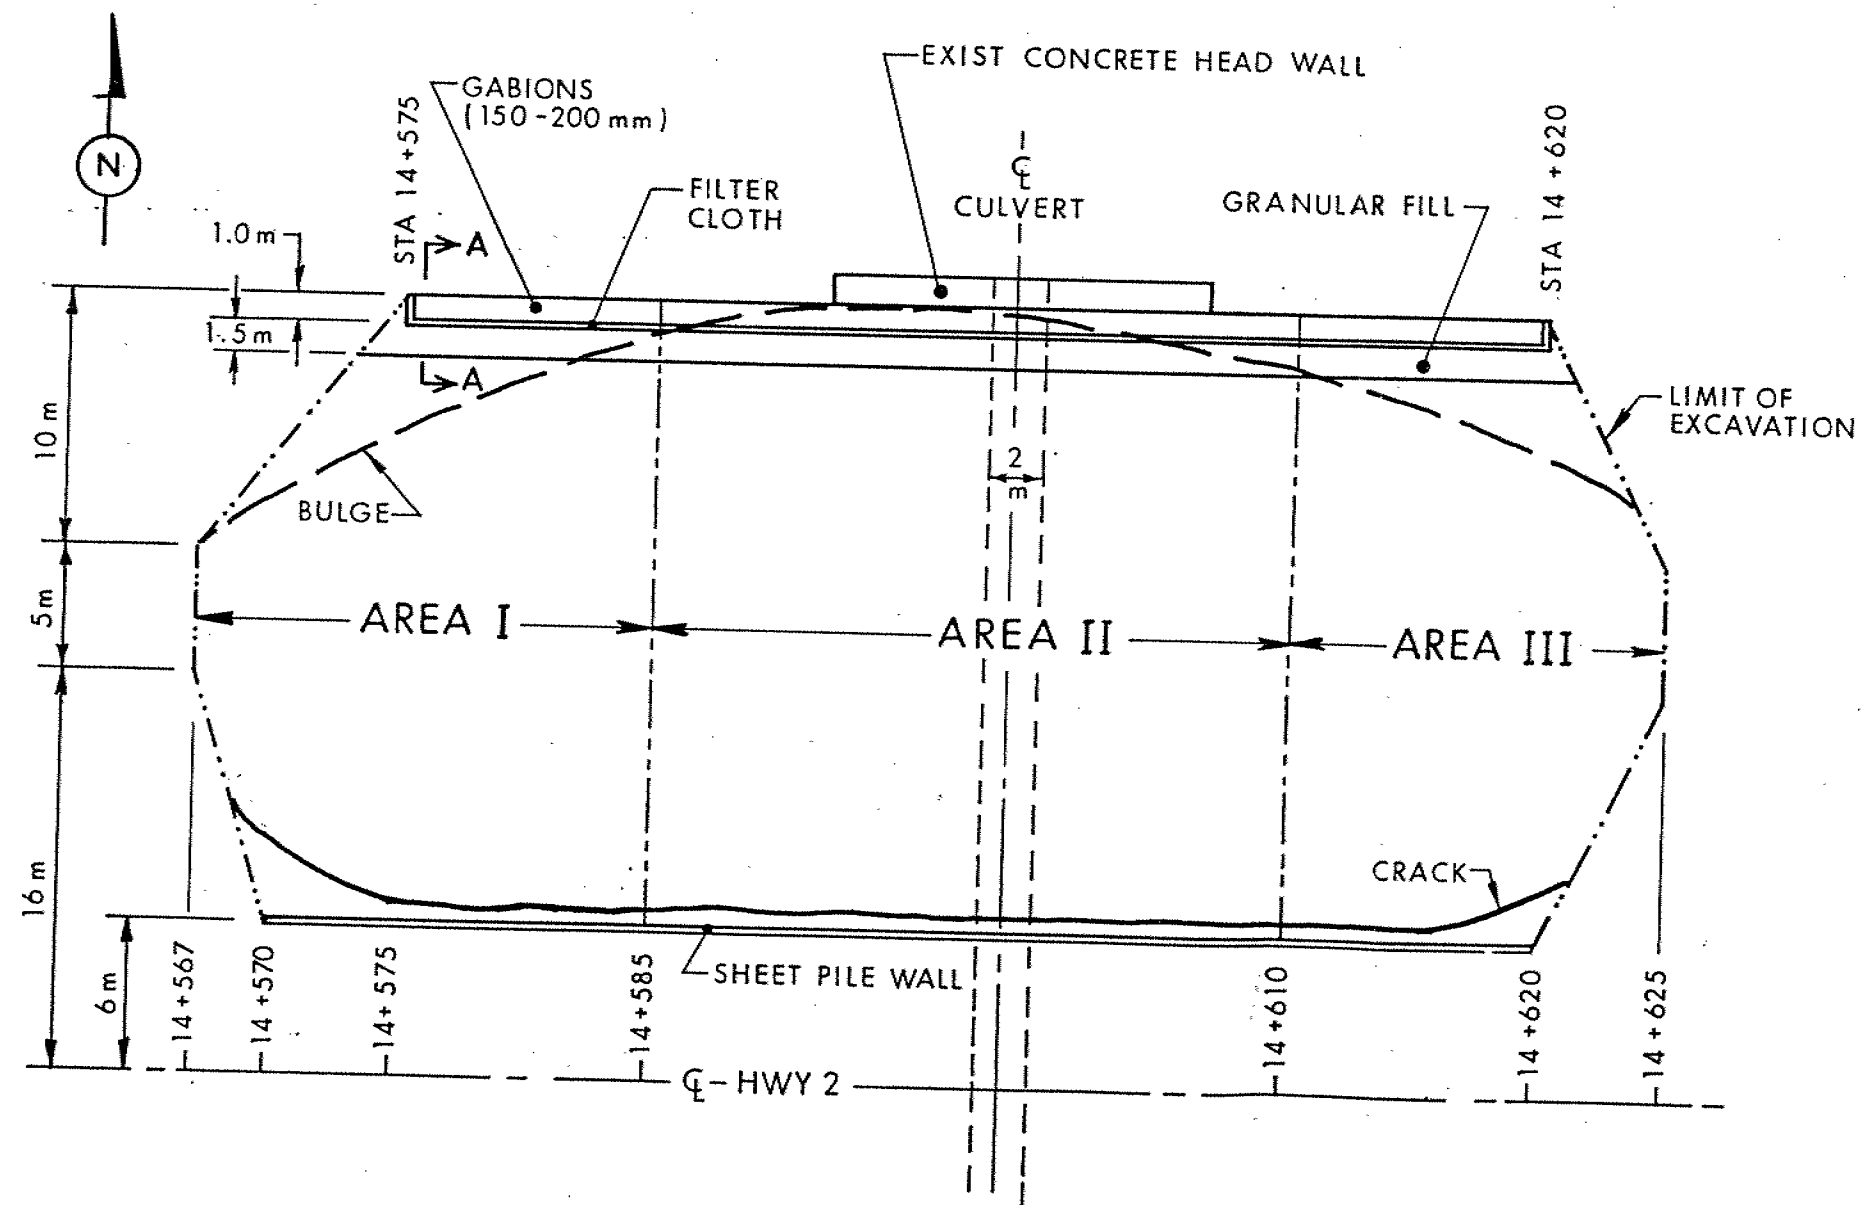
FIGURE No 1

Subsequent to the meeting we had on March 30, 1995, Engineering Services, District 32, Chatham made arrangements for excavation of trenches and flooding of auger holes with dye. Trenches were excavated at three locations (Stns. 14 + 582, 14 + 598.5 & 14 + 616) on June 1, 1995 to locate the failure surface. The elevations of the slip surface were established by taking spot level within the trenches. Based on this information, the cross-sections showing the slip surface were prepared by Dennis Kay, Engineering Services, District 32.

The area of subexcavation as well as details such as location of gabion and sheet pile wall are shown on Figure 1. Benching arrangements are shown on Figures 2, 3 & 4.

- 1) Drive the sheet pile to El. 203 from Stn. 14 + 570 to Stn. 14 + 620
- 2) Provide benching as shown on Sections 14 + 582 for Area I, 14 + 598.5 for Area II and 14 + 615 for Area III
- 3) Remove any spongy or soft areas observed below the bench level specified and backfill with acceptable fill material.
- 4) Place the gabion and filter cloth as shown on Figures 1, 2, 3 & 4.
- 5) Place the fill in layers and compact.

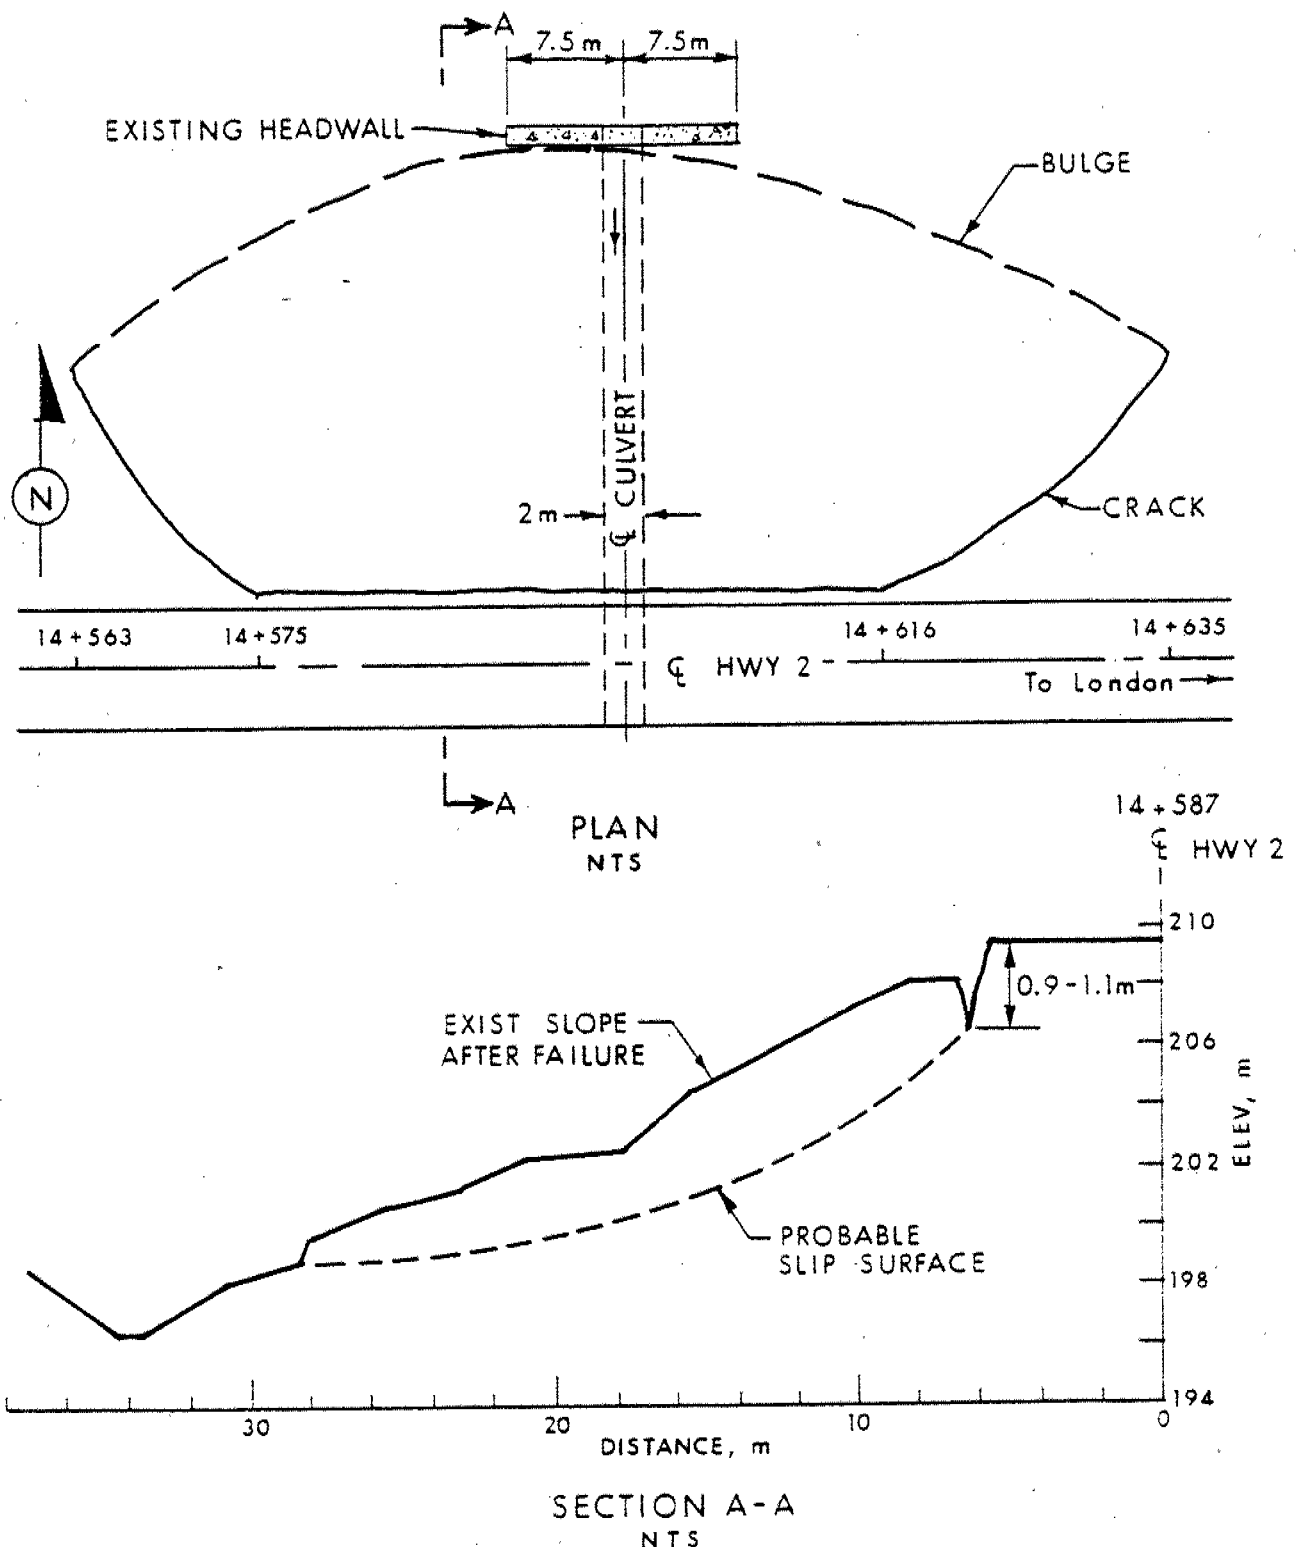
**Fig 1 - EMBANKMENT INSTABILITY**  
(BETWEEN STA 14+563 & 14+635 HWY 2 )

The failure at this location is not recent and this site has a history of repeated failures. Restoration work by providing counterfort drains was carried out in summer of 1993 after the failure in May 1991. The recent slide (May 1994) may have taken place along the same slip surface along where previous failures occurred.

The surface crack adjacent to the guard rail extends to a distance of about 41 m, however, the failed area gradually spread to a distance of about 72 m near the middle of the embankment and narrows down to about 4.5 m at the toe. Surface cracks varying in width from a few millimetres to a maximum of 600 mm were observed. The failed portion is displaced by approximately 0.9 m to 1.1 m vertically and 0.3 m to 0.6 m horizontally. However, near the toe of the embankment, bulge of soil varying in thickness from a few millimetres to a maximum of about 300 mm was observed. The details of the failure are shown on Figure 1.

Based on the information gathered, it appears that the failure is confined to the fill itself and centred around the culvert location. The probable failure surface is shown on Figure 1 and it is expected to extends to a depth of 2.5 m to 3.0 m below the existing slope at the deepest location.

In order to stabilize the slope, it is recommended to subexcavate and backfill as suggested below. The subexcavation should extend below the slip surface and the benching for the restoration work shall be carried out in accordance with OPSD 208.01.
