DEPARTMENT OF HIGHWAYS ONTARIO

GEOCRES No 40 I12-25

Tecumseh Park Bank Slippage near Hwy. #2 -
Approximately 2.0 Miles East of Thamesville
District #1 (Chatham)

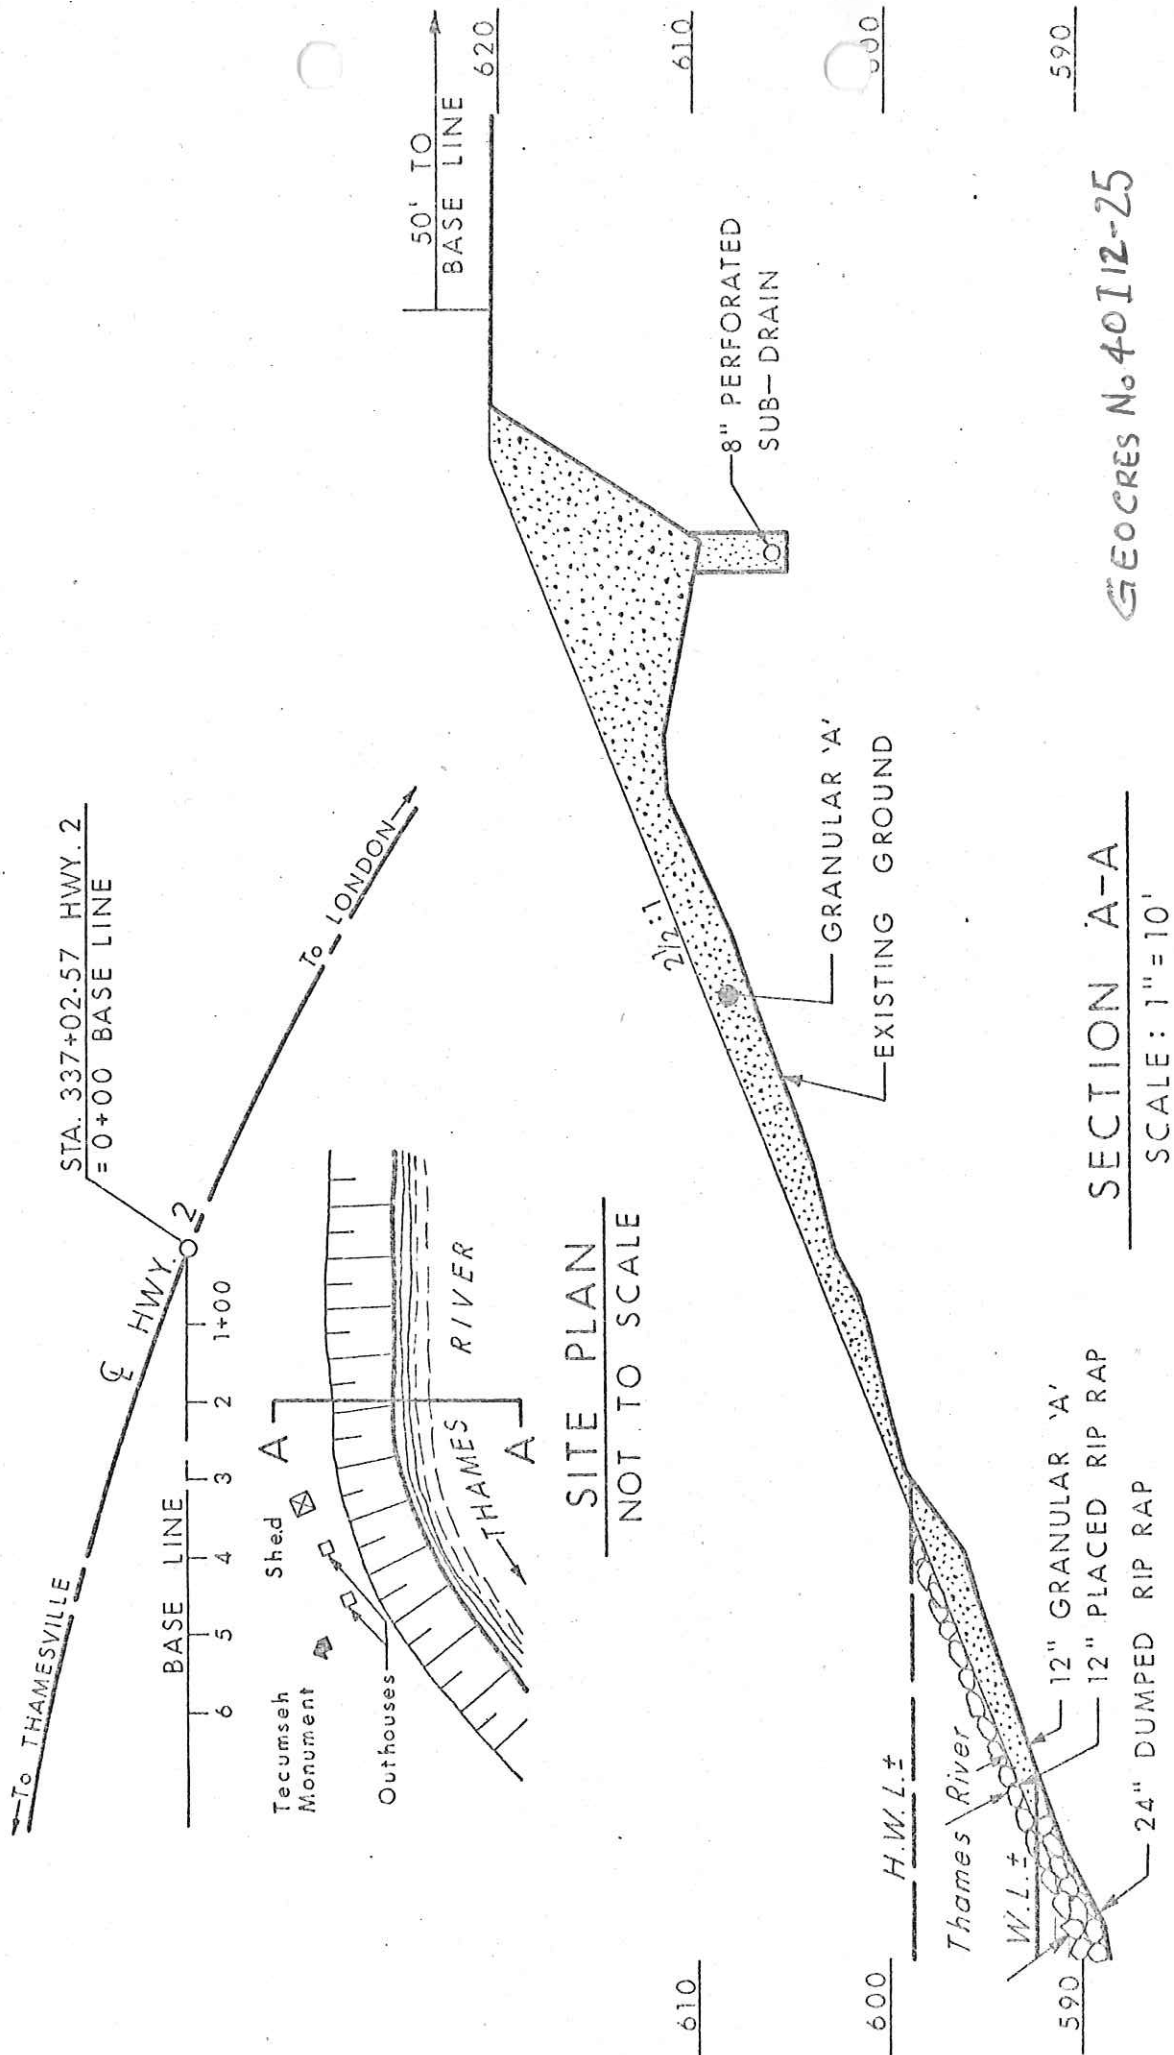
SUGGESTED REMEDIAL MEASURES
 TECUMSEH PARK BANK SLIPPAGE-THAMES RIVER
 HWY. 2 APPROX. 2 MILES EAST OF THAMESVILLE

The subsoil in the river banks mainly consists of a deposit of silty fine sand to silt. Numerous spring water systems can be observed on the side slopes of the banks within the upper 15 feet. At many locations a considerable amount of water was emerging from these springs. This has resulted in appreciable amounts of fine-grained soil particles being washed out and accumulating at the toe of the river banks. Due to the action of seepage forces through the slopes, erosion by surface water run-off, and frost-thaw cycles in fine-grained granular materials, progressive failures of the river banks have taken place during the past several years. In order to prevent such progressive failures, blanketing side slopes of the river banks with suitable granular material will be necessary. In addition, an adequate drainage system with perforated sub-drains is essential to collect all seepage from the springs within the river banks. If these measures are not carried out, further slippage of river banks can be anticipated. The remedial measures, in general, were discussed with Mr. W. Katarynczuk at the site, and it was agreed to confirm this in a memo after the cross-sections of the slippage area were submitted to the Foundation Section by the District.

i) All the loosened material in the affected area on the river banks should be removed.

ii) Random rip-rap of at least 24 inches in thickness should be dumped at the toe of the river bank up to N.W.L. (Normal water level).

iii) Positive drainage measures should be adopted to relieve pore pressure buildup due to the spring water system in the upper 10 to 15 ft. of the river bank material. This can be achieved by means of an 8" ϕ perforated sub-drain, as shown on the enclosed drawing. The sub-drain should have a minimum cover of at least 4 ft. for frost protection. It is essential to provide outlets for the sub-drain and these outlet pipes must be prevented from freezing.

iv) A granular blanket, consisting of a free-draining material, such as Granular 'A', should be placed on the slope, as shown on the enclosed drawing. The blanket should have a minimum thickness of at least 12 inches.

v) Place additional rip-rap on top of the granular blanket above the normal water level and up to high water level of the river.
