FOOTING EXCAVATION INSTABILITY

Re: Nineteen Mile Creek Crossing, Hwy. #3,  
Contract No. ~~4-59-13~~ -- District #2.

FOUNDATION REPORT --

Hwy. No. 3 and Nineteen Creek Crossing  
- Structure Widening -  
3.5 Miles E. of St. Thomas, Lot 19, Con. IX,  
Twp. of Yarmouth.

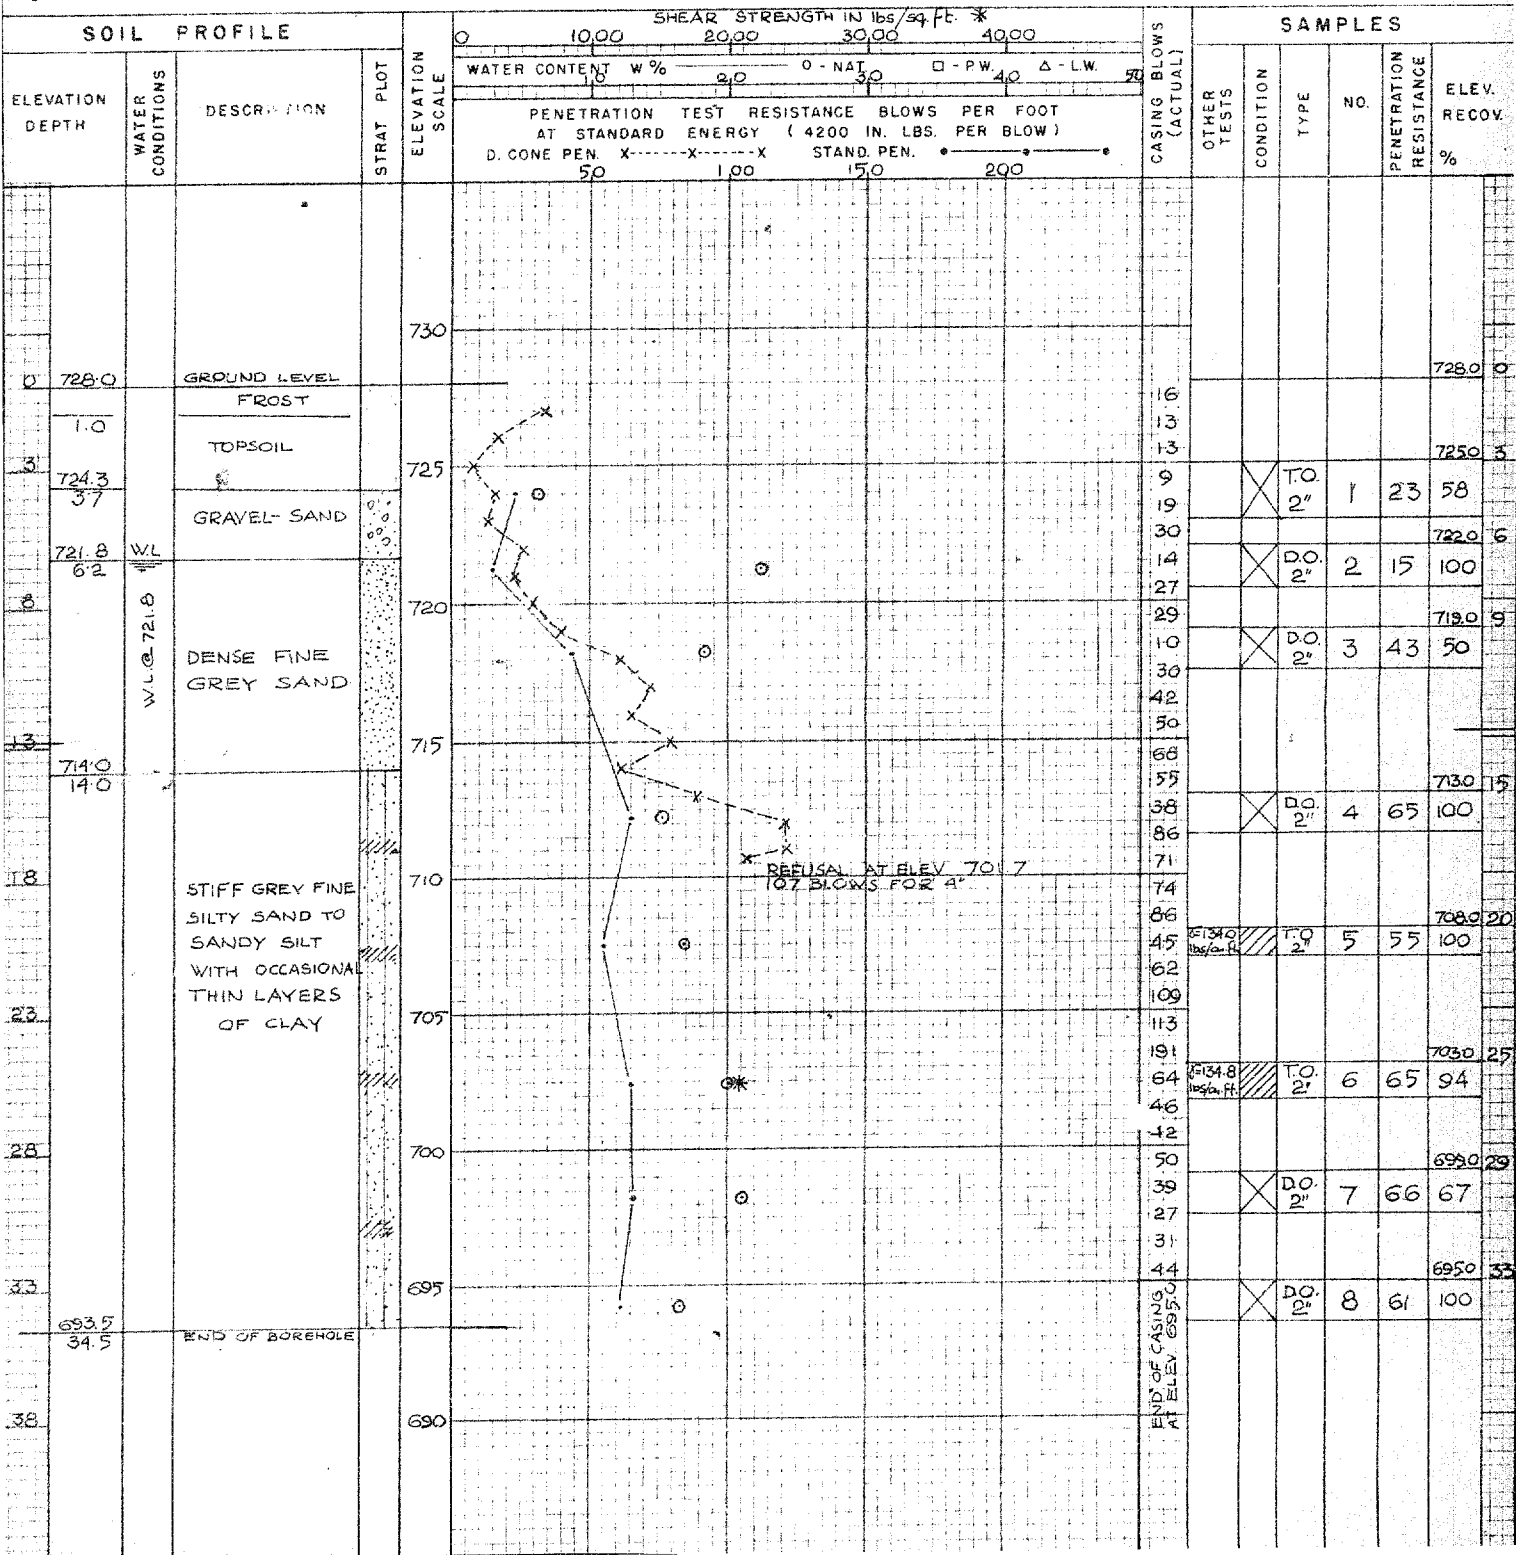
BORING 1 STA. 155+86.53' LEFT  
 DATE REPORT MARCH 1959  
 DATE BORING 3 MARCH 1959

On the south side of the existing Hwy. No. 3 in Borings No. 1 & 2, the alluvial topsoil was found to be underlain by a layer of dense gravel-sand and fine grey sand extending from Elevations 724 to 714 in Boring 1 and Elevations 721 to 713 in Boring 2. In Boring 1, underneath the dense sand layer, the stratum of dense grey silty sand and sandy silt interbedded with occasional thin layers of clay, was encountered at Elevation 714'. This stratum of dense silty sand and sandy silt in Boring 1 was explored to a depth of 35' below the ground surface (i.e., - Elev. 694'.) In Boring 2, however, the dense sand layer was found to be underlain by a stratum of stiff grey clay silt and silty clay at Elev. 713'. It was explored to a depth of 27' below the ground surface (i.e. - Elev. 670'.)

Laboratory shear strength tests show an average of 2800 p.s.f. to be representative for the cohesive portion of the strata. Field penetration test results show an "N" value of 40 to be a minimum for the entire formation. This formation was encountered below the dense sand layer at approximately Elev. 713 in Borings 1 & 2 only, and was not encountered in Borings 3 & 4.

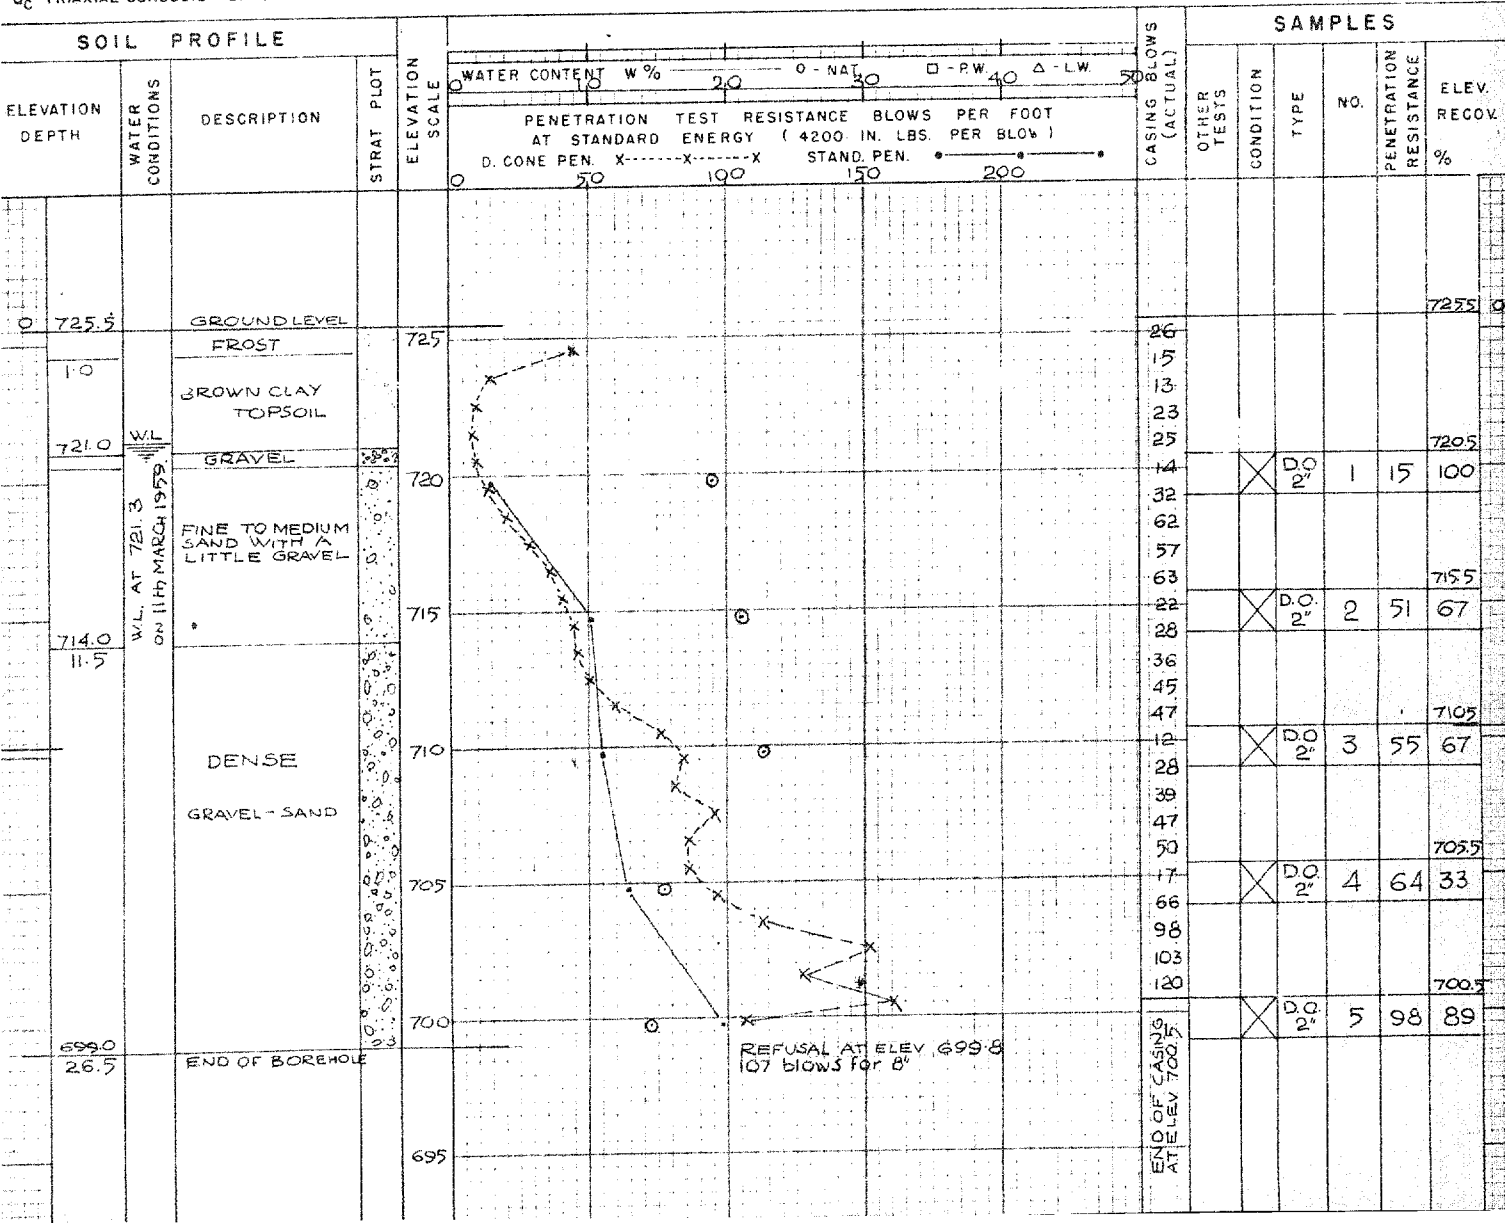
DRILL RIG CORE DRILL: 54-5 OPERATION BORE & PENET'N JOB F-59-18 WP 100-55 BORING 4 STA. 156+04 71' BT.  
CASING BX (standard samplers to fit unless noted) DATUM GEODETIC DATE REPORT MARCH 1959  
SAMPLER HAMMER WT. 140 LBS. DROP 30 INCHES COMPILED BY B.M. CHECKED BY DATE BORING 10th MARCH 1959

On the north side of the existing Hwy. No. 3 in Borings No. 3 & 4, the alluvial deposits of clay silts and clays were found to be underlain by the stratum of dense gravel-sand at approximately Elev. 721'. This stratum of dense gravel-sand was explored to a depth of 31' below the ground surface (i.e. - Elev. 697'.)

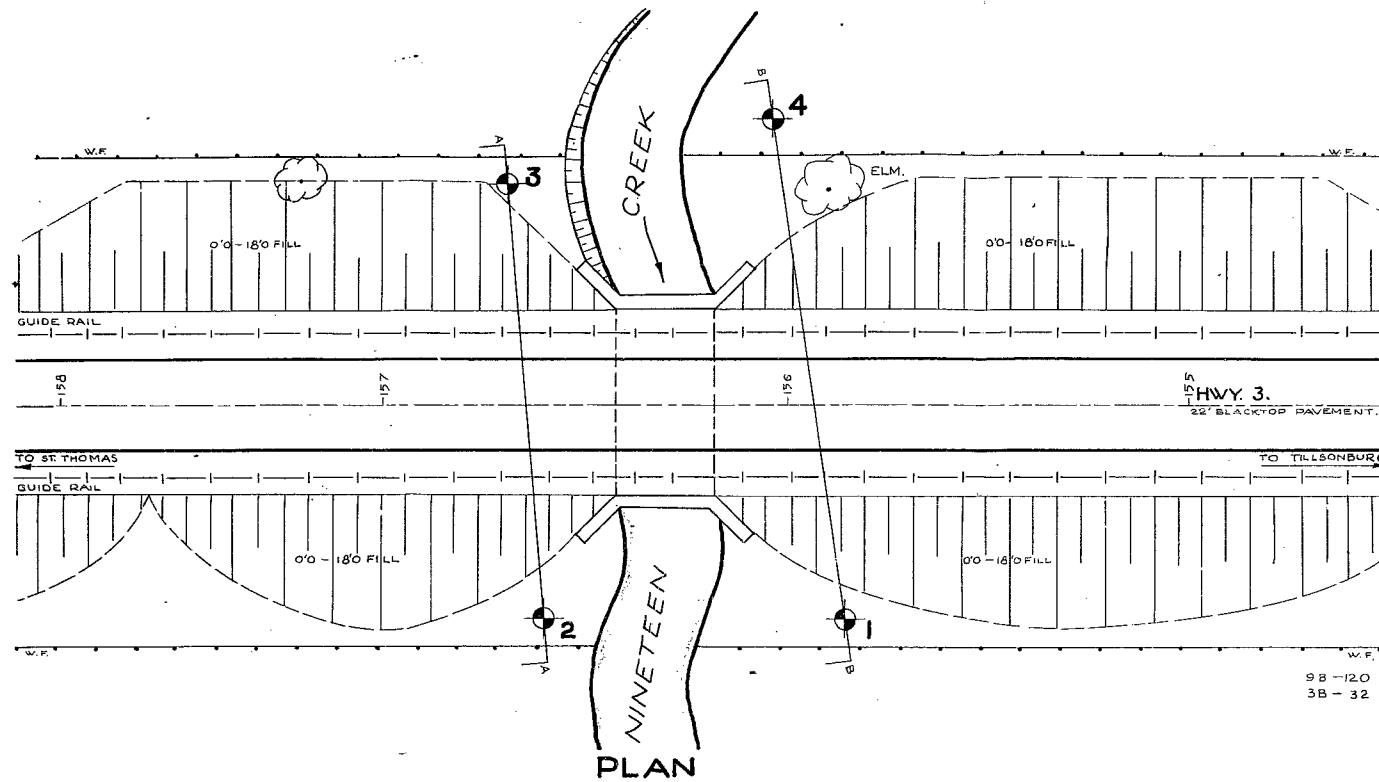
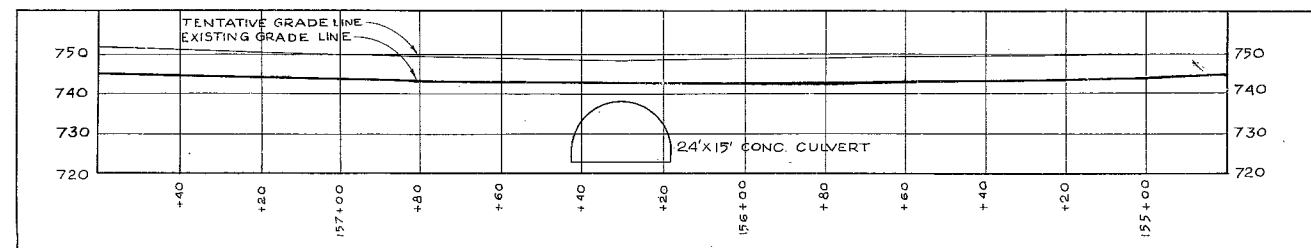
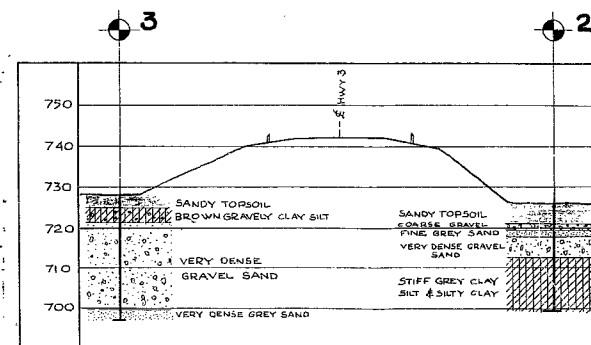
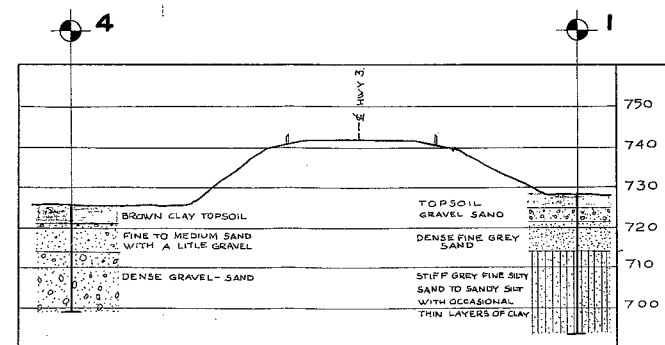
The location plan and subsoil profile are presented in Drawing No. F-59-18A.
