Re: Catfish Creek - Bank  
Stability, Hwy. #3, Station  
116+00 to 123+00, near New  
Sarum Twp., Yarmouth.

Re: Soil Investigation and Stability Analysis,  
Highway 3,  
New Sarum, Ontario.

S6913  
REPORT  
TO  
DEPARTMENT OF HIGHWAYS, ONTARIO  
ON  
SOIL CONDITIONS AND STABILITY ANALYSIS  
HIGHWAY 3  
NEW SARUM ONTARIO

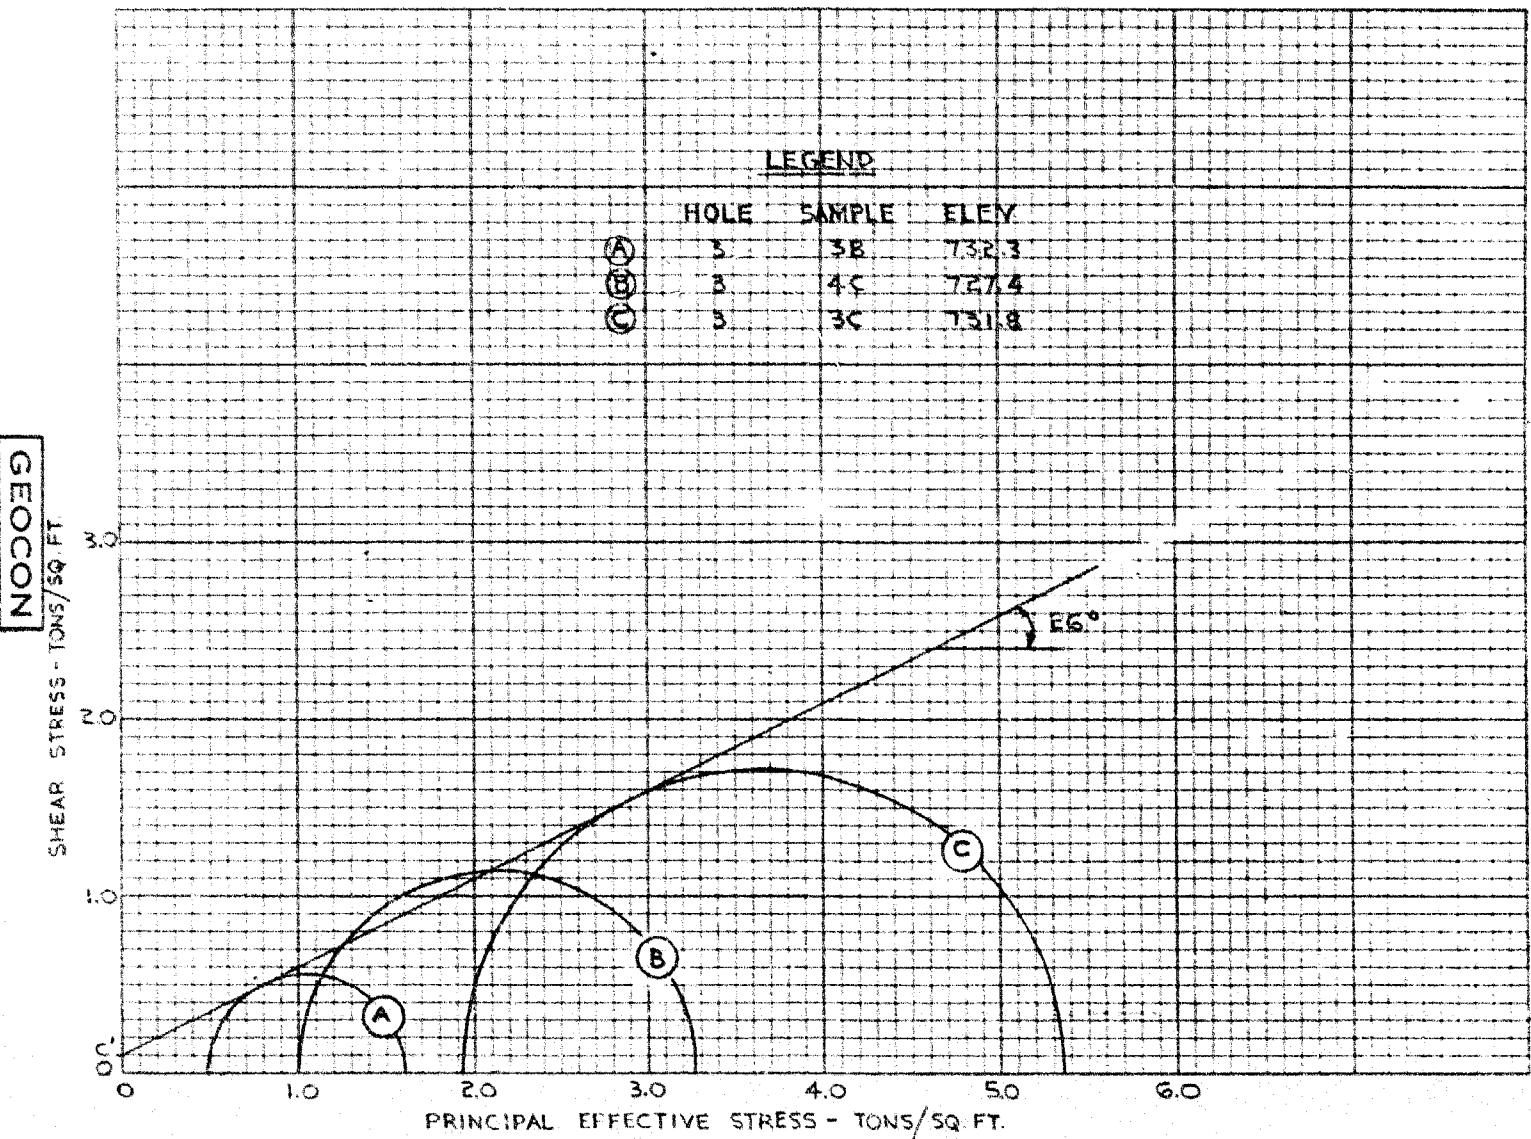
FIGURE 1

a cohesion,  $C'$ , of 200 pounds per square foot. The Mohr circle diagram from which these values were deduced is shown as Figure 3 of Appendix II.

A series of consolidated undrained triaxial tests were carried out with measurement of pore pressures. The results are plotted on a Mohr circle diagram given as Figure 1 in Appendix II, and show that, in terms of effective stress, the clay has an angle of shearing resistance,  $\phi'$ , equal to 26 degrees, and a cohesion of 0.1 tons per square foot.

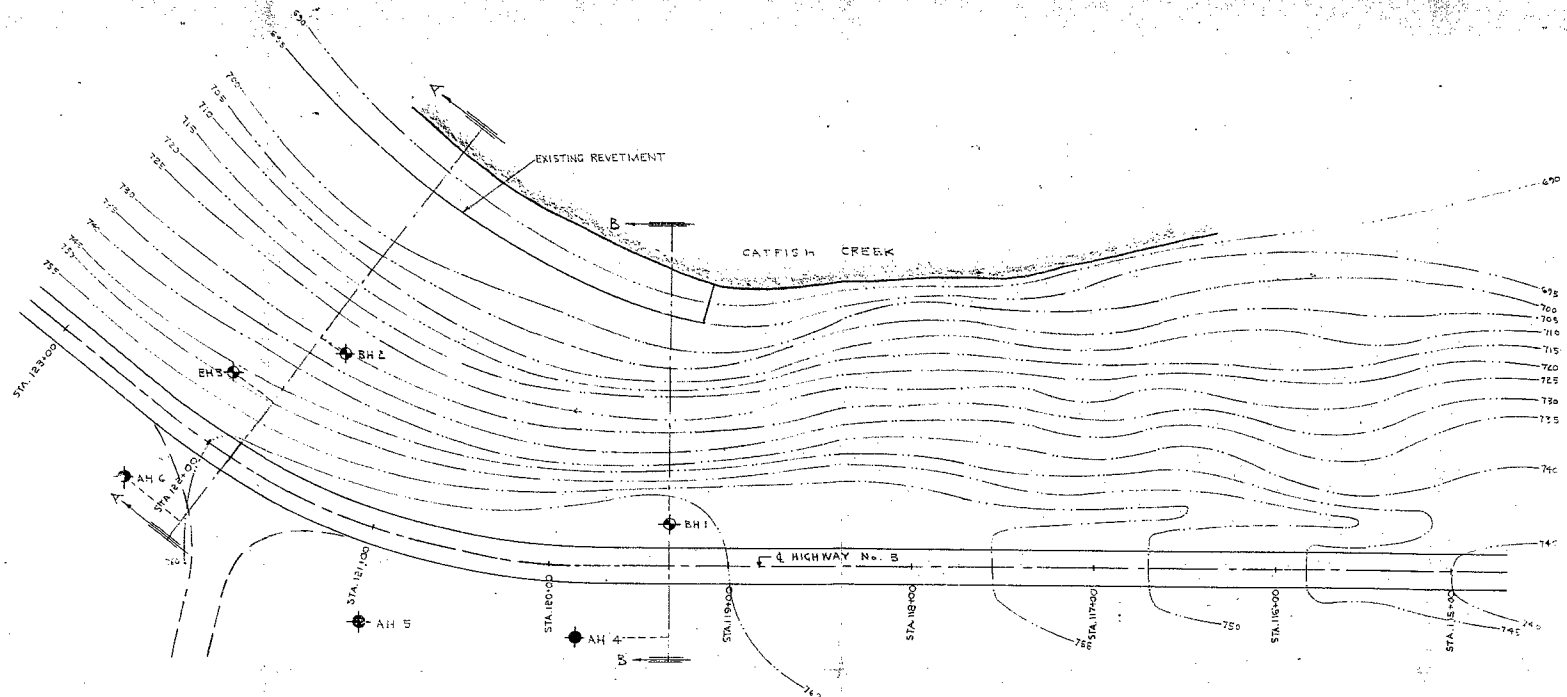
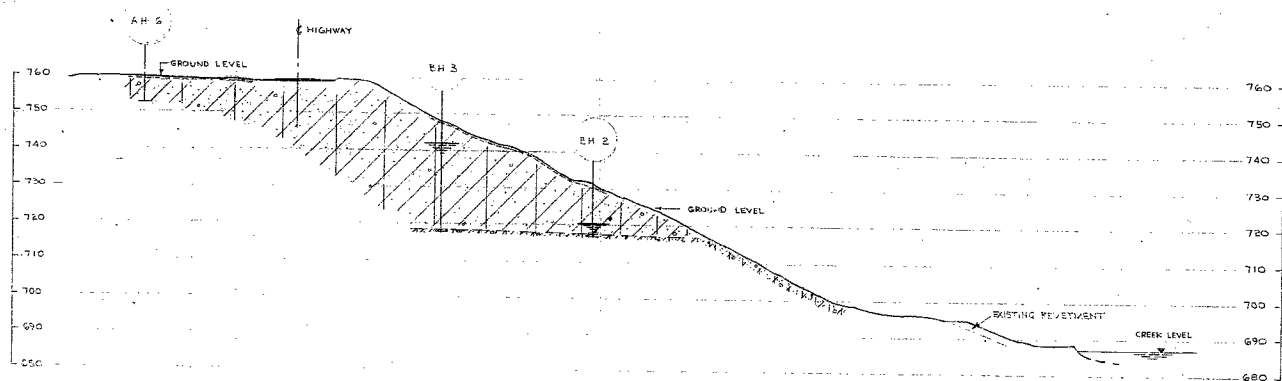
PLAN  
SCALE 1" = 40'-0"

Drawings S6913-1 and S6913-2 located in the pocket at the rear of this report show the location of the boreholes and auger holes together with the inferred soil stratigraphy and results of stability analyses carried out on the slope. A detailed log of each boring is given on the Office Reports on Soil Exploration in this Appendix.

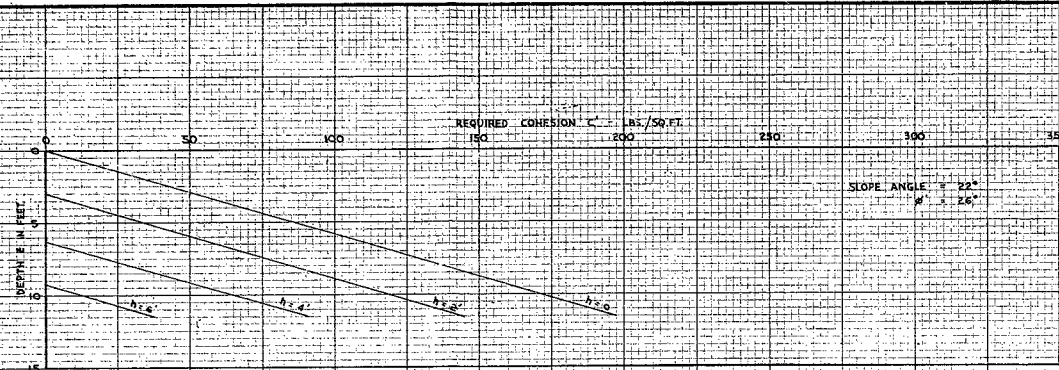
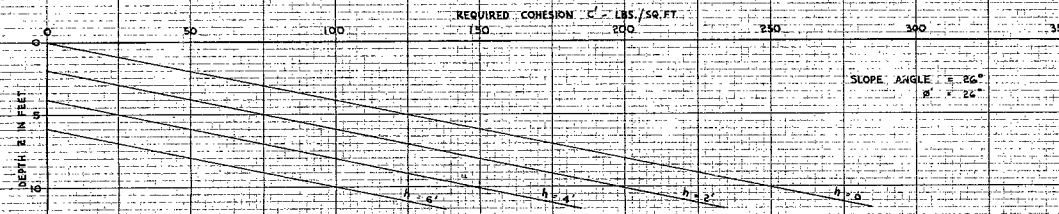
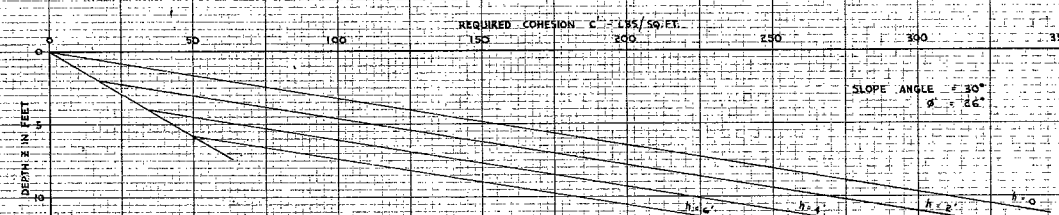
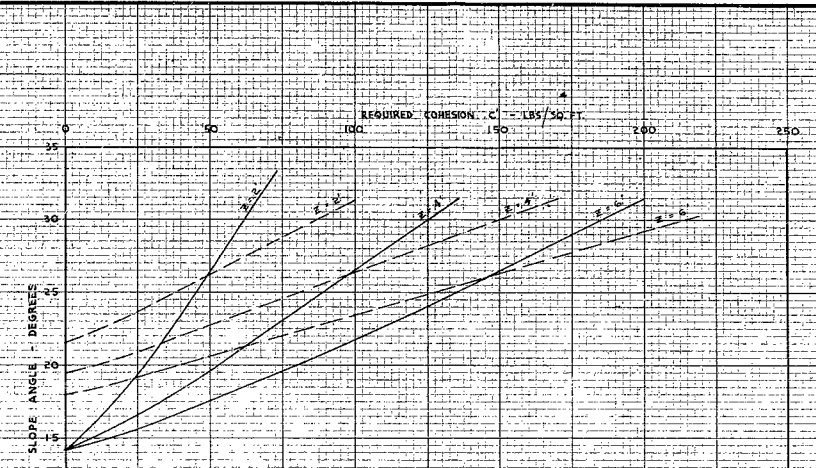
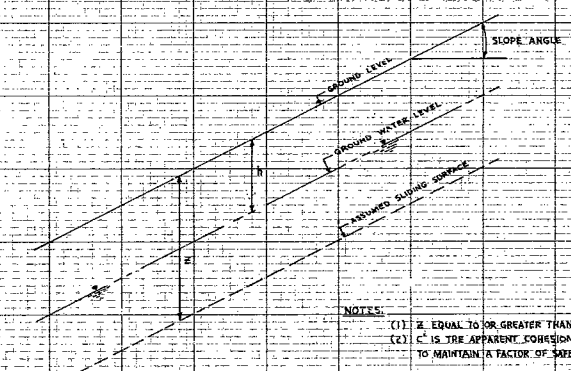
EFFECT OF 36" GRAVEL BLANKET ON STABILITY REQUIREMENTS

The results of the stability analysis, which are summarized graphically on Drawing S6913-2 in the pocket at the rear of this report, show that the most unstable condition for any slope is when the free water surface is coincident with the surface of the slope. This corresponds to conditions at the time of spring thaw when the combination of snow melt, low permeability, and high precipitation saturates the upper portion of the slope, forming what is in effect a perched water table.

However, even for slope angles of 30 degrees, the cohesion required to maintain stability in the upper 3 to 5 feet of the slope is considerably less than the 200 pounds per square foot measured in the laboratory. Therefore, in view of the observed instability of the slope, it is considered that a loss of shear strength is occurring in the unstable zone. Such a loss of strength is indicated by the results of the vane shear tests in borehole 3 which are plotted on the Office Report in Appendix I. These show the average undrained shear strength in the upper 5 feet to be about one third of the average from 5 to 10 feet.

bedding planes of the clay and extensive fissuring. Thus, on the basis of the analysis, it would appear that the cohesion,  $C'$ , is being decreased to a value of about 50 pounds per square foot or less.

The portions of the slope which have been stripped, trimmed, and graded should be provided with a 3 feet thick protective blanket of coarse gravel for frost protection and to facilitate surface drainage. It is also suggested that gutters be constructed along the north side of the highway in order to prevent excess runoff water from entering the slope above the interceptor trench.
