Our Reference:
 OF 7554, FD 299
 August 6th, 1954.

SOIL INVESTIGATION REPORT
 For
DEPARTMENT OF HIGHWAYS, CHICAGO
 (W. H. Dillon, Consulting Engineers.)
 at
ALABAMA AVE., BOSTON, ILL.

Our Reference:
OF 7554 PC 311
August 18, 1954.

SOIL INVESTIGATION REPORT
for
DEPARTMENT OF HIGHWAYS, ONTARIO
(M. M. Dillon, Consulting Engineers.)
at
HIGHWAY 401, DORCHESTER #3 & #4.

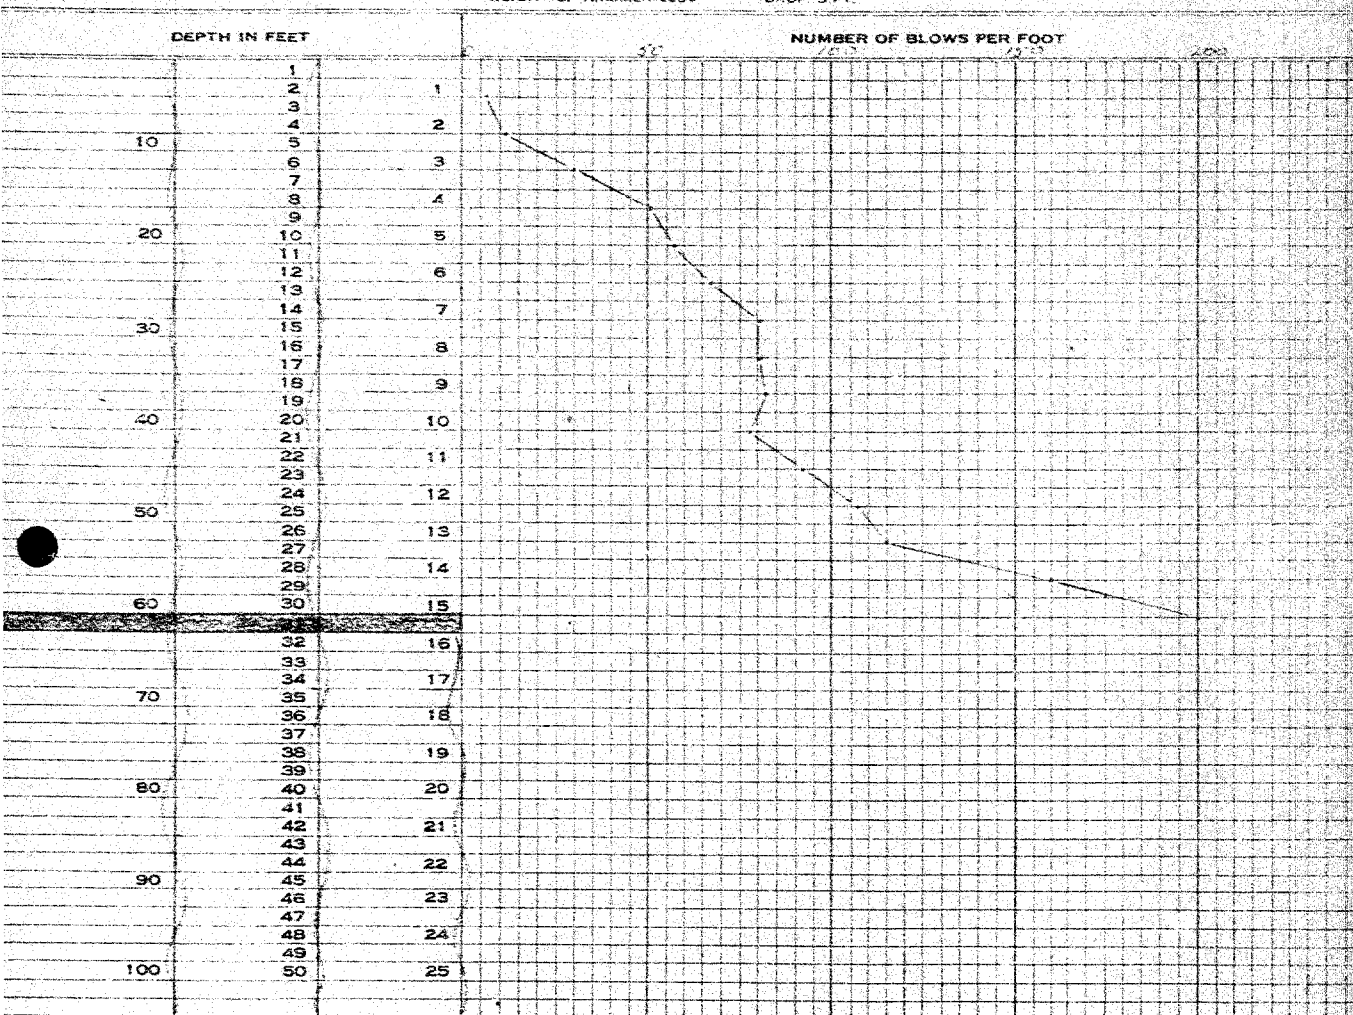
TEST NO.: 10

Hole No:	Ground Surface	2,000 lbs per sq. ft.	4,000 lbs per sq. ft.	Refusal	No. of Blows
10	876	873	872	861	200 for 5"
11	876	871	871	857	200 for 8"

Ground Surface Elevation 876
Refusal Elevation 861
Number of Blows 200 for 5"

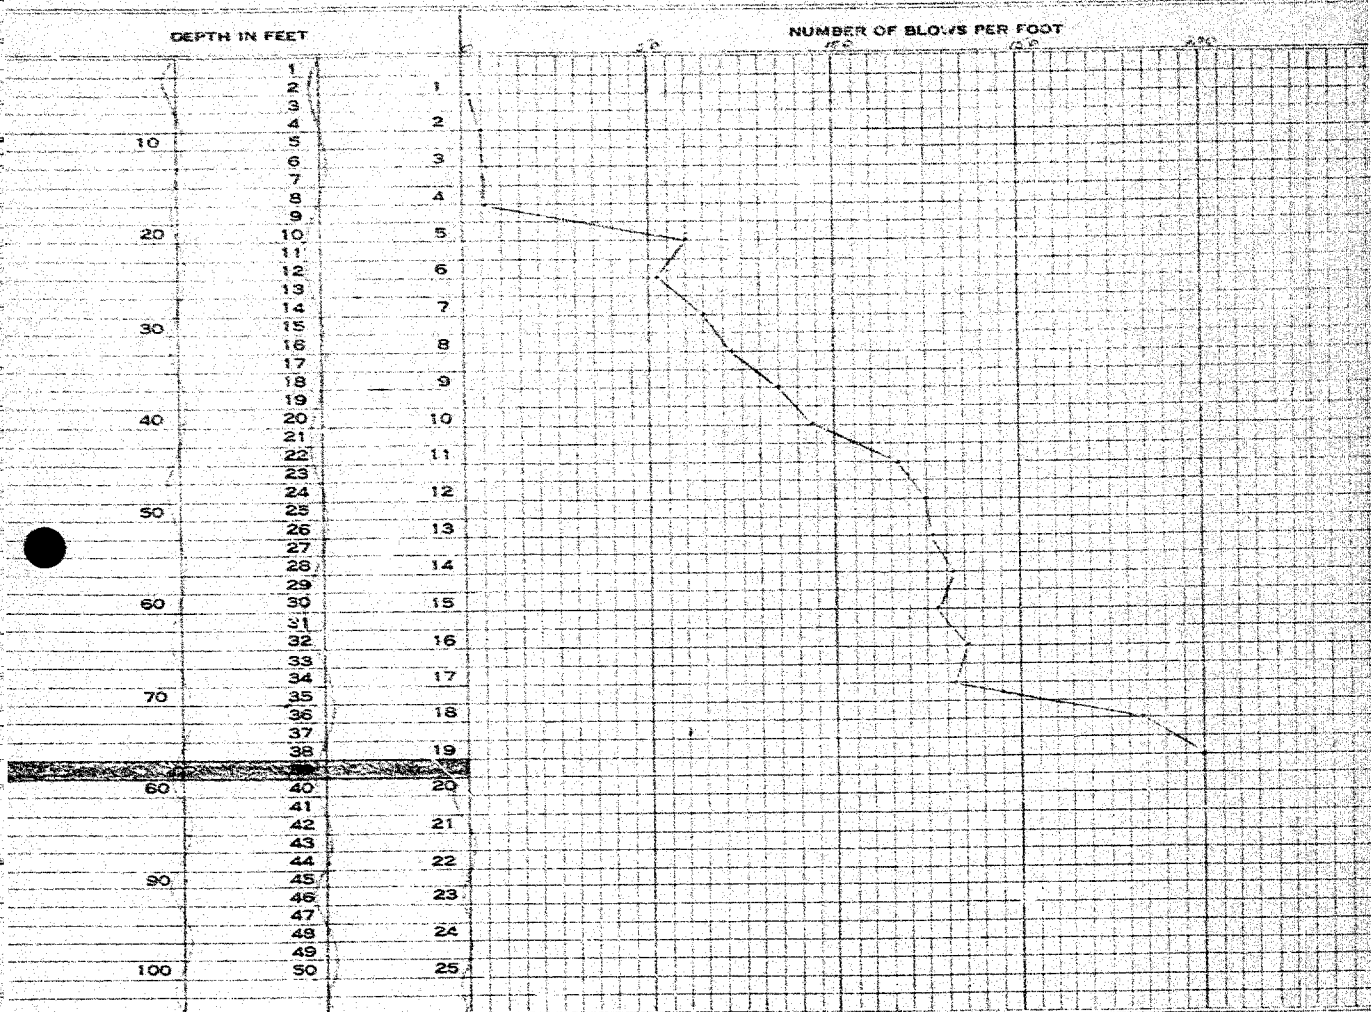
TEST NO.: 11

Ground Surface Elevation 876
Refusal Elevation 857
Number of Blows 200 for 8"
