HWY. No. 3LOCATION Hwy 3 WBL - Slope  
FailureNo. of PAGES - (400m W of Hwy 19)=====  
OVERSIZE DRAWINGS TO BE INCLUDED WITH THIS REPORT. \_\_\_\_\_REMARKS: \_\_\_\_\_  
\_\_\_\_\_  
\_\_\_\_\_  
\_\_\_\_\_

Re: Embankment Instability on Highway 3 West-Bound Lane  
400 m West of Highway 19; W. O. 96 - 11007  
Highway 3, District 31, London/Stratford

Re: Slope Failure on Highway 3 West-bound Lane  
400 m West of Highway 19  
W.O. 96-11007, District 31, London/Stratford

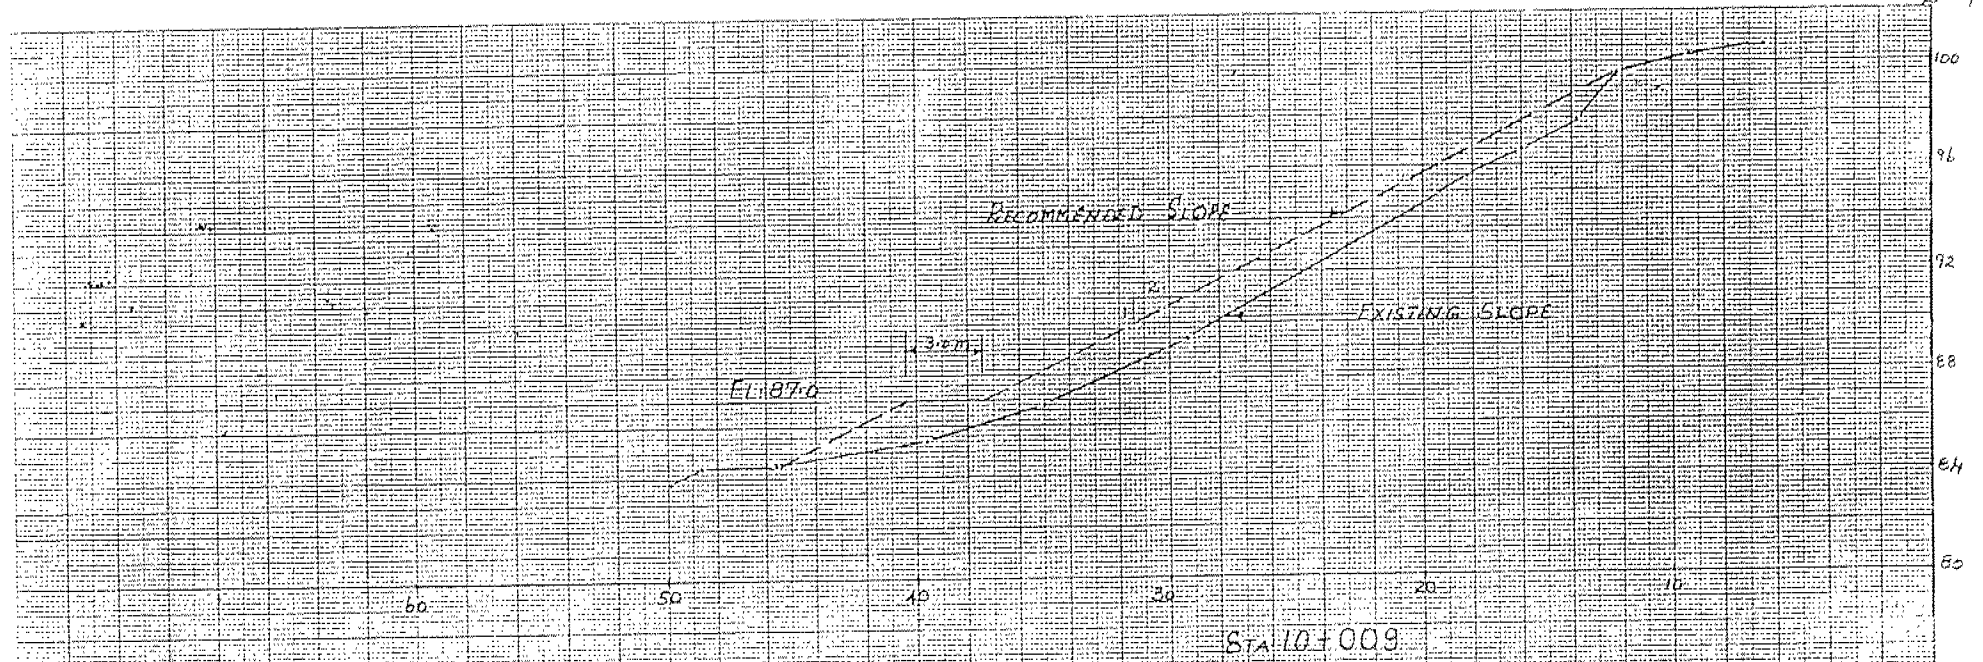
Q Hwy 3

The cross-sections forwarded to us indicate that the existing slope from Sta. 10 + 000 to Sta. 10 + 015.3 is slightly steeper than 2 horizontal to 1 vertical and also, the failure is centred around Sta. 10 + 009. The following remedial measures are suggested to stabilize the slope:

- 1) Clean the drainage ditch on the south side of Highway 3 and provide a positive drainage to avoid any water seepage through the fill.
- 2) Remove all the loose and soft material in the unstable area and rebuild the slope with granular material.
- 3) Provide a 3 m wide berm at an elevation of 87.0.
