**PRELIMINARY FOUNDATION
INVESTIGATION REPORT**

**MTO FERRY DOCKS AT LEAMINGTON, KINGSVILLE
AND PELEE ISLAND
TOWNSHIPS OF MERSEA, GOSFIELD SOUTH
AND PELEE ISLAND
DISTRICT 31, CHATHAM
WORK ORDER NUMBER: 01-33-001
PURCHASE ORDER NUMBER: 3005-A-000218
GEO CRES NUMBER 40J2-57**

February 26, 2003

021-4216

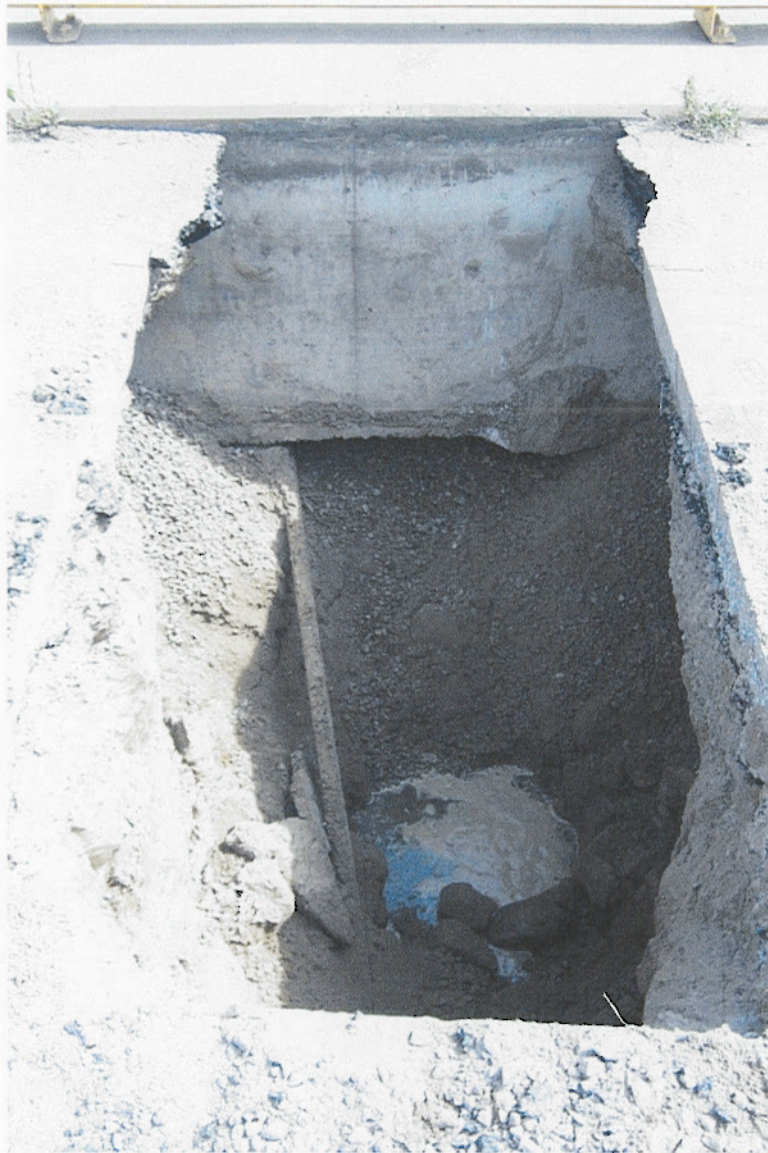
TEST PIT 1 - LEAMINGTON FERRY DOCK

- The Granular "A" type fill materials are generally underlain by crushed stone (i.e. clear stone sized) fill materials.
- Testpits excavated through the existing, unrepaired asphalt pavement encountered variable amounts of sand fill overlying crushed stone (i.e. clear stone sized) fill materials down to approximately the lake water level, below which rock fill was found. The sand fill thickness in the testpits was greatest furthest away from the steel sheet pile wall. Correspondingly, the thickness of crushed stone fill decreased moving further away from the wall. This detail is clearly visible from the attached Photographs 1 and 7.
