66-F-35
W.P. 233-65
HWY. #2
GRAND RIVER
AT PARIS

FOUNDATION INVESTIGATION REPORT

Hwy. #2 Crossing of Grand River
District #3 (Stratford)

W.J. 66-F-35 -- W.P. 233-65

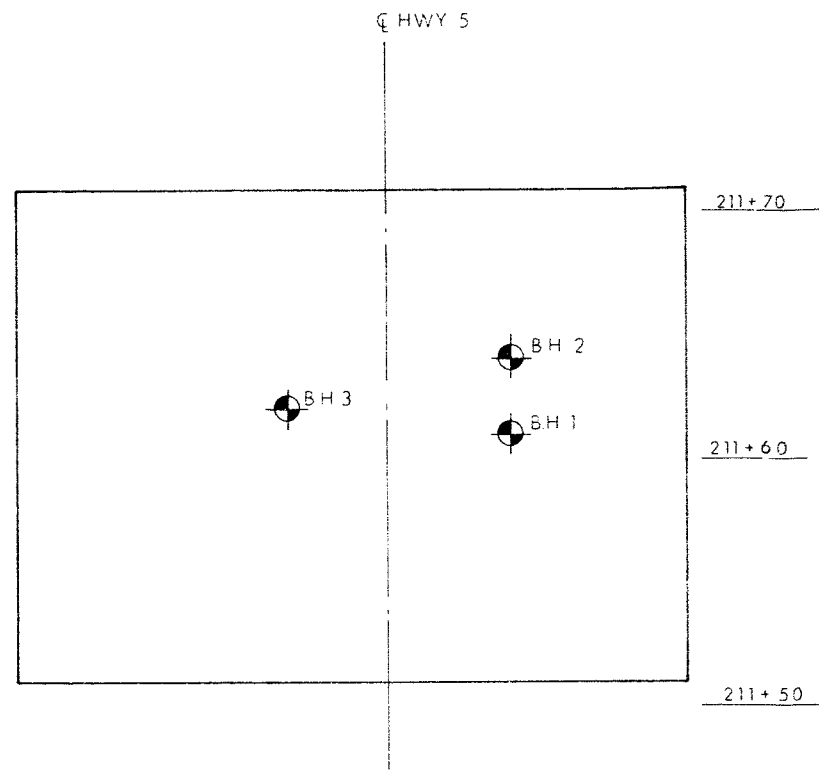
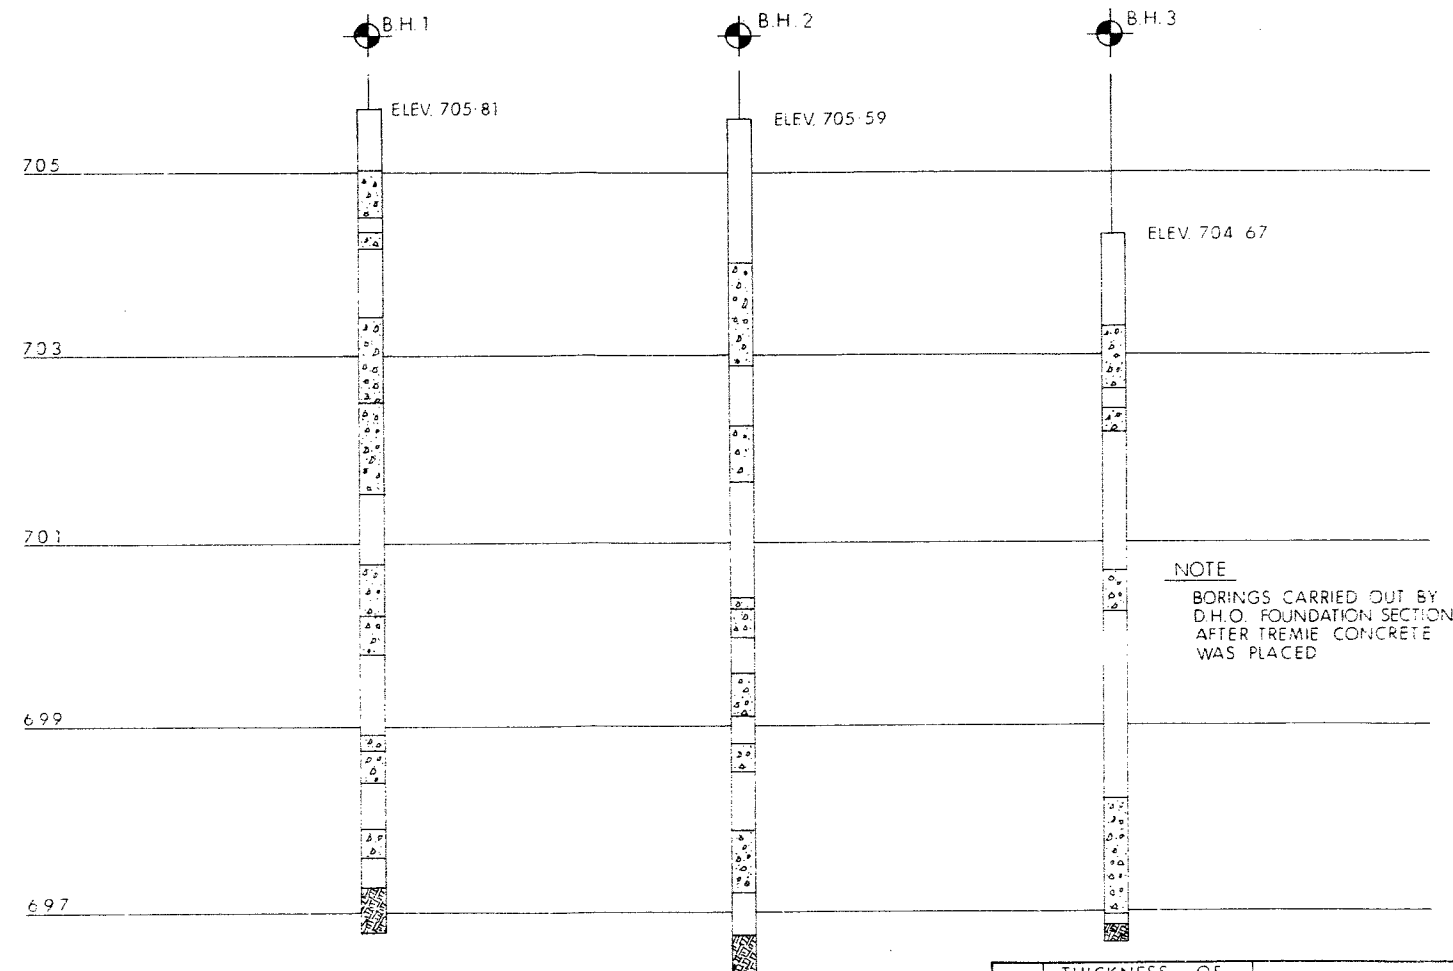
PLAN
PIER NO 4 FOOTING
SCALE 1" = 5'

It is readily observed that this concrete is not satisfactory due to the many interspersed layers of loose aggregate.

NOTE
BORINGS CARRIED OUT BY
D.H.O. FOUNDATION SECTION
AFTER TREMIE CONCRETE
WAS PLACED

As requested during our telephone conversation of to-day's date, please advise this office what proposal your Company intends in order to rectify the condition in which this concrete now exists.

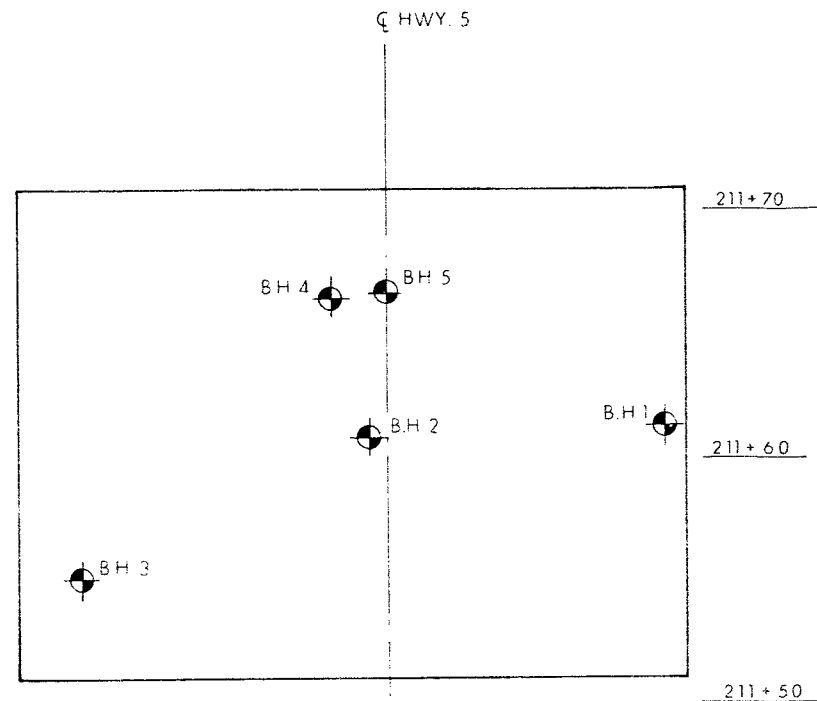
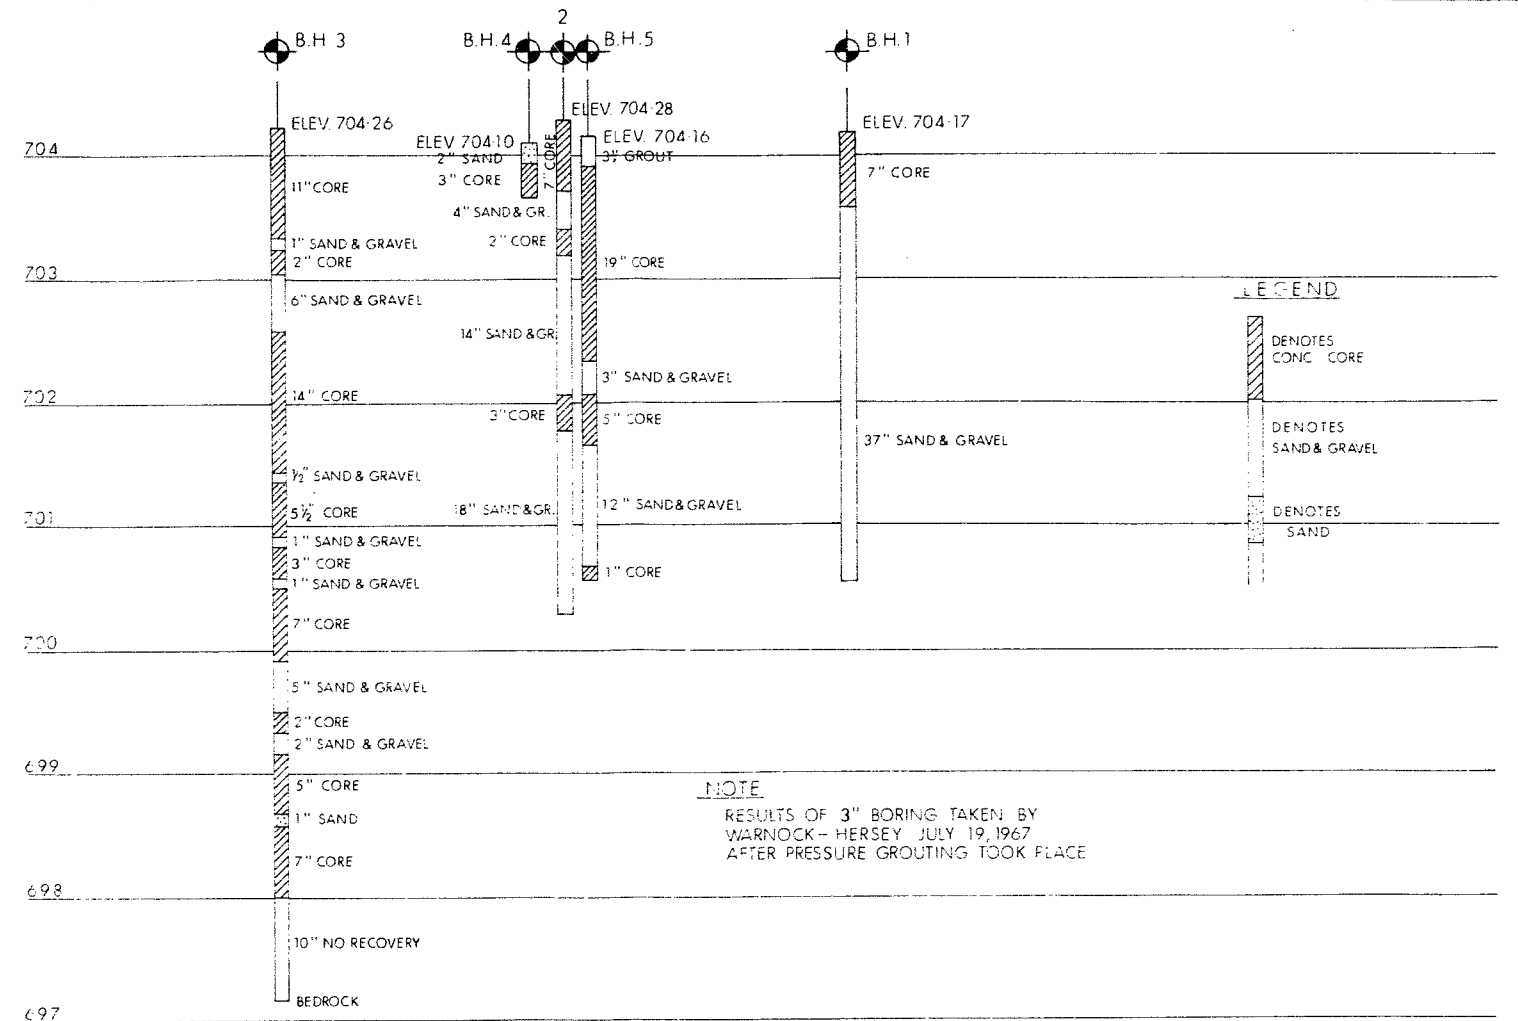
PLAN
PIER NO 4 FOOTING
SCALE 1" = 5'

ONTARIO	DEPARTMENT OF HIGHWAYS MATERIALS and TESTING DIVISION	GRAND RIVER BRIDGE AT HWY. 5 PIER NO 4 FOOTING (PARIS - ONTARIO)	
	DATE JULY 19, 1967	APPROVED <i>[Signature]</i>	W.P. 233-65
		DRAWING NO. 66-F-35 C
