BELLHOUSE CULVERT
COUNTY ROAD NO. 6
COUNTY OF BRANT, ONTARIO

PROJ. H 218 DATE JULY, 1967 DWG. NO. 1

FOUNDATION INVESTIGATION
BELLHOUSE CULVERT
BRANTFORD SUBURBAN ROAD NO.6,
TOWNSHIP OF BRANTFORD, CO. BRANT, ONT.

Foundation Investigation
Bellhouse Culvert
Brantford Suburban Road No. 6,
Township of Brantford, Co. Brant, Ont.

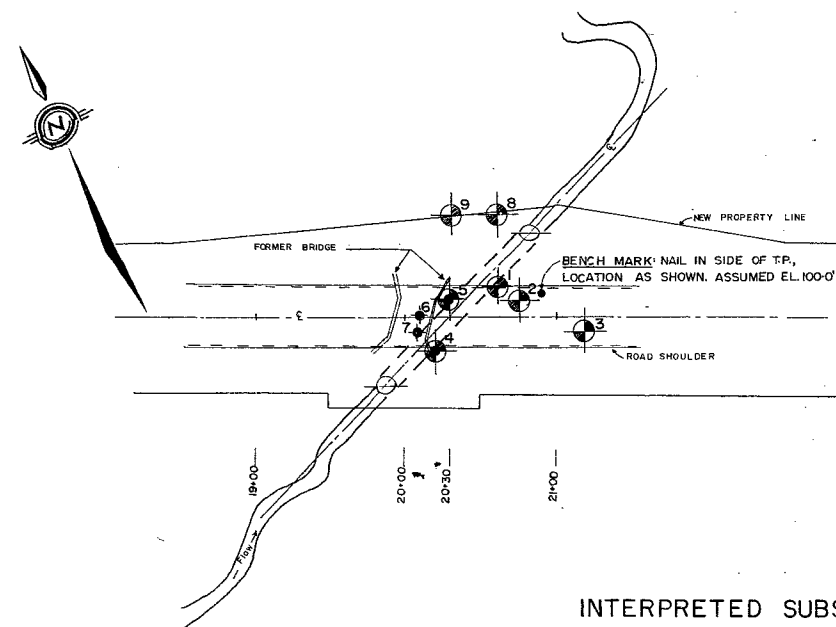
PLAN
SCALE: 1" = 50'

The existing skew culvert has deformed most evidently at two locations: a) at the northeast end, where general lateral movement towards the north has occurred, and - b) near the southern shoulder of the roadway, where the pipe has possibly been forced against the remains of the previous concrete bridge or culvert structure and has become buckled. The old abutments and footings of this structure were observed in test pits in several locations, and were encountered by a cone penetration test, (see detail of Dwg. 1). Distortion of the plates at shoulder level near the northeast end of the culvert has also occurred, possibly due to frost action.

a) The remaining portions of the old concrete structure in the vicinity of the culvert should be removed, and the excavations made good with well compacted granular material.

b) The backfill surrounding the culvert should be removed and replaced with well compacted free-draining granular material. Some of the existing fill, particularly to the south of the structure is sufficiently free of cohesive and other deleterious material to be re-used, providing all fine grained silt and clay is removed. If necessary, the pipe should be re-bedded on a similarly free-draining granular mat at least 18 inches to 2 feet thick. All granular backfill should be placed in well compacted layers alongside the repaired culvert barrel, with each layer not exceeding about 9 to 10 inches loose thickness. The backfill must be built up to a similar height on either side of the structure, to avoid any eccentric loading.

c) The major portion of the steel plate pipe can be re-used. Badly deformed sections will probably have to be replaced, where the pipe has become structurally weakened (i.e., areas where buckling has occurred).

d) Provisions should be made to suitably drain the roadway embankment to the east of the culvert. Existing drainage ditches should be dug deep enough along the sides of the embankment to prevent water from the hillside and adjacent borrow pits entering the upper granular road base fill and seeping down against the top or sides of the steel pipe.

e) Alignment should be improved if possible.

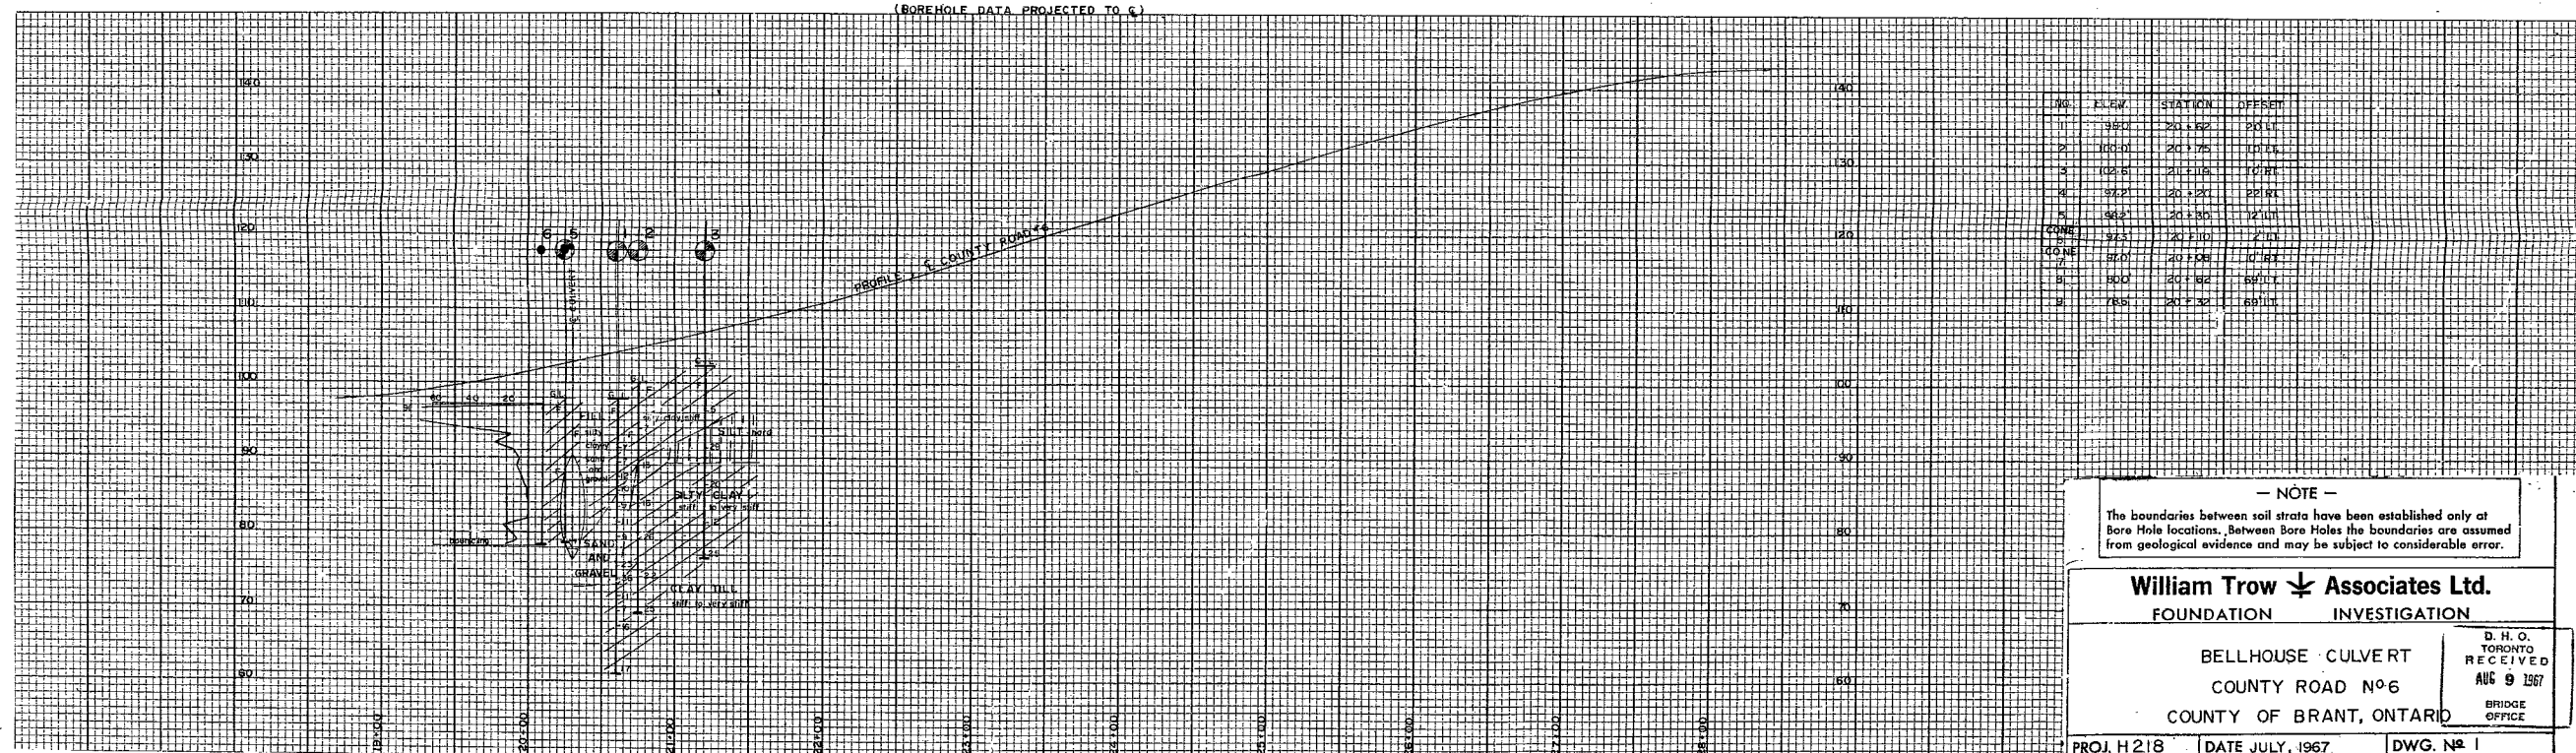
INTERPRETED SUBSOIL PROFILE ALONG C₆ ROAD

The backfill material surrounding the steel plate culvert was found to be quite variable. To the southeast of the structure essentially granular material has been placed adjacent to the culvert (borings 1 and 4). Along the northeast side the backfill consists of moist to wet silty clay material, containing numerous gravel sizes (boring 5). The natural subsoil underlying the site consists generally of stiff to very stiff silty clay and clay till.
