W.P. #199-63-02

HWY. #54

DATE: July 12, 1966

SUBJECT: Failure of Hwy. 54 between Sta. 223+00 and Sta. 228+00,
Caledonia to Onondaga, Hwy. 54, District 4 (Hamilton).
W.P. 199-63-02

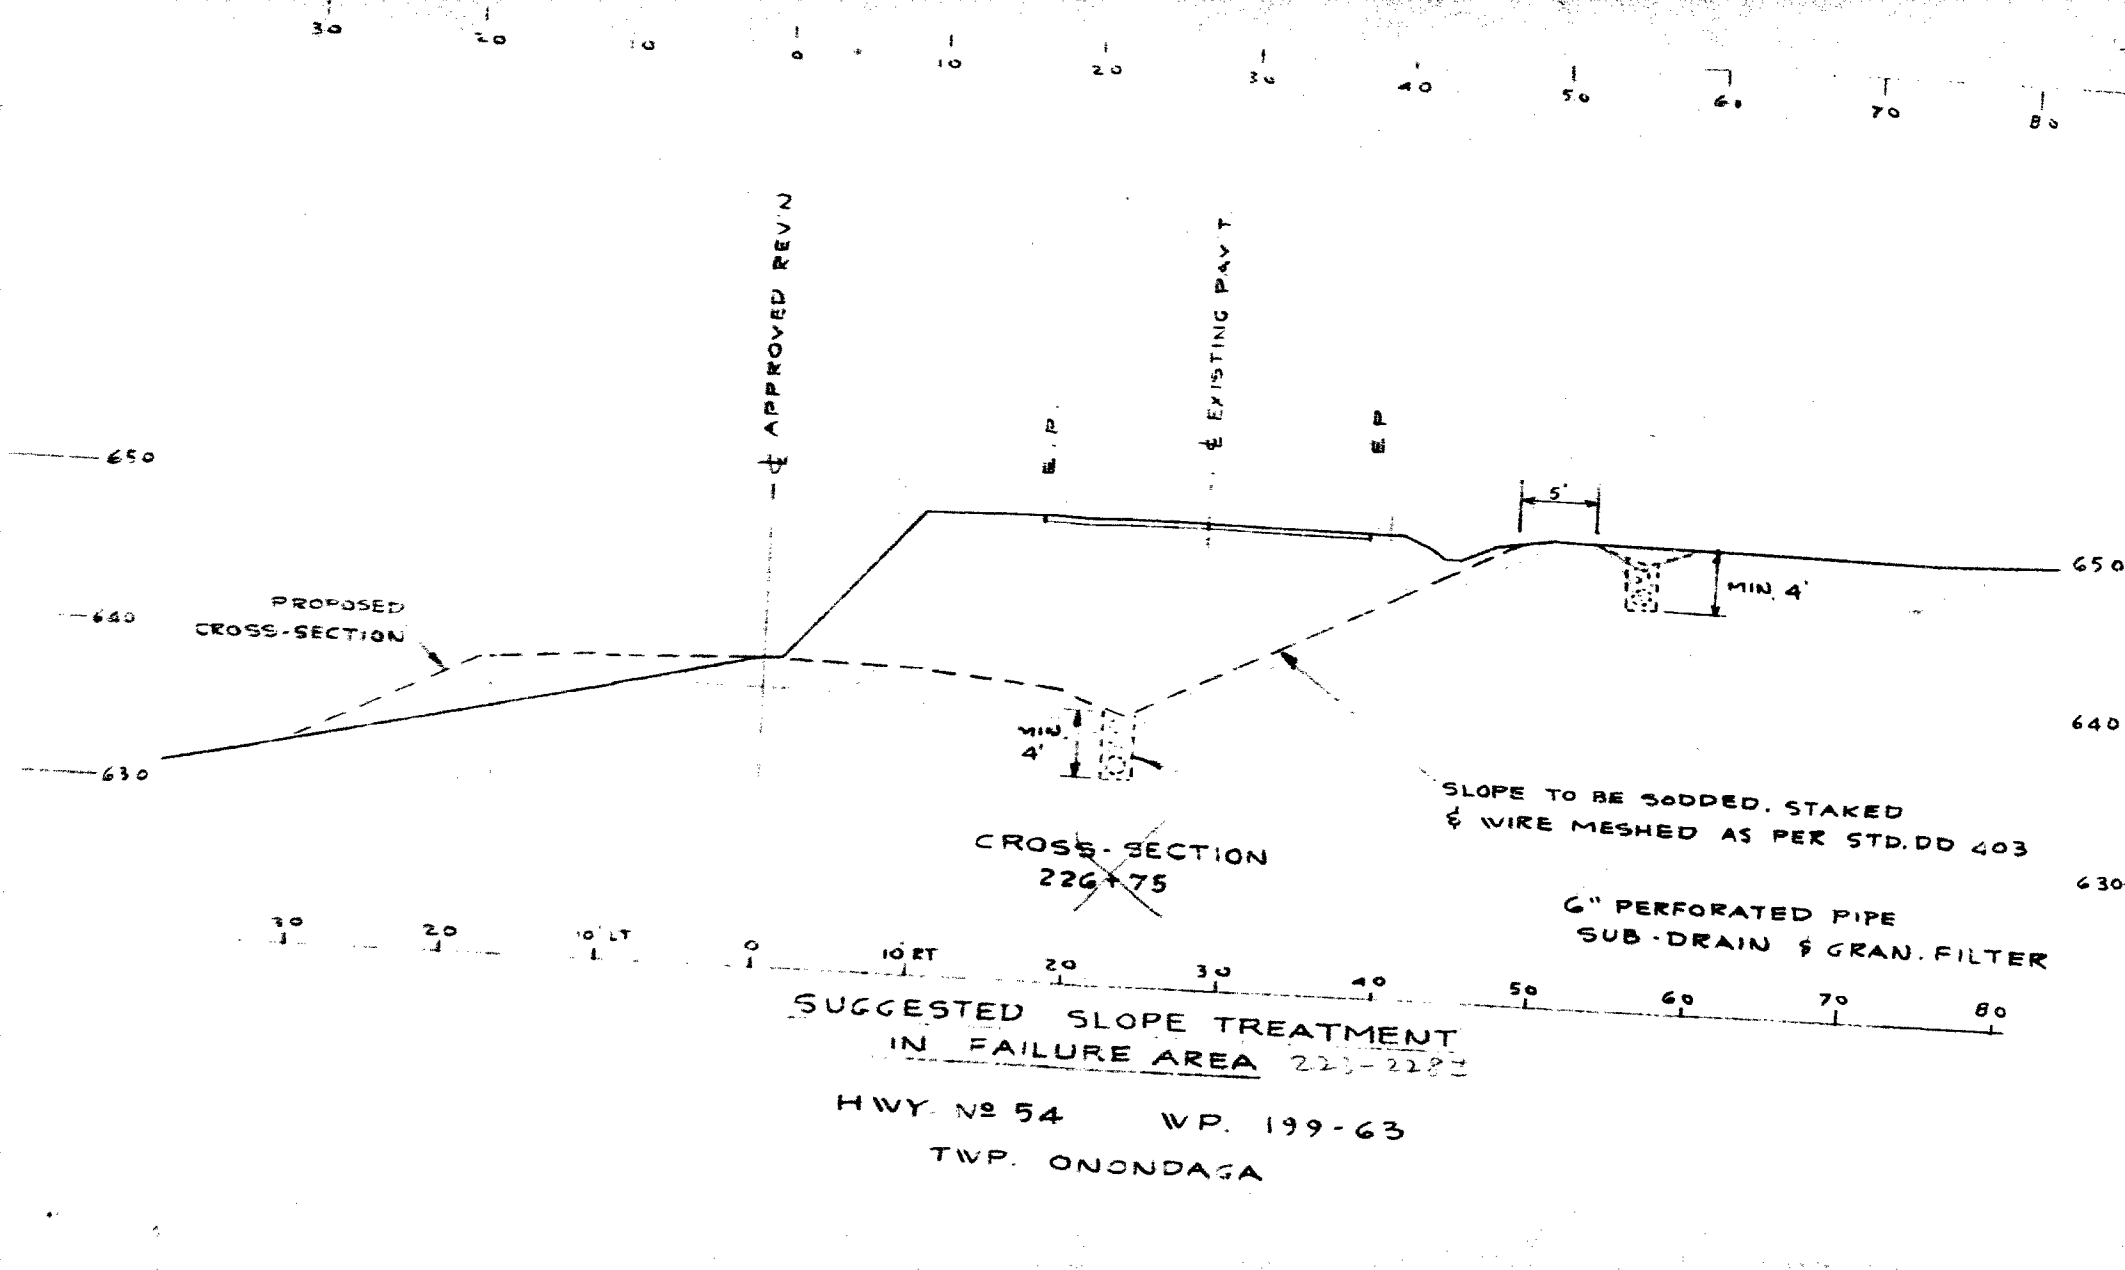
DWG #2

APPROXIMATE SLOPE - APRIL 1967

EXISTING SLOPE - AUG. 1966

APPROXIMATE SLIP PLANE

RECOMMENDED FILL SLOPE TREATMENT

IN FAILED AREA STA. 226+75 - 228+50

Since the seeping ground water is the main cause of instability, it is recommended that the future slopes be designed and constructed in such a manner so as to provide adequate and effective drainage that will eliminate possible seepage forces. A suggested typical section of the new roadway of Hwy. 54 (Scheme D) at Sta. 226+75, including subdrains at the toe and at the top of the cut on the north side of the proposed roadway, is shown on the enclosed drawing.

The 6" Ø perforated pipe subdrains backfilled with suitable granular filter material, should be located at least 4 ft. below the ground surface to provide for adequate frost protection. The slopes should be sodded, staked and wire-meshed as per D.H.O. Standard DD-403.

SLOPE TO BE SOODED,
STAKED AND WIRE MESHED
AS PER STANDARD DD-403
