W.D. 70-11119

Embankment FailureBrant County Road No 8 (White Swan Road)  
1 mile of Hwy. # 53.Effective Stress Stability Analyses

Re: Embankment Instability  
White Swan Road, Brant County  
Road No. 8

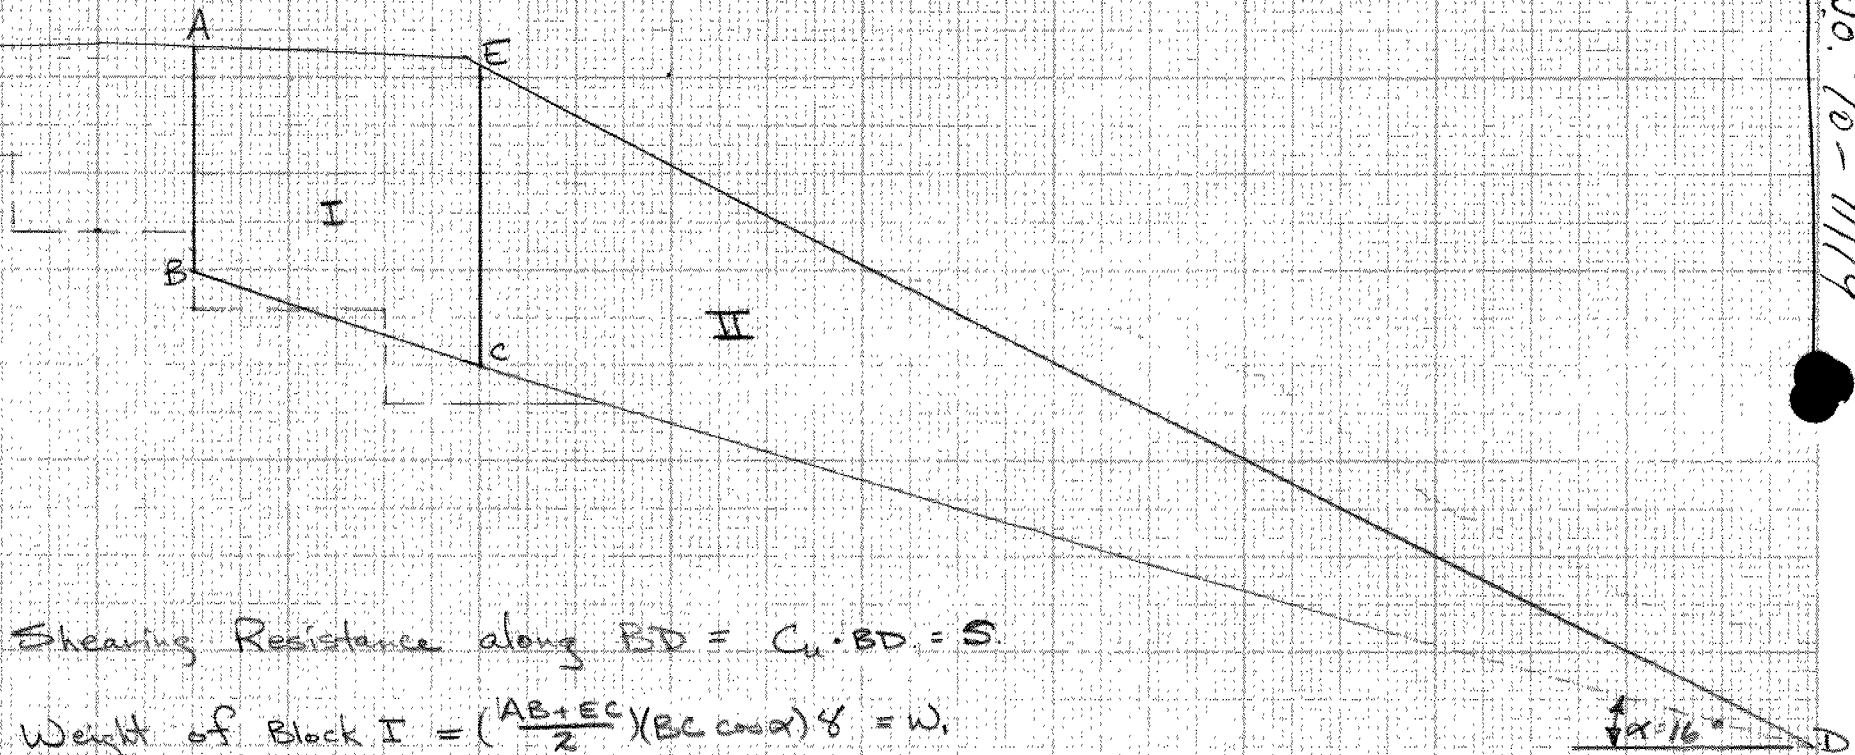
# TOTAL STRESS ANALYSIS.

Shearing Resistance along BD =  $C_u \cdot BD = S$

Weight of Block I =  $\left(\frac{AB+EC}{2}\right)(BC \cos \alpha) \gamma = W_1$

" " " II =  $\frac{1}{2} EC \cdot CD \cos \alpha \cdot \gamma = W_2$

$$\frac{S}{F} = (W_1 + W_2) \sin \alpha \quad (\text{Assume } F=1)$$

$$\therefore C_u \cdot BD = \gamma \sin \alpha \cos \alpha \left( \frac{AB+EC}{2} \cdot BC + \frac{1}{2} EC \cdot CD \right) \quad (\text{Note } \sin 2\alpha = 2 \sin \alpha \cos \alpha)$$

$$C_u = \frac{\gamma}{4} \sin 2\alpha \left( \frac{AB+EC}{2} \cdot BC + \frac{1}{2} EC \cdot CD \right) \left( \frac{1}{BD} \right)$$

$$= \frac{125}{4} \times .53 \left( \frac{11.5+15.5}{2} \cdot 15.5 + \frac{15.5 \times 12.5}{2} \right) \left( \frac{1}{28} \right) = 16.6 (209.5 + 962.5) \frac{1}{28}$$

$$= 146 \text{ psf}$$
