GEOCRES No. 40P1-69

LOCATION PROP. COCKSHUTT
RD. BRIDGE, BRANTFORD

McCORMICK RANKIN & ASSOCIATES LIMITED
PRELIMINARY SUBSURFACE INVESTIGATION
PROPOSED REPLACEMENT STRUCTURE
COUNTY ROAD NO. 4
BRANT COUNTY ONTARIO

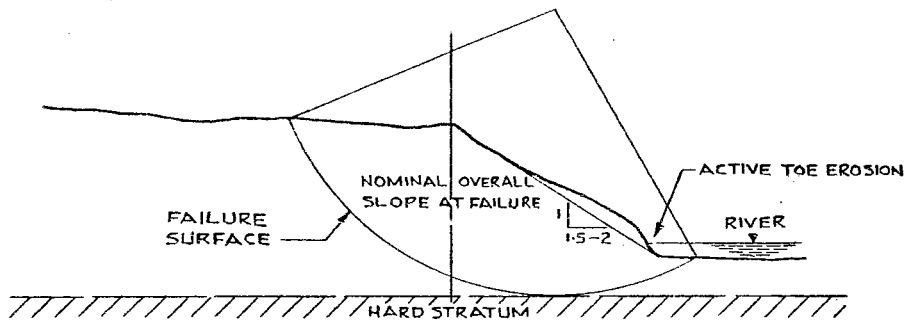
ILLUSTRATION OF POSTULATED FAILURE MECHANISM SOUTH VALLEY WALL

MAJOR FAILURE OF OVER-STEEPENED SLOPE

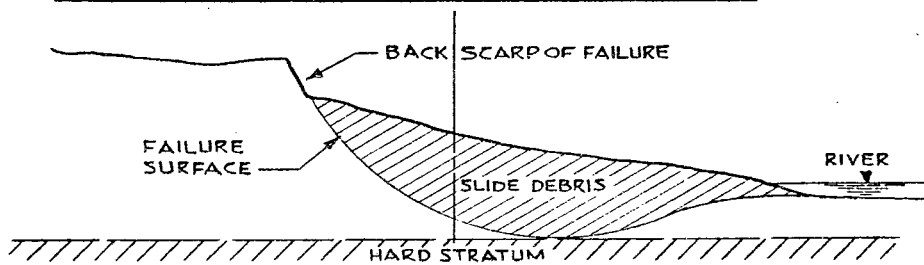
POST FAILURE CONDITION

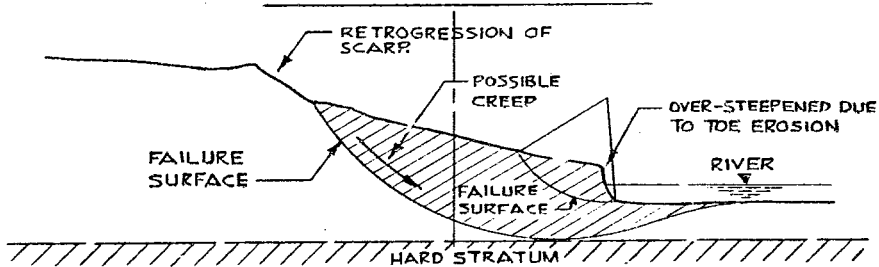
RETROGRESSION OF SLOPE DEBRIS

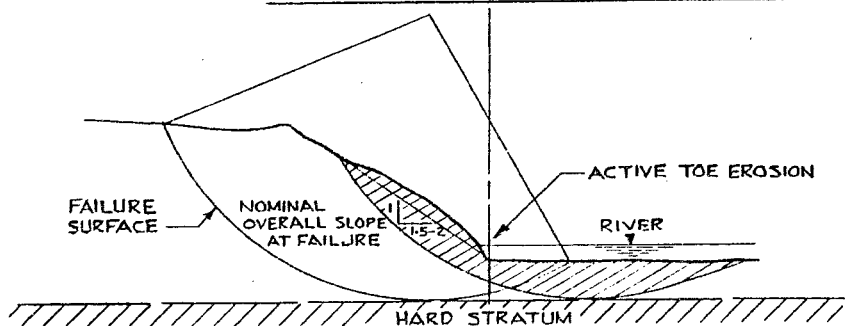
SECOND MAJOR FAILURE OF OVER-STEEPENED SLOPE

only a few feet above the river level (the flatter debris being generally associated with the larger slides). As a result of the failure, the river is generally diverted from its original position.

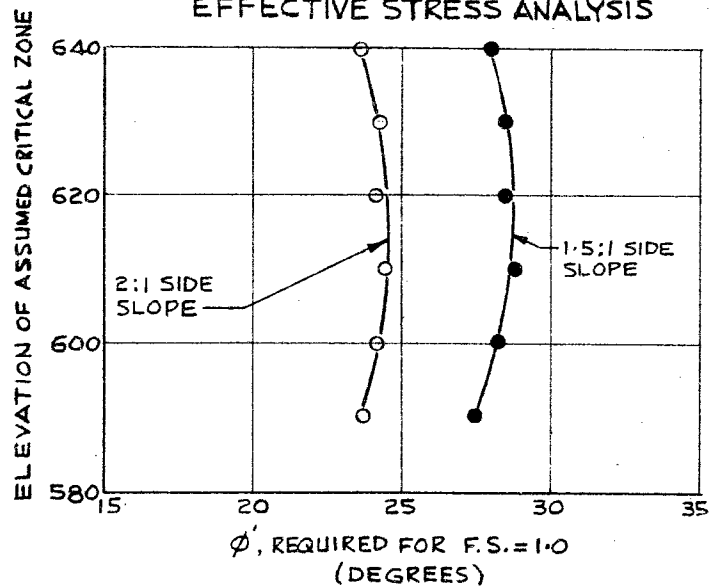
FIGURE 23

ANALYSIS OF THE '1957" FAILURE SLIDING WEDGE ANALYSIS

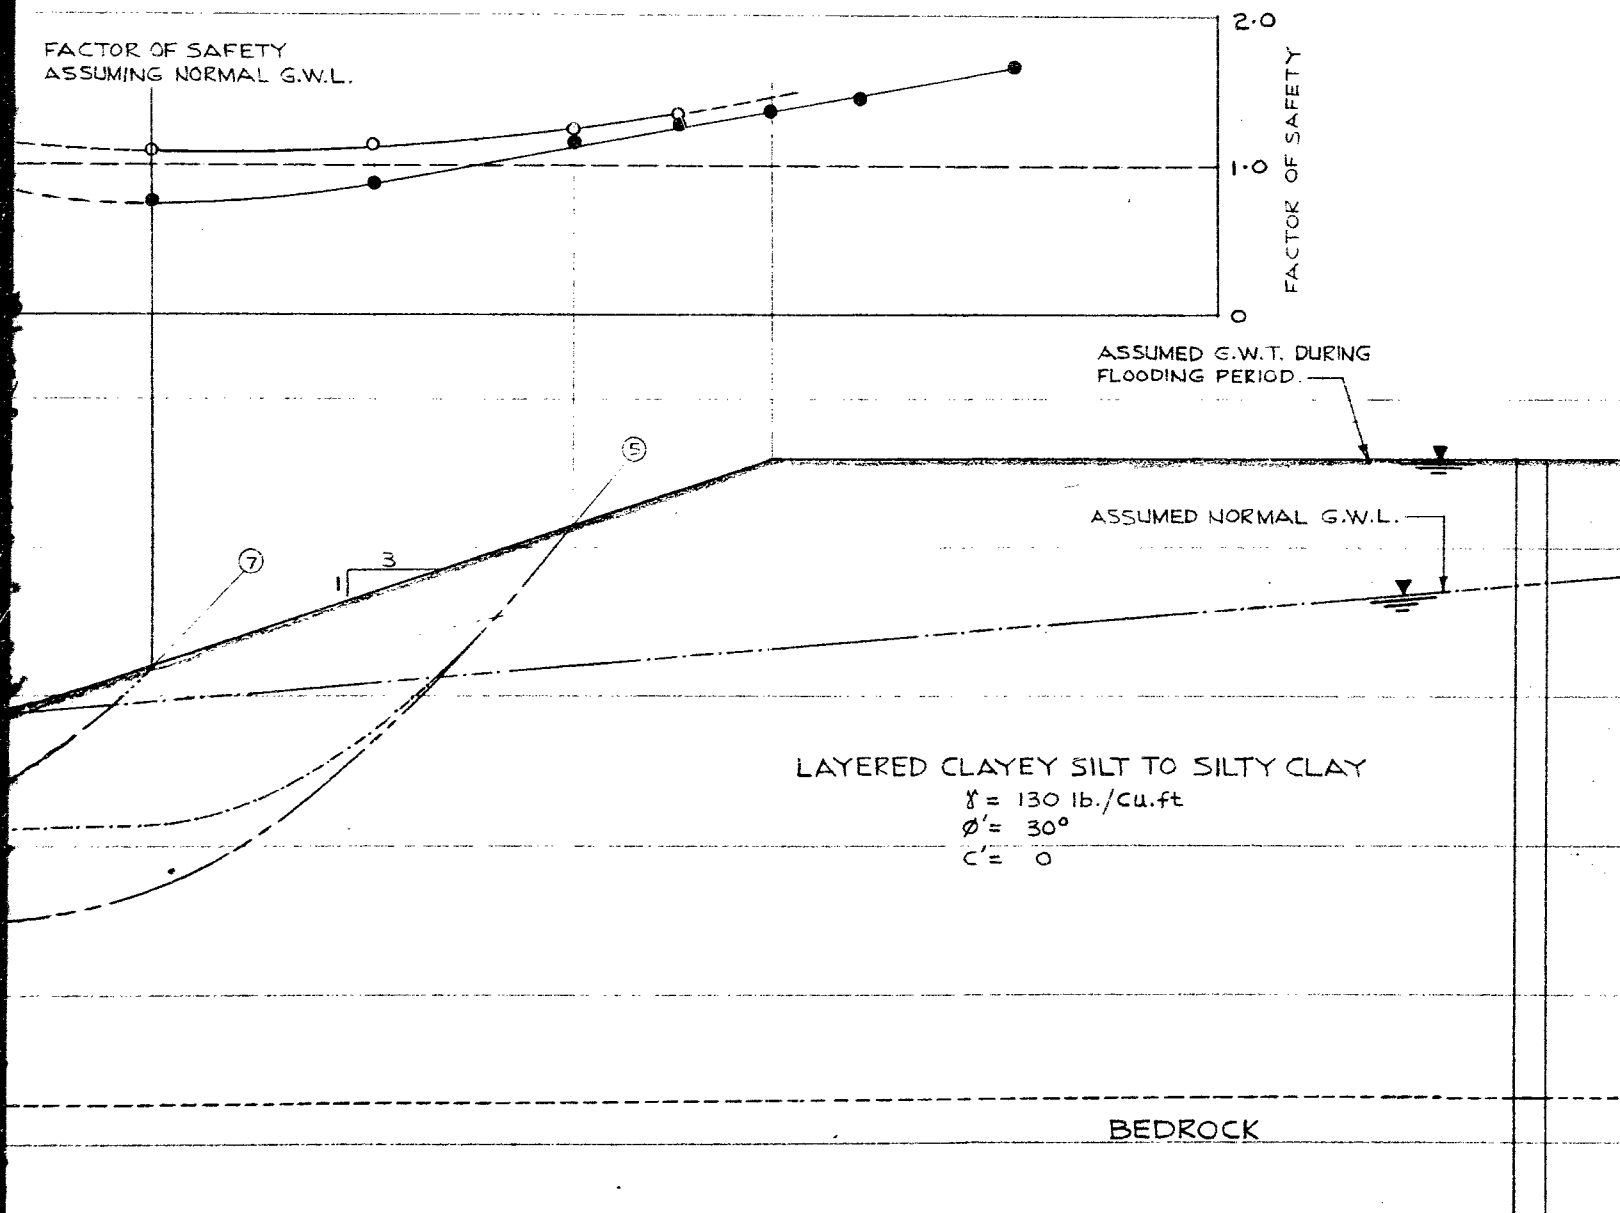
FIGURE 28

SUMMARY OF STABILITY ANALYSES TYPICAL SLOPE

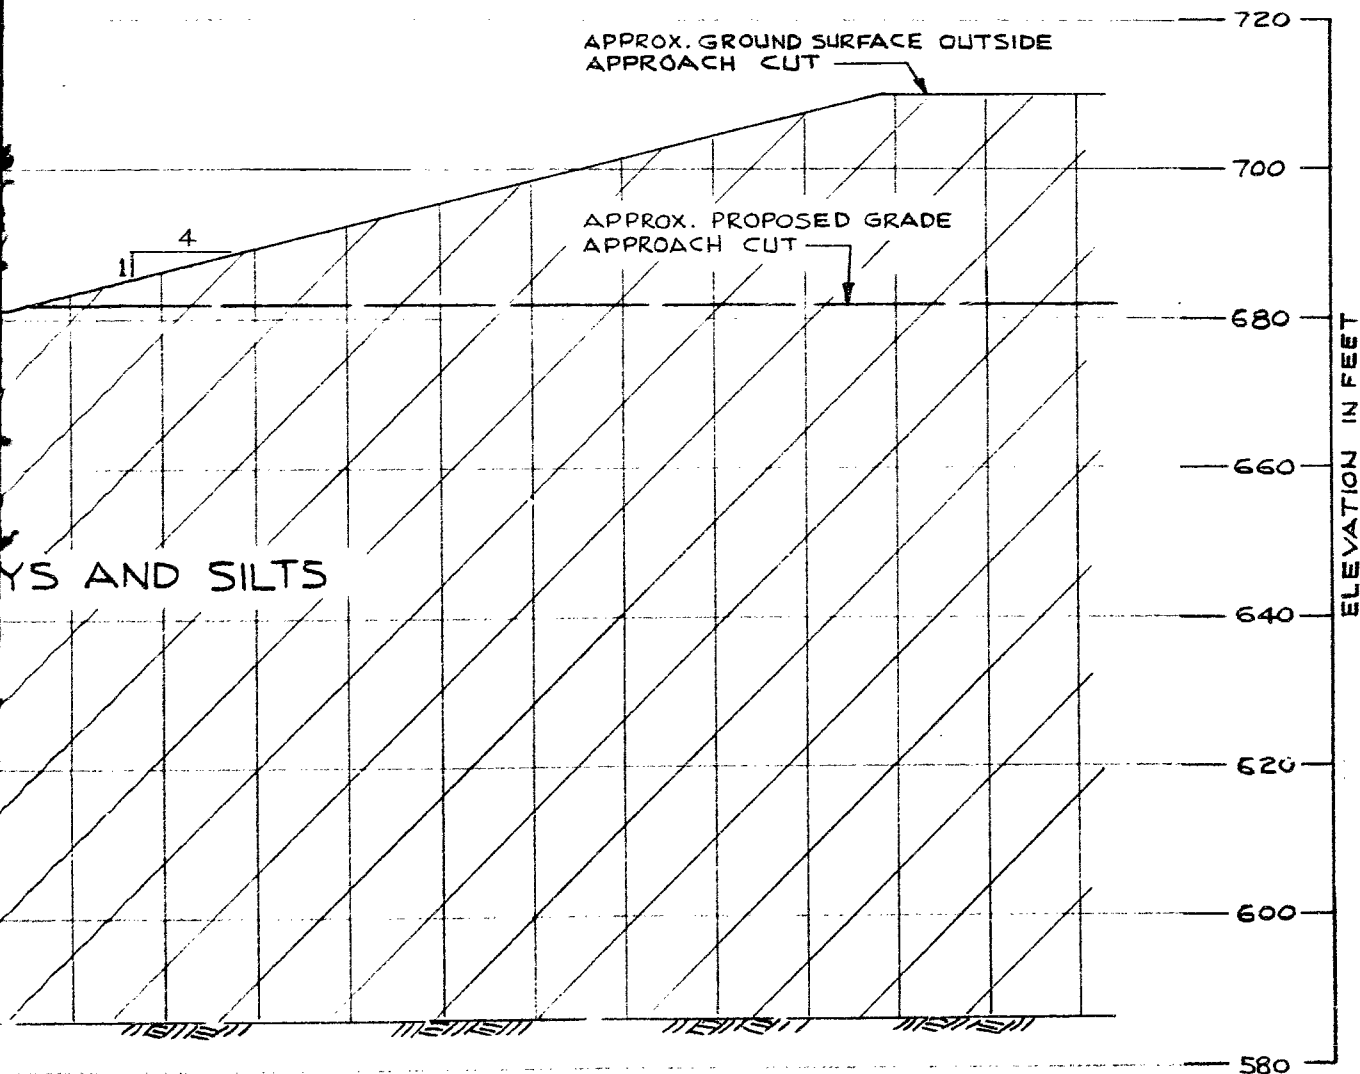
FIGURE 31

ILLUSTRATION OF PROPOSED SLOPE PROTECTION

For preliminary design purposes, earth slopes should be constructed at overall slopes of 4 horizontal to 1 vertical. Toe protection, including rip rap, will be necessary along the lower portions of the slope at the Grand River in order to minimize any potential for erosion. Abutments and piers within the slopes should be founded on steel H-piles.
