LOCATION Hwy 401, 1 km E of
Culloden Rd. - Slope Failure

Re: Embankment Slope Failure
Highway 401 at Whiting Creek
East of Culloden Road
W.O. 94-11009 (Cont. 92-06, W.P. 374-94-00)
District 2, London

Re: Slope Failures
Highway 401 at Whiting Creek
East of Culloden Road
District 2, London/Stratford
W.P. 374-94-00

Re: Embankment Slope Failure
Highway 401, 1 km East of Culloden Road
W.O. 94-11009 (Cont. No. 92-06, W.P. 479-89-00)
Geocres 40P2-54
District 2, London

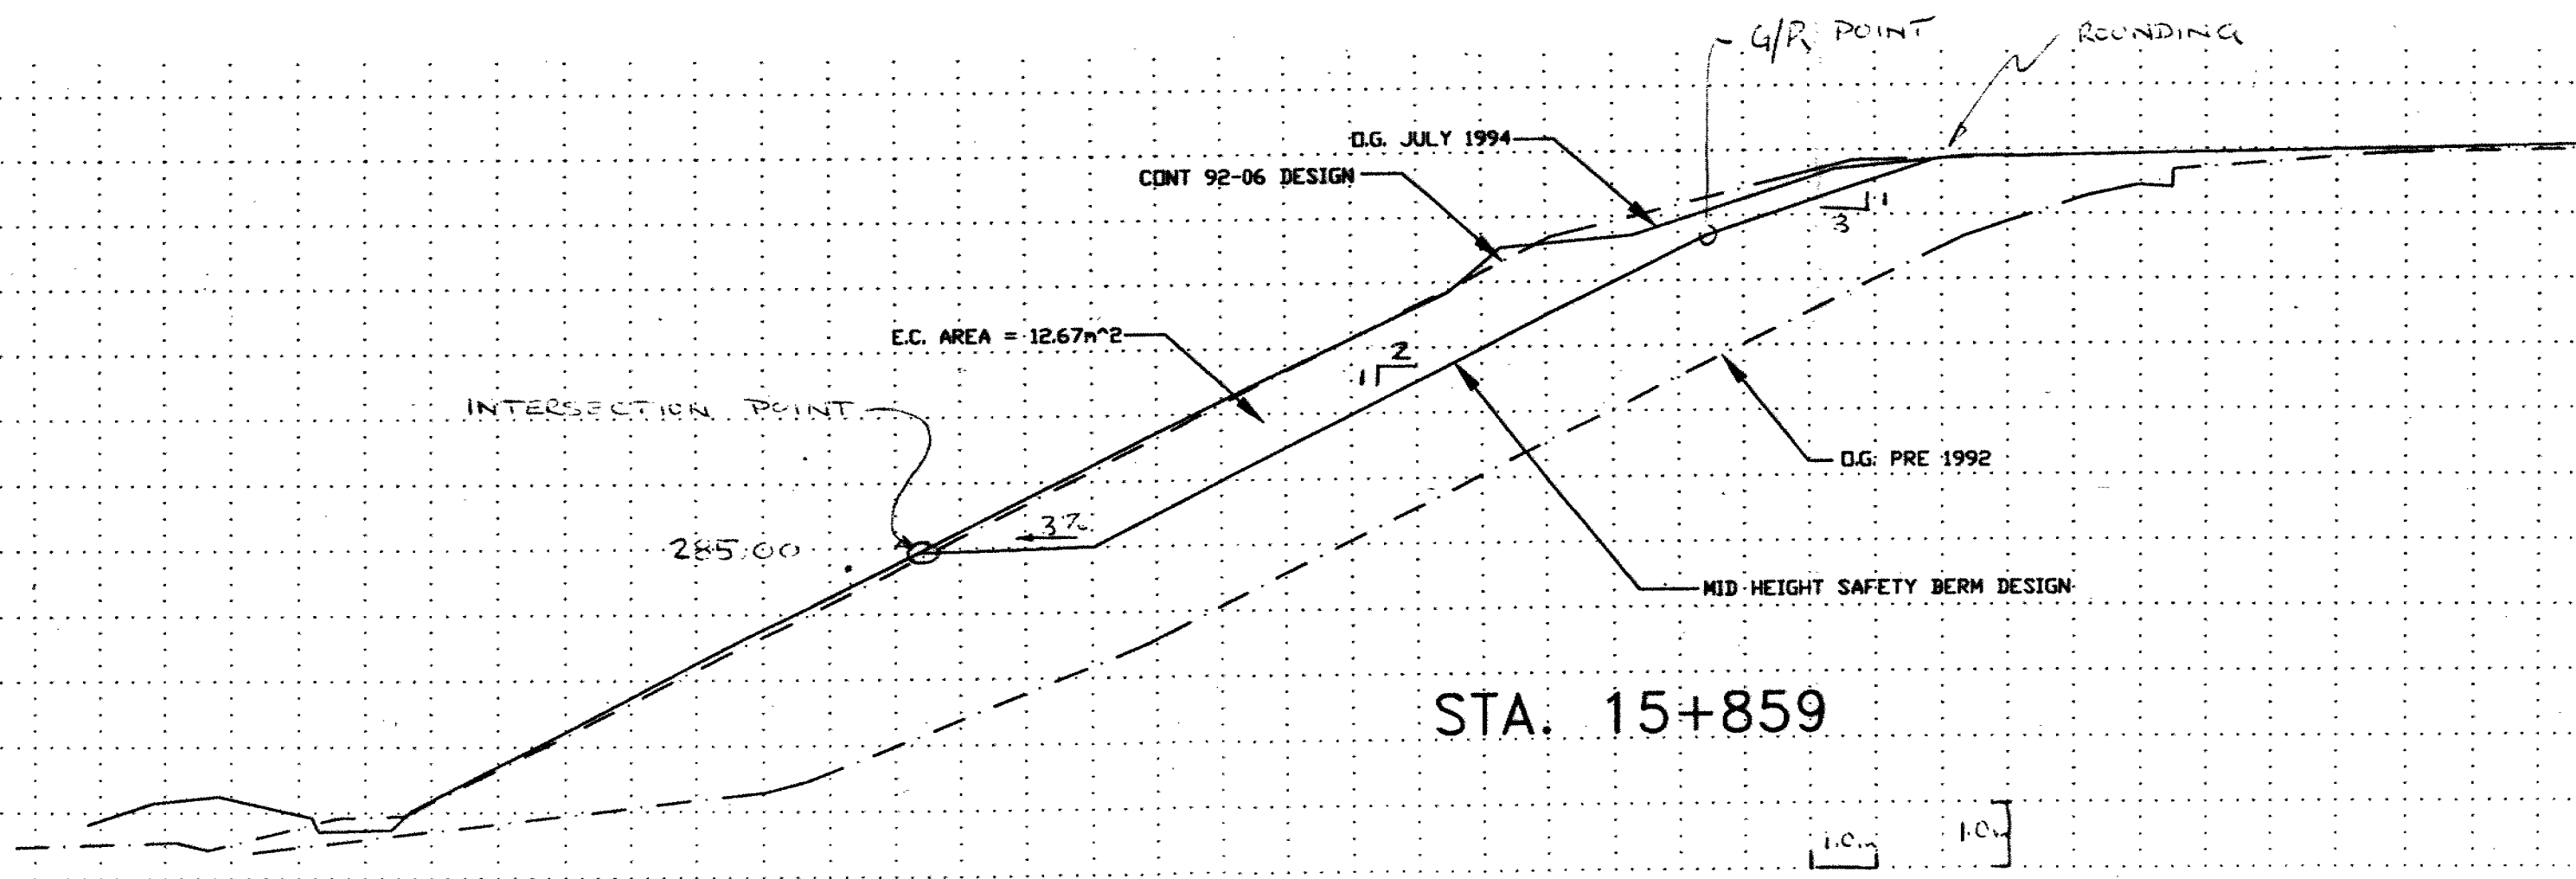
STA. 15+900

Cross-sections at Sta 15+900, 15+934, 15+970 and 16+025 show material in excess of the Contract 92-06 design line. Towards the end of construction in 1993, surficial failures occurred on both north and south slopes and equipment was used to pull excess material back up the slope. In many cases the G/R point was covered with earth preventing positive seepage from the granular base.

Hand auger holes put down by the Geotechnical Section indicated approximately 0.5 to 1.0 m of soft, wet material overlying firm to stiff, moist soil. These depths correspond with the 'excess' material shown on the cross-sections. Three trenches through the shoulder granular indicated that the earth in the fill widening was hard.

MID HEIGHT SAFETY BERM DESIGN

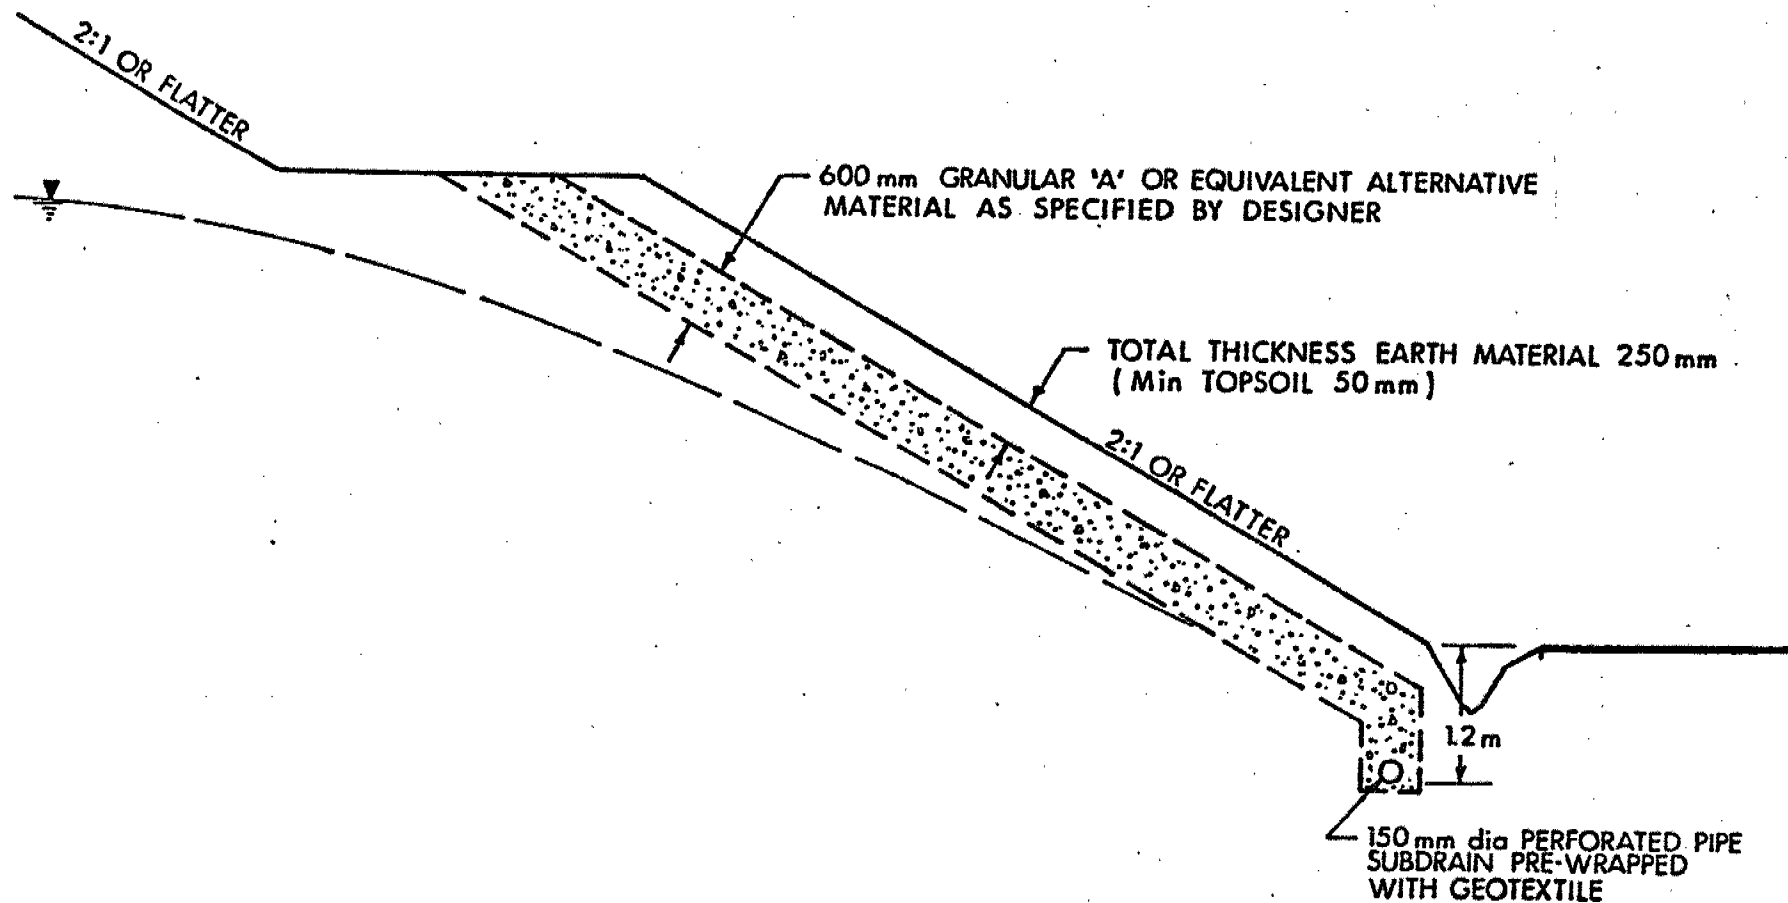
GRANULAR BLANKET

As discussed at the meeting, alternatively, Gravel sheeting or Granular blankets can be used where groundwater flow must be controlled to ensure slope stability. However, Granular blankets do not adequately sustain vegetation cover since granular materials promote moisture depletion and do not contain sufficient nutrients.

The attached figure is a detail summarizing the consensus reached during the meeting with the landscape unit of the Central Region. It incorporates a sufficient thickness of earth and topsoil (250 mm) to meet architecture requirements while providing drainage to ensure slope stability.

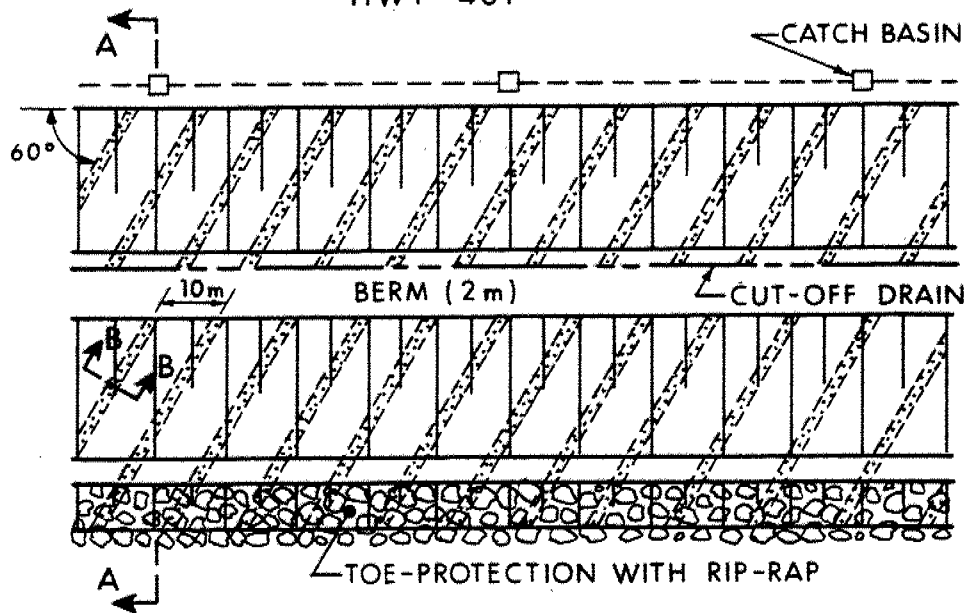
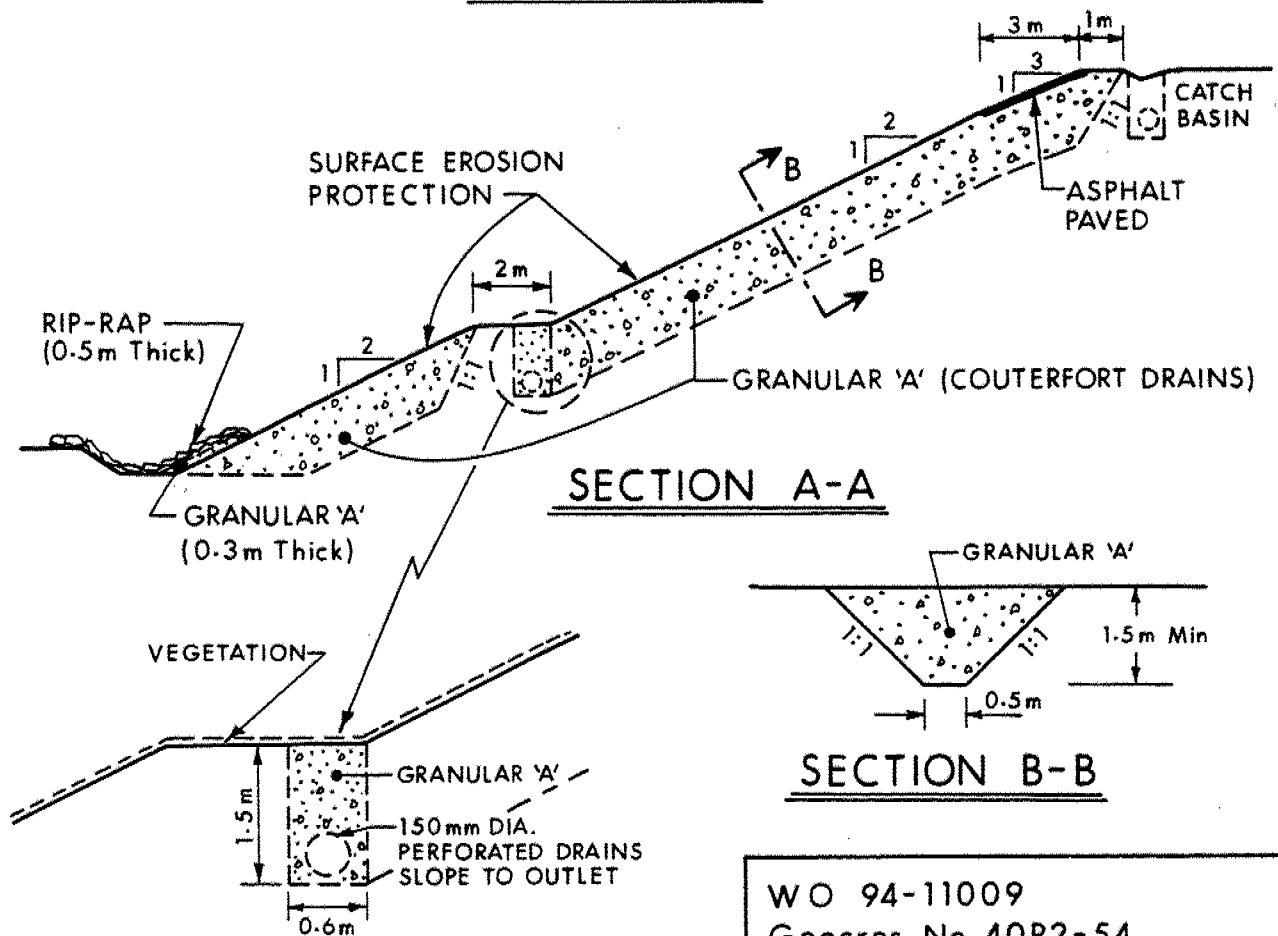
WO 94-11009
Geocres No 40P2-54
Fig. 1

- 1) Tension cracks and surficial sloughing running parallel to the roadway, were noticed at the north side slope of Hwy. 401 WBL. These failures generally are present along the crest below the asphalt paved shoulder, outside the guide rail, and extend to about 200 m from east to west.
- 2) It was found that localized surficial sloughing was also present on the south side of Hwy 401 EBL slope in the vicinity of the concrete culvert.
- 3) The material within top 3-4 m from the crest was very wet and silty.

Based on our visual observation at the site, the slope instability of the approach embankment of the C.P.R. Overhead structure at Hwy 401 appears to be of a surficial nature within the fill embankment itself rather than a deep-seated one. The primary cause of these surficial sloughing (localized failures) is probably due to the poor compaction of the silty fill material with high water content and the action of surface water seeping through the slopes which resulted in softening of the fill material composed

- 1) All of the unstable and/or loosened material in the area where the slippage has occurred should be removed and restored to a slope with a geometry not steeper than 2H:1V with a 2 m mid-height safety berm along the entire length of the fill slope, as shown on Figure 1. The fill should be keyed into the pre-existing slope in accordance with current MTO Standards and practice (OPSD 208.01).

- 2) Concrete curb or asphalt gutter with catch basins should be constructed along the crest of the upper slope on the shoulder of the highway.
- 3) An adequate cut-off trench (base width of 0.6 m) should be constructed along the crest of the mid-height berm in order to intercept the runoff water. A 150 mm diameter perforated subdrain pipe should be installed within the cut-off trench as shown on Figure 1.

- 5) Diagonal counterfort drains at least 1.5 m deep and having a minimum base width of 0.5 m should be constructed from the limit of the fill slope to the toe of the slope. The spacing of these drains should be about 10 m from centre to centre at their upper surface. The material used for the drains should consist of free-draining granular material, such as Granular "A". The details of the counterfort drains are shown on Figure 1 attached.
