HWY # 81

BRIDGE

Memo to Mr. A. M. Toye, **Date** December 11, 1959.
Bridge Engineer. **Subject** SOIL & STABILITY ANALYSIS
From Materials & Research Section. by Geoccon, Limited.

S6636
REPORT
TO
DEPARTMENT OF HIGHWAYS, ONTARIO
ON
ENGINEERING STUDY
HIGHWAY 81 STA. 53+00 - STA. 55+00
AUSABLE RIVER BRIDGE

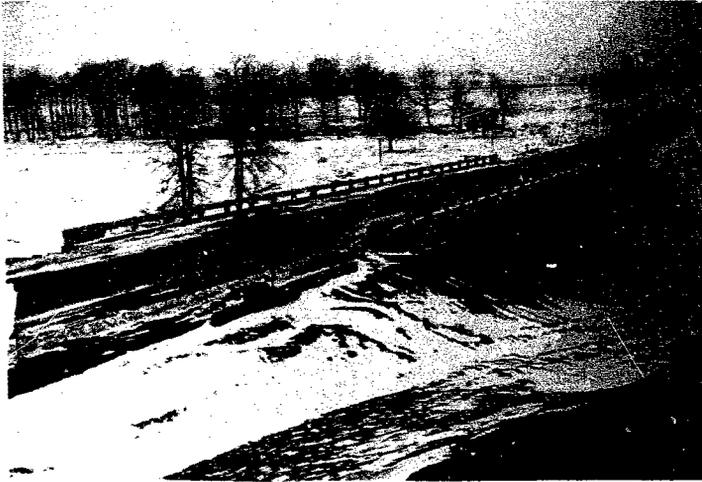
**APPENDIX III
FIGURE I
PROJECT - S6636**

**General View of Bridge
Looking North**

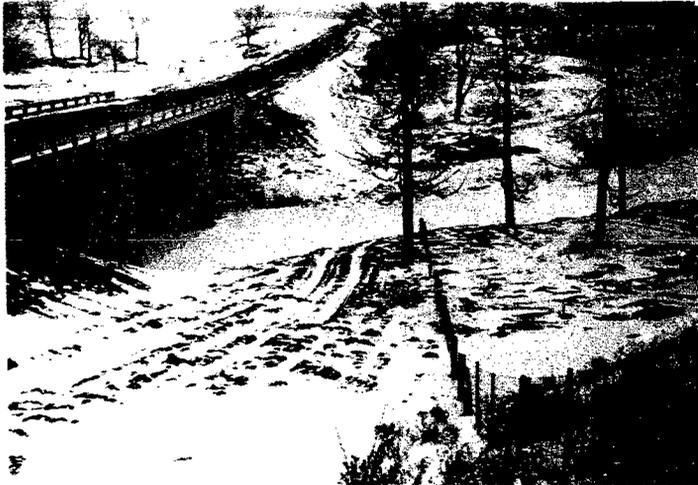
**General View of Bridge
Looking North**

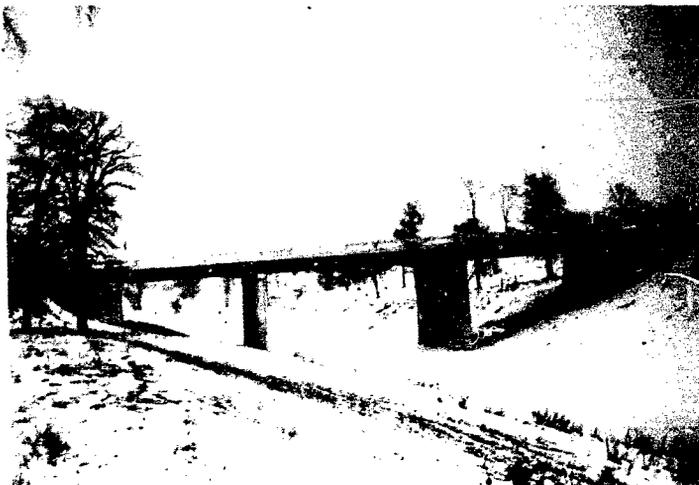
**General View of Bridge
Looking East**

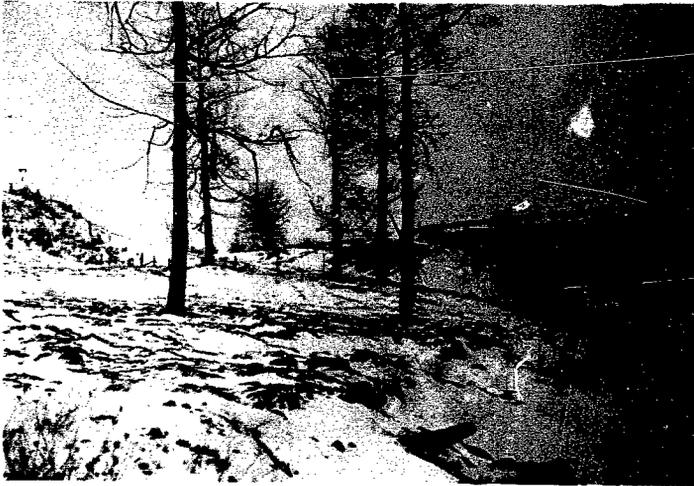
**APPENDIX III
FIGURE 2
PROJECT - S6636**

**South Abutment
Looking West**

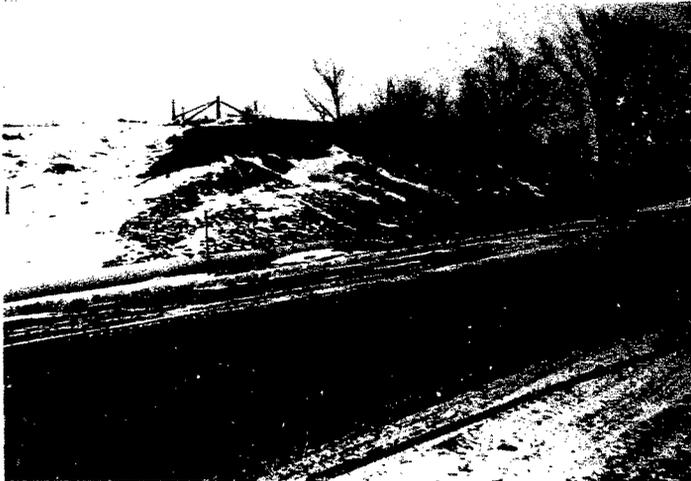
**Hill "A"
Above South Approach Road**

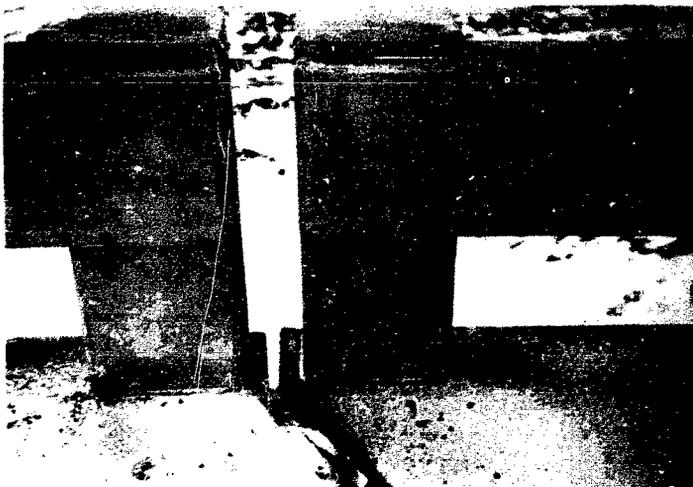
1. A gap about 6 inches wide has occurred between the road surface on the south abutment and the concrete at the south-east corner of the deck - Figures 2 and 3, Appendix III.
2. A movement of apparent closure between the south abutment and the south-west corner of the deck has also taken place - Figure 3, Appendix III.
3. Settlement has taken place of the south ends of the wing walls on both sides of the south abutment.

**S.E. Curb
Present Condition**

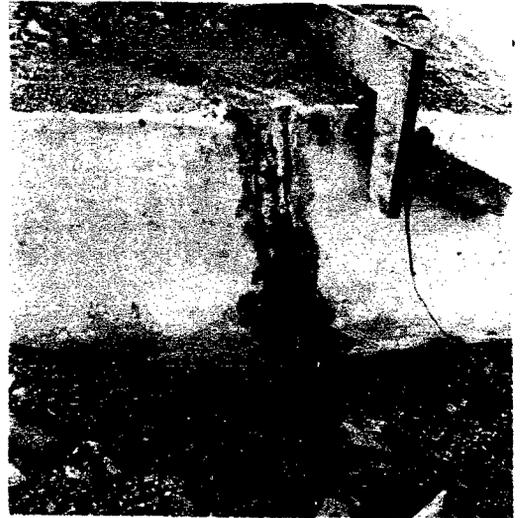
**S.W. Curb & Expansion Joint
Primary Movement**

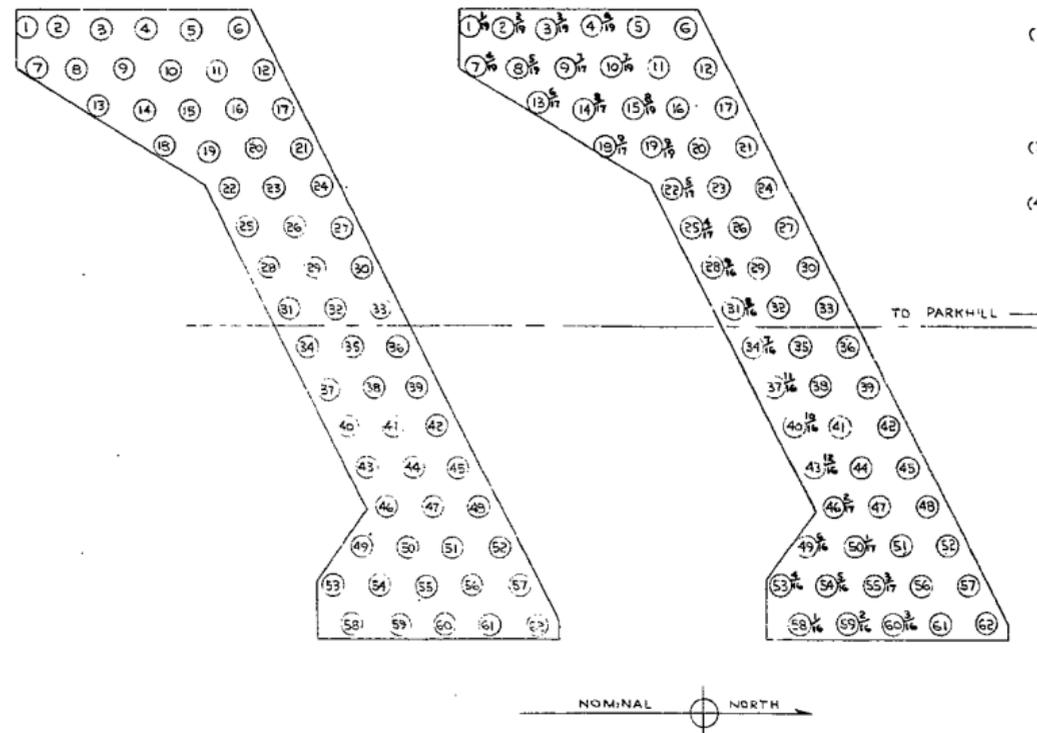
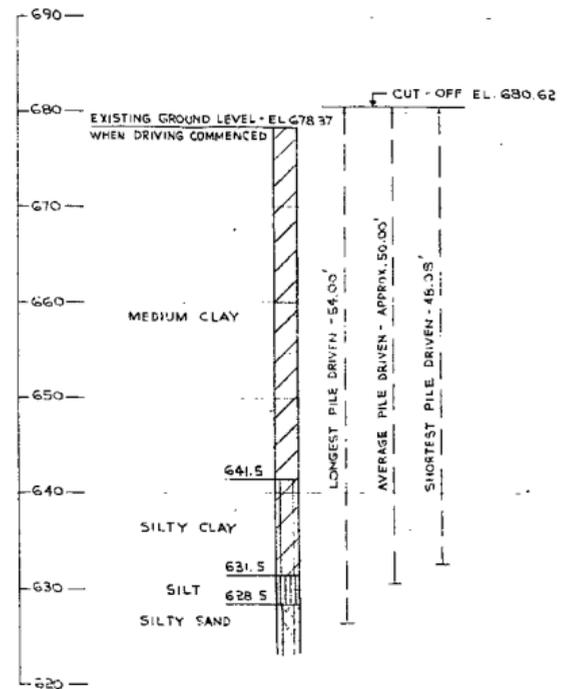
MADE CHD. APPD. J.A. 17-7 17-7 No. 56636-4

It may be noted that piles numbered 3 to 6, 10 to 12, and 15 to 23, although driven in the period March 16th to 23rd, 1956, were not concreted until over a month had passed. At that time the piles were filled with concrete in the same pour as the abutment footing. These piles are all located in the western corner of the abutment or at the area of apparent closure of points 5 and 6, Drawing S6636-3D. Since the piles are bonded approximately 2 feet into the abutment footing, it seemed possible that lateral movement of the abutment could have been caused by structural deformation of imperfectly filled piles, thus inducing a partial bond failure in the local area between the piles and the footing. Consequently an inspection was carried out at the pile/abutment base interface from test pits dug along the front face of the abutment. No signs of bond or concrete shear failure could be detected and the pile tops examined were in sound condition.

It may further be noted that the back vertical piles in the wings of the south abutment represent the shortest piles driven. These piles are numbered 1 to 3, 7 to 9, 13, 14, 49, 53, 54, and 58 to 60. If no local bond failure occurs, it can be assumed that settlement of the back of the abutment must be accompanied by corresponding settlement of the back piles. It is therefore of interest to examine the range of probable load on the piles.

- (1) PILES DRIVEN IN PERIOD MARCH 16-23
PILES MARKED AS DRIVEN EACH DAY E.G. 19
FIRST PILE DRIVEN ON MARCH 19.
- (2) ALL PILES FILLED WITH CONCRETE ON
MARCH 24, WITH THE EXCEPTION OF THOSE
PILES MARKED ○ WHICH WERE FILLED ON
APRIL 25, THE SAME DAY AS FOOTING.
TEMP. RANGE 32° TO 40° F. WORK CEASED
1.00 A.M., TIME OF CONCRETE POUR 17 HRS.
- (3) VERTICAL PILES ○
BATTER PILES ○
- (4) PILE NUMBERS FROM D.H.D. RECORDS

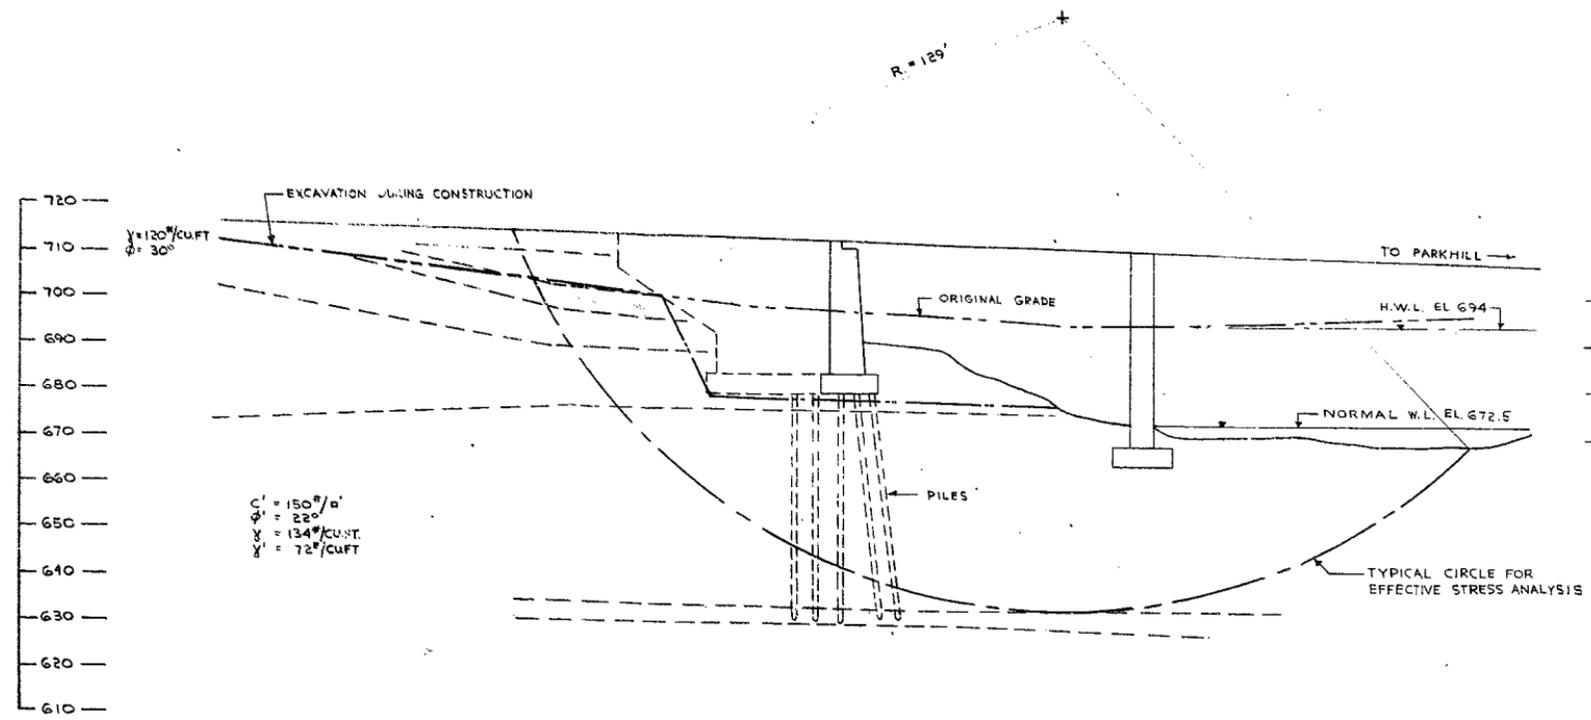
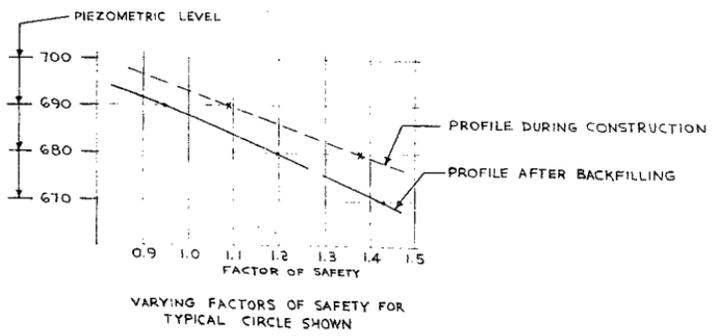
Considering assumption (b) the most radical change in piezometric pressures within the slope, would take place following a rapid drawdown of river level. This drawdown condition could occur immediately following spring flooding, as for example in March 1956. Piezometric surface was assumed to coincide with the face of the slope below HWL, taking \bar{B} as 1. On this assumption, the factor of safety for a drawdown from HWL of 694 to LWL of 672.5 is computed to be 1.1.

It may be seen from the stability computations that the overall stability of the south abutment is critical for high piezometric pressures within the slope. It is therefore recommended that piezometers be installed to measure the variation in piezometric pressure at depth over a period of from 6 months to 1 year. Readings should be taken at regular intervals within this period of both rainfall and river level in order

- (1) TOTAL STRESS ANALYSES GIVE RANGE OF FACTOR OF SAFETY 1.6 TO 2.0 DEPENDING ON RIVER WATER LEVEL.
- (2) SLIDING PLANE ANALYSIS ABOVE SAND AND GRAVEL FILL ON SECTION A-A, DRAWING S6636-2 GIVES A FACTOR OF SAFETY = 1.1, IF PIEZOMETRIC HEAD OF 4 FEET EXISTS IN SAND AND GRAVEL.
- (3) EFFECTIVE STRESS ANALYSIS OF SECTION SHOWN, ON CONDITIONS OF RAPID DRAWDOWN FROM H.W. - EL. 694 TO N.W.L. - EL. 672.5, GIVES FACTOR OF SAFETY = 1.1

5. It is recommended that piezometers be installed to determine the degree of piezometric pressure within the clay and silt strata. The suggested locations of the piezometers are given in the report.
