STABILITY ANALYSIS REPORT --

Re: Au Sable River Bridge, Hwy. 81,
District 2, London, Ontario,
Cont. 55-274.

REPORT ON
STABILITY ANALYSIS

Au Sable River Bridge, Highway 81,
District 2, London, Ontario.

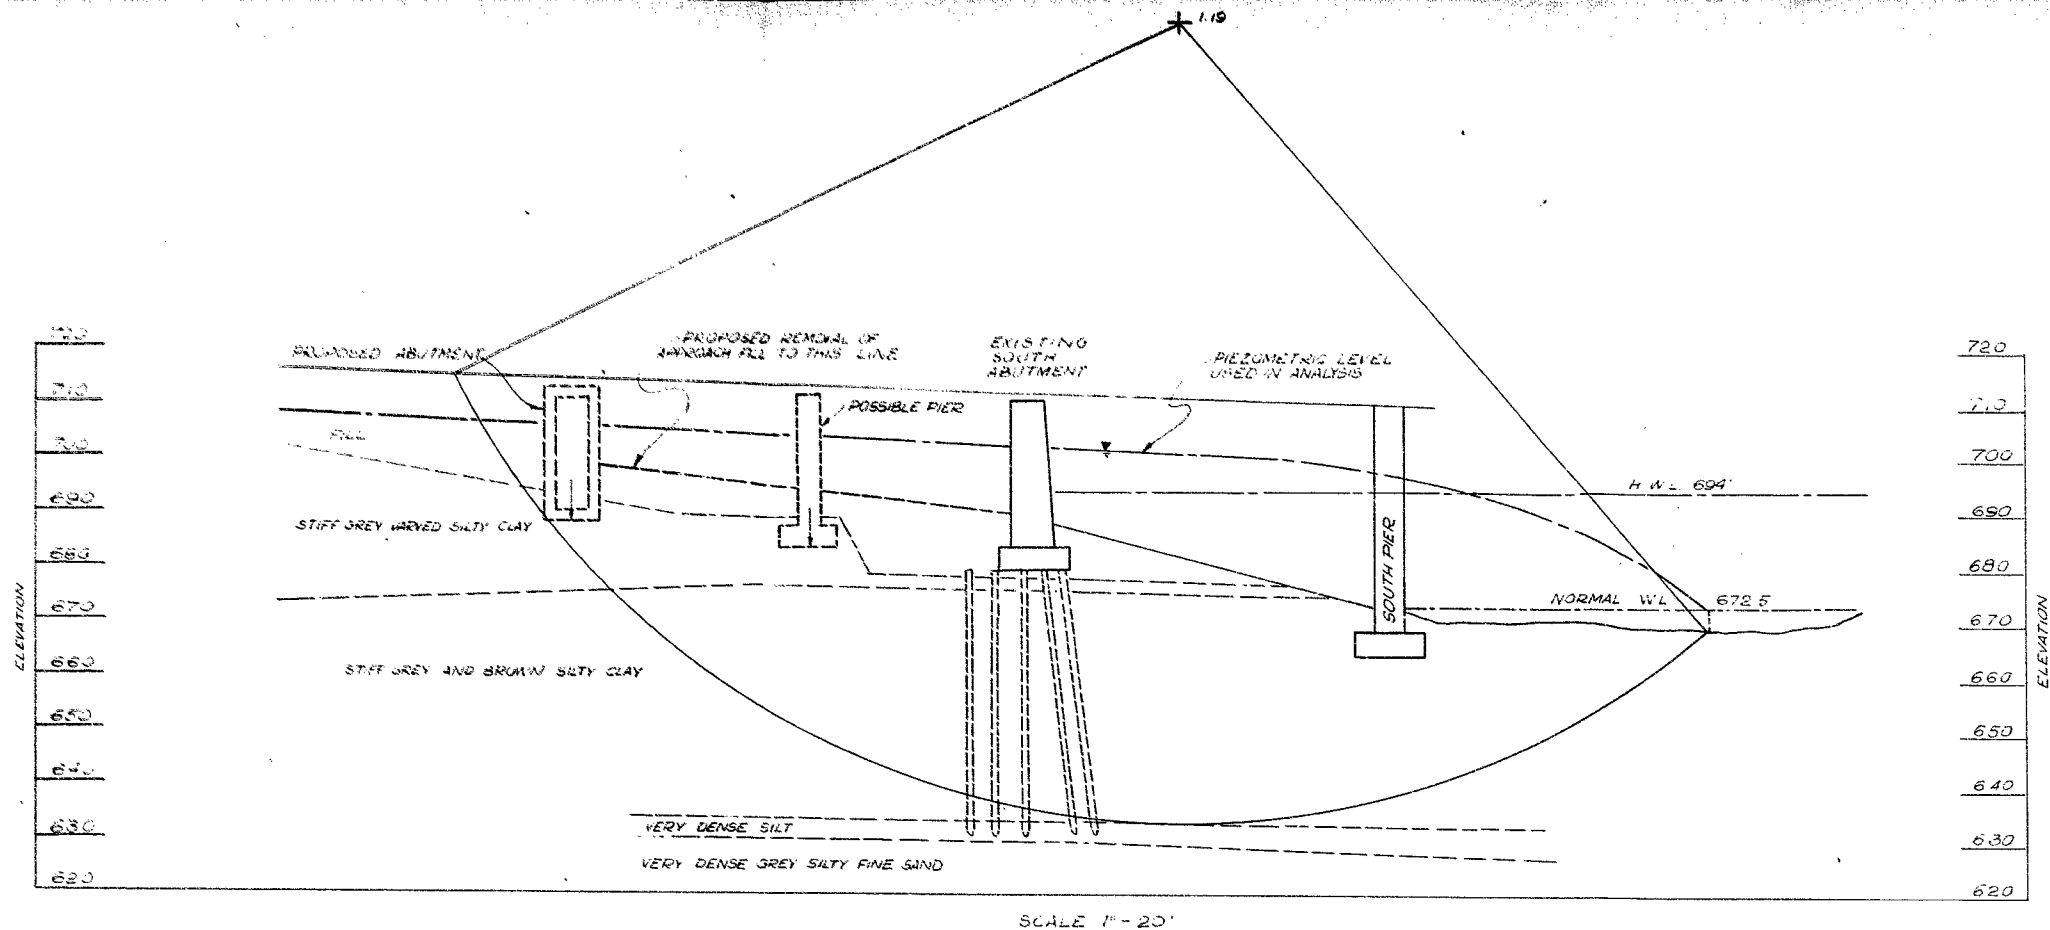
Calculations indicate that the lengthening of the span by 80 ft., as shown in Figure 2, and the removal of the approach fill over this length, would increase the factor of safety of the slope to a rotational type of failure by 15 to 20 percent. The increase in the factor of safety would be of the same order whether or not an intermediate pier were used between the proposed new abutment and the existing abutment. These calculations are based on the proposed abutment and pier being supported on spread footings in the stiff, grey, varved silty clay. A further increase of about 10 percent in the factor of safety of the slope would be obtained if the abutment were supported by friction piles in the clay or on longer piles penetrating to the dense, silt layer.

FOR ANALYSIS, LOAD AT BASE OF PROPOSED
NEW ABUTMENT WAS ASSUMED TO BE 25 K/FT
OF LENGTH WHEN ADDITIONAL PIER WAS USED,
40 K/FT. WITHOUT PIER, LOAD AT BASE OF
PROPOSED PIER WAS ASSUMED TO BE 40 K/FT.

It is recommended that the approach fill to the present South abutment be removed for a distance of at least 80 ft. and the span be lengthened the same amount. The additional span could be supported by a new South abutment and an intermediate pier, or an abutment alone. Spread footings could probably be used for the pier and abutment, but the foundation conditions would have to be determined more exactly when the proposed type of structure is known.

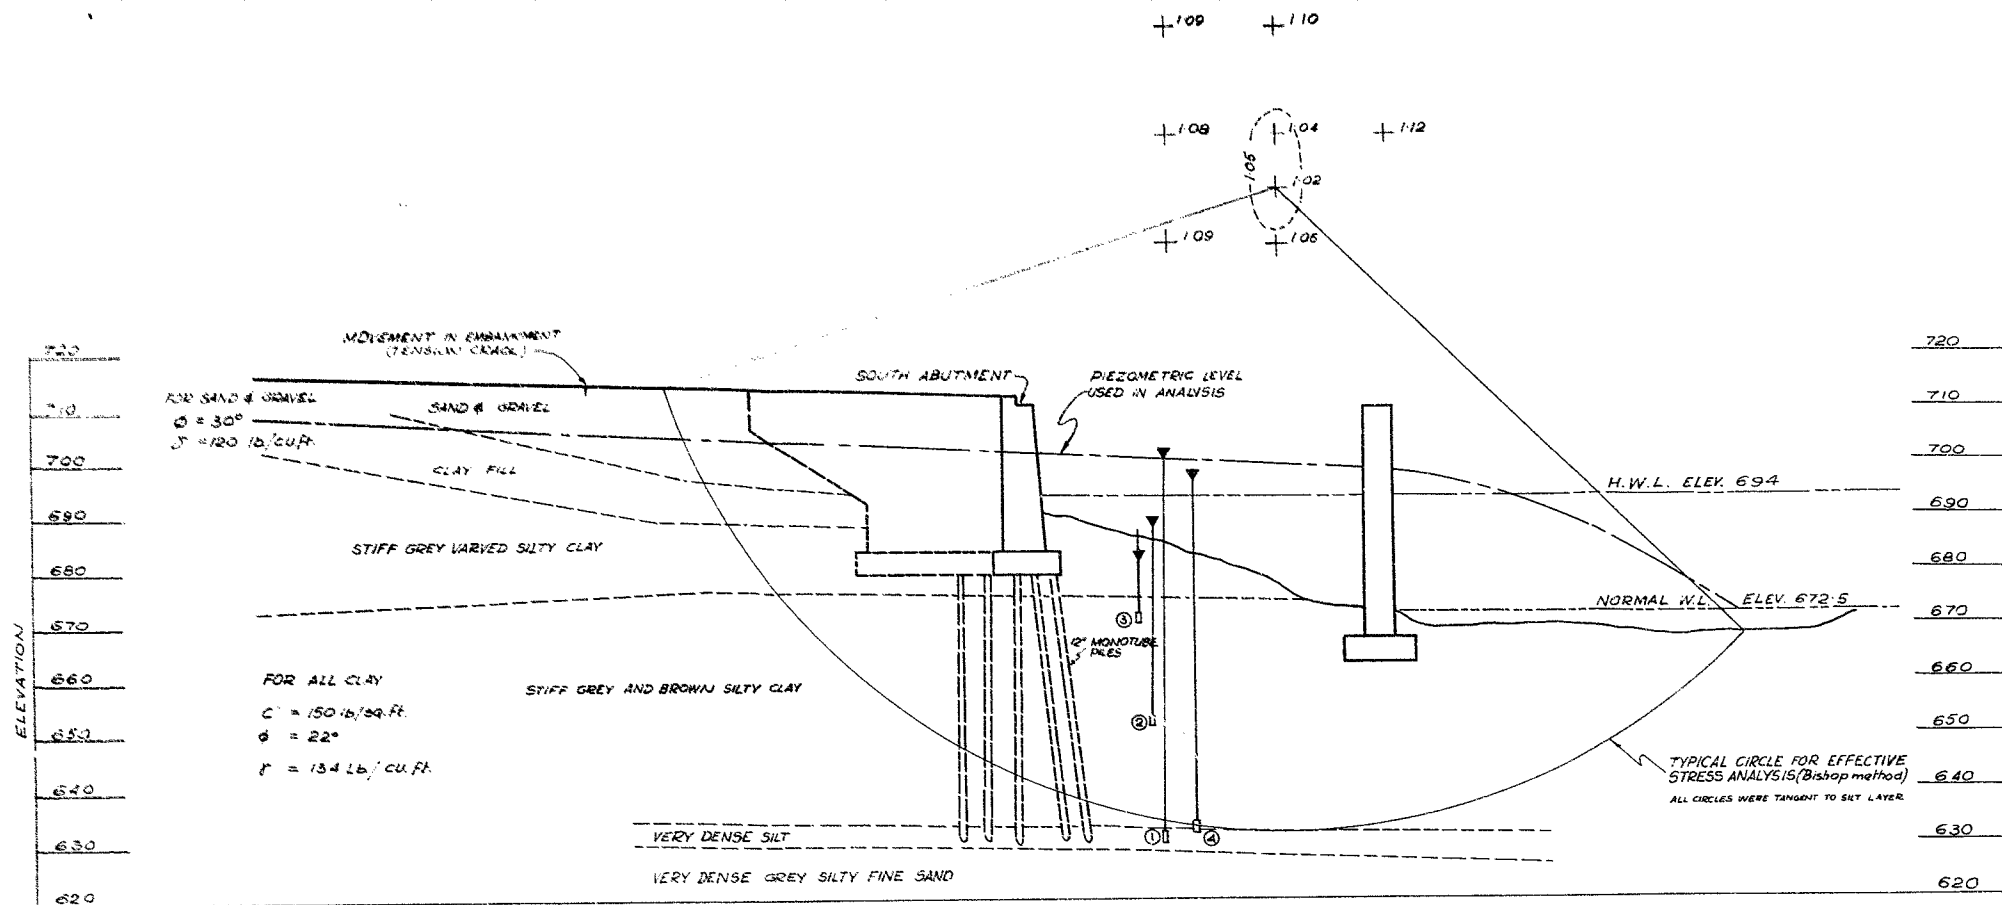
RESULTS OF
STABILITY CALCULATIONS
AUX SABLES RIVER BRIDGE
HIGHWAY 81 STA 53+00 - STA. 55+00
JOB NO 60-F-47 FIG 1.

A study of the stability of the South slope and abutment was carried out using the measured piezometric levels. The study consisted of assuming a rotational type of failure (see Fig. I.) the circle of which was tangent to the silt layer containing the high piezometric level. Such a circle would pass almost under the piles supporting the abutment and the weights of the abutment, pier and their loads were assumed to be carried outside the slip surface.

Analyses of this type give the factors of safety shown in Fig. I. with a minimum factor of safety of 1.02. A factor of safety this close to unity is fortuitous but does indicate that the type of analysis is a reasonable one for the case.

The analysis indicates that the suspected rotational type failure is probable and therefore, remedial measures may consist of: (1) increasing the shearing strength of the soil by lowering the piezometric water level, or: (2) of reducing the weight tending to cause failure. The lowering of the water table could be accomplished by the installation of filter walls which would tap the artesian head in the silt and fine sand. However, it is not possible to estimate how many wells would be required for this as the supply of the water under the artesian head and the permeability of the aquifer is unknown. The installation of one or two wells could give some indication of the number which might be required, but as the permanence of filter wells is questionable, since they may become silted up, it is better to consider more permanent methods of increasing stability. In the case of this bridge, the instability was apparently caused by the addition of the weight of the approach fill to a natural slope which had reached its stable state by geologic processes. The most logical, as well as the most practical method of stabilizing the slope, therefore, is to remove the fill which started the movement.
