DEPARTMENT OF HIGHWAYS - ONTARIO			
MATERIALS & TESTING DIVISION - FOUNDATION SECTION			
DEVELOPMENT ROAD 724			
STA. 39 + 00 TO STA. 42 + 00			
KING'S HIGHWAY NO. _____		DIST. NO. 2 _____	
CO. MIDDLESEX			
TWP. W. WILLIAMS & ADELAIDE LOT _____		CON. _____	
BORE HOLE LOCATIONS & SOIL STRATA			
SUBWD. A B	CHECKED <i>19</i>	W.P. NO. _____	M.S.T. DRAWING NO. _____
DRAWN S.O.	CHECKED _____	JOB NO. 67 - F - 95-1	67 - F - 95 B.
DATE 18 JUL 1968	SITE NO. _____	BRIDGE DRAWING NO. _____	
APPROVED <i>A. B. Thomas</i>	CONT. NO. _____

SUPPLEMENTARY REPORT ON THE SOILS  
INVESTIGATION AT THE FAILURE AREA

On Development Road #724  
Sta. 39+00 to Sta. 42+00  
County of Middlesex  
W.J. 67-P-95-1 -- Dist. #2 (London)

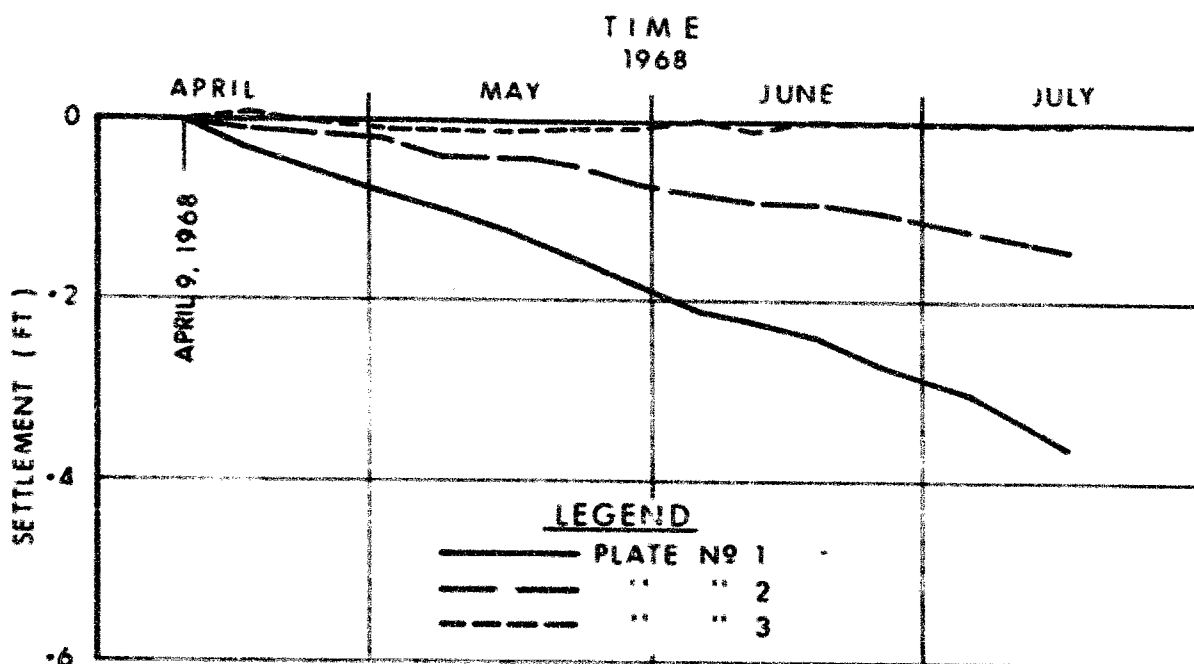
FIG. 1

The settlement plates have been installed and observed now by the District for a period of 14 weeks. The locations of the plates and the observations of settlements are plotted on Figures #1 and #2. By the end of May 1968, it became obvious that the settlements at the approx. centre of the failure area (Plate #1) proceeded at a constant rate, averaging about  $3/16"$  -  $1/4"$  per week. Due to the fast rate of settlement, it was decided that further field investigation and instrumentation be implemented in order to present some remedial measures at an early date.

PLATE NO	INITIAL PLATE ELEVATION	STATION	OFFSET
1	739.6	39+98	17.9' RT
2	741.2	41+24	20.6' RT
3	740.9	43+35	18.9' RT

APPROX DEPTH OF PLATES 5 Ft BELOW GROUND LEVEL

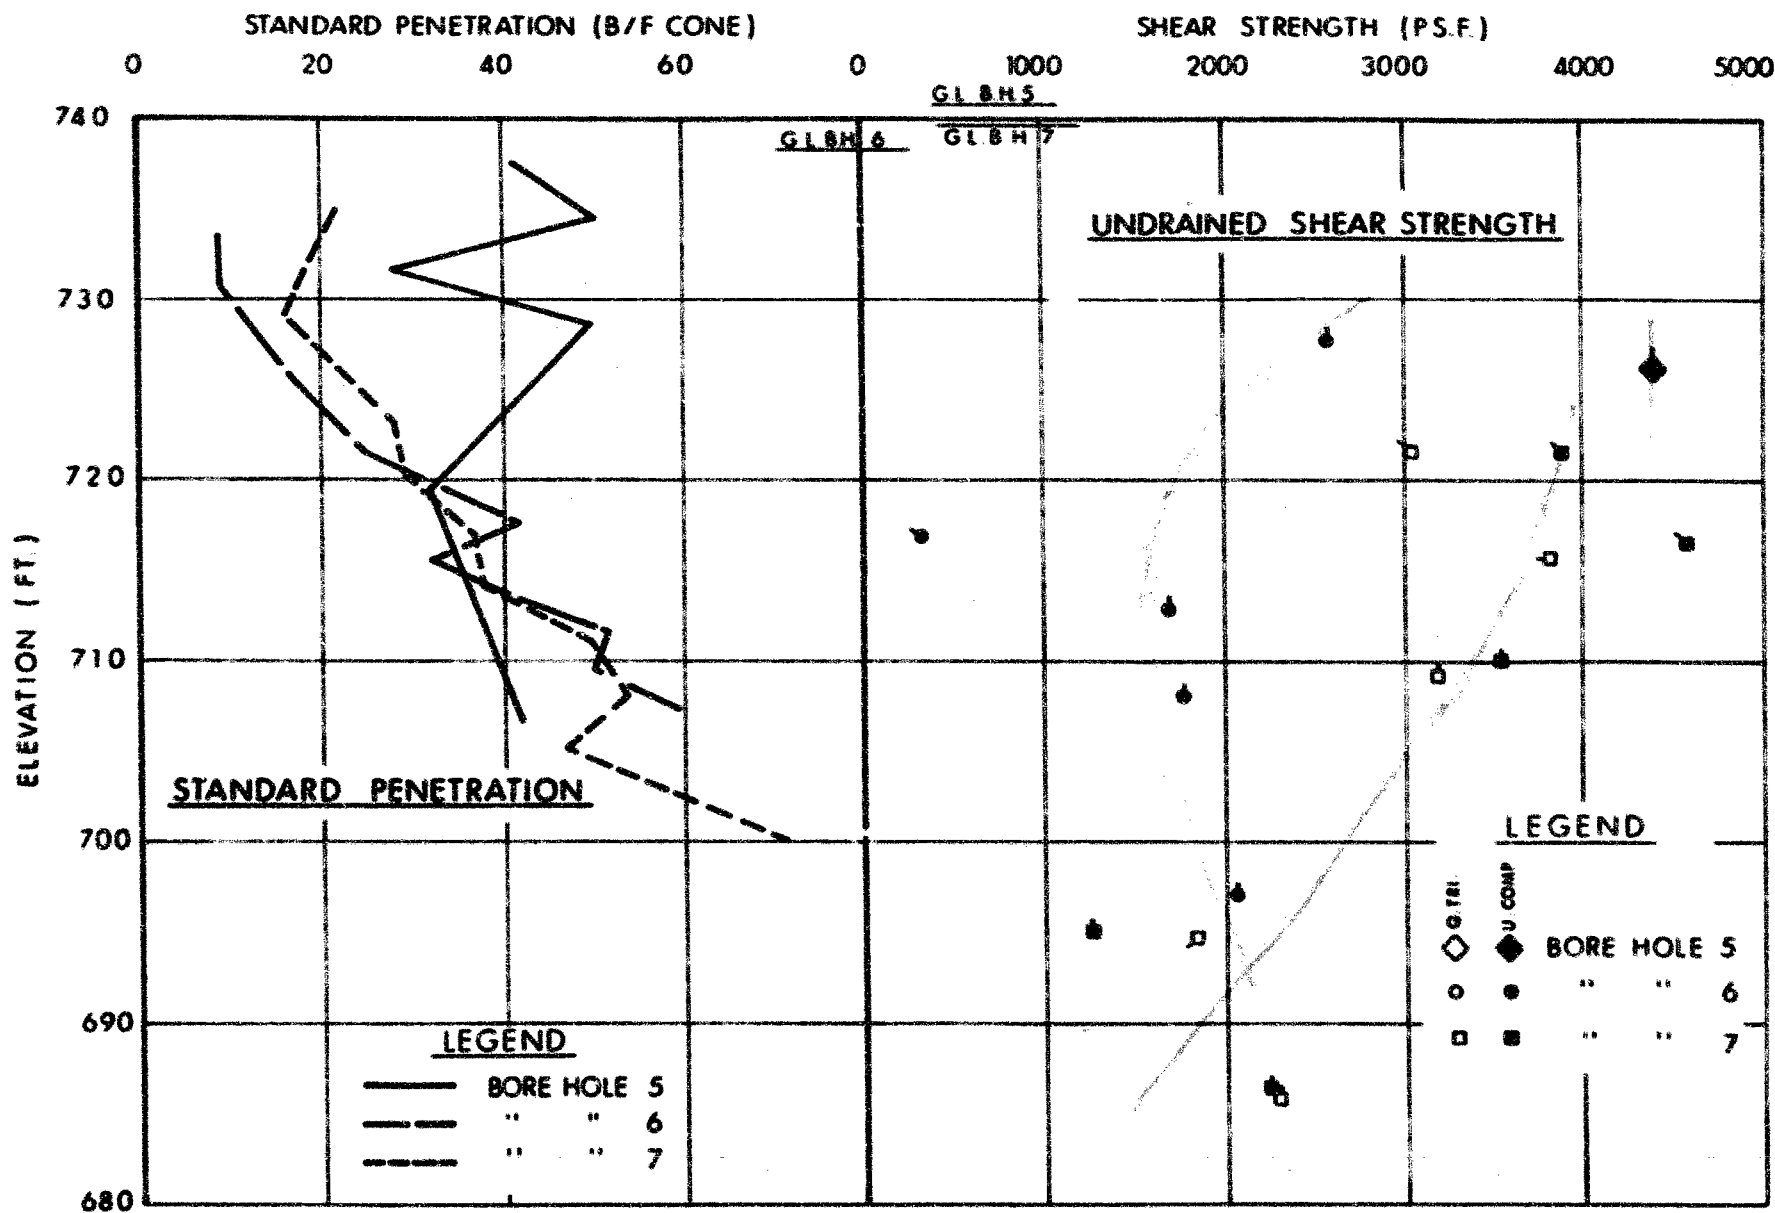
FIG. 3

certain physical properties of the samples. By examining the graphs it may be noted, that the values of the standard penetration tests are lower at the centre of the failure than at the sound zones. The weaker layer extends to approx. 20 ft. below shoulder level, corresponding to the depth of the new fill (Fig. #3). By comparing the undrained shear strength values, the difference appears to be even more pronounced. The upper approx. 40 ft. of material exhibits shear strengths lower in B.H. #6 than in B.H.'s #5 and 7. The 40 ft. includes the old dumped fill as well, indicating that this material, however dense it is, shows a great deal of disturbance and remoulding. On Fig. #5, a comparison is made of the liquidity indices. From the figure it is postulated that certain layers within the failure zone are wet, likely being caused by percolating groundwater. (See Fig. #5 - Elevation above 731 ft. again around El. 716 ft. and 697 ft.)

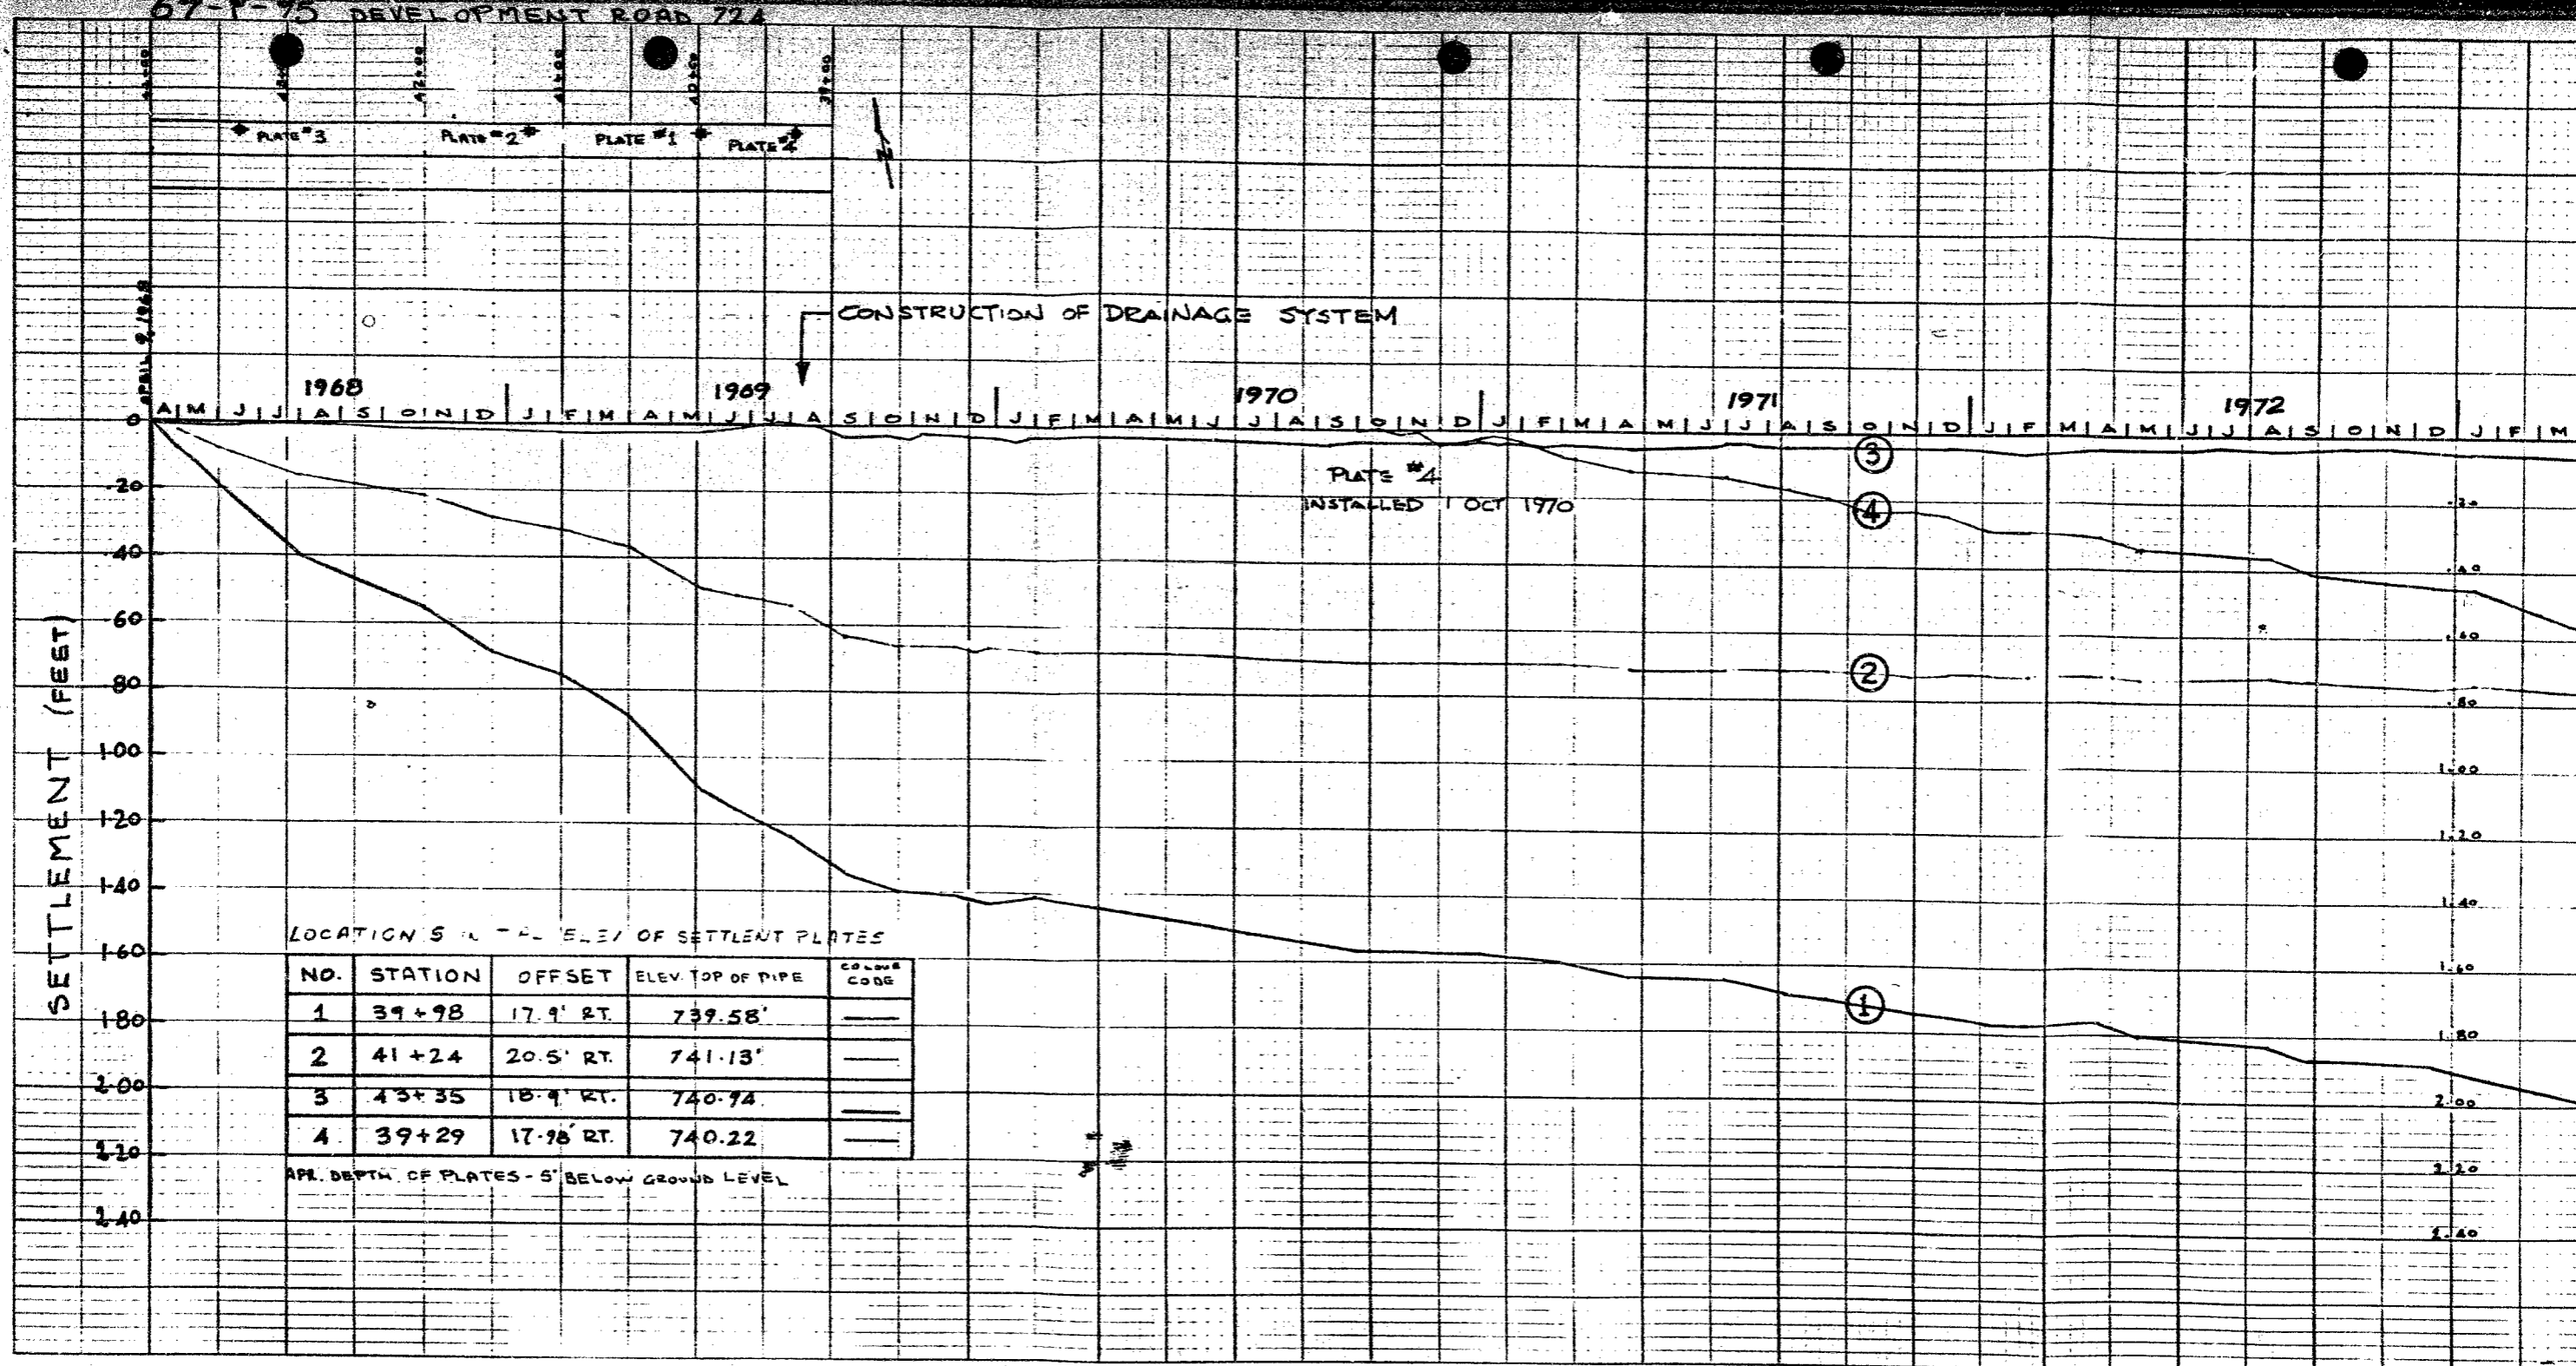
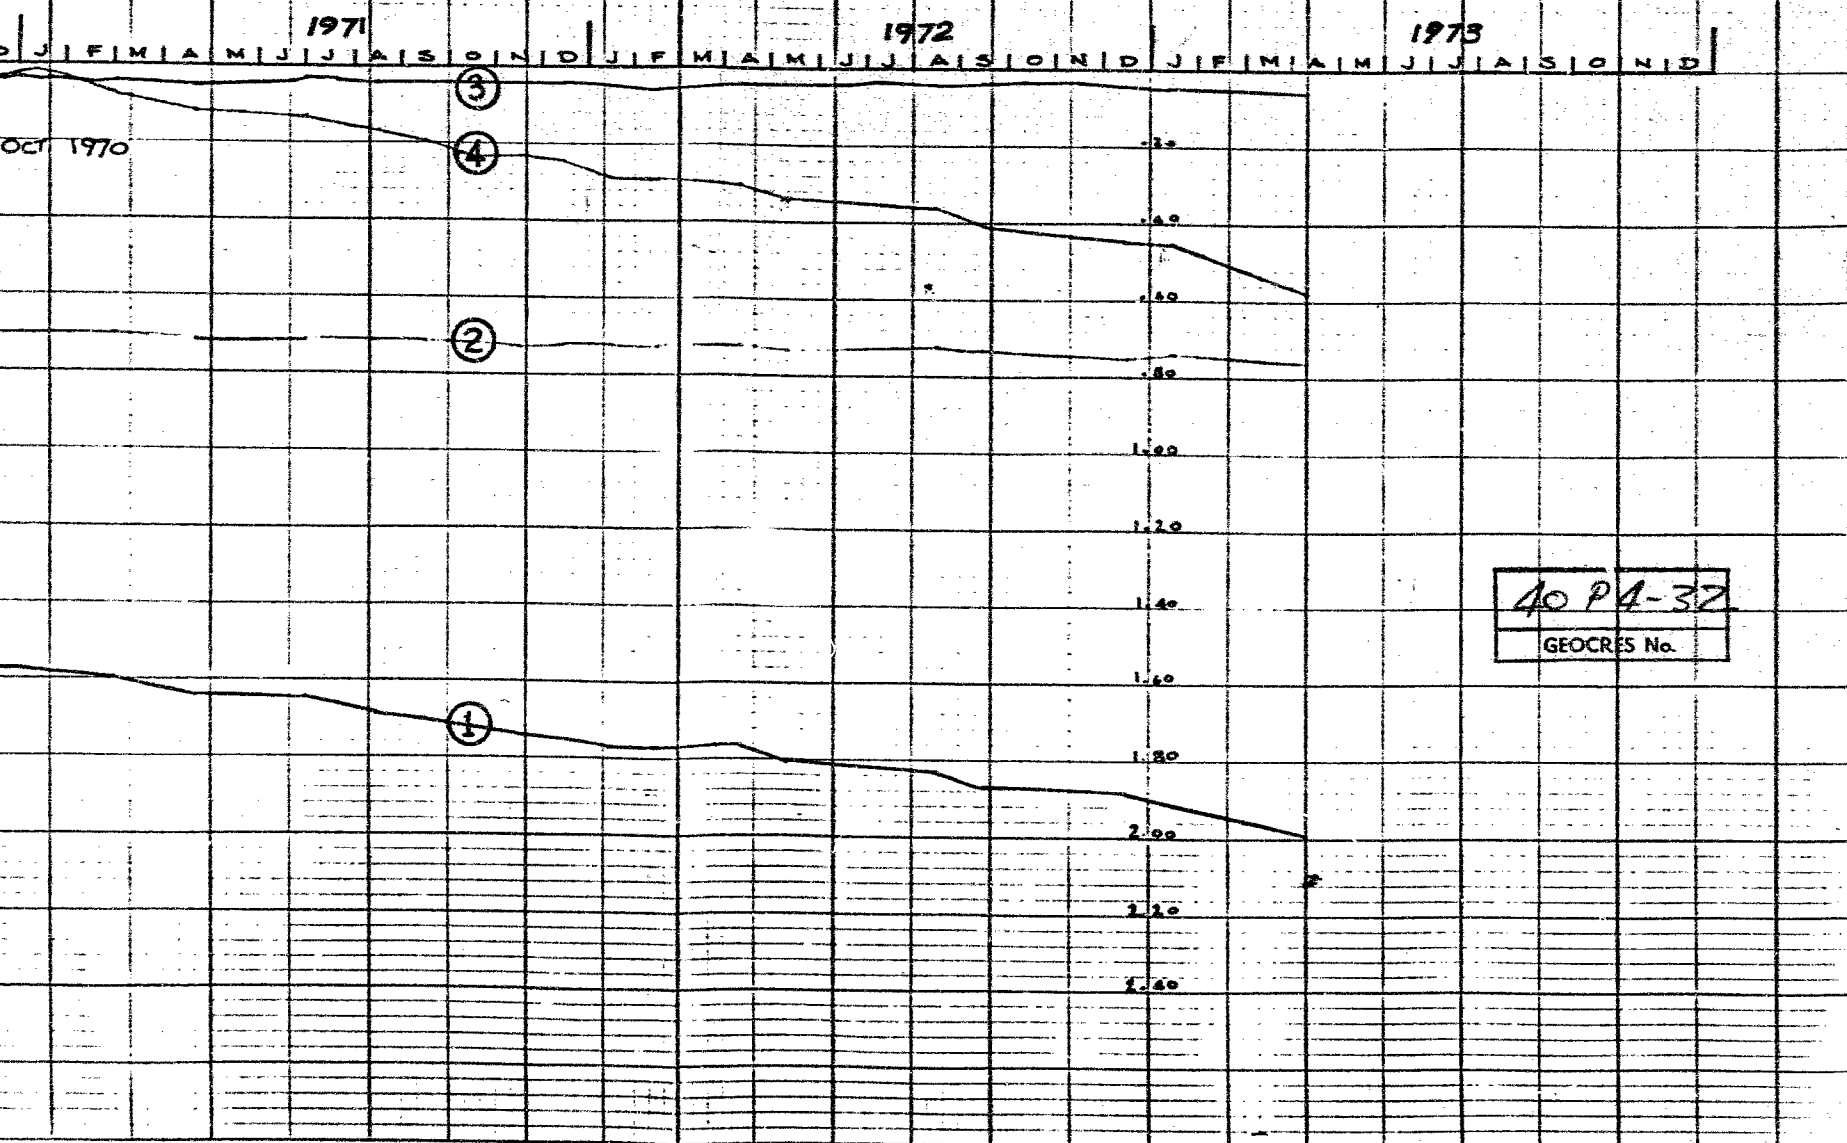
DRAWING 67-F-95 D

A study of the settlement records (see attached Drawing 67-F-95D) shows that the immediate result of the new drainage system was a significant decrease in the rate of settlement; i.e., at Sta. 40+00 the rate decreased from 1/4 inch per week to 1/25 inch per week. West of Sta. 41+25 the rate decreased from 1/10 inch per week to zero. In the fall of 1970 the new pavement cracked over an area some 200 ft. long centred about Sta. 39+30. A new settlement plate was installed at Sta. 39+25 in October 1970 and subsequent records show a steady rate of settlement of about 1/20 inch per week. It is now evident that settlement is likely to continue at more or less the same rate along the entire area between Stas. 38+00 and 41+00 for many years to come.

- 1) The main cause of the settlement is a poorly compacted layer of clayey silt with organics which was dumped on the old slope surface prior to construction of the new embankment.
- 2) The installation of the drainage system has considerably improved, but not cured the settlement problem. Some seepage water is still entering the fill, as is evident from the existence of a wet area on the north slope.
- 3) Further improvement to the problem might result if a drain and filter is provided in the wet zone on the north slope of the embankment. The purpose of this drain would be to release water trapped in the fill and the purpose of the filter to prevent piping.
- 4) Without major reconstruction of this embankment it appears likely that settlement will be a continuing problem for the foreseeable future.
