#63-F-138
HWY. #23
MITCHELL
PATROL YARD

MITCHELL PATROL YARD

FOUNDATION INVESTIGATION REPORT

Mitchell Patrol Yard
Lot 26, Con. IV, Twp. of Fullarton,
Hwy. #23, District #3.

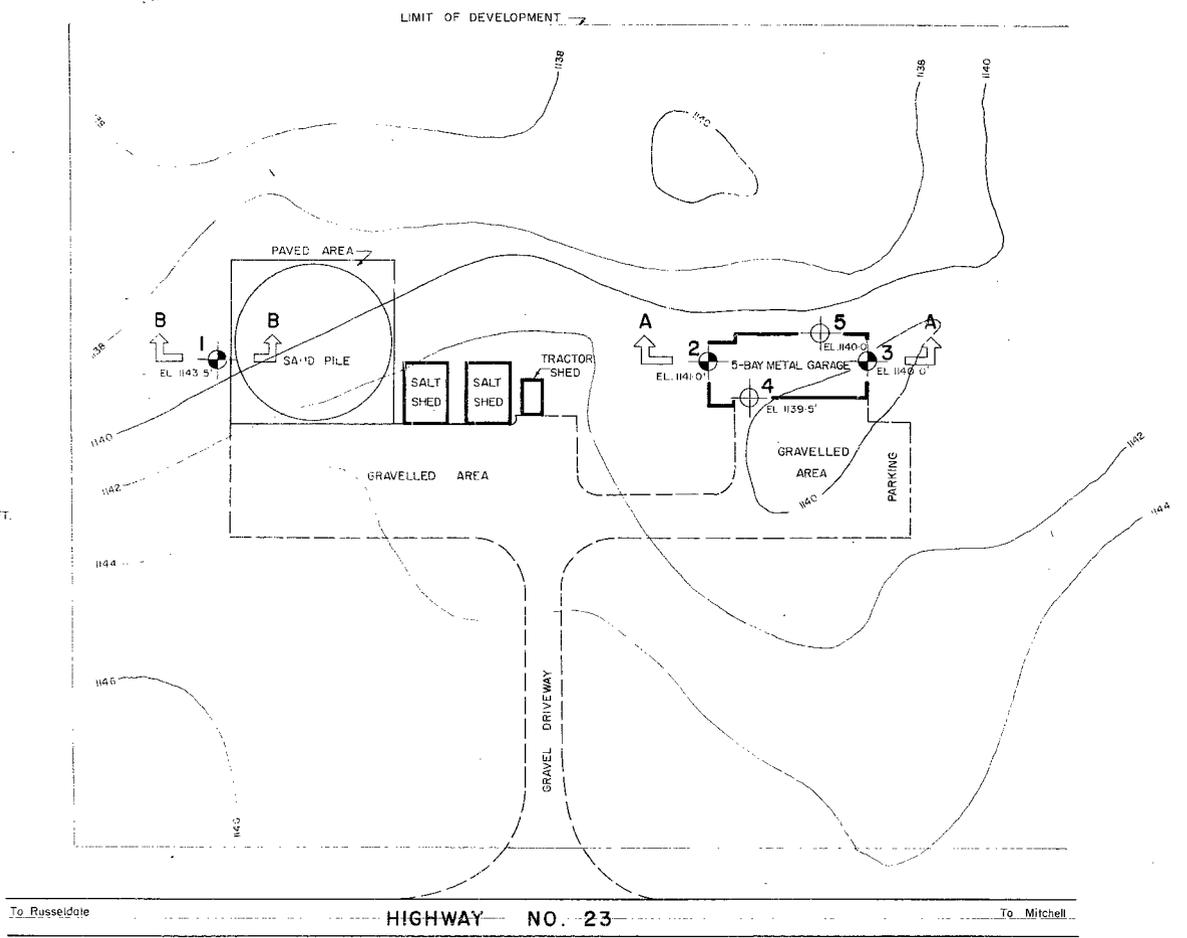
The field investigation consisted of 3 sampled boreholes and 5 dynamic cone penetration tests. The locations and elevations of these boreholes are shown on Dwg. 63-F-138A.

Because of the water condition encountered in Holes 3, 4 and 5 (see attached plan) which could partially be caused by the run off of

water from the ditches on Hwy. #23, 6" perforated pipe should be placed here to lower the water table that presently exists. This pipe could then be connected to the drainage system proposed for the parking areas.

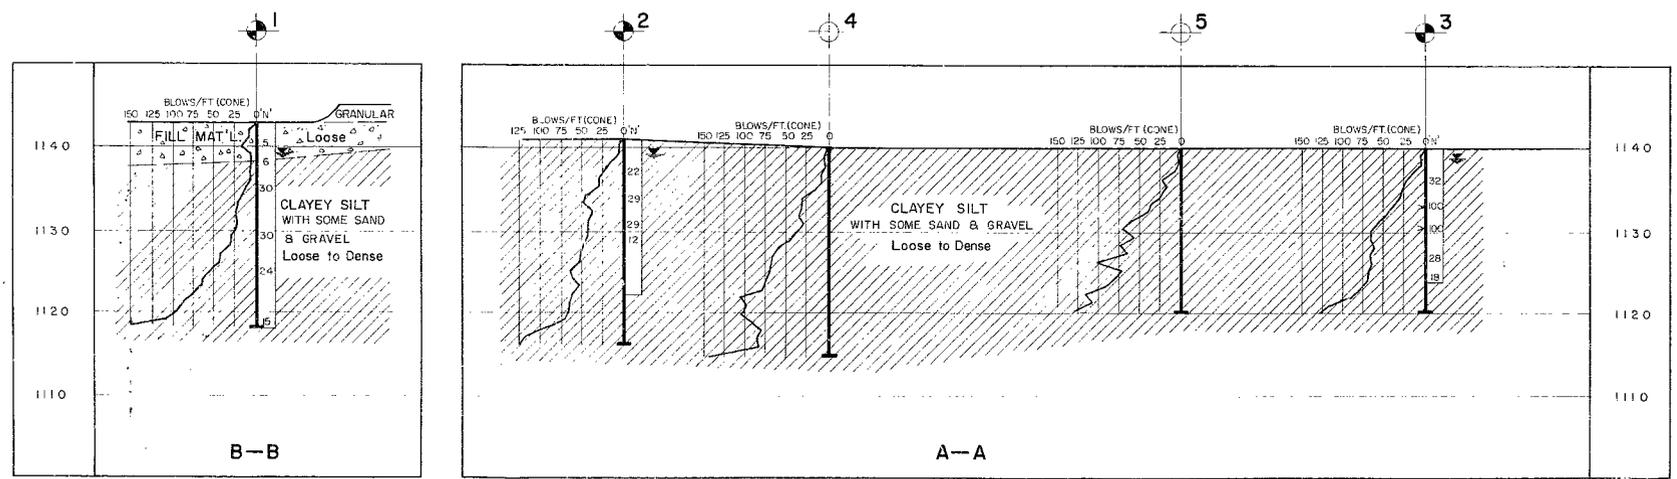
SECTIONS
SCALE
10 5 0 10 20 FT.

NOTE
THE BOUNDARIES BETWEEN SOIL STRATA HAVE BEEN ESTABLISHED ONLY AT BORE HOLE LOCATIONS. BETWEEN BORE HOLES THE BOUNDARIES ARE ASSUMED FROM GEOLOGICAL EVIDENCE AND MAY BE SUBJECT TO CONSIDERABLE ERROR.

The subsoil at the site was found to be generally uniform and consisted of firm to hard clayey-silt with some sand and gravel to a depth of 25 feet. The upper 10 feet of this layer is oxidized and brown in colour.

The water level was found to be 1 to 3 feet below ground level at the time of the investigation.
