#62-F-326 M

Bridge Widening on Brewery Street -  
Village of Baden, Twp. of Wilmot, Ont.  
(Bridge Office Ref. BA 1504)

Re: Inspection of Foundation Construction  
for proposed Bridge Extension in  
Baden, Ontario - Our Ref: 3-5-22

Re: Subsoil Conditions  
Culvert on Brewery St.,  
Baden, Ontario.  
Our Reference: 2-7-3

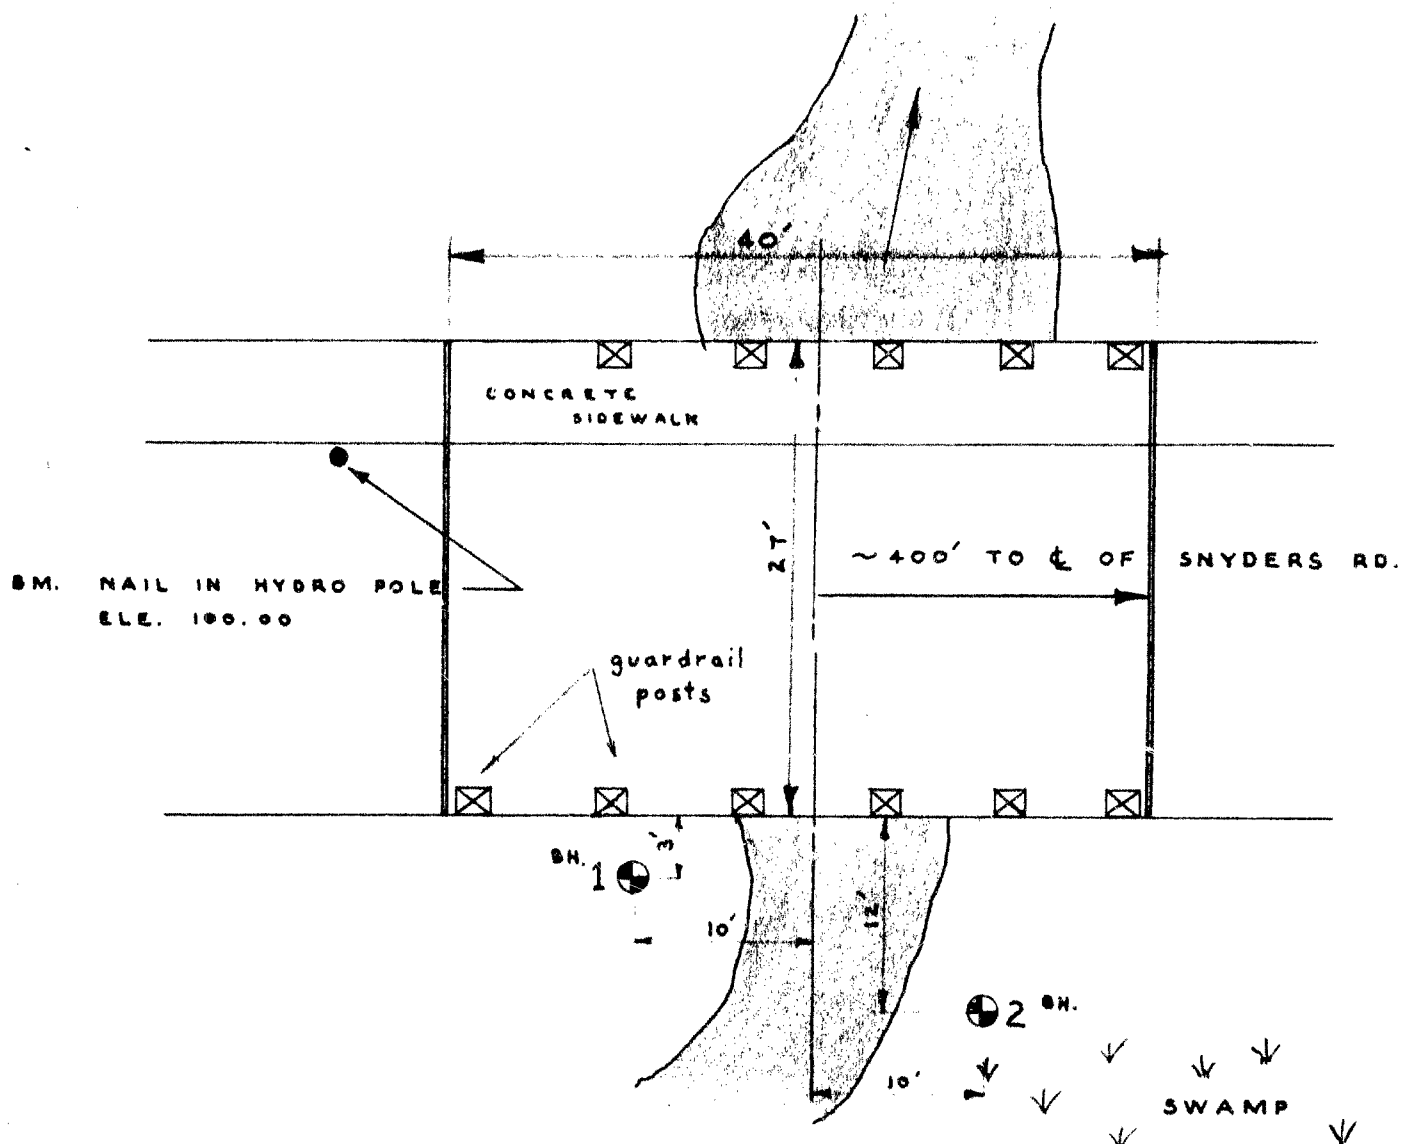
### LOCATION OF BOREHOLES

Field work was carried out during the period July 5th to July 7th and comprised two boreholes and two dynamic cone penetration tests at the locations shown on Enclosure #2. The positions of the test holes were set out on the site together with Mr. N.A. Haufschild. Elevations were measured relative to a nail driven into a hydro pole immediately south of the bridge (=el 100.0) - also indicated on Enclosure #2.

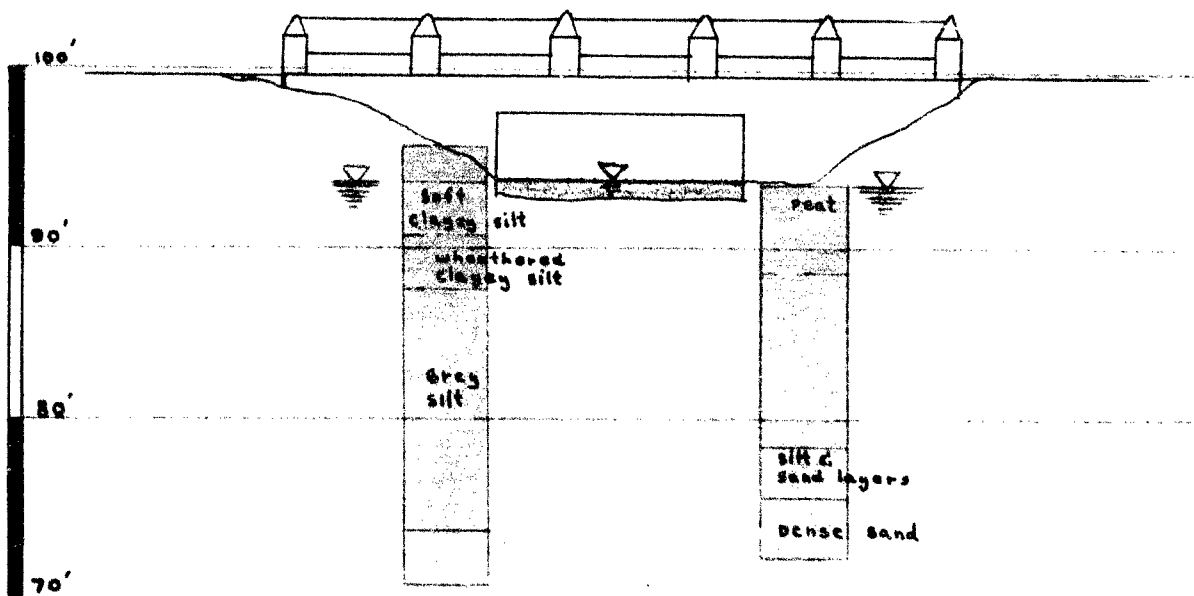
### SUBSURFACE PROFILE

Marshy conditions prevail at the site, hence peat was encountered first. This material is not capable of supporting any load, has a high moisture content and it is very compressible.

In Borehole #1, firm, brown, clayey silt was encountered. This stratum is missing from Borehole #2 where the boggy conditions are more advanced.

A greyish, compact silt with layers of firm, grey, silty clay was found below Elevation 88 ft.(average). The material has no plasticity but the grains are finer than those of the finest sand. It is very sensitive to vibration, in fact, it turns into a "heavy liquid" when dynamic loading is applied on it. This is the reason why both dynamic tests (cone and split spoon) met little resistance. The soil, however, as proven by the high unit weight and low moisture content, has a low void ratio - i.e. it is compact.

The soil turns into a fine, dense sand around Elevation 75 ft.

The ground water level corresponds to that in the creek (Elevation 93.9 ft.).
