Re: Soil Engineering Studies, County Road #31,
Hamlet of Saltford, Ontario.

REPORT
ON
SOIL ENGINEERING STUDIES
FOR
COUNTY ROAD #31
HAMLET OF SALT FORD, ONTARIO.

REFERENCE
5-7-12
JANUARY - 1966

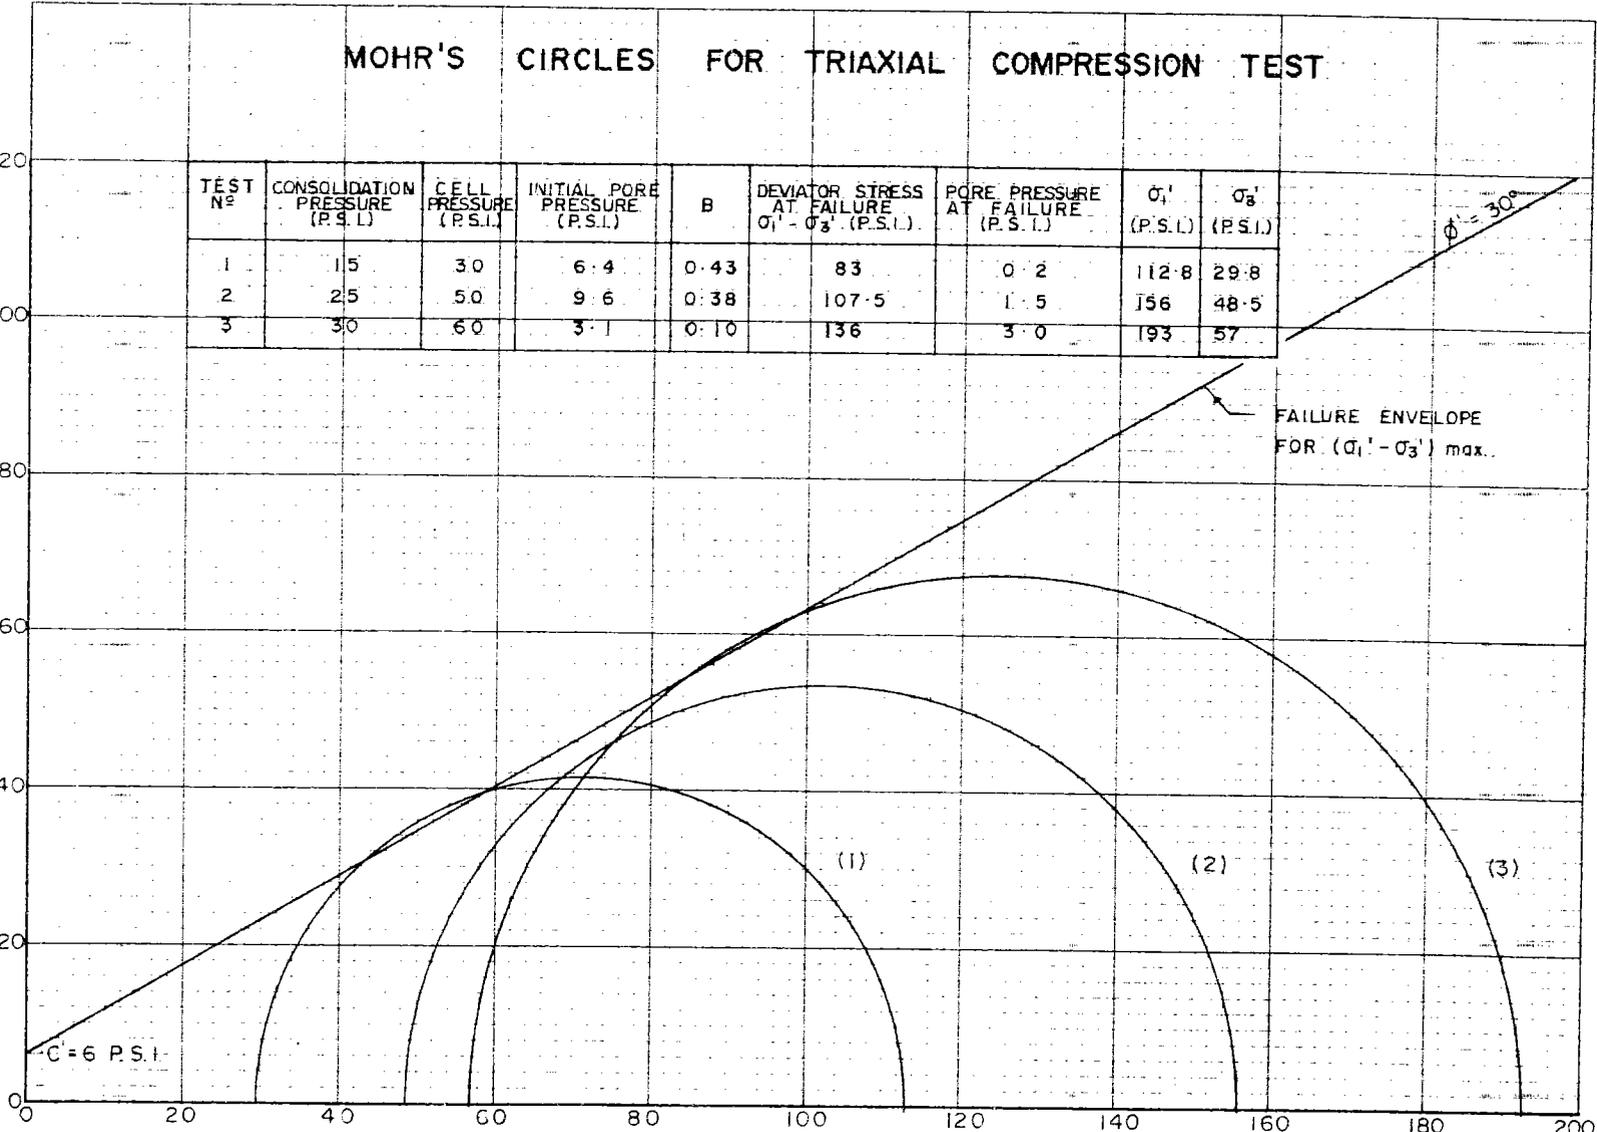
MOHR'S CIRCLES FOR TRIAXIAL COMPRESSION TEST

This is illustrated on Enclosures Nos. 18 and 19 where the triaxial test results are presented in the form of Mohr stress circles observed at both the maximum values of $\sigma_1' - \sigma_3'$ and σ_1' / σ_3' . The failure envelopes drawn to these stress circles indicate a ϕ' value of 30° and 31° and c' values of 6 and 7 P.S.I. respectively.

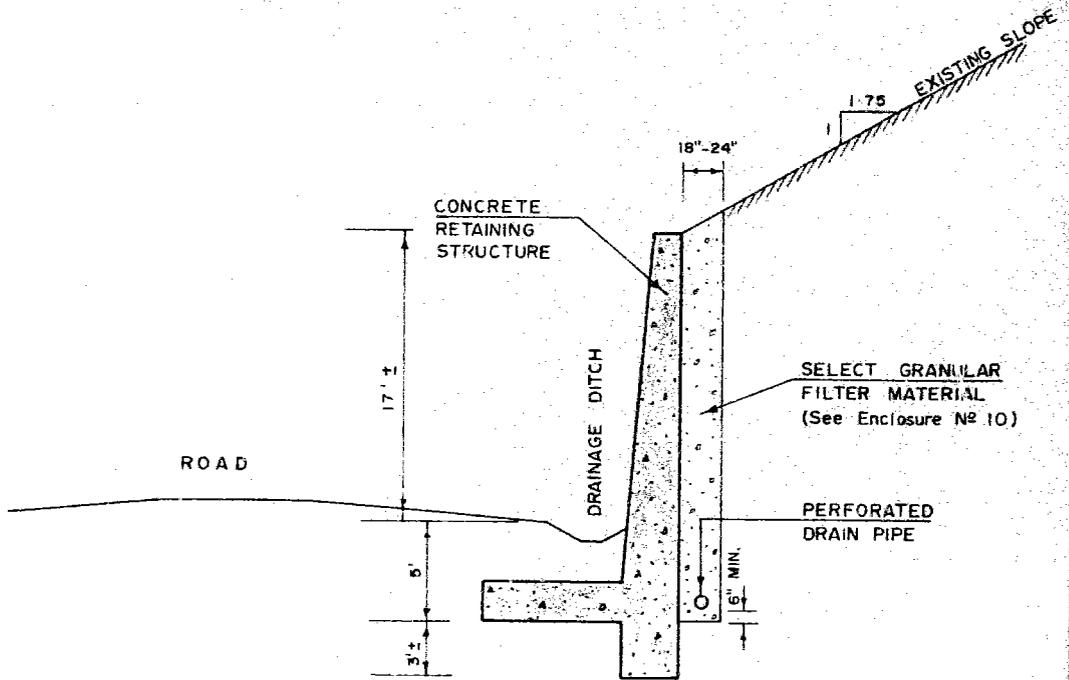
SKETCH SHOWING SUGGESTED LAYOUT OF RETAINING STRUCTURE AND DRAINS ON UPHILL SIDE

The possibility of widening the road on the uphill side was investigated and it was found to be feasible. By cutting into the slope the factor of safety against rotational slip failure will not be decreased, in fact, because of the removed weight of the excavated earth it will be slightly increased. To secure the long term stability of the

For the design of the wall the following design values are recommended.

Allowable bearing pressure:	3 tons per square foot
Maximum edge pressure:	3½ tons per square foot
Unit Weight of Natural Soil:	130 lbs. per cubic foot
Angle of Shearing Resistance:	$\phi = 30$ degrees
Cohesion:	C = 250 lbs. per square foot
Coefficient of friction between the base of the foundation and the subgrade	= 0.3
Recommended safety factor against horizontal sliding:	S.F. = 2.0

Preliminary calculations indicate that in order to secure a Factor of Safety of 2 against horizontal sliding it will be necessary to construct a shear key below the general foundation level, and also the water level behind the wall will have to be kept at least five feet below the road level. A sketch showing the general layout of the retaining structure and the proposed drain is shown on Figure 4. The drain should be surrounded, and the space between the wall backfilled, with a select granular filter material for which the grading requirements are shown on Enclosure No. 10. The grading of the recommended filter material is such that it will prevent the silt or fine particles from the subgrade soil from being washed into the drain and at the same time it will be pervious enough to allow the free movement of the ground water.

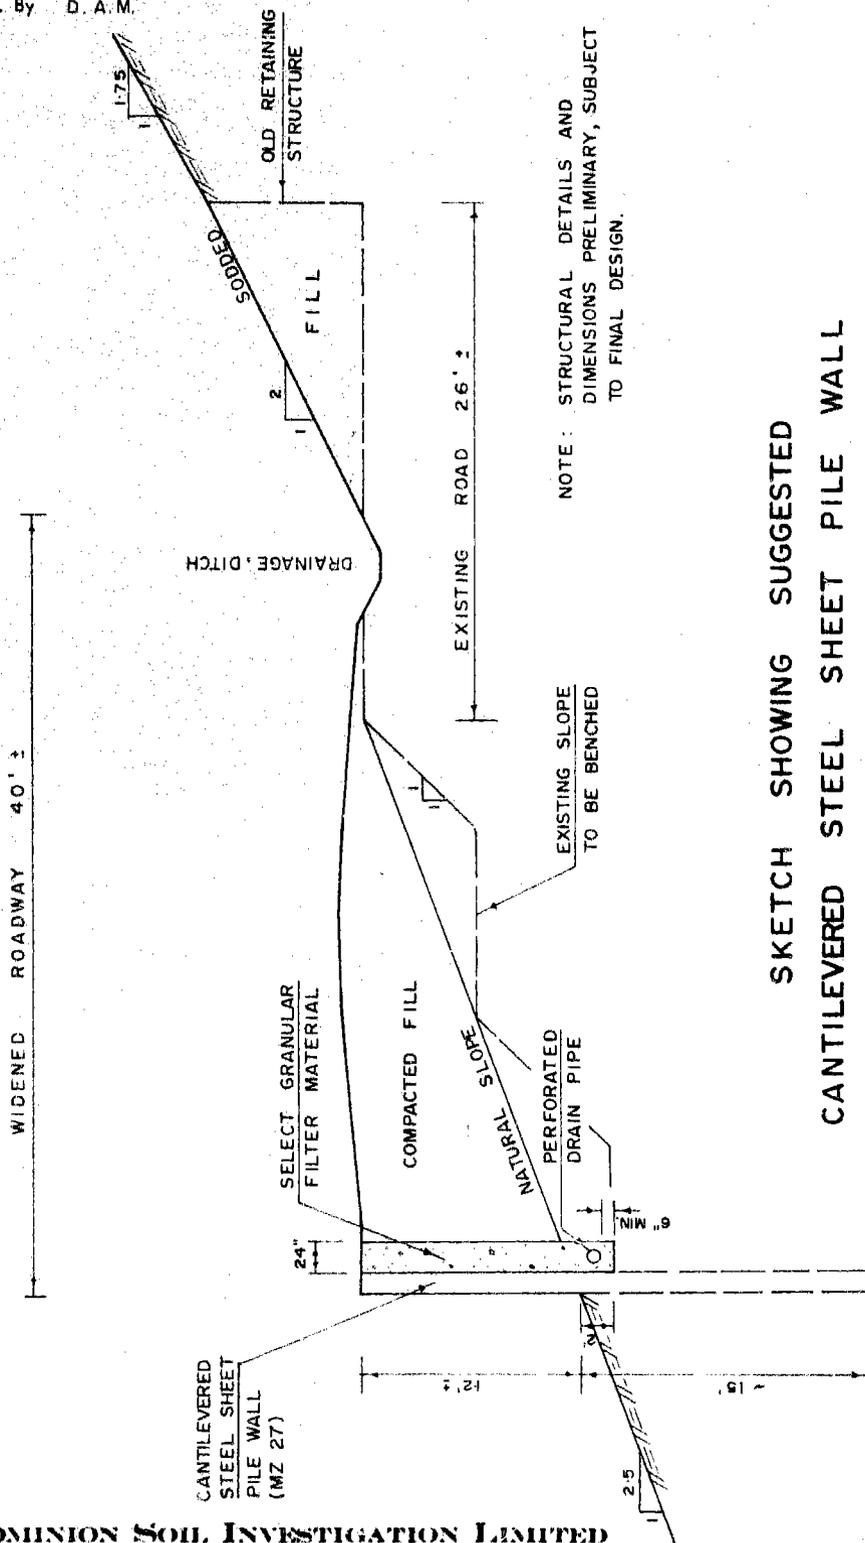
SKETCH SHOWING SUGGESTED CANTILEVERED STEEL SHEET PILE WALL ON DOWNHILL SIDE

struction of the existing retaining walls and to improve the conditions on this side. Thus the greatest portion of the new road width is gained on the downhill side by filling. The filling could be achieved by free dumping on top of the benched natural slopes and allowing the fill material to assume its angle of repose. This, in the case of predominantly granular materials, would probably be about 30 degrees, that is a slope of about 1 vertical in 1 3/4 horizontal. The success of such operation will largely depend on the actual degree of incline of the natural slope but in any event it will require large quantities of fill. The layout of the subdrains required for stability purposes are shown on Figure 3b.
