**FOUNDATION INVESTIGATION AND DESIGN REPORT  
REHABILITATION OF RETAINING WALL  
BAYFIELD RIVER BRIDGE, HIGHWAY 21  
SITE NO. 12-188  
W.P. 348-98-00, AGREEMENT NO. 3005-A-000012**

**January 27, 2000  
Project No.: TK99-8-4**

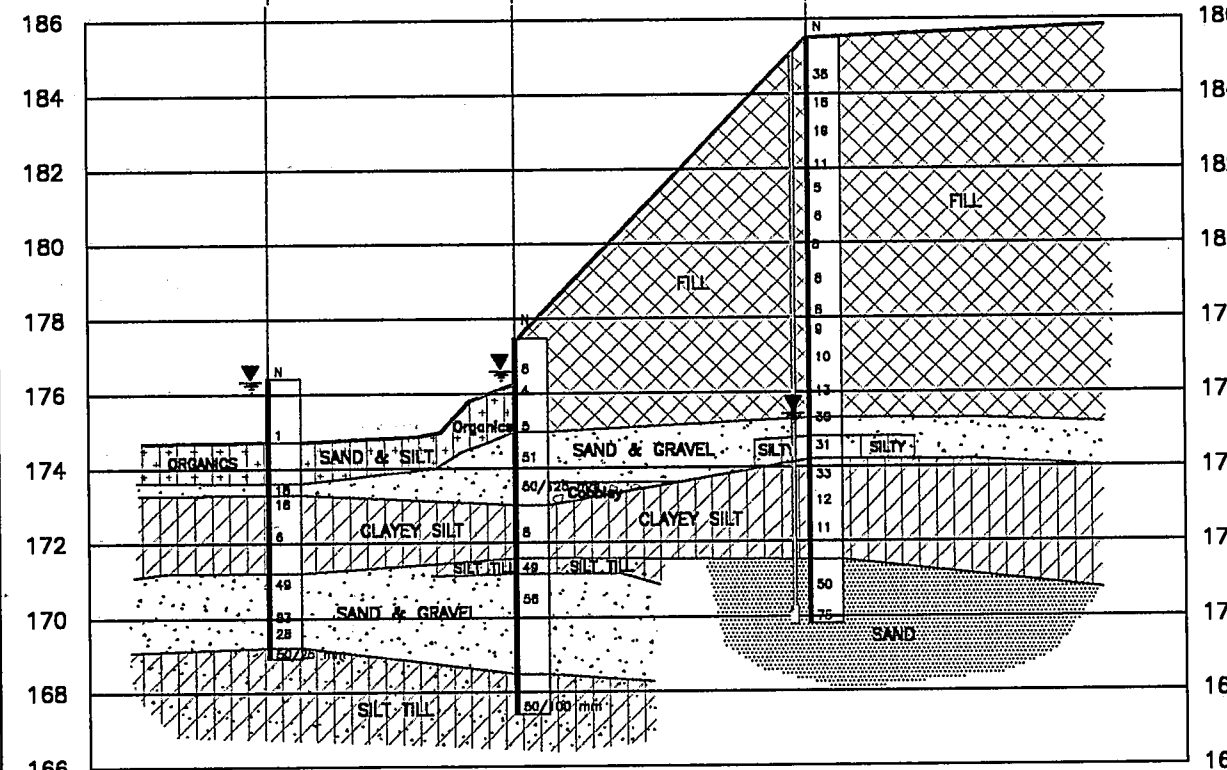
SECTION B-B'

Slope stability analyses were performed on the most critical section of the embankment (Cross-section B-B as indicated on Drawing No. 1). The results of the analyses indicate that the fill embankment slope has a factor of safety in the order of 1.1 to 1.2 against surficial translational type failure depending on the geotechnical parameters chosen for the existing fill materials. The results correspond with our field observations as the surficial sliding taken place is shallow and is limited to the toe portion of the slope. The slope has re-stabilized and surficial sliding has stopped unless further triggered by scouring. The trees and surficial vegetation have aided to minimize the extent of the failure.
