Foundation Investigation
New Maitland River Bridge
Highway No. 87 - Harriston, Ontario

FOUNDATION INVESTIGATION
NEW MAITLAND RIVER BRIDGE
HIGHWAY NO. 87 - HARRISTON, ONTARIO

Project: J403

August 14, 1959.

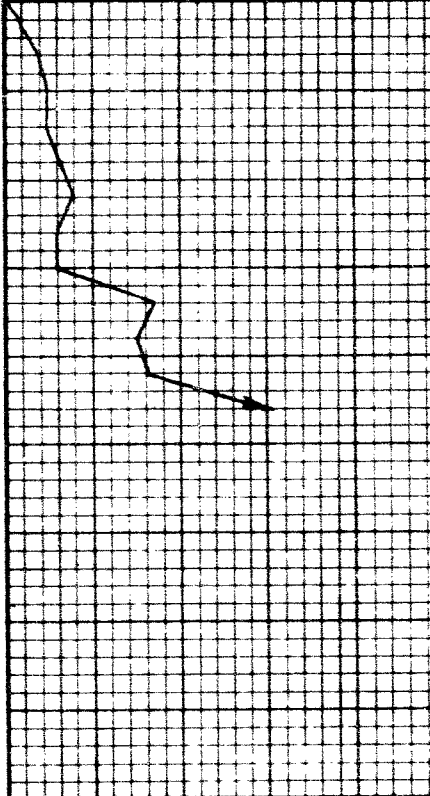
BOREHOLE NO. **Probing A**
FIELD SUPERVISOR
DRILLER
PREP.

The probe put down in the river showed loose material extending to a depth of 10 feet. The soil becomes dense at 12 feet.

Although a depth of 8 feet below the river surface is indicated from the borehole results, this foundation level may not provide sufficient protection against river scour. This opinion is based upon the results of the probing made in the existing river bed. In three attempts to determine the probable depth of re-sorted river bed deposits, two encountered refusal, at shallow depth, on boulders, and the third test was taken to a depth of 12 feet, through 10 feet of loose to medium dense granular material. It was concluded from this test that river scour, at some time, has penetrated to a depth of 10 feet. Therefore footings for the new bridge must be carried down to this level, or to approximate elevation 81 feet. This will involve footing excavations 10 feet below the present river surface.

- 2) Deep footing excavations will be required to prevent undermining by river scour. A minimum footing elevation of 10 feet below proposed river bed elevation is recommended.

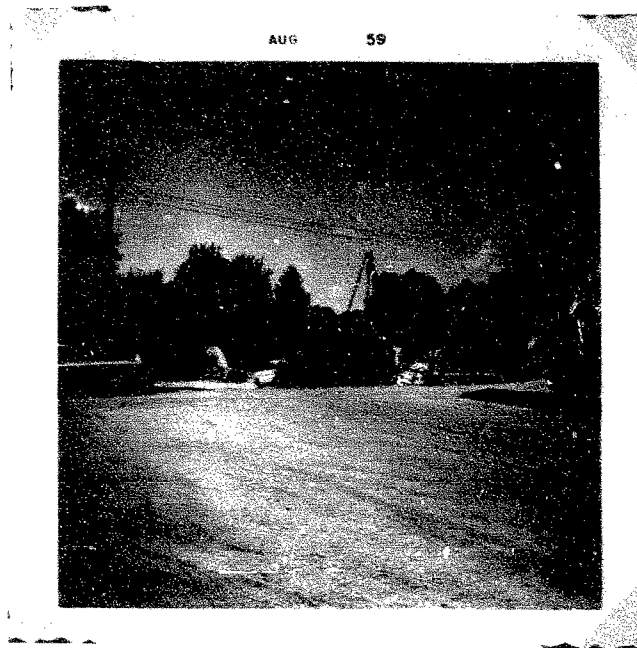
New Bridge to be located in centre of photograph.
Existing Hwy. 87 bridge to right; John St. bridge in background.

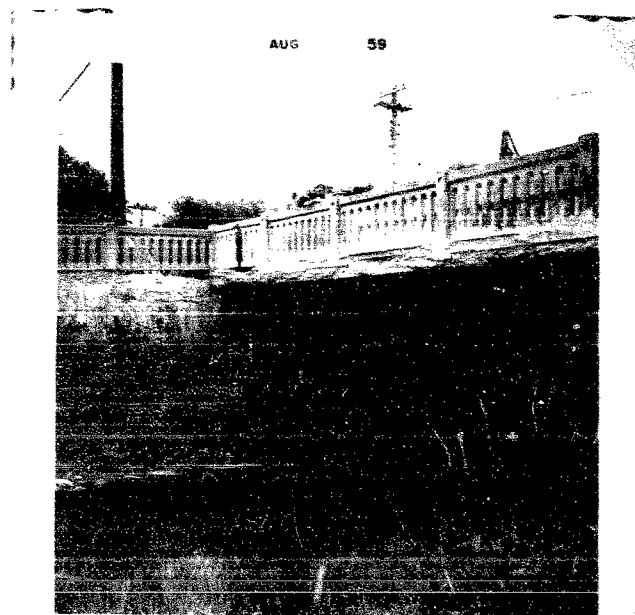
Drawing No. 1 illustrates the general layout of the existing roads and bridges at the crossing site. Two bridges presently span the river in this vicinity. Highway 87 is carried by a reinforced concrete plate-deck and girder structure, while John Street passes over a through-arch bridge of reinforced concrete. Both bridge structures are in an advanced state of disrepair, with much spalled concrete exposing the steel reinforcing. Portions of the guard railing have either been broken or fallen off.

East side of Hwy. 87 bridge, looking towards south
abutment.

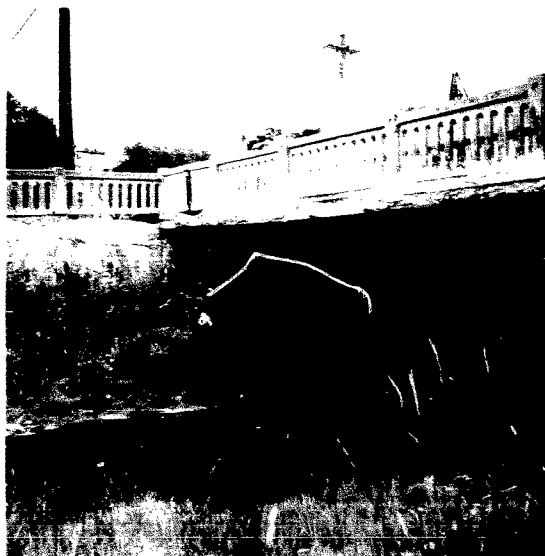
East side of Hwy. 67 bridge, looking towards south
abutment.
