RE: FOUNDATION INVESTIGATION FOR  
A CULVERT, AT THE CREDIT RIVER,  
HIGHWAY 10 CROSSING, APPROXIMATELY  
FOUR MILES NORTH OF CALEDON, ONTARIO.

Report No: S-500/T-487

Racey, MacCallum and Associates Limited

5 November 1956.

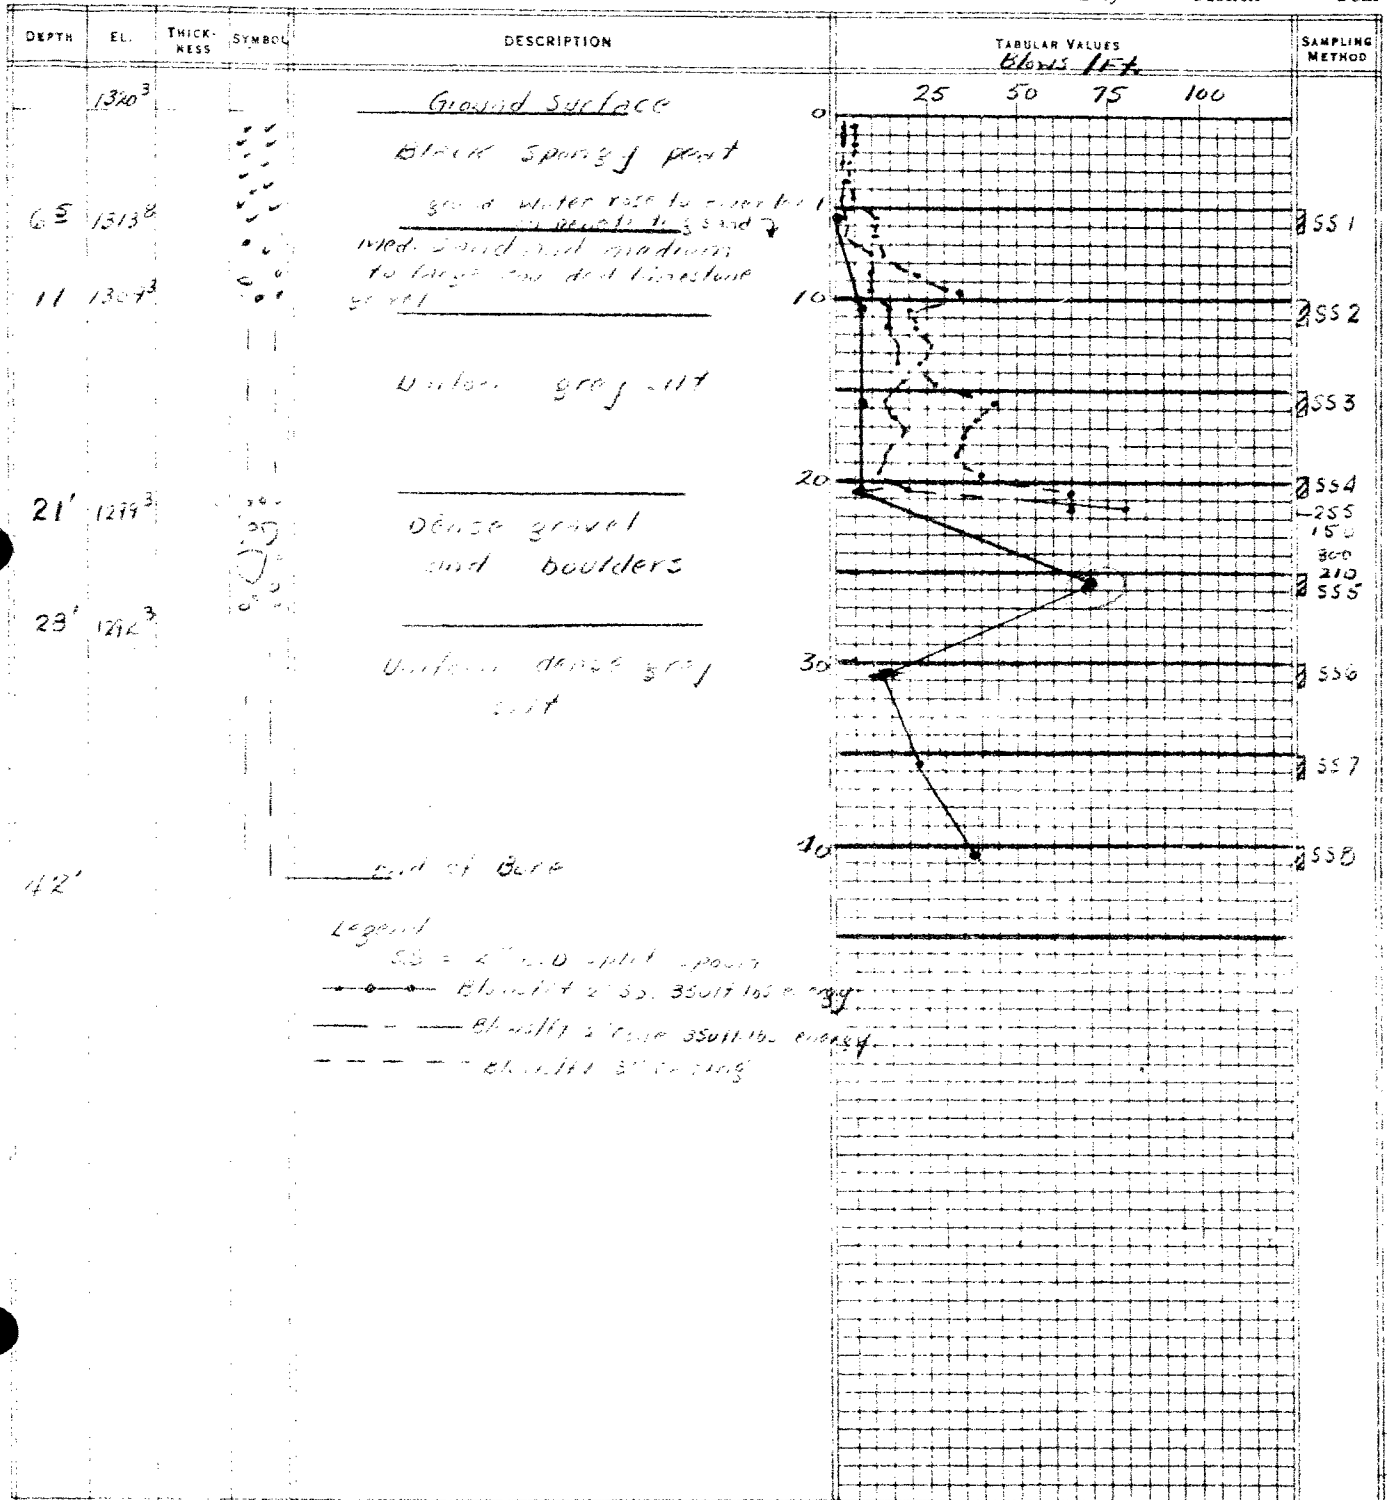
Engineering Data Sheet for Borehole: 2

The subsoil profiles, as determined by the two borings, are indicated in enclosures 2 and 3, and are relatively self-explanatory. Hole 2 showed a surface layer of six and one half feet of very spongy topsoil, which remained dry until the underlying sand and gravel stratum was encountered. The ground water then rose immediately to a level coinciding with river level. This coarse granular stratum had a thickness of approximately four and one half feet and was underlain by uniform grey silt, which extended to El.1299.3 feet. According to the empirical standard penetration test, which determines relative density on the basis of the driving resistance per foot required to drive a standard two inch O.D. split-spoon, under 350 foot pounds energy, this silt may be classed as loose to medium dense. However, measurements of its density, as determined on undisturbed Shelby tube samples, indicates that it has a relative density of the order of 77 percent of the maximum possible obtainable. This was also noted for the silt deposits in the bridge investigation made approximately half a mile north of this site.

Below the silt between El.1299.3 and 1292.3 feet, was a seven foot stratum of dense gravel and boulders which, in turn, was underlain by uniform dense grey silt. This latter material continued at least to El.1278 feet, the maximum depth of the boring. The subsoil profile observed in hole 2 was closely duplicated in hole 3, near the north east corner of the bridge. The only difference between the two borings was the absence of the four foot sand and gravel stratum at El.1314 feet, and the less spongy nature of the topsoil in hole 3.
