MEMORANDUM

FOUNDATION INVESTIGATION REPORT
For

Embankment Distress
Between Sta's 622+00 & 635+00
Hwy. #10 - Orangeville Diversion
Town of Orangeville Co. of Dufferin
District No. 3 (Stratford)
Contract No. 70 - 03
W.O. 71-11062 --- W.P. 5-66-00

FOUNDATION INVESTIGATION REPORT
For
Embankment Distress
Between Sta's 622+00 & 635+00
Hwy. #10 - Orangeville Diversion
Town of Orangeville Co. of Dufferin
District No. 3 (Stratford)
Contract No. 70 - 03
W.O. 71-11062 --- W.P. 5-66-00

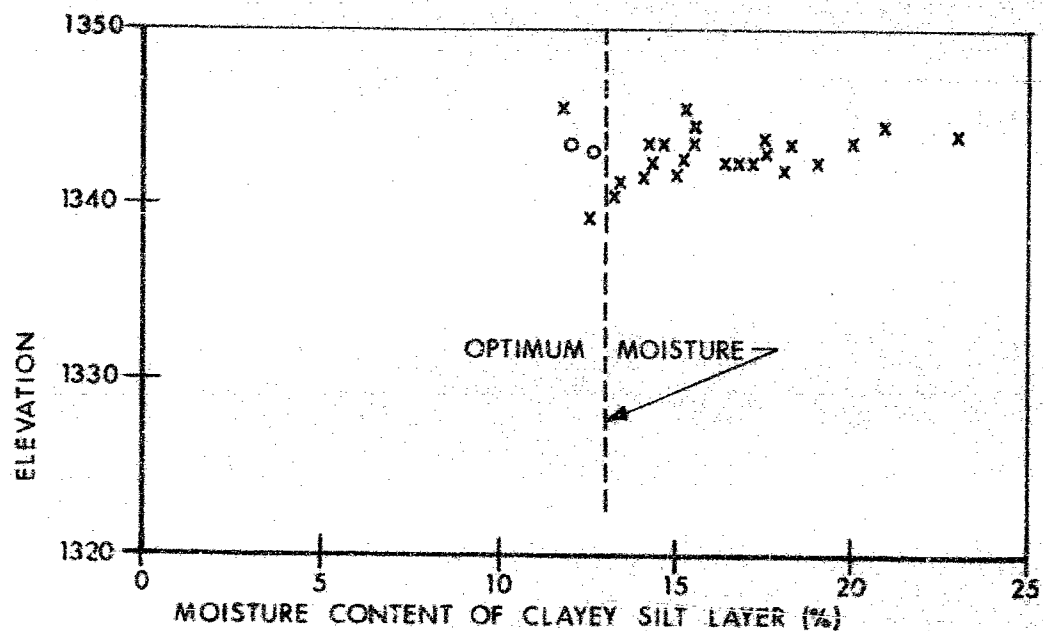
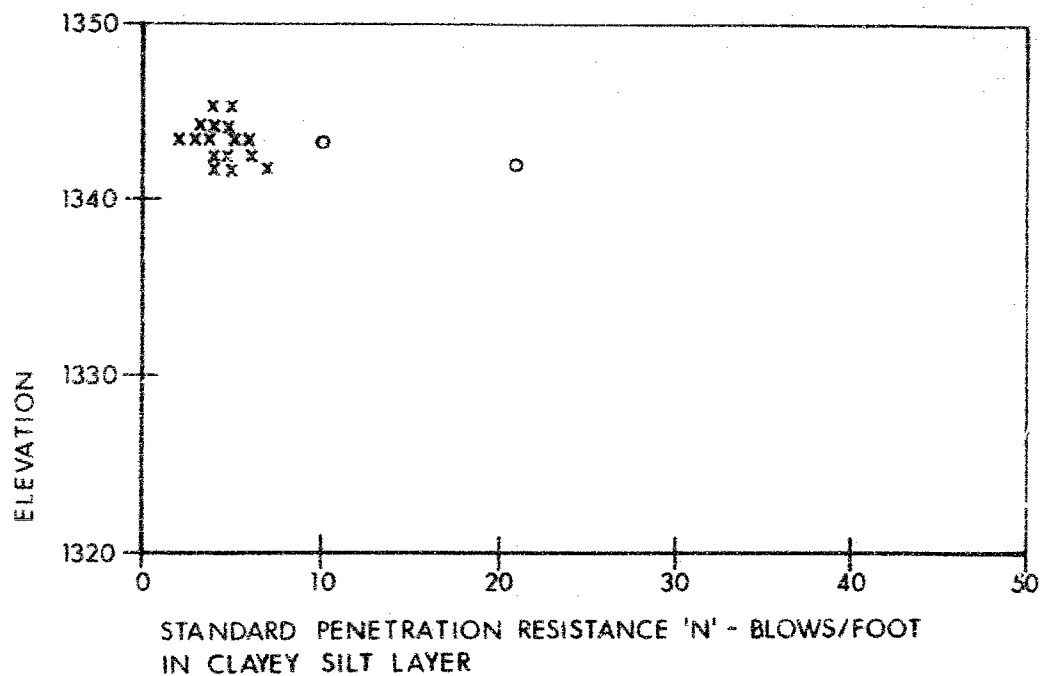
FIG.1

- ii) Standard Penetration Resistance testing, carried out within the affected area, gave 'N' values which ranged from 2 to 8 blows/ft. A limited number of tests carried out in the unaffected area gave values between 10 and 22 blows/ft. Based on these results, it is estimated that the major portion of the cohesive fill, in the affected area, is in a soft state, while in the unaffected area, it has a consistency which ranged from stiff to very stiff. This pattern was further confirmed by the dynamic cone penetration tests carried out in the affected and unaffected areas. The engineering properties discussed in the previous paragraphs, are plotted on Figure #1, located in the Appendix to this report.

x -- AFFECTED AREA
o -- UNAFFECTED AREA

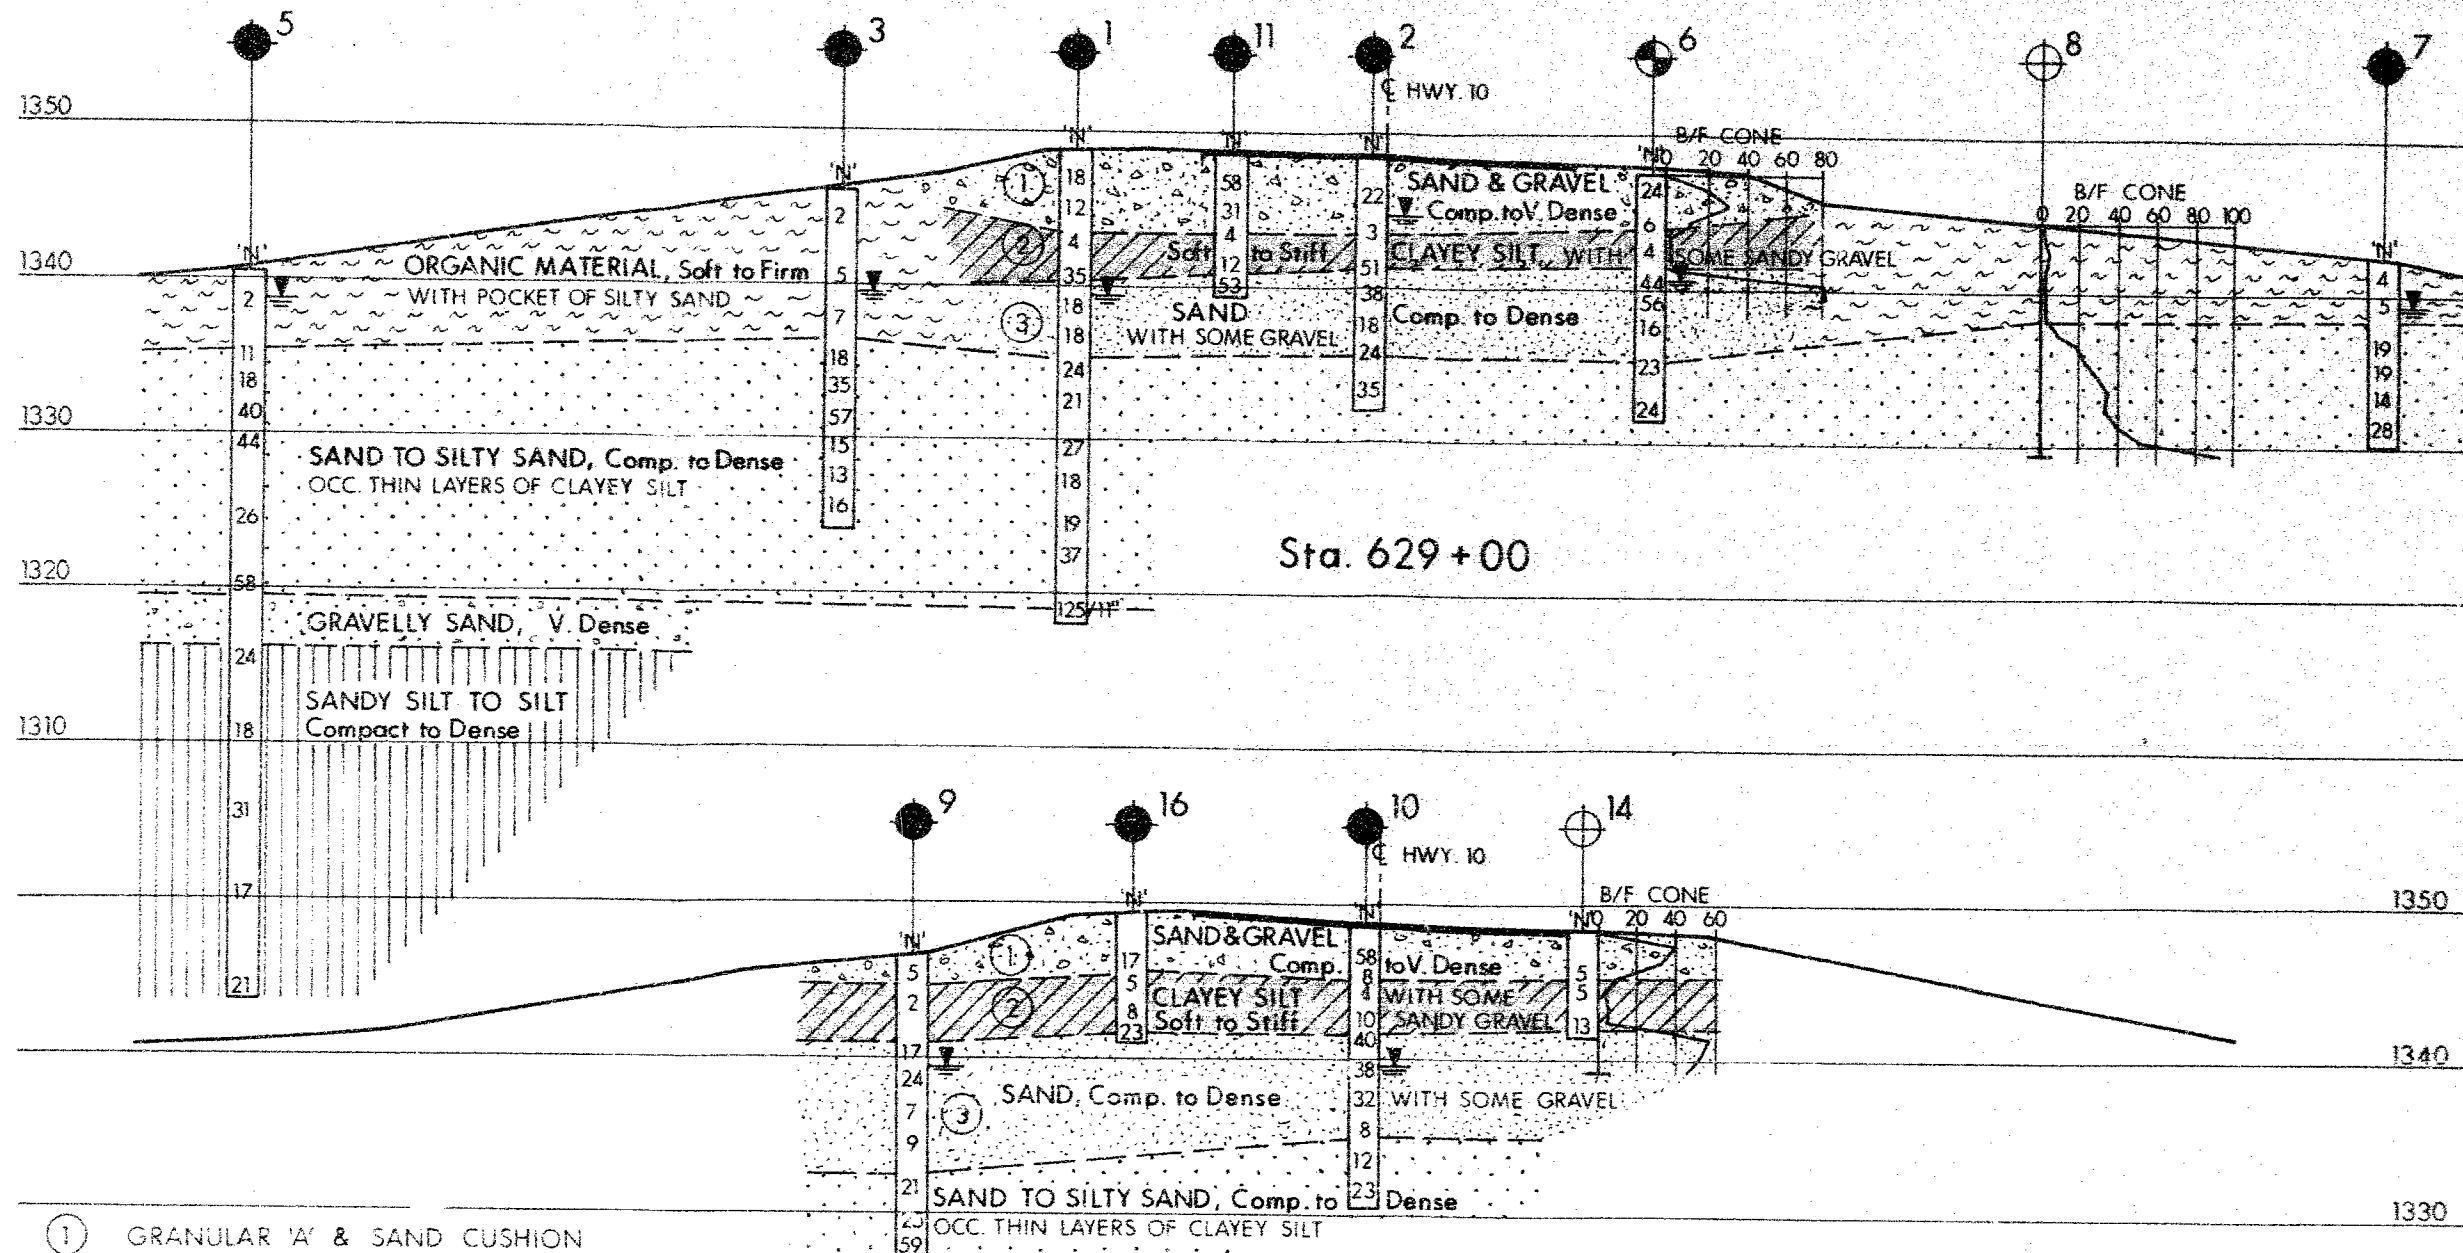
DRAWING NO. 71-11062 B

Two stratigraphical cross-sections, within the affected area, namely at Stations 629+00 and 632+67, have been inferred from the boring information obtained, and are plotted on Drawing No. 71-11062E, attached to this report.

Groundwater level observations were carried out, during the period of the investigation (June and July, 1971) by recording the water levels in the open boreholes. The results are plotted on Drawing #71-11062B. The groundwater level across the site was found to vary between elevations 1339 to 1341, which corresponds to depths of from 1 to 2 feet below original ground level.

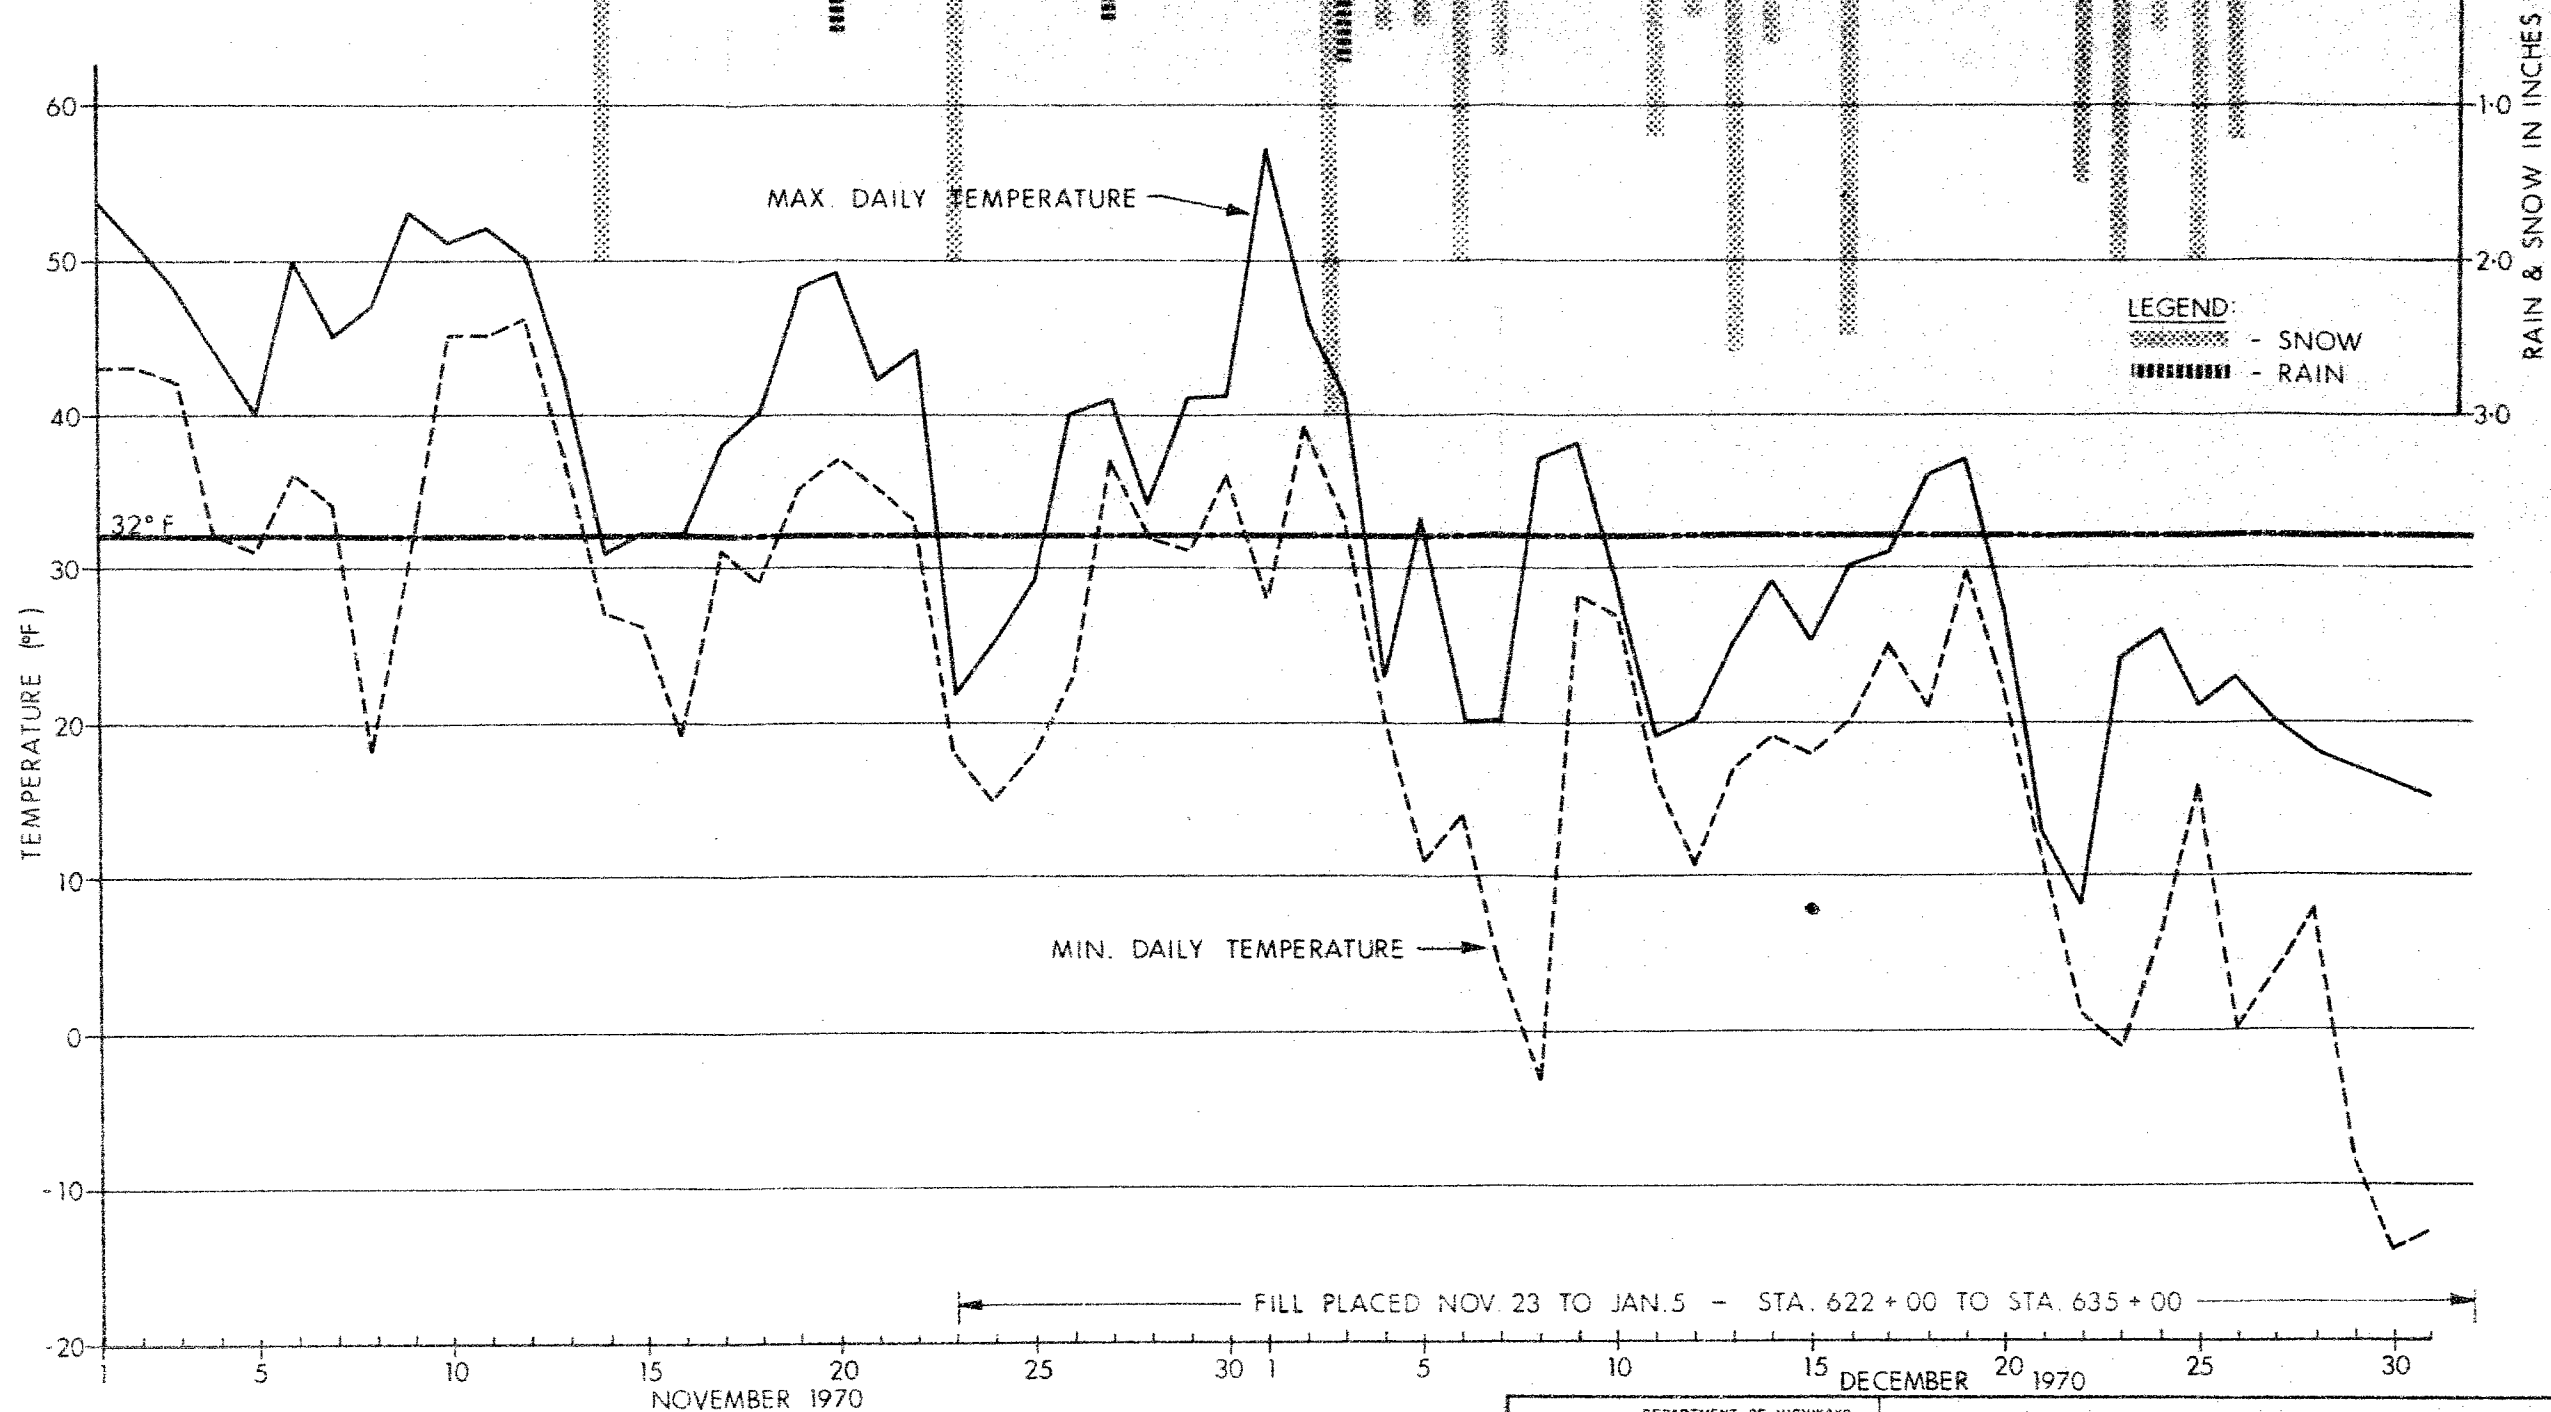
DRAWING NO. 71-11062 C

The lower portion of the embankment core was formed of a fill composed of clayey silt with some sand and gravel; it is understood that the in-place thickness of this fill was to be of the order of 4 feet. This material was obtained from the cut treatment performed in the vicinity of Hwy. #9, which is located on the higher table land to the south of this particular section. It should be noted that major construction difficulties were encountered during the placement and compaction of this cohesive subsoil. The compaction and related construction equipment often bogged down within this soil during the field operations. These complications can at least partially, be explained by the severe weather conditions existing during the construction period. Information, obtained from the Department of Transport, indicated that, in this particular area, during the period in question, - 1) the mean average daily temperature was consistently below freezing (32°F), and 11) that the amount of precipitation (combination of snow and rain) was relatively large in comparison to the average conditions that normally occur. The recorded temperature and precipitation data are shown in graphical form on Drawing No. W.O. 71-11062C, appended to this report.

As discussed previously, from Station 622+00 to 635+00, which encompasses the affected area, embankment construction was carried out in the winter months of 1970 and 1971. The mean temperature was consistently below freezing, and the precipitation (snow and rain) was relatively high during this period. It is difficult to place and compact fill under these conditions, particularly if the fill is cohesive in nature, as is the clayey silt material. In such soils the in-place moisture content must be reasonably close ($\frac{1}{2}$ to $2\frac{1}{2}$) to the optimum compaction water content in order to obtain a suitable degree of compaction. Most likely, at least a portion of the clayey silt fill was frozen during the placement and compaction operations. Under such conditions, it would be extremely difficult to achieve the required degree of compaction. It is concluded that the clayey silt fill, in the affected area, was in a soft, compressible state during
