**GEOTECHNICAL INVESTIGATION
EAST EMBANKMENT BETWEEN
STATION 11+600 AND 11+700
HIGHWAY 10/24 IMPROVEMENT
ORANGEVILLE, ONTARIO**

PROJECT NO. 10183

September 17, 1998

**Re: Geotechnical Investigation
East Embankment Between Station 11+600 to 11+700
Highway 10/24 Improvement
Orangeville, Ontario**

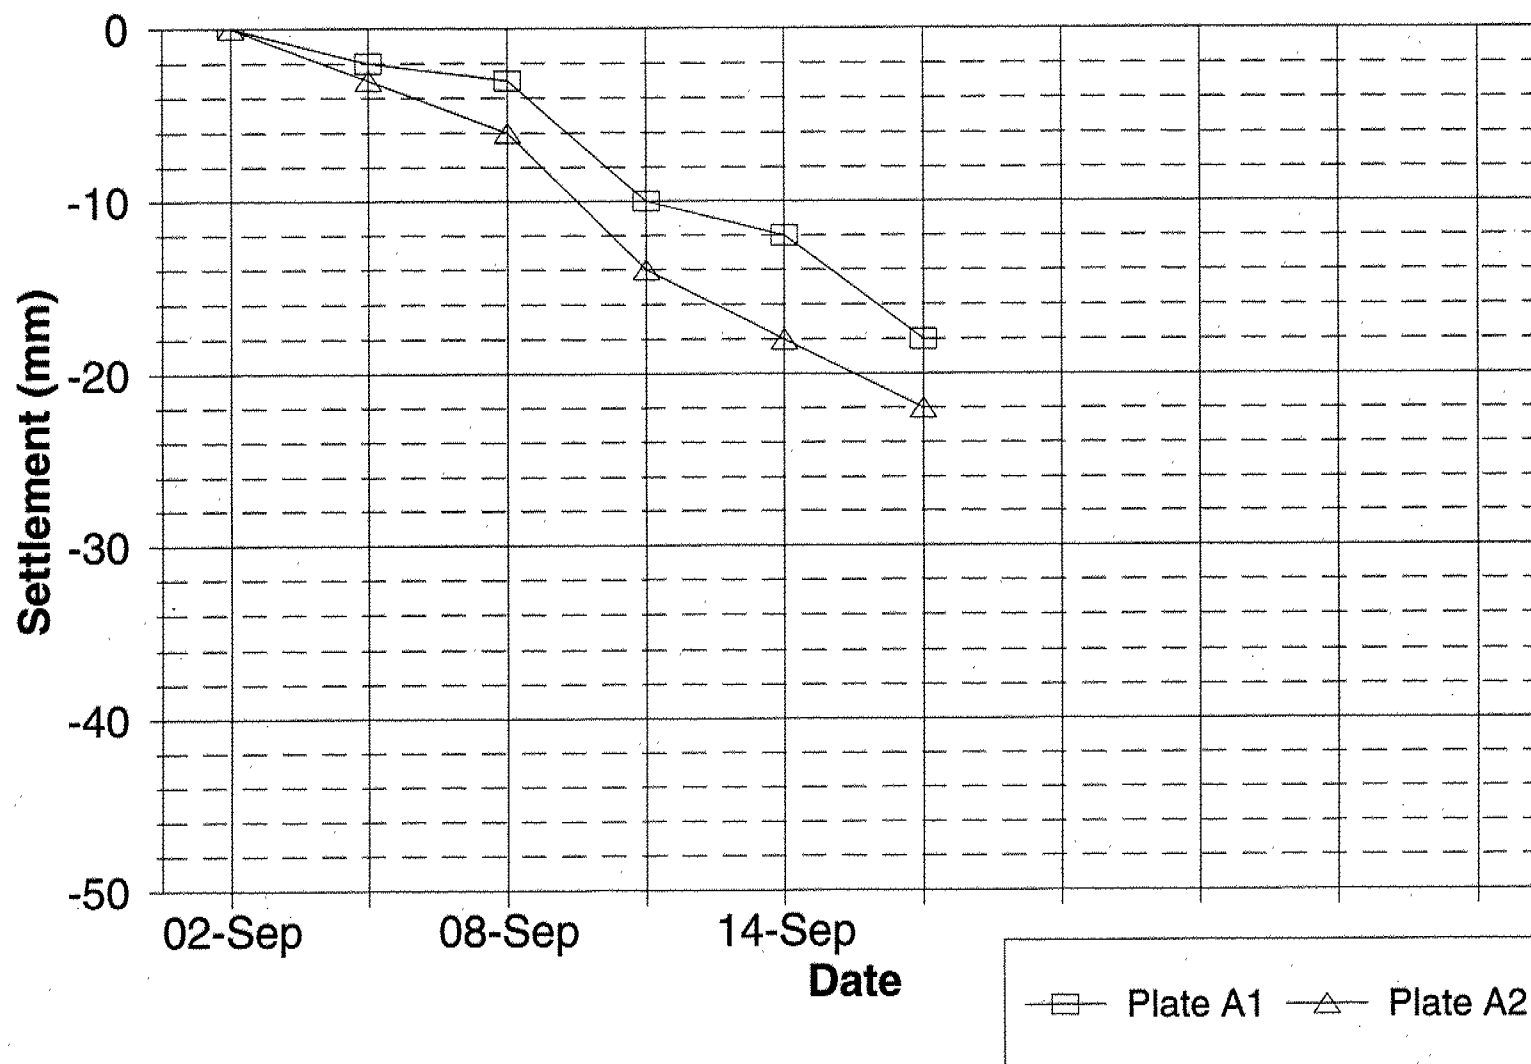
Figure 1: Settlement Monitoring Settlement Plates A1 & A2

The monitoring is therefore, limited to the settlements occurred since the commencement of the monitoring. For the period between September 2 and 16, 1998, a maximum total settlement of 22 mm was noted at Plate No. A2. The results for the settlement monitoring are illustrated in Figures 1 to 3 inclusive.

The result suggested that the bulk of the settlement has been completed and the present reading is most likely represent the secondary consolidation end for the peat and organic silt soil layers. The slow rate of settlement will likely continue for some time before stabilizing. When the additional fill is placed in this area to complete the final construction, more settlement is anticipated. The monitoring of the settlement should therefore be continued until there is a stabilizing trend in the readings.

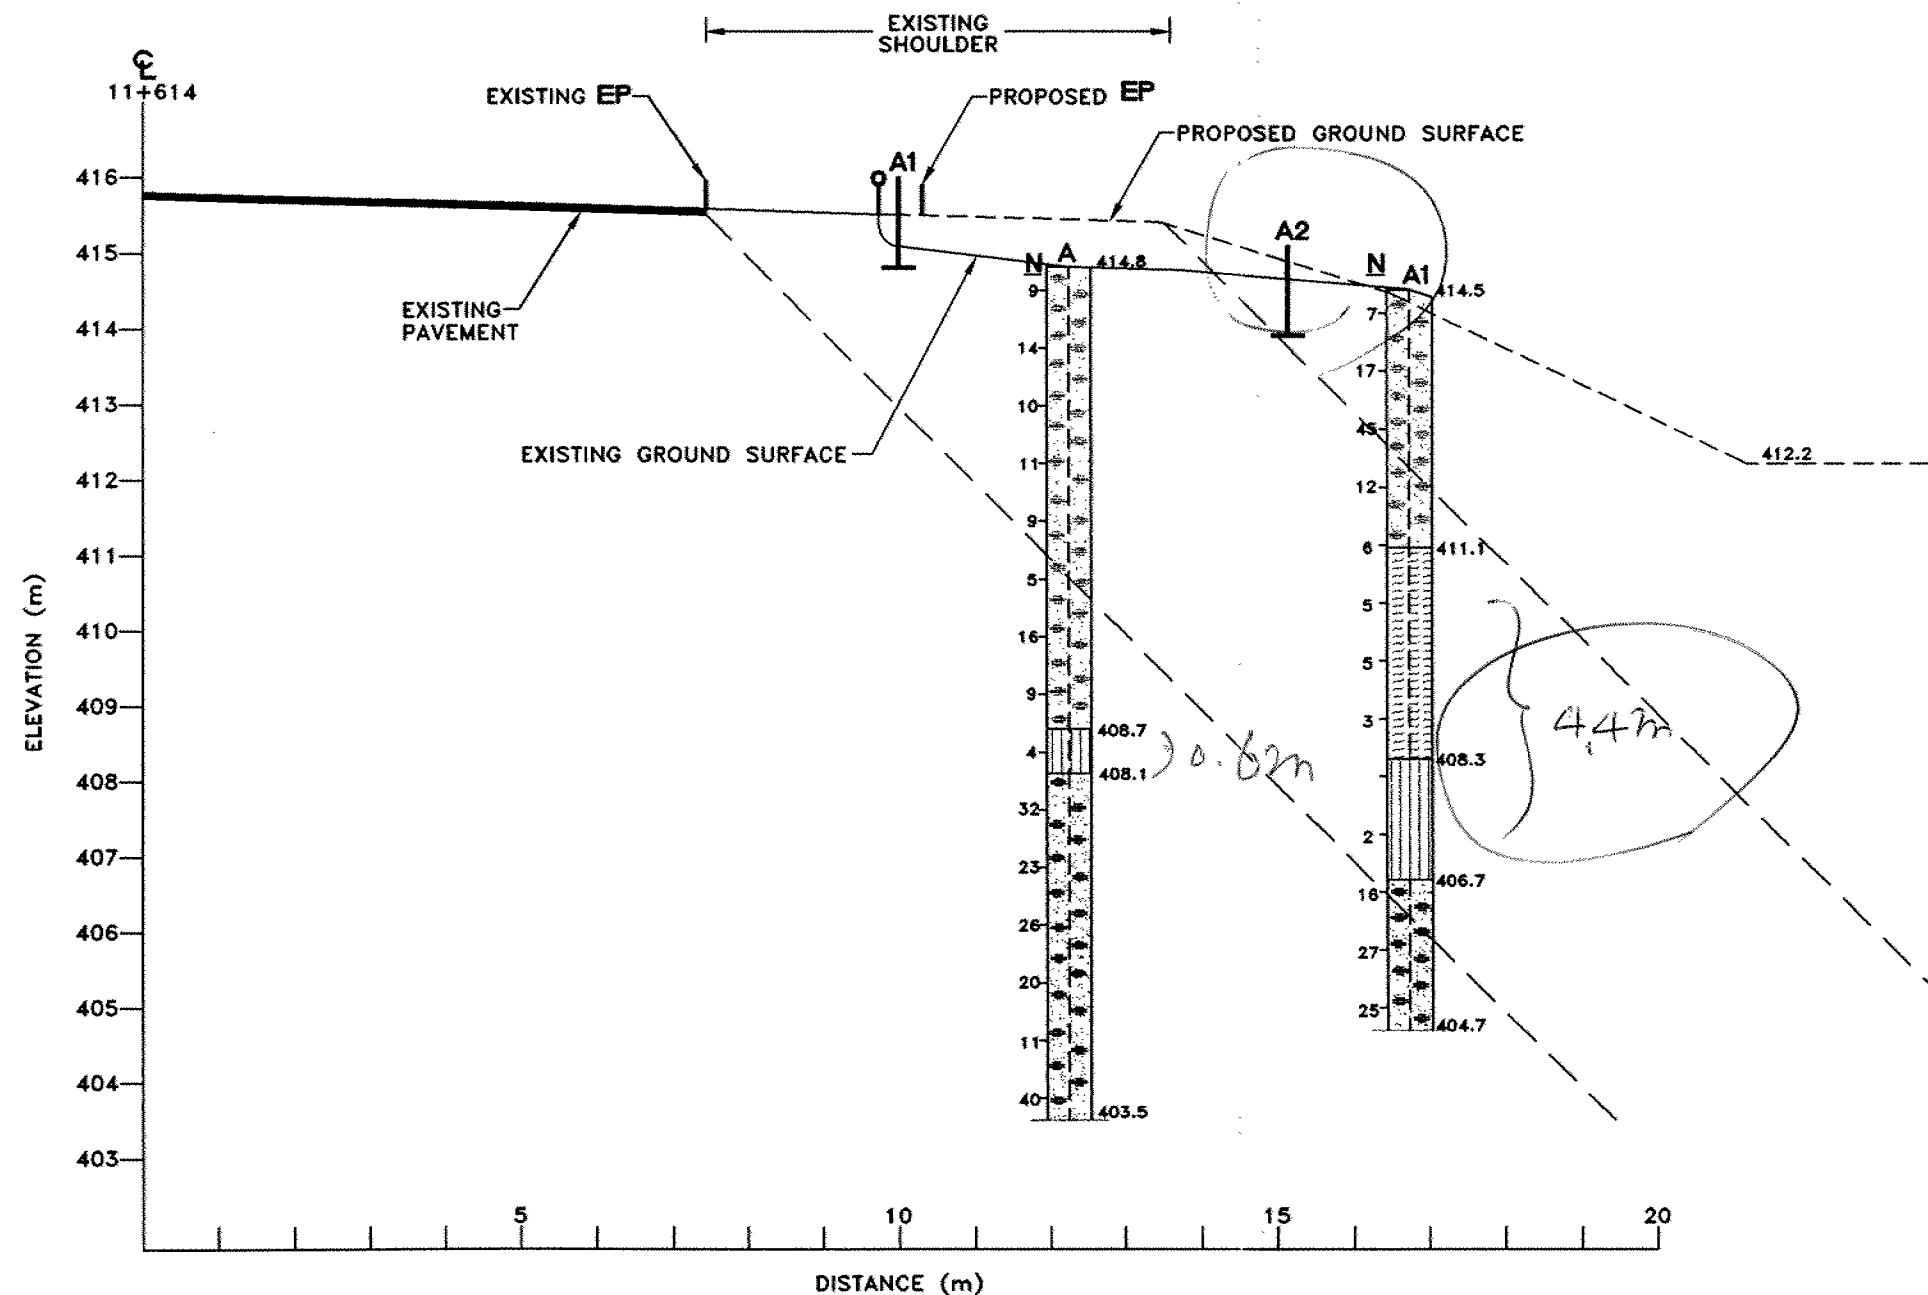
CROSS SECTION SHOWING BOREHOLE A AND A1 LOCATION AND SUBSOIL STRATIGRAPHY
STATION No. 11 + 614
HIGHWAY 10/24, ORANGEVILLE, ONTARIO

Based on the subsoil conditions revealed from the boreholes, the cause of the observed settlement and cracking were predominantly caused by the settlement of the peat and organic silt underlying the widened embankment. It appeared that during the original construction, the organic silt and small amount of peat were also not totally removed in some areas. Our previous boreholes, located just east of the cable guardrail, did not show any significant peat or organic soil which could be an indication that the organic soil did not extend much west of the shoulder area.

Based on the current borehole information, the base of the peat is near Elevation 408.3 to 409.6 m which is approximately 2.4 to 3.9 m below the reservoir. The base of the organic silt is near Elevation 406.7 m which is up to 5.5 m below the toe of the slope.

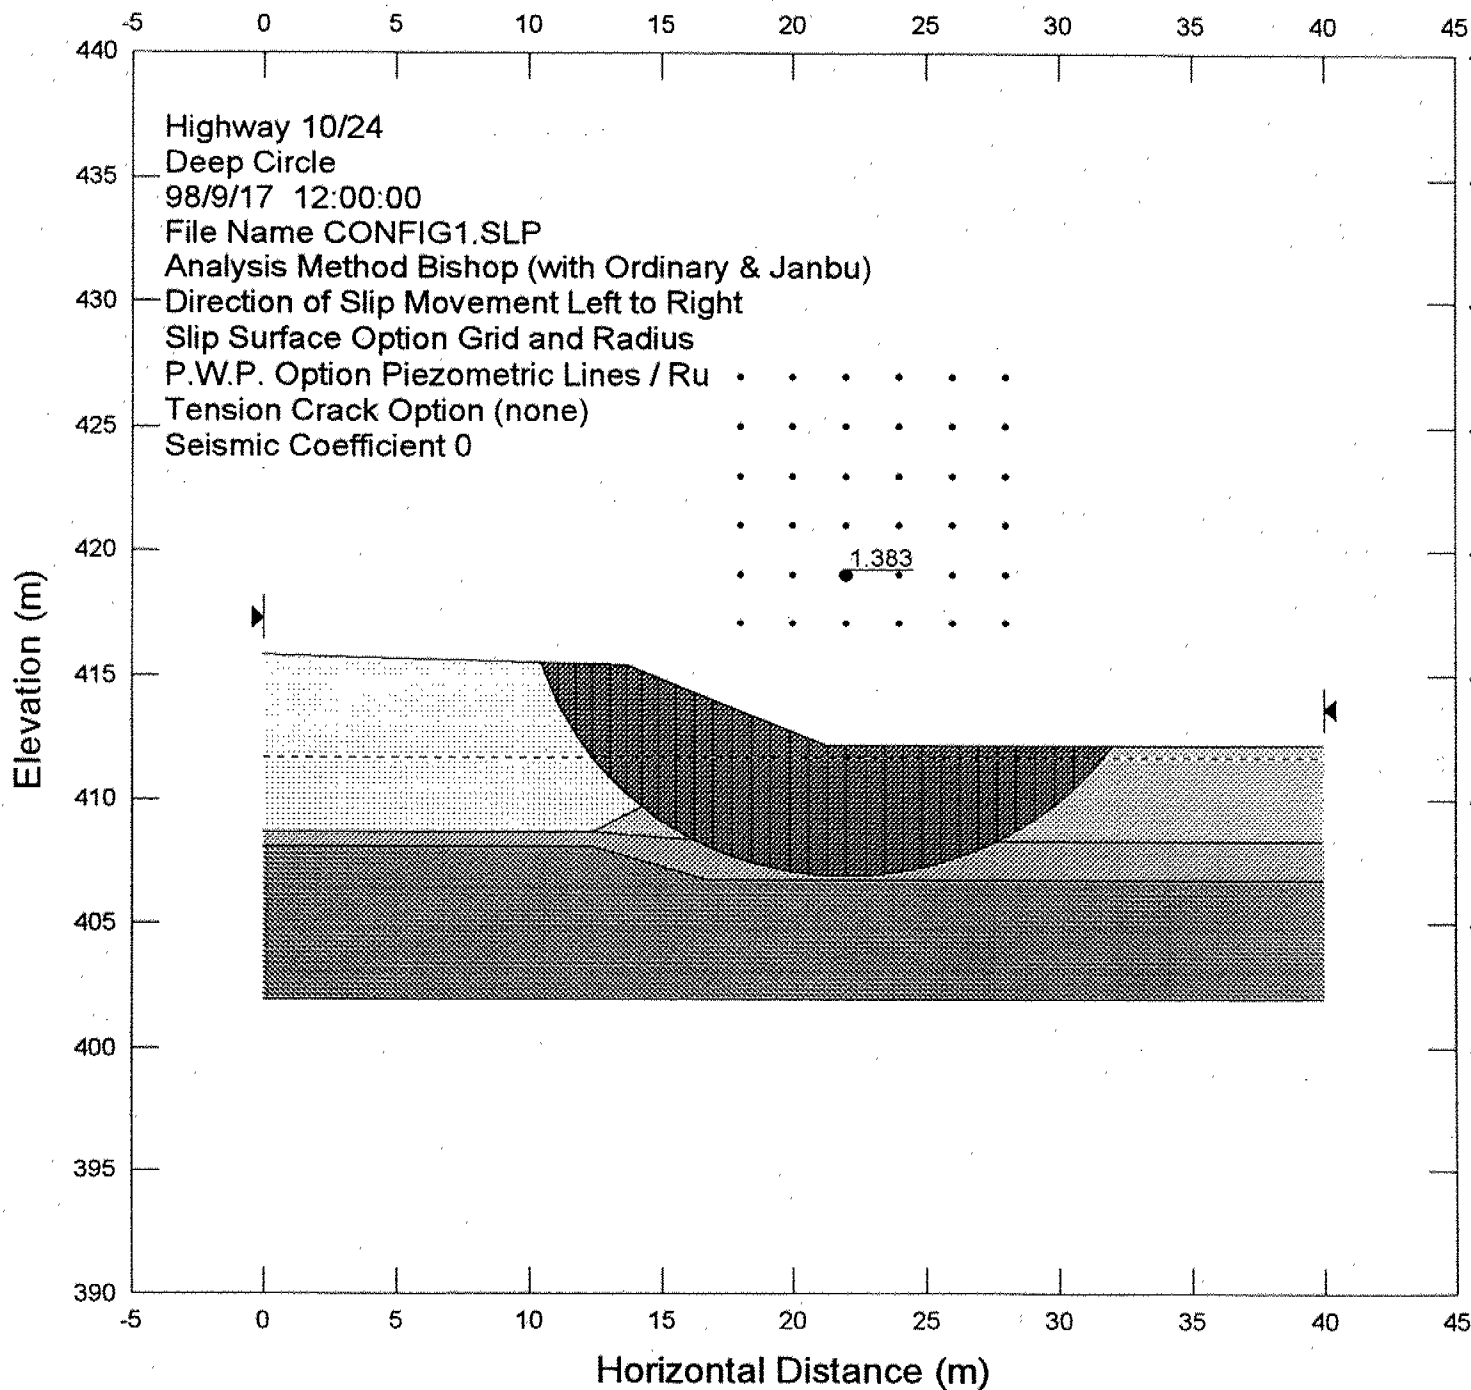
Stability Analysis Result

In view of the presence of the peat, slope stability analyses were carried out to determine the minimum factor of safety for the finished embankment. Since tension cracks occurred at the shoulder location, it is assumed that the failure circle would pass through this point. Using some typical parameters for the various soil types, (ϕ of 35° for the granular fill and peat, 28° for the organic silt, and 45° for the native sand and gravel), the overall minimum factor of safety, at the Borehole A and A1 section, is 1.38. It is our opinion, therefore, that the finished embankment should be stable. The results of the stability analyses are presented in Appendix C.

- Level the granular in the area and proof-roll the area with conventional compaction equipment;
- Place additional granular fill up to 150 mm above the finished grade and compacted to the required compaction effort or 100 percent Standard Proctor Maximum Dry Density;
- Continue the monitoring of the settlement in the area using the settlement plates installed;
- Delay the paving of the base course asphalt as long as possible or until the settlement plates showed little to no movements;
- Repair the granular shoulder as needed over the winter and spring;
- Repair the base asphalt if required in 1999;
- If settlement has been completed, place the surface asphalt in the summer or fall of 1999.
