FOUNDATION INVESTIGATION REPORT

PROPOSED REPLACEMENT/EXTENSION OF
STRUCTURAL CULVERT 8-469C
OVER MEAFORD CREEK
HIGHWAY 26 FROM MEAFORD TO THORNBURY

G.W.P. 57-00-00
Agreement # 3006-E-0002

December 17, 2008
07-6-IEG1-8-469C

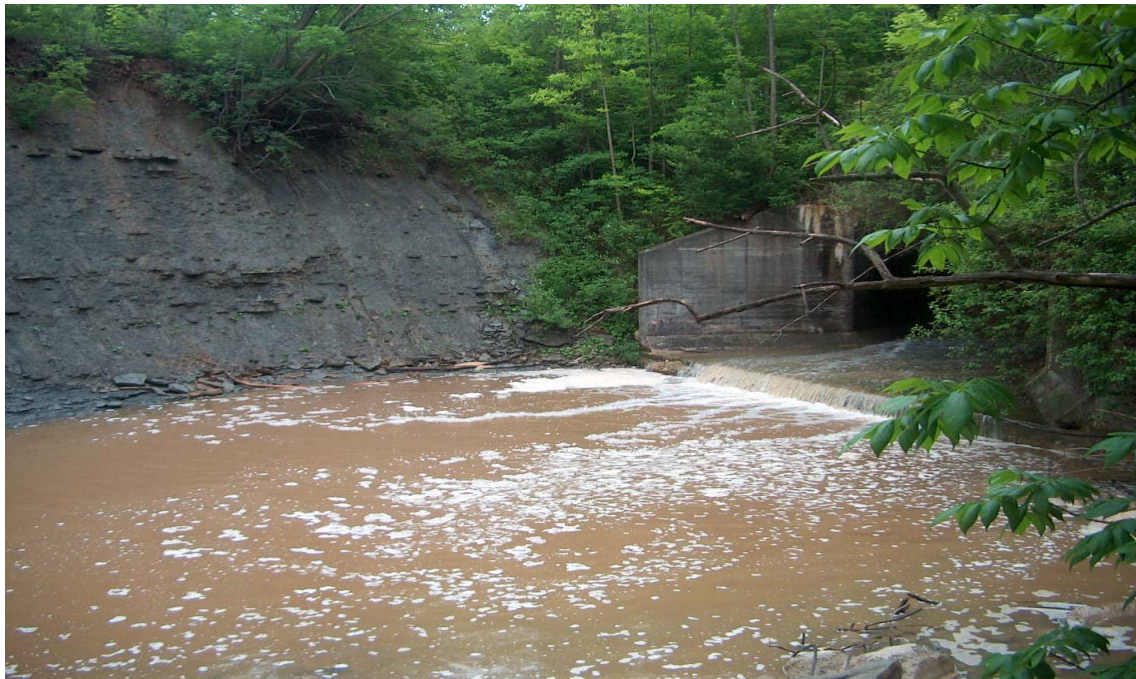
Station 25+314 – Downstream end (Meaford Creek)

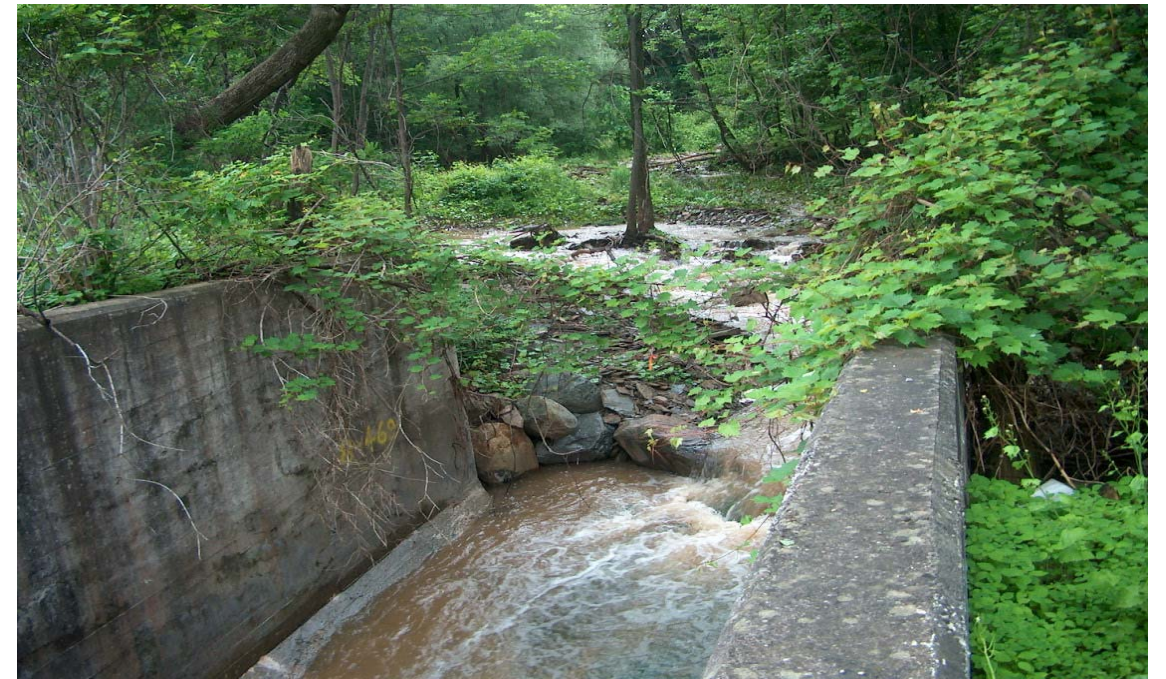
Station 25+314 – Looking upstream (south)

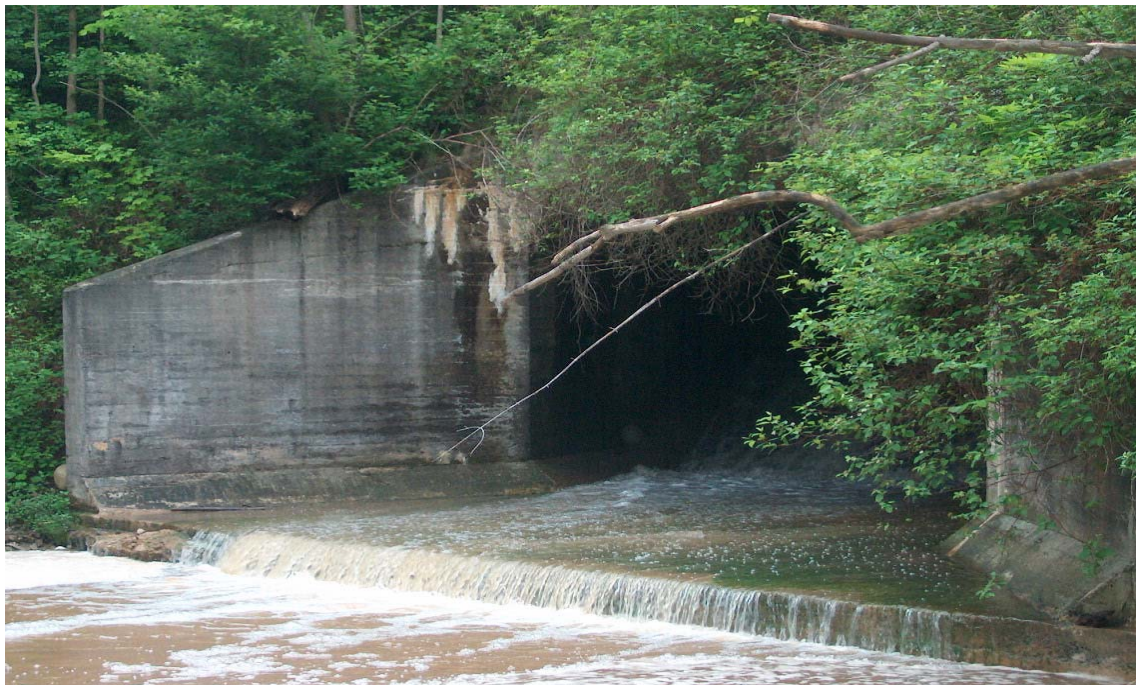
Station 25+314 – Downstream end (Meaford Creek)

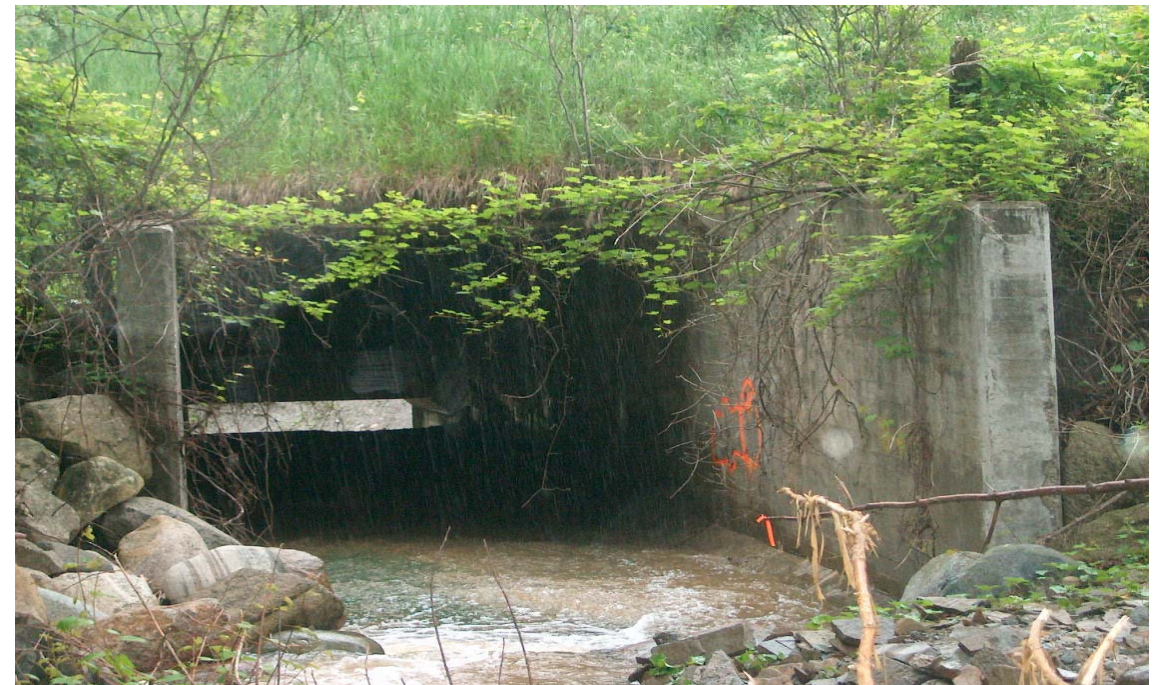
Station 25+314 – Upstream end (south)

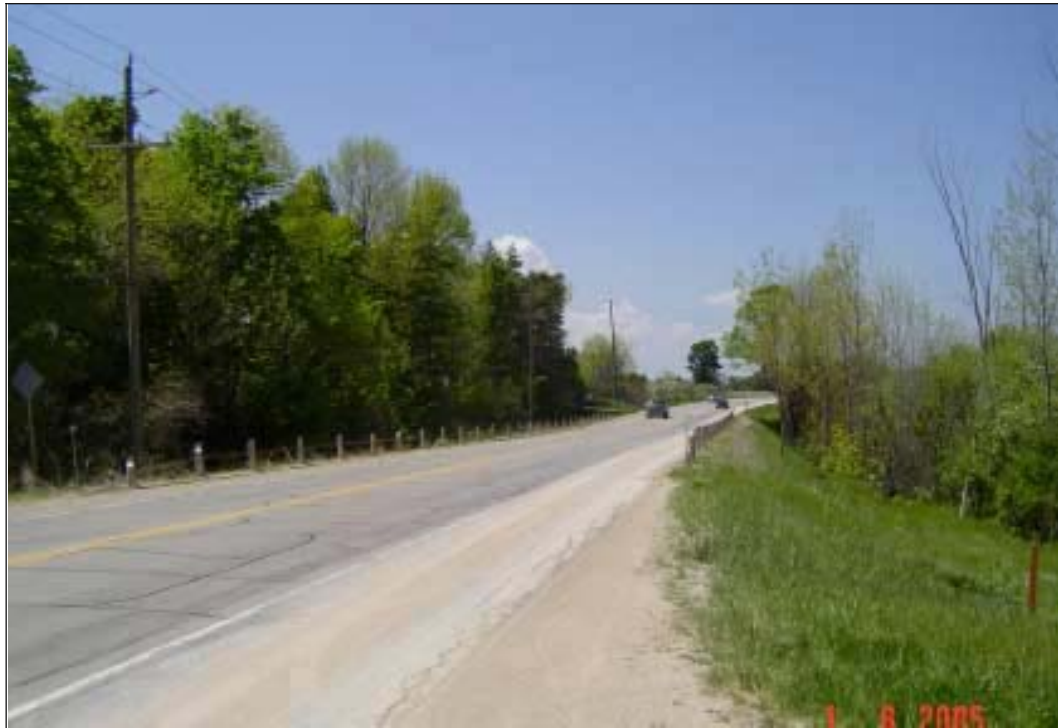
Photo 1: General view of road, looking west.

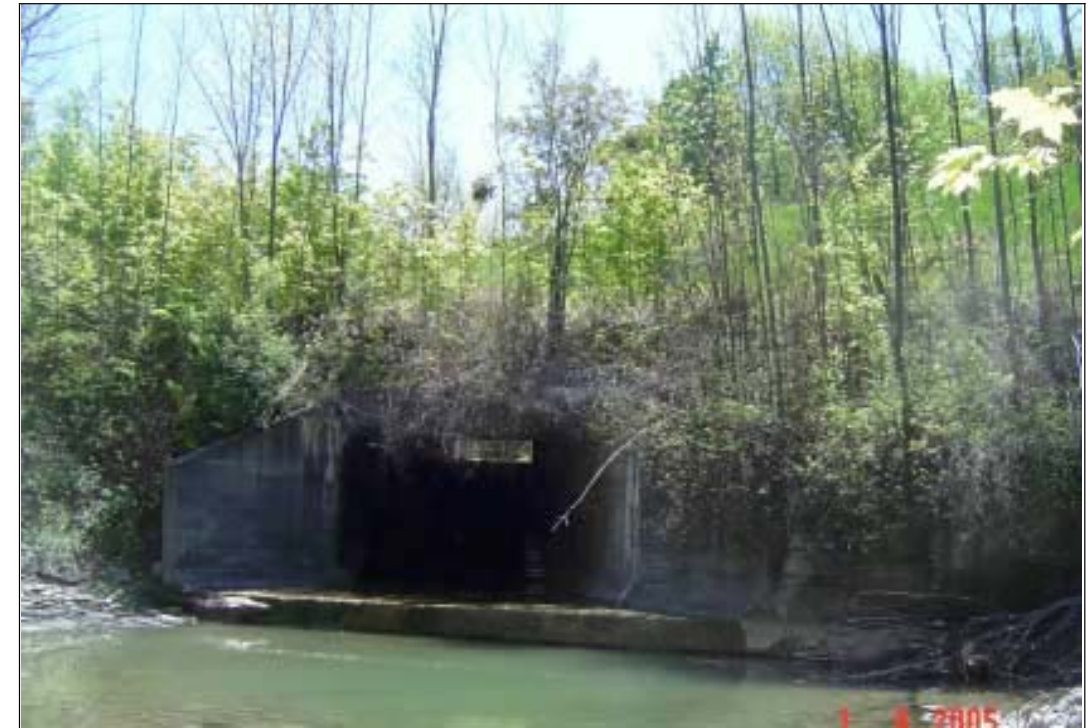
Photo 3: North elevation.

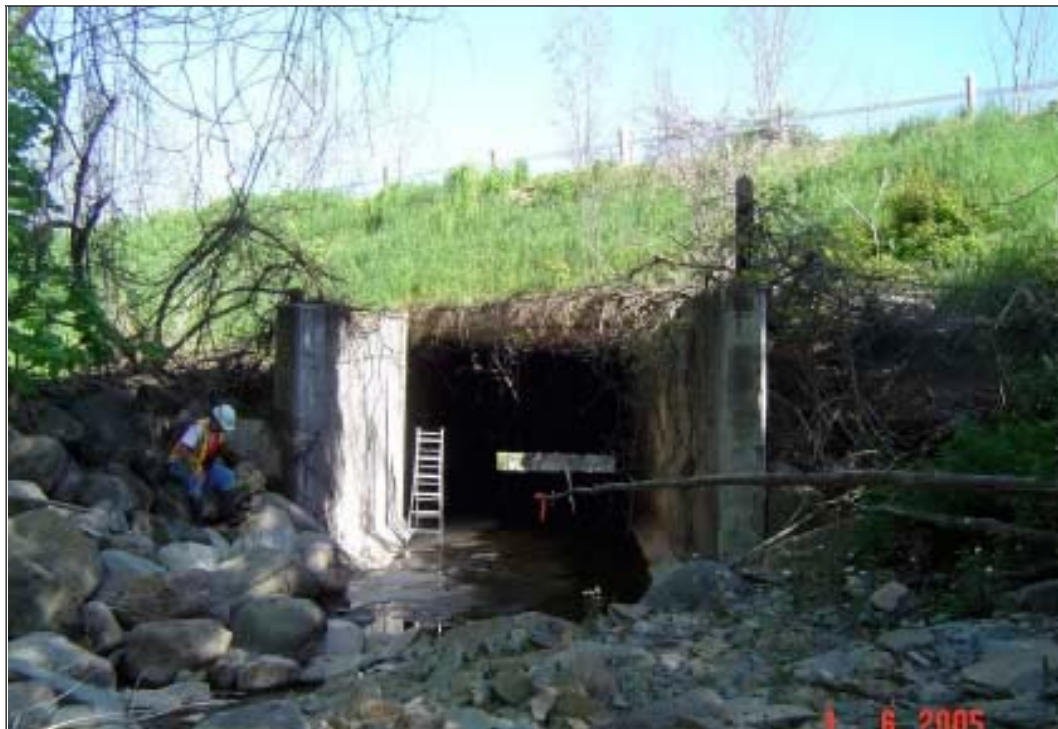
Photo 2: South elevation.

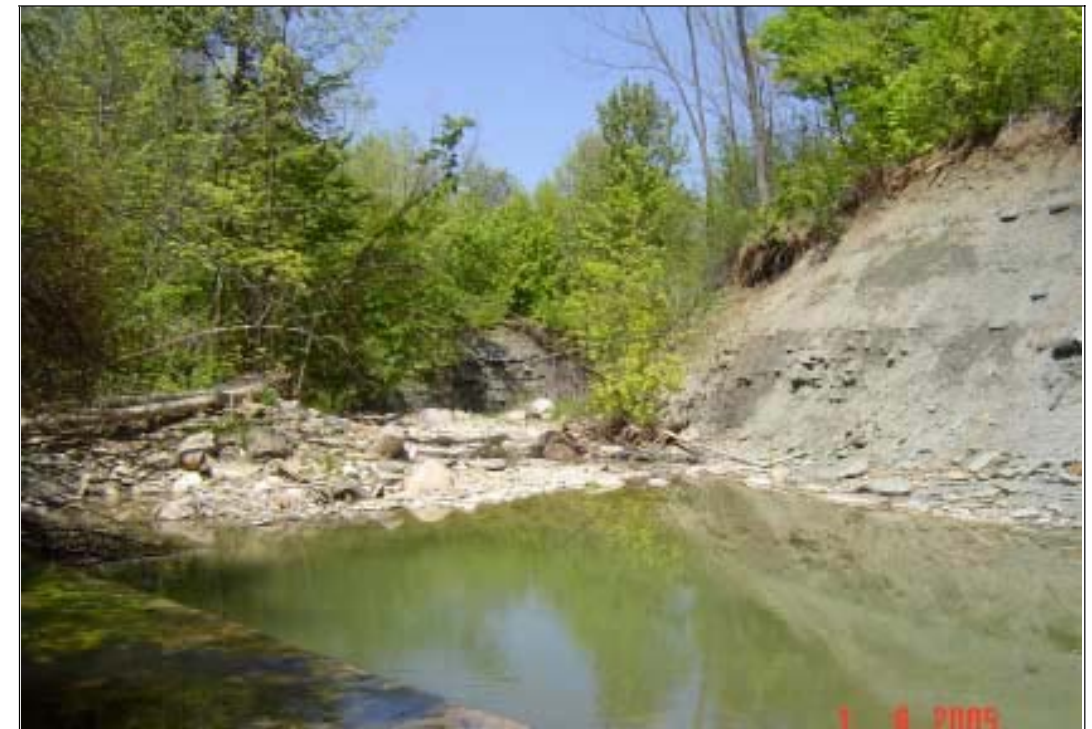
Photo 4: Looking downstream.

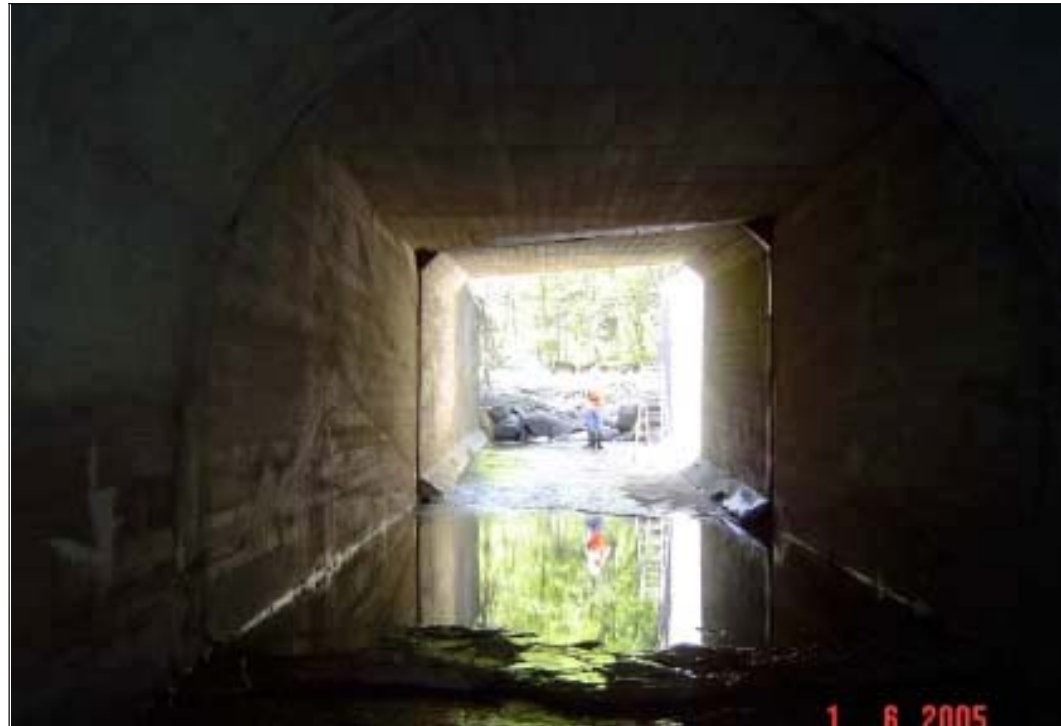
Photo 5: Looking south through culvert.

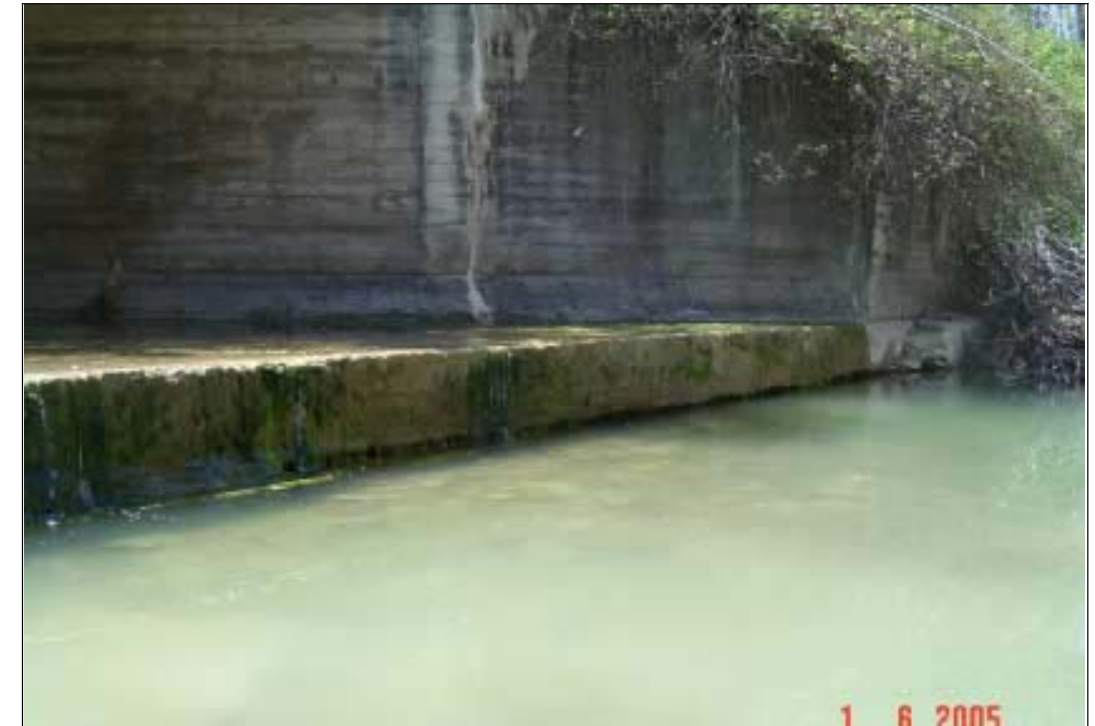
Photo 7: Undermining at outlet.

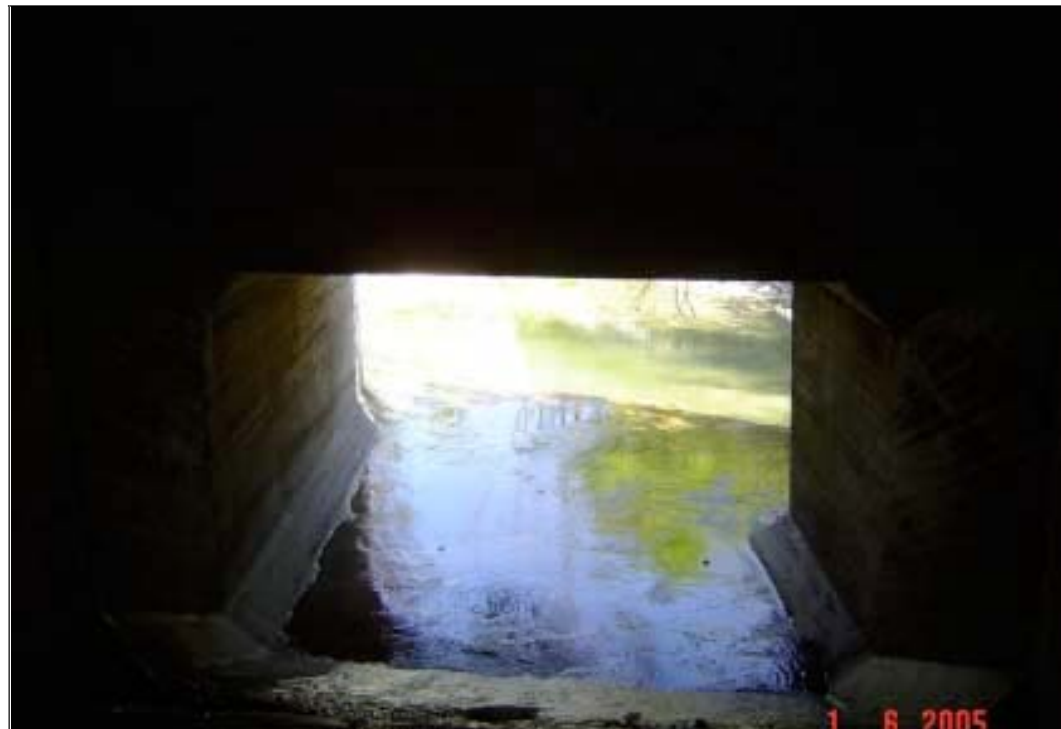
Photo 6: Looking north through culvert.

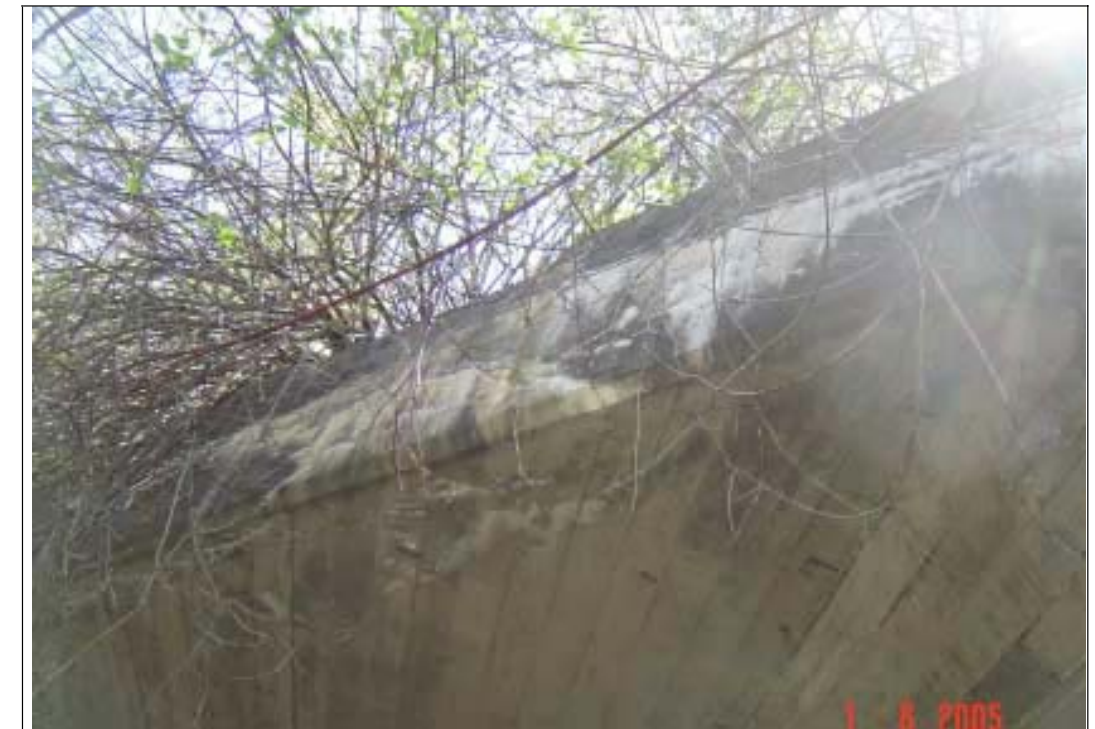
Photo 8: Cracking and leaching at north headwall.

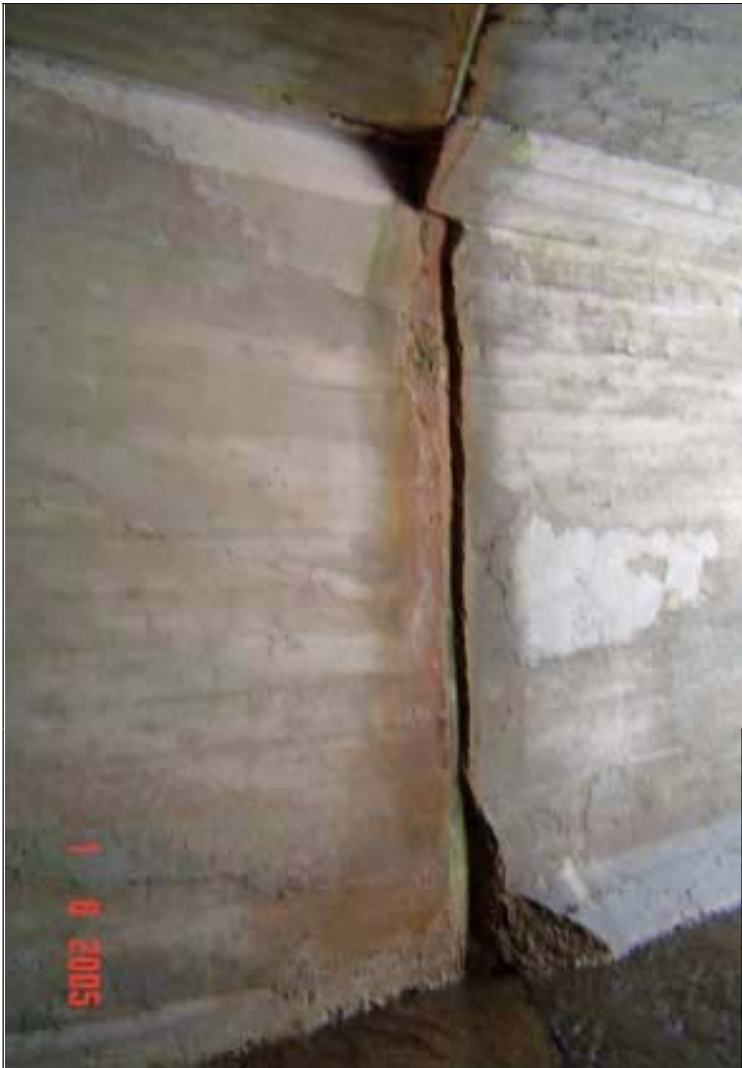
Photo 9:
Typical construction joint at
south extension.

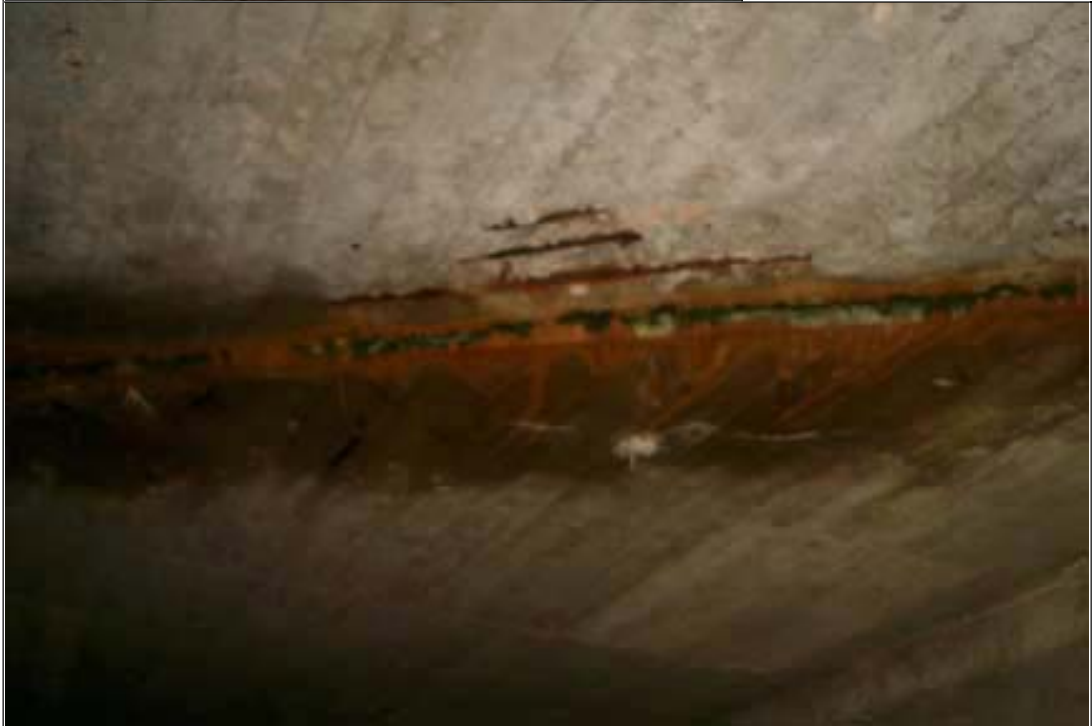
Photo 10:
Delamination and wetness
at soffit construction joint
(south extension).

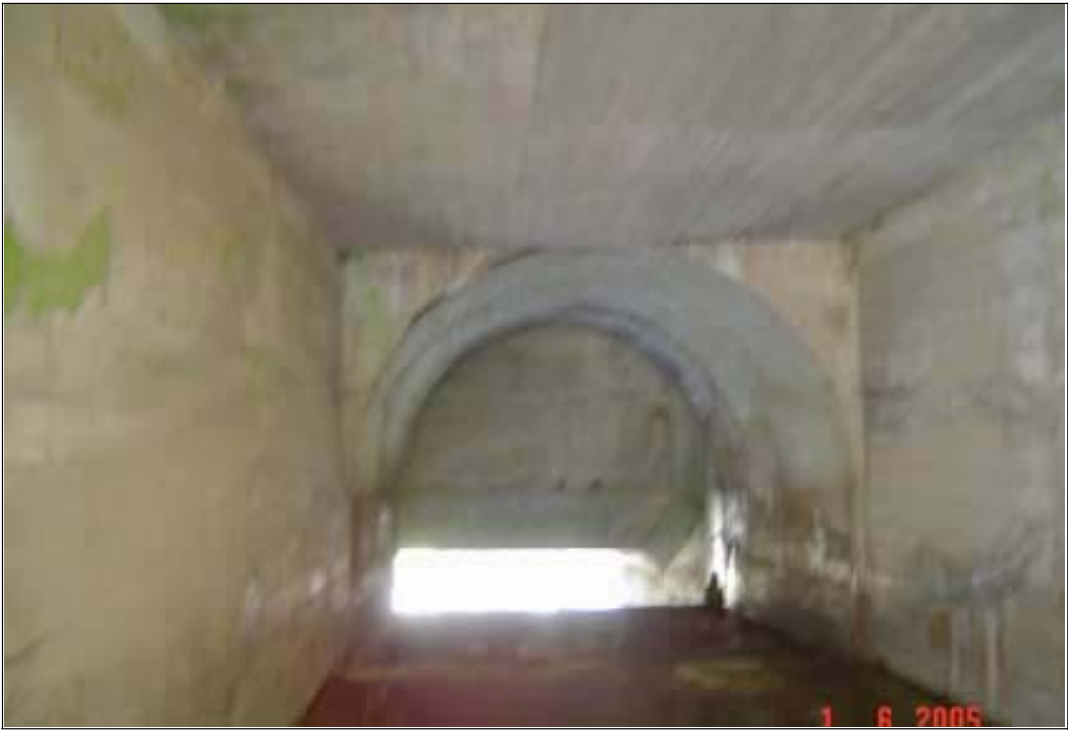
Photo 11: View of arch, looking north.

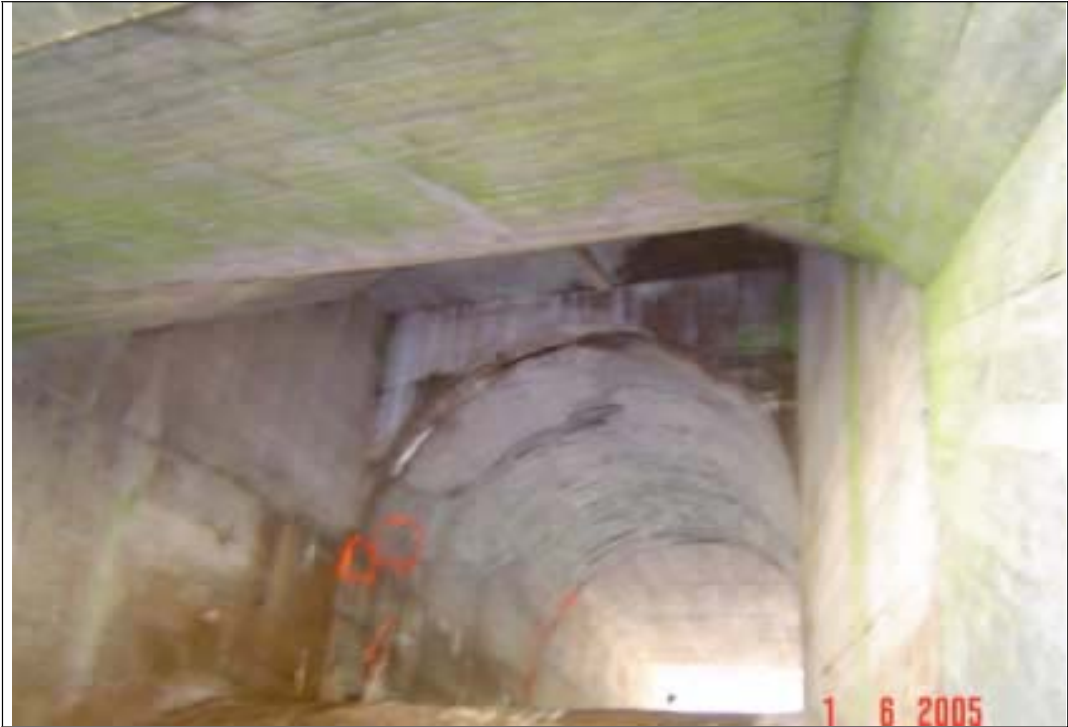
Photo 12: View of arch, looking south.

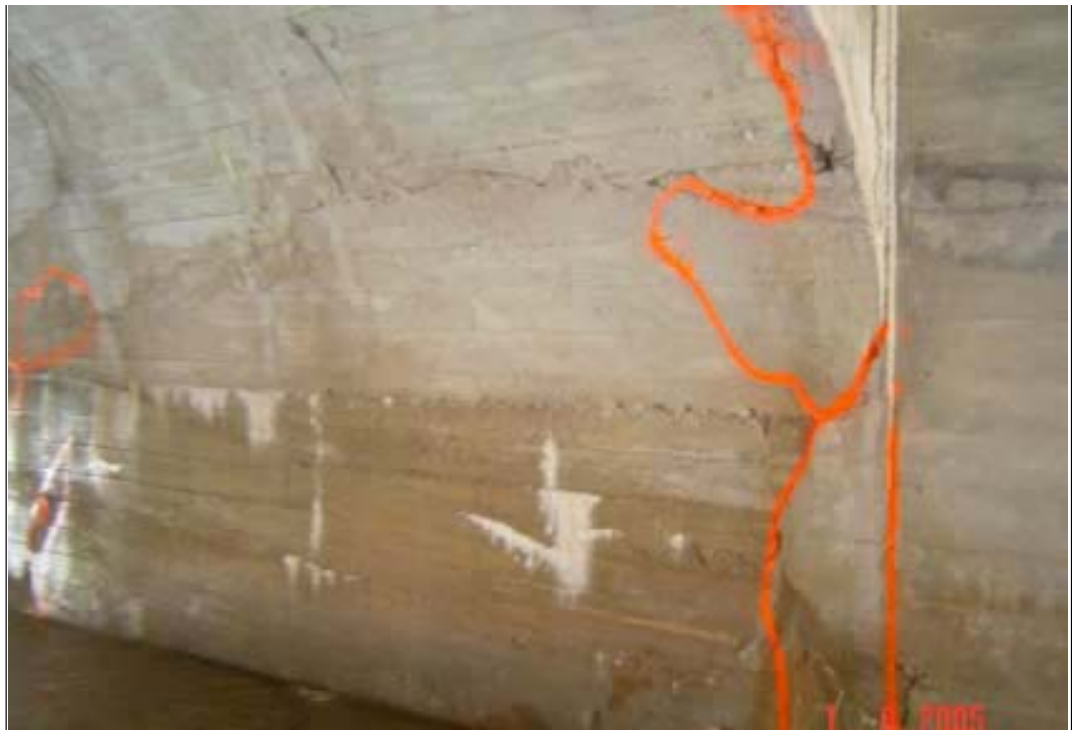
Photo 13: Delaminations and cracks in arch, east wall.

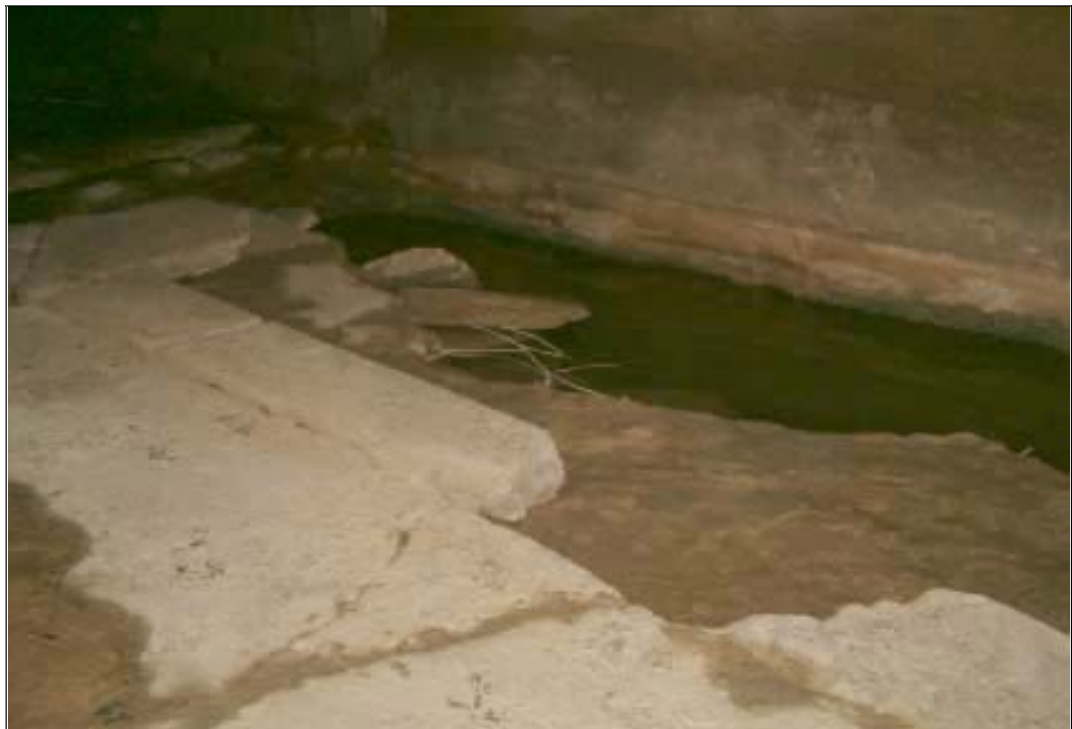
Photo 14: Floor slab failure at arch, looking southwest.

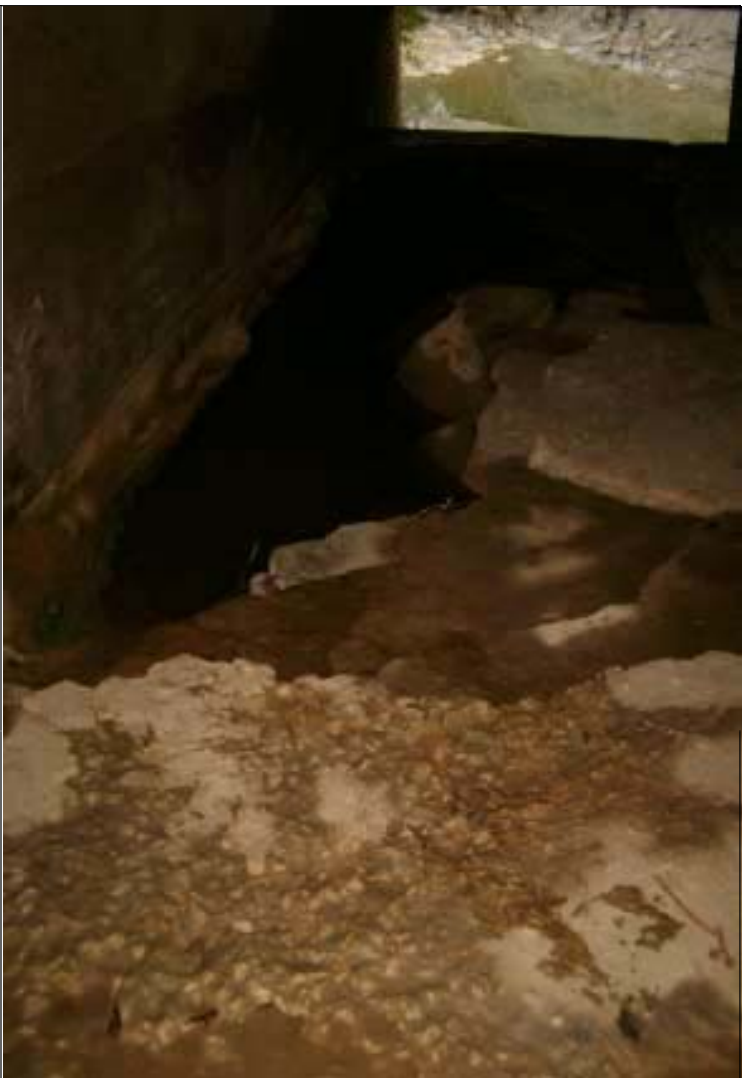
Photo 15:
Floor slab failure at arch,
looking north.

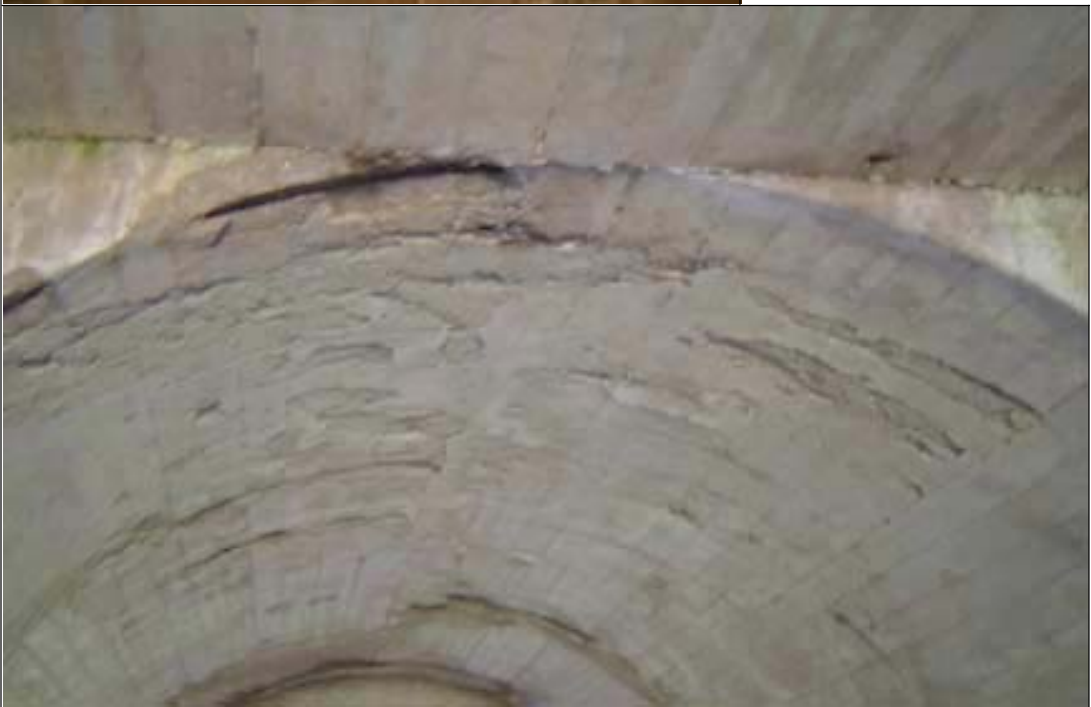
Photo 16:
View of arch soffit, looking
north.
