FOUNDATION INVESTIGATION REPORT

Slope Failures of Cut Sections
Between Eugenia and Kimberley
Development Road #783-1

Artemesia Twp. -- Grey County
District No. 5 (Owen Sound)

W.J. 68-F-35(R)

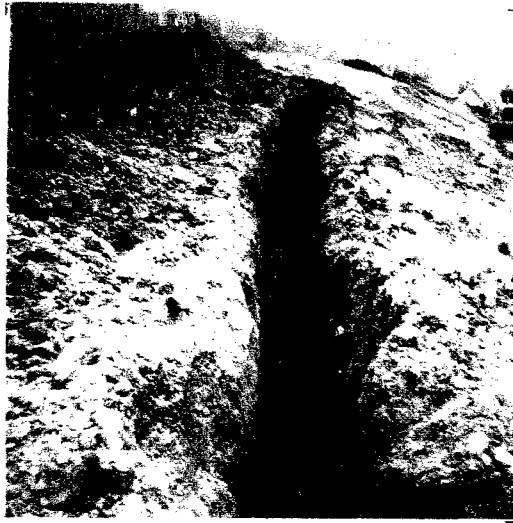
1. 7'± deep trench at top of slope, Sta. 307+50 - 308+00. Water beginning to accumulate at bottom one hour after excavation.

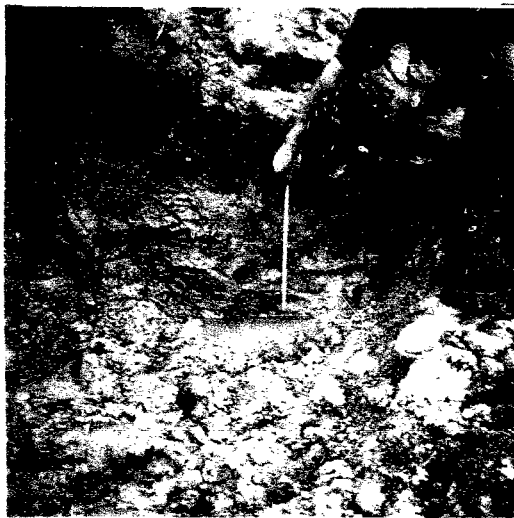
On the high slope between Stations 303+00 and 308+00, excavation of small cuts near the top of the slope revealed a spring or source of water in the vicinity of the slump, or flow type failures that had occurred on the slope (see Fig. 1, Plate II, Appendix III). In some cuts the water was noted flowing out of small sand pockets, whereas in others the water was found to be coming through very thin

1. Accumulation of water from spring at a test pit excavation near the crest of the slope at approx. Sta. 306+00.

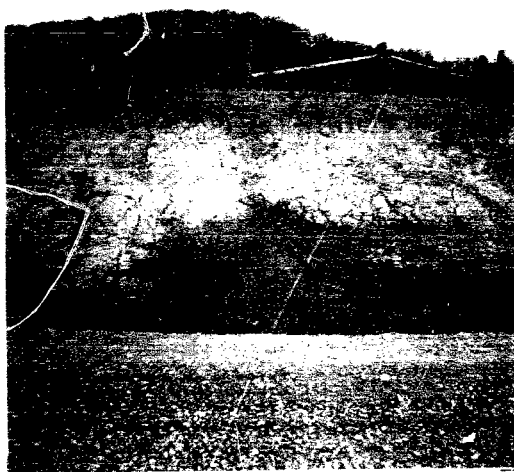
cracks or fissures in the glacial till deposit. Between about Stations 312+00 and 316+00 the surface of the cut slopes is generally dry with the exception of an isolated wet zone in the vicinity of Sta. 315+00. A cut was made into this wetted zone and it was found that the wetness was caused by a spring located approximately 3 ft. below the top of the wetted zone (see Figure 2, Plate II, Appendix III). The spring was found to be emerging from fissures in the subsoil.

2. 10'± high side slope near Sta. 315+00. Excavation revealed spring nearly 3' below boundary of wet and dry soil. Ground behind fence was dry. Note cliffs in background.

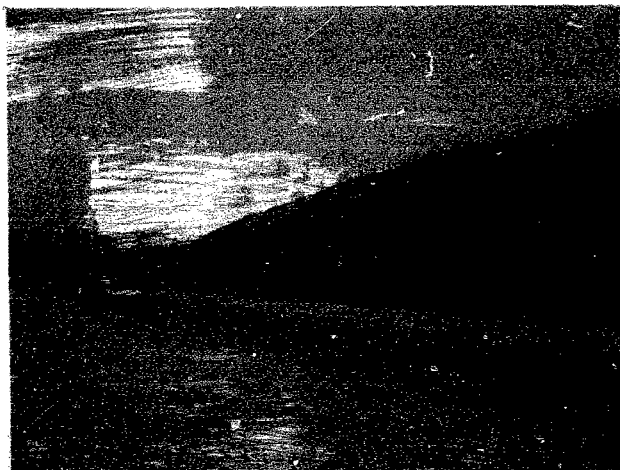
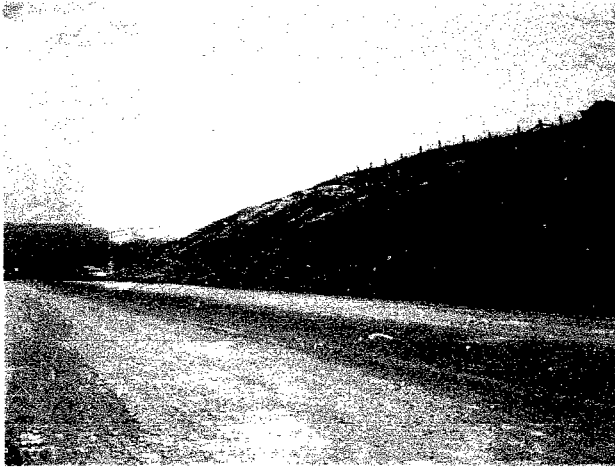
-View of large slope.

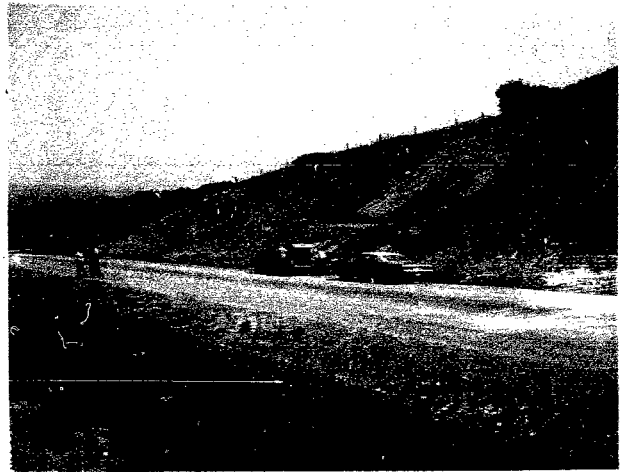
-Large cut.

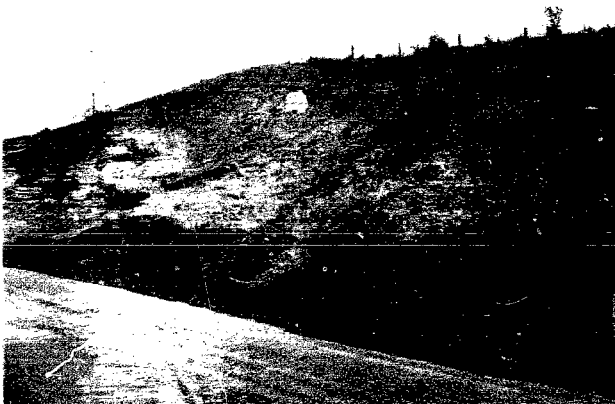
-View of failure south of large slope.

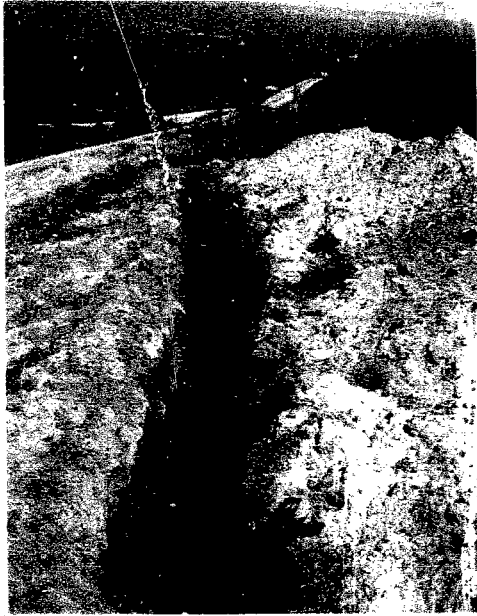
-Looking north along trench on
top of big slope.

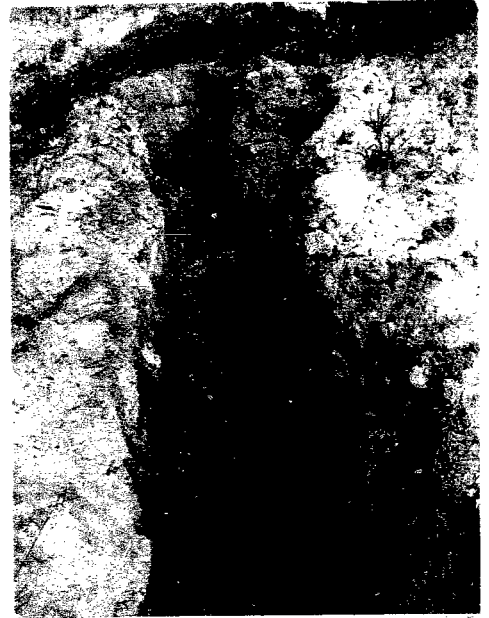
-Trench at top of big cut showing
wet bottom.

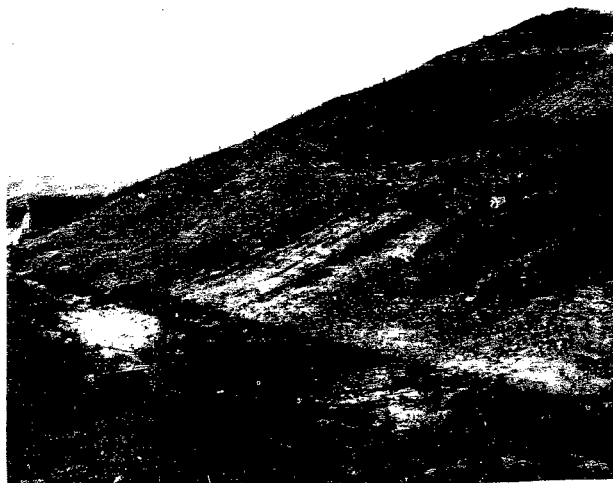
-Closeup of big cut looking north.

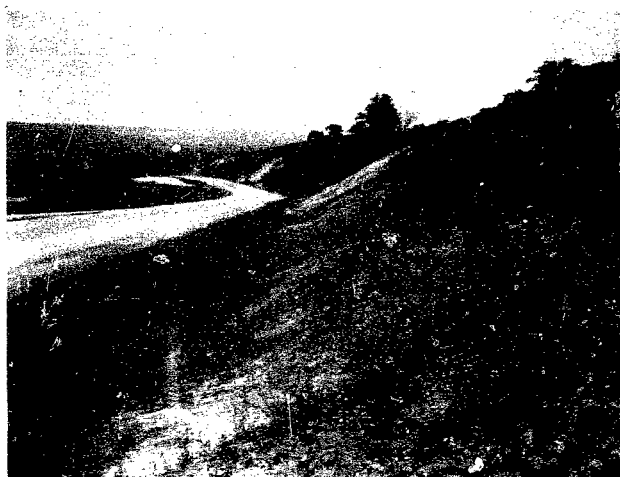
-View of large failures along three
locations. Big cut failure is last in
picture.

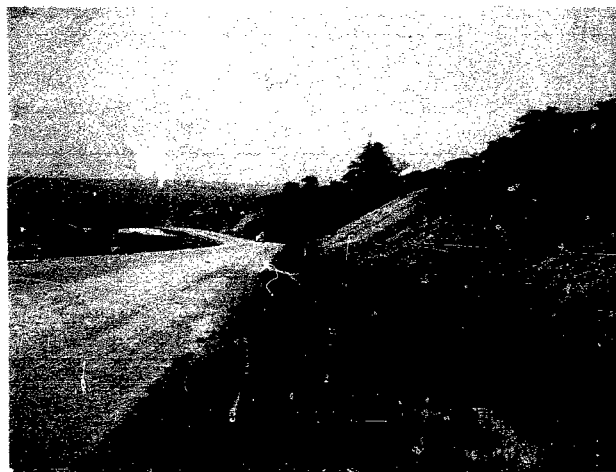
-View of 3 slope failures with
largest cut slope in background.

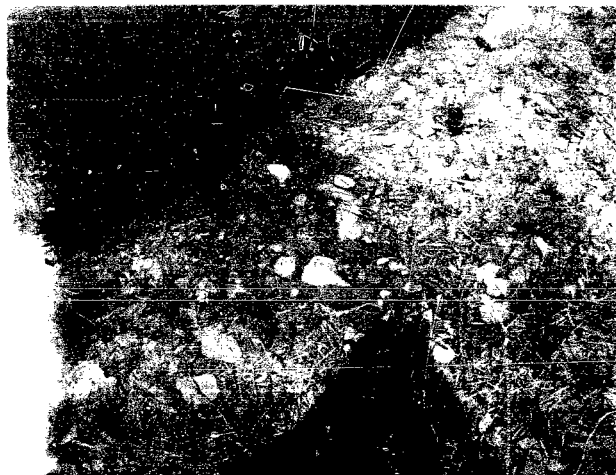
-View of spring water emerging
from toe of cut slope.

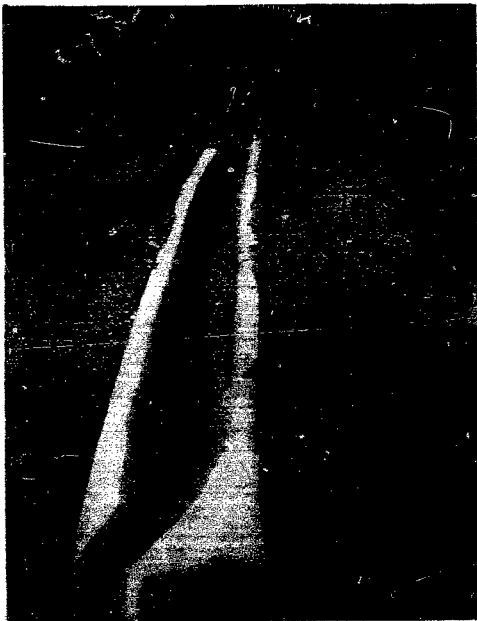
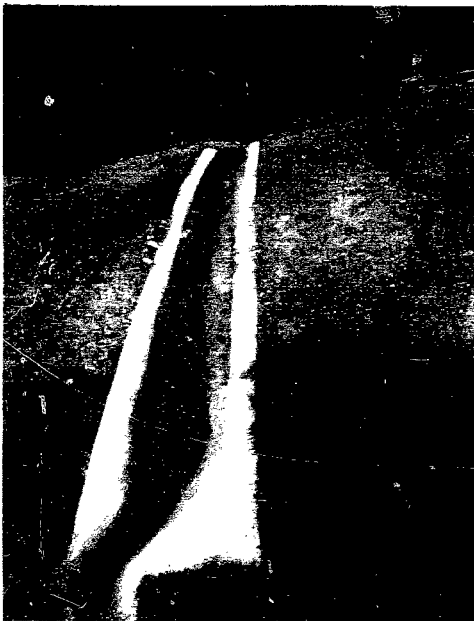
-Water flowing-spring located at
top centre of picture.

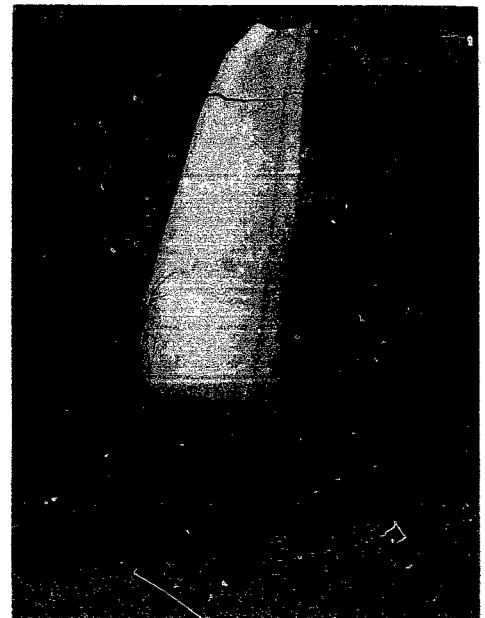
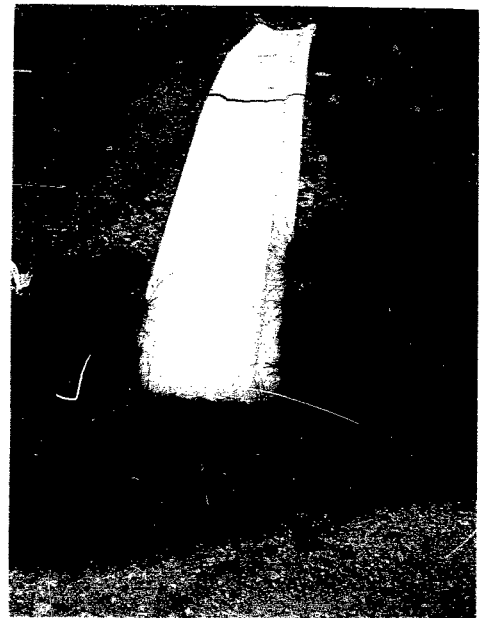
-Ponded water, collected from
spring flowing beneath cracked
concrete drainway.

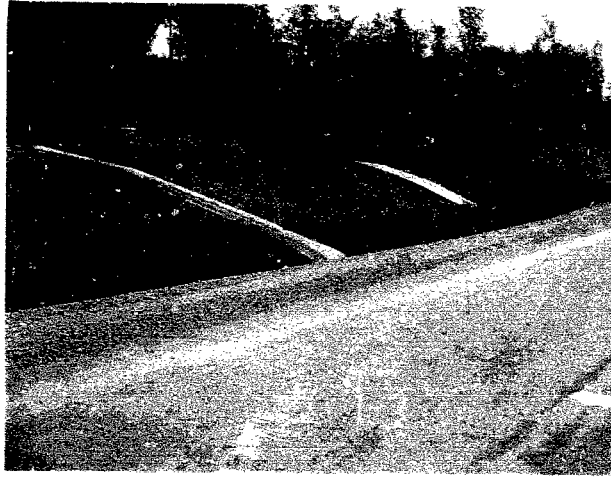
-Water flowing from concrete drain as it did
in April 1968. No water in concrete drain
in background which has cracked due to
removal of soil support beneath it by
erosion of springs.

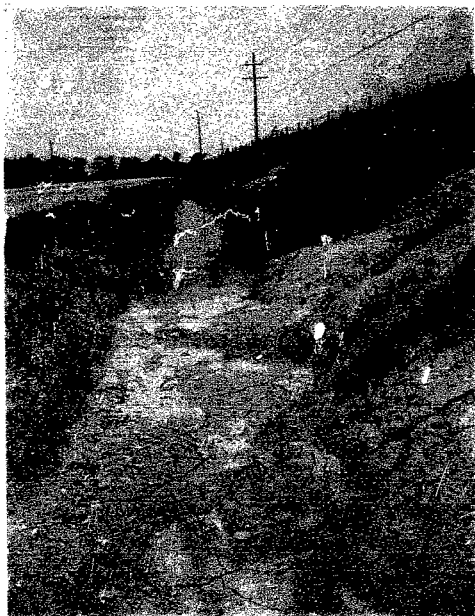
-Water in roadside ditch; evidence of springs in slope.
